Inspection Photos
Operator: Simcoe
API: 067-08408
Date: 3/9/2021

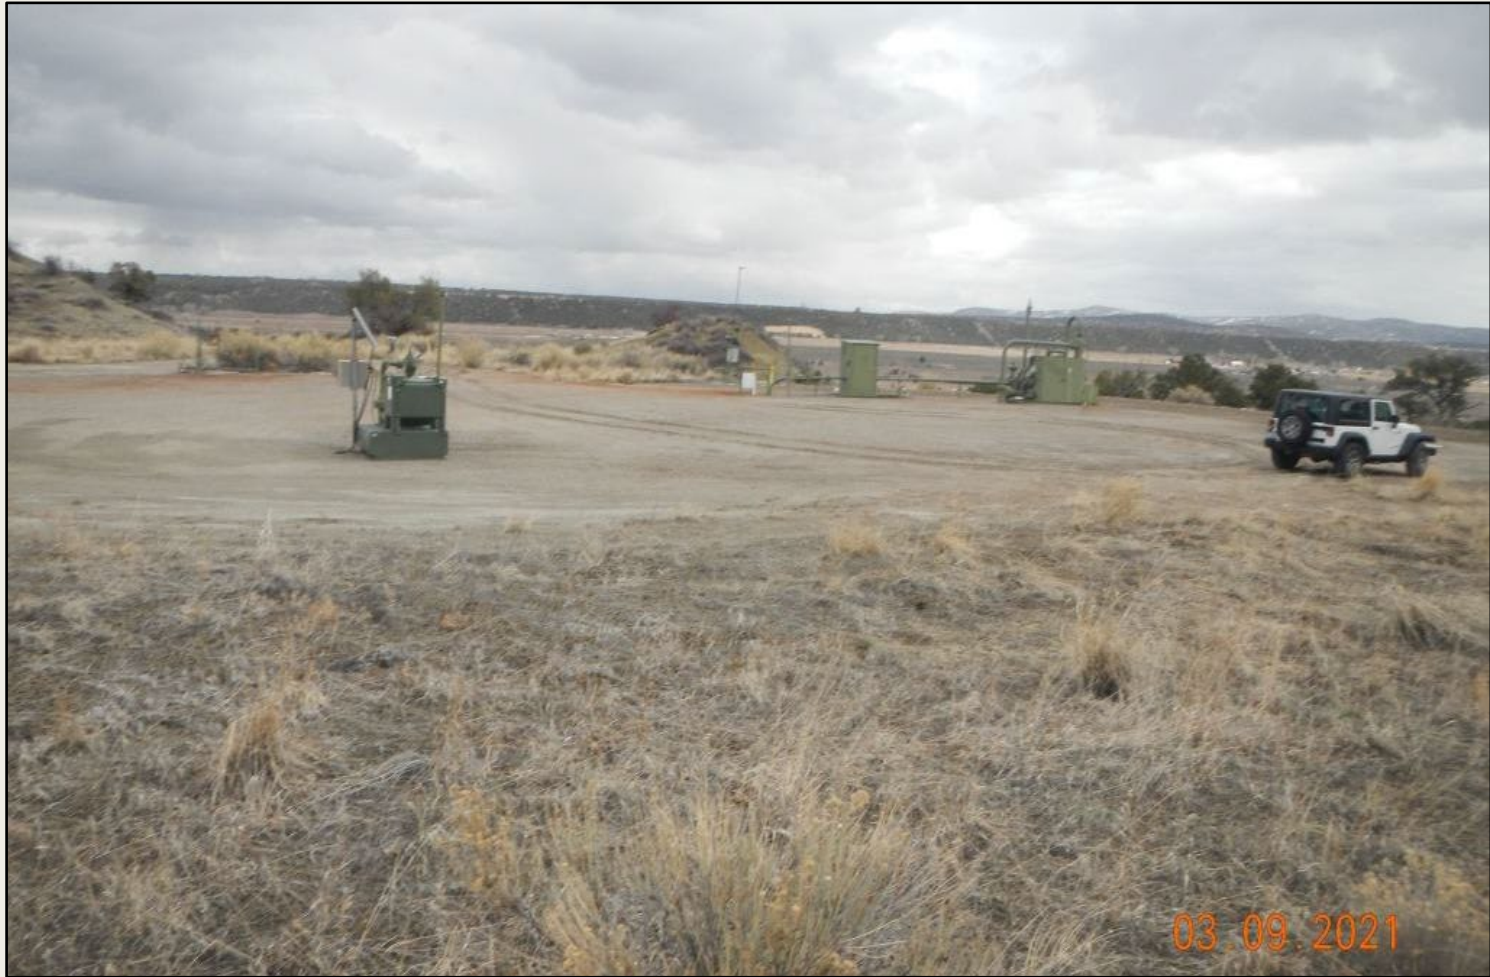
Photo 1. View of the project area from the southwestern edge facing center. Revegetation is conducted in portions of the well pad identified during 2019 reclamation inspection, continued monitoring and management is needed. Russian thistle debris needs to be removed and managed.

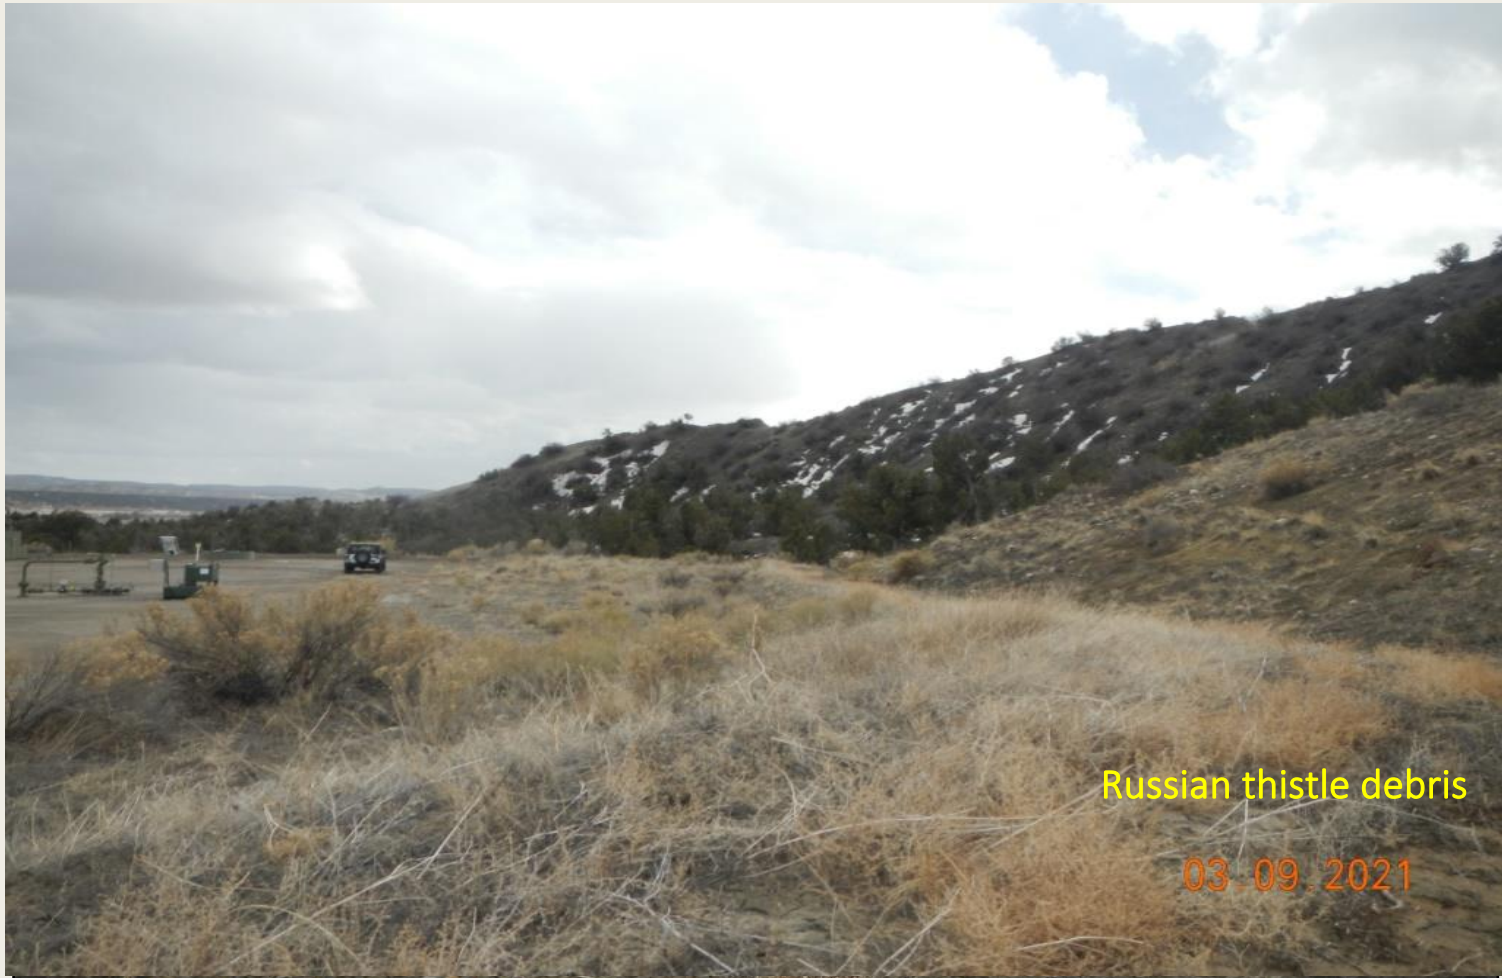
Photo 2. View of the western project area facing southward. Revegetation is progressing with sand dropseed, western wheatgrass, and rubber rabbitbrush. Dense Russian thistle debris observed along the western diversion.

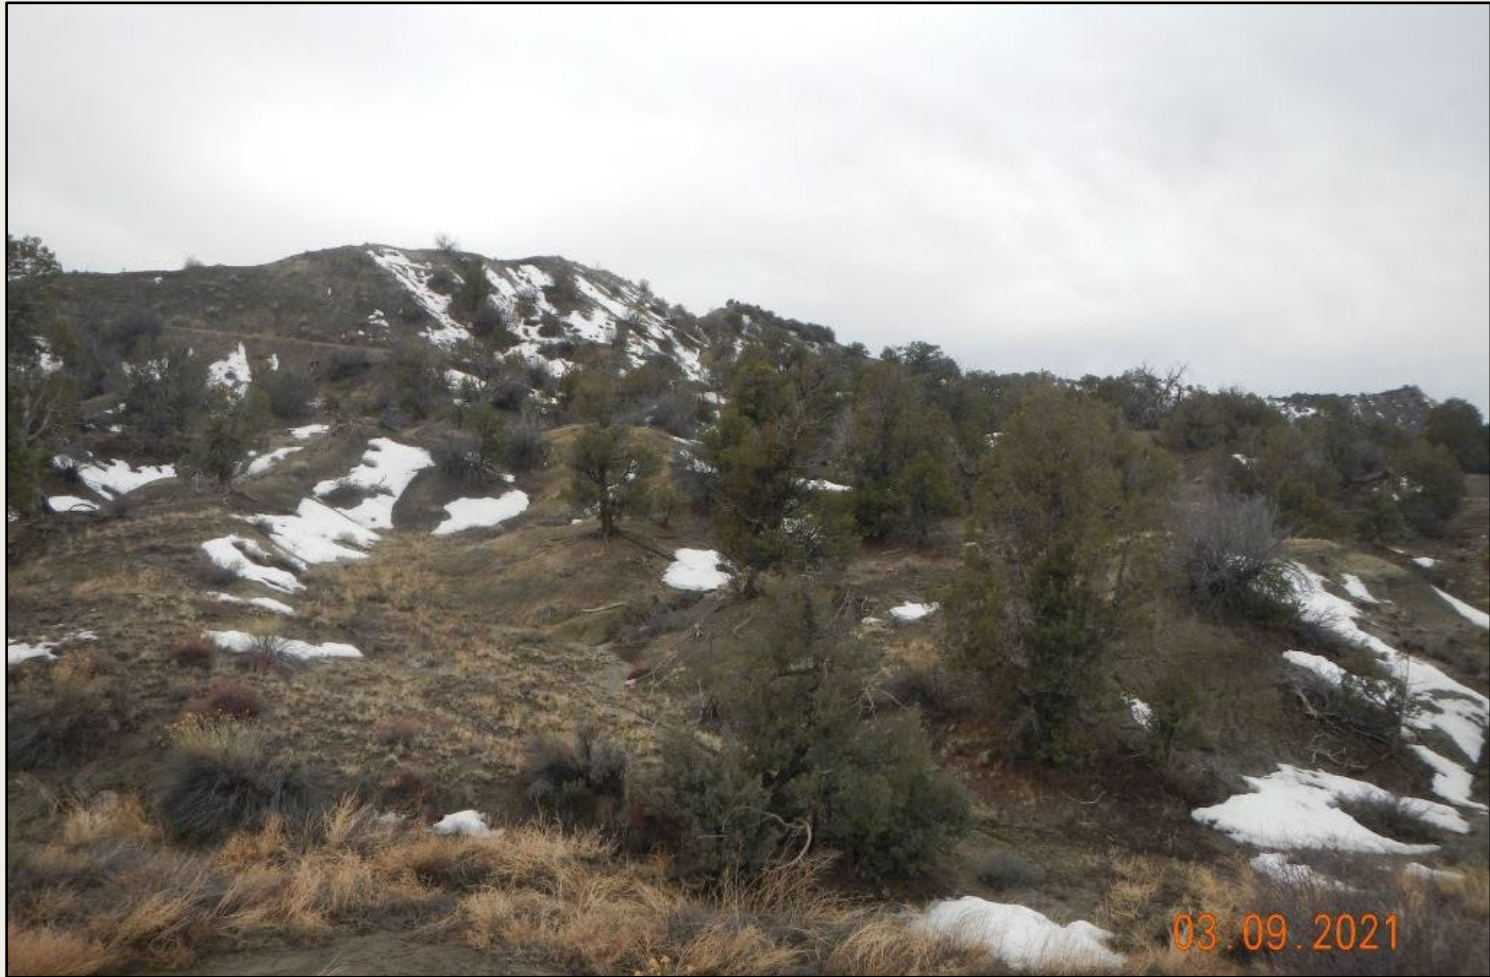
Photo 4. View of the reference area comprised of pinyon and juniper woodland, with understory of grasses and forbs such as Palmer's penstemon and Indian ricegrass.
