Inspection Photos
Location Name: Bentley 11-25
Location: 324025

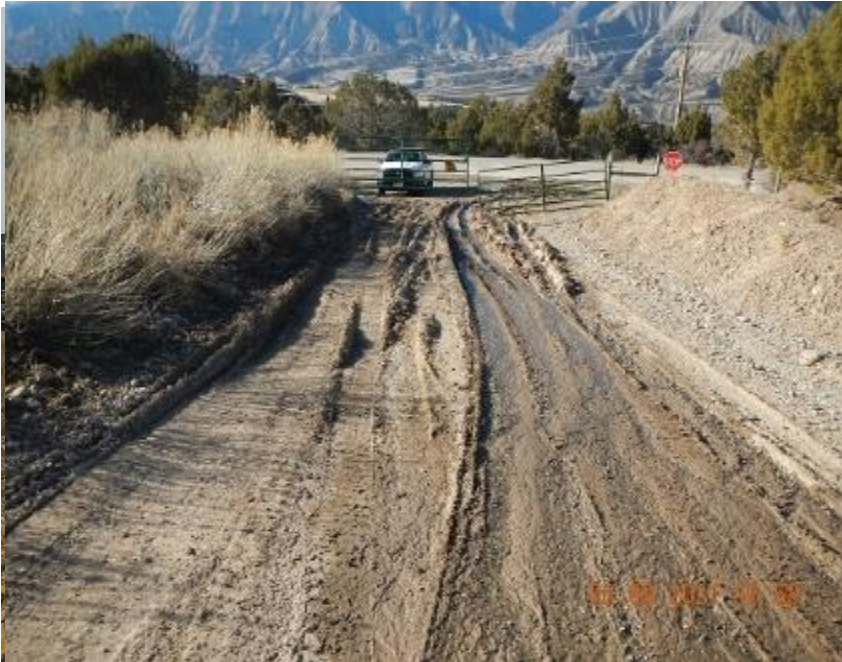
Lease road entry from CR 301

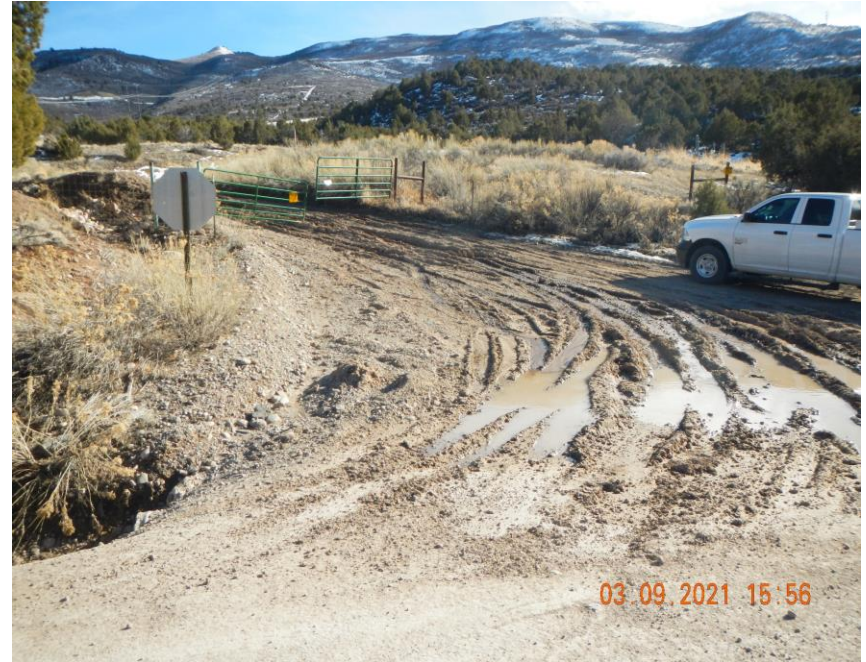
Lease road looking SE From CE 301.

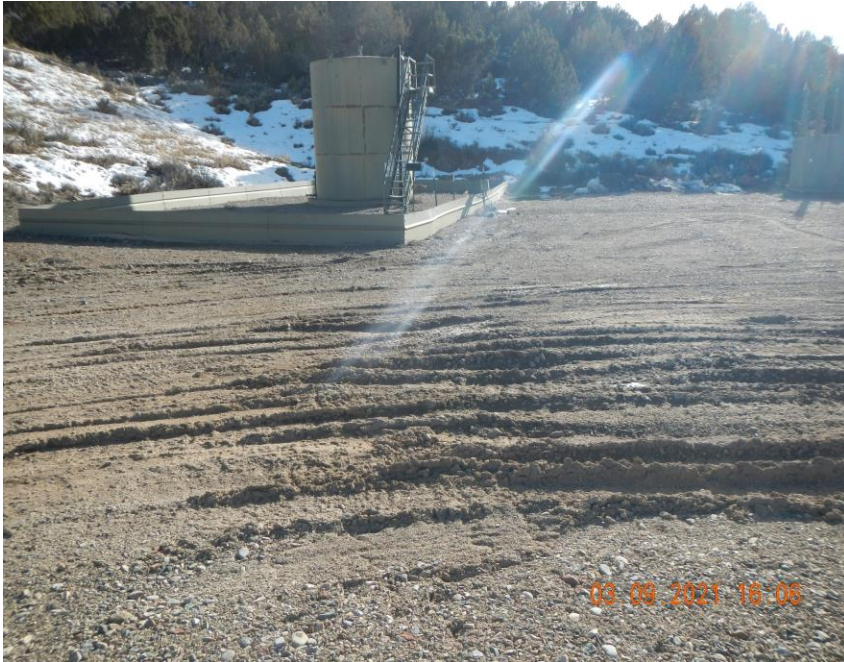
Location shows inconsistent stabilization

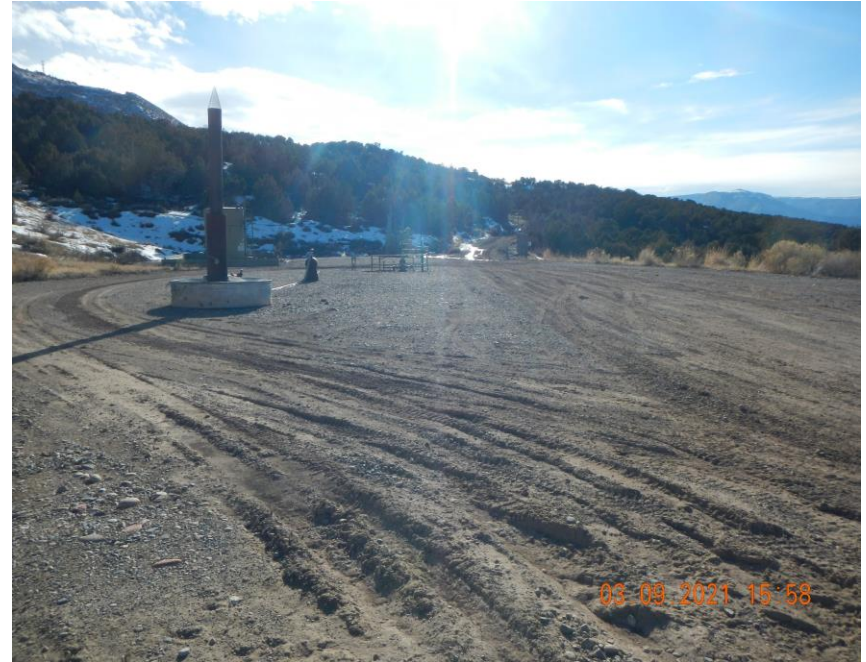
Tracking occurring from location onto the lease road.

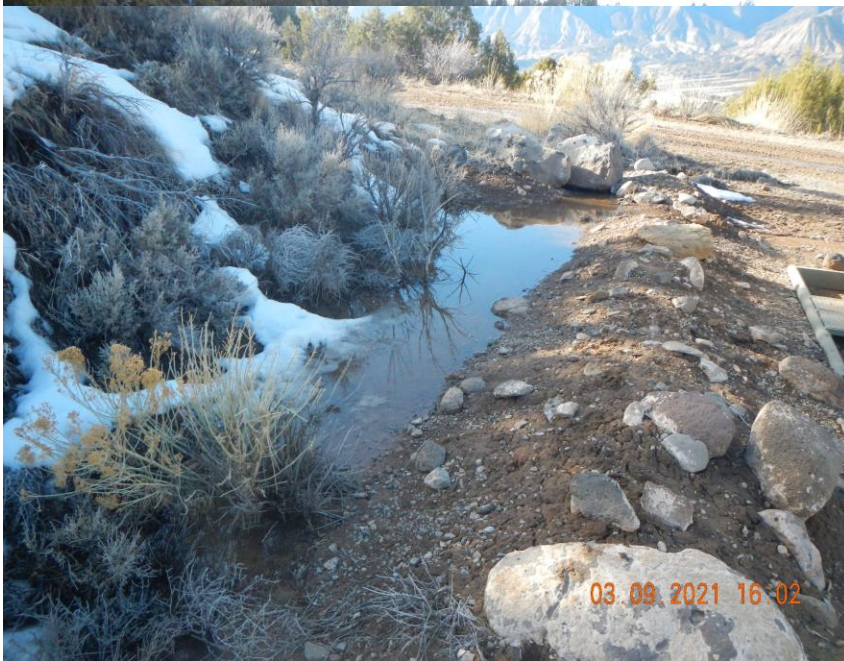
Storm Water is impounded, and saturating the soil along the pad edge and lease road used to access facility # 268858

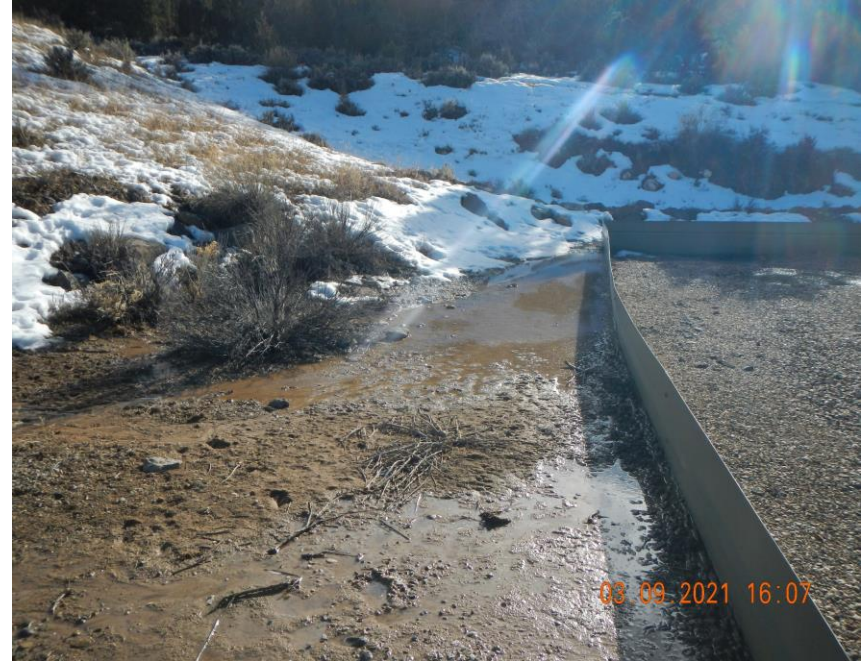
SW run-on and sediment are impeded by the production tank battery berm at the south corner of location

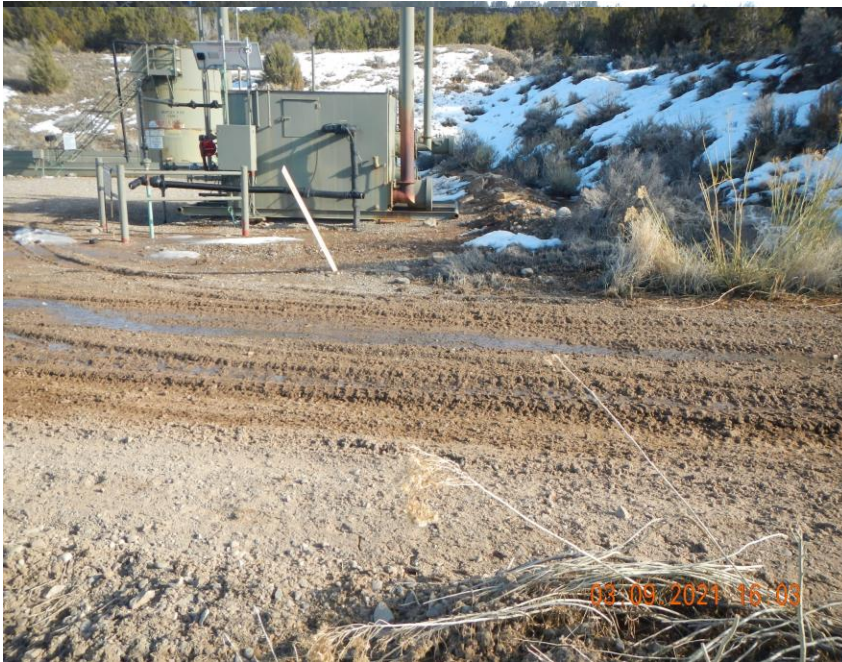
Storm water is allowed to move across location and lease road at the west side of location.

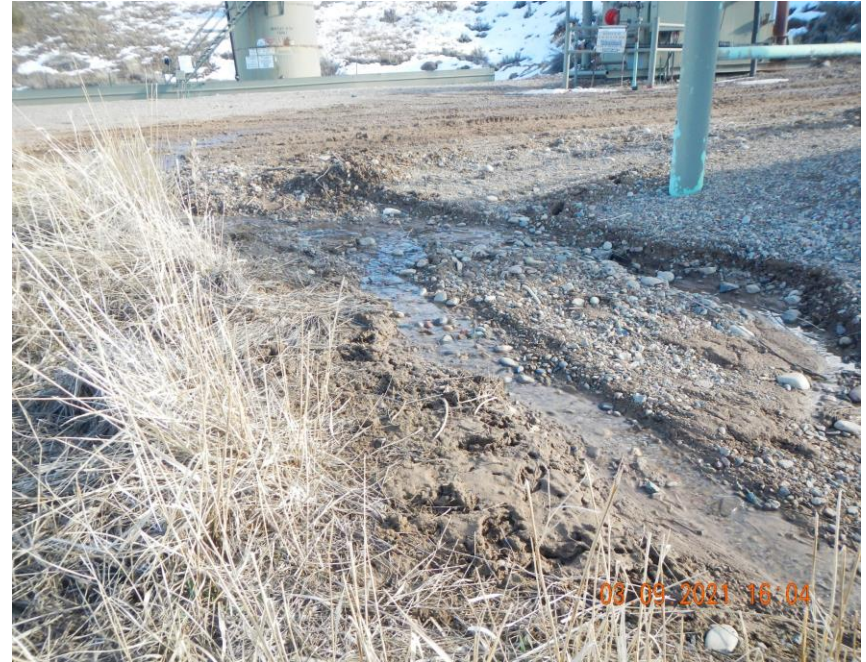
Storm water run off is causing migration of sediment from the pad surface to the vegetated areas on the North side of location.
