Inspection Photos
Location Name: Harris
Location: 311678

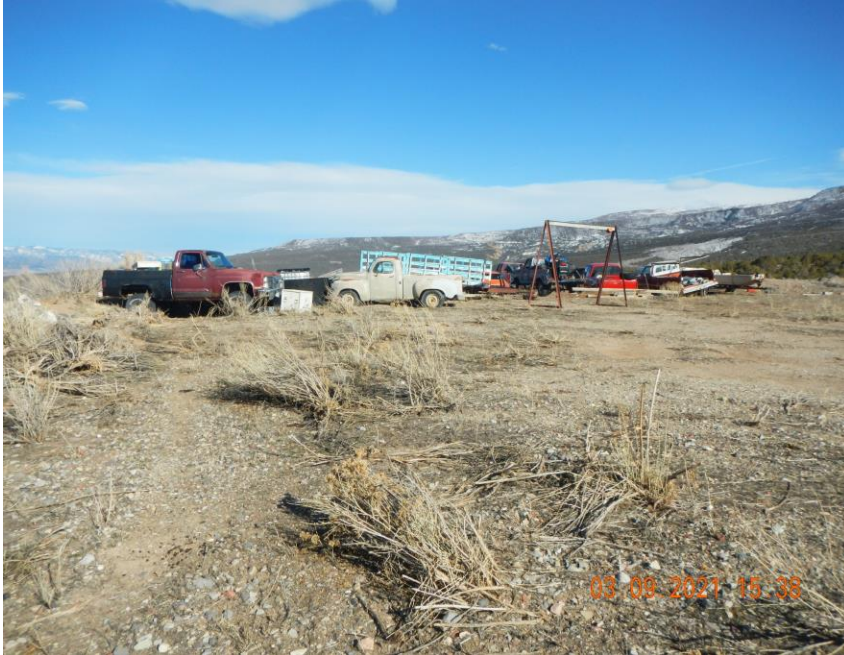
Vehicle Storage at the North corner of location

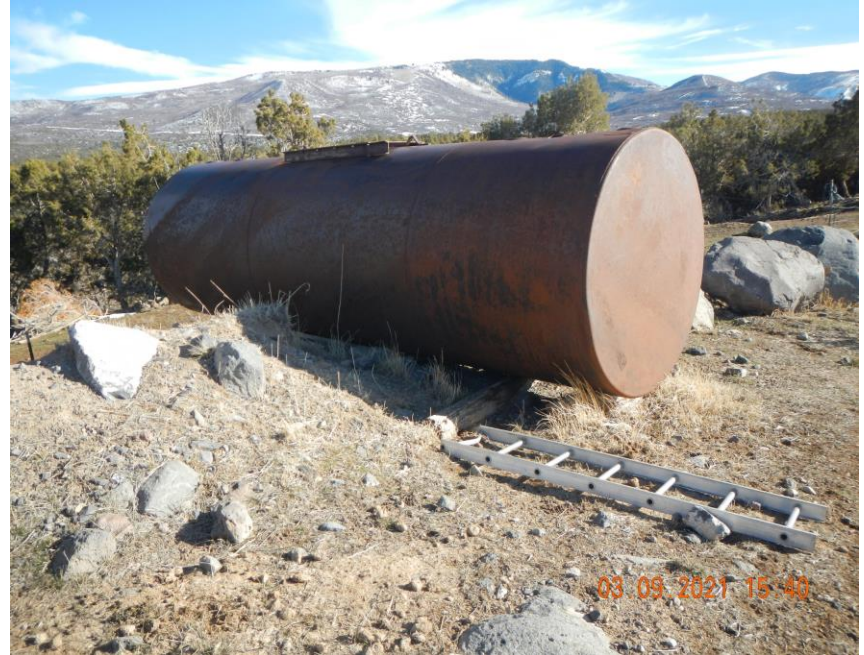
Tank stored on the East edge of lease

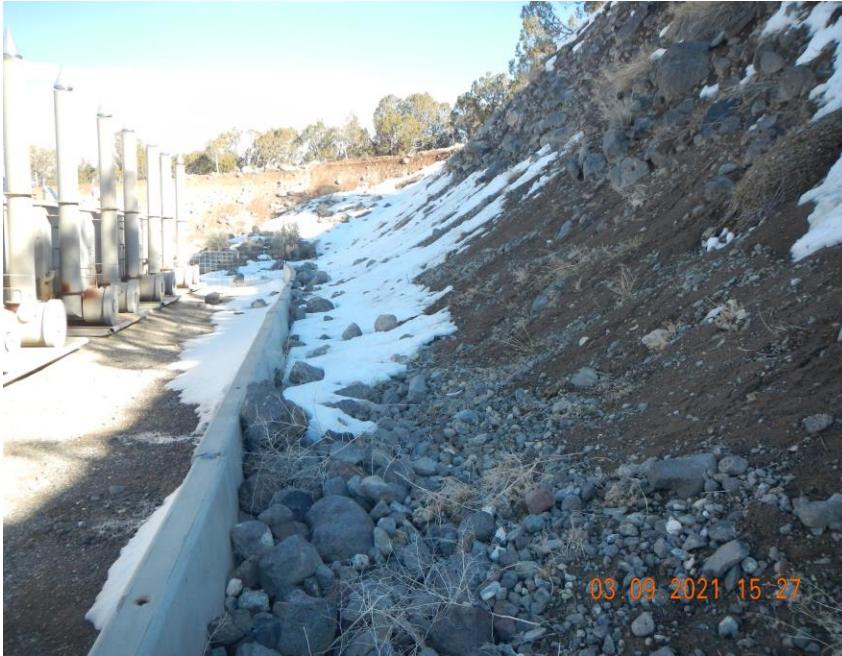
Slope not stabilized on the South cut slope

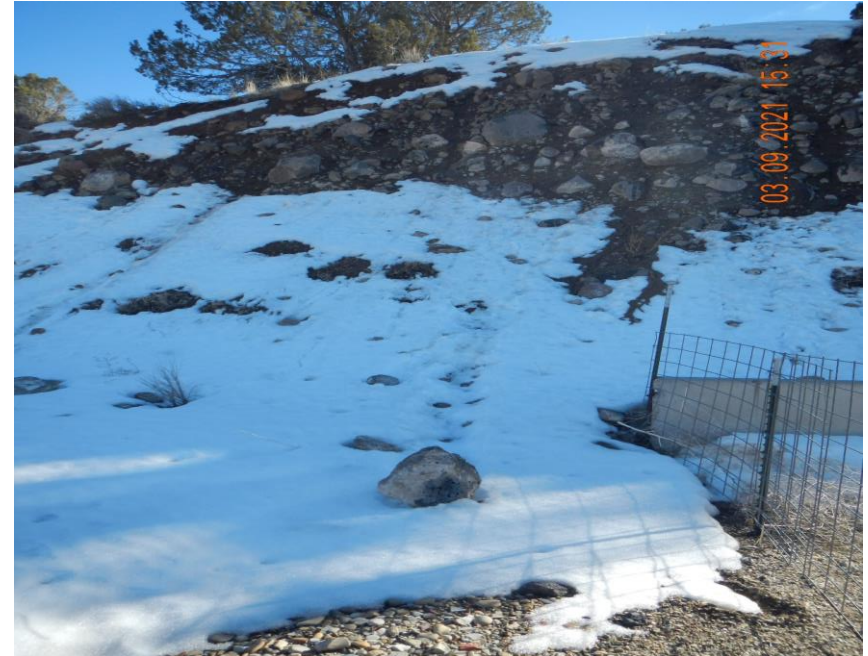
Large Rocks are falling off of cut slope onto the pad.

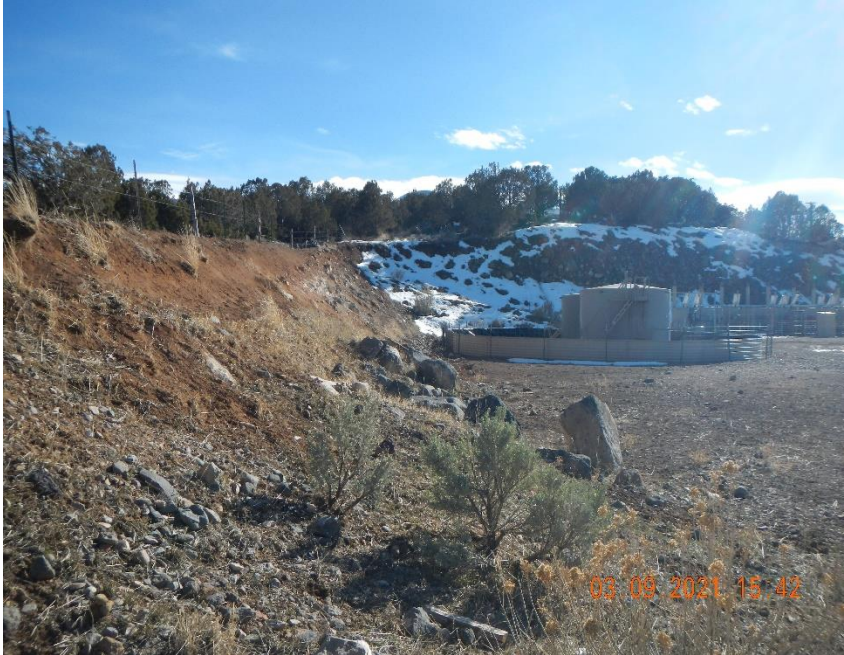
Slope not stabilized on the East cut slope

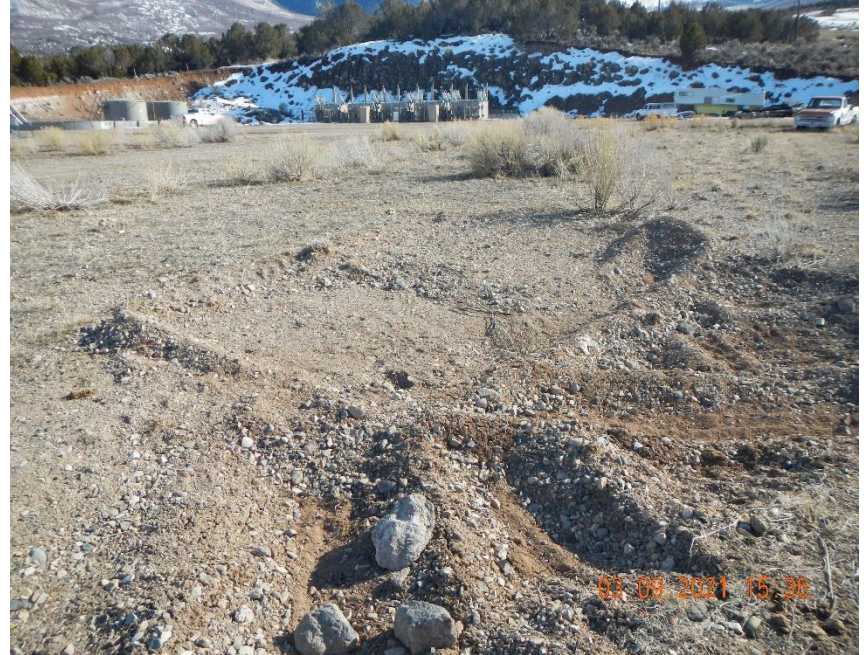
Unused areas of pad have not been stabilized or reclaimed.

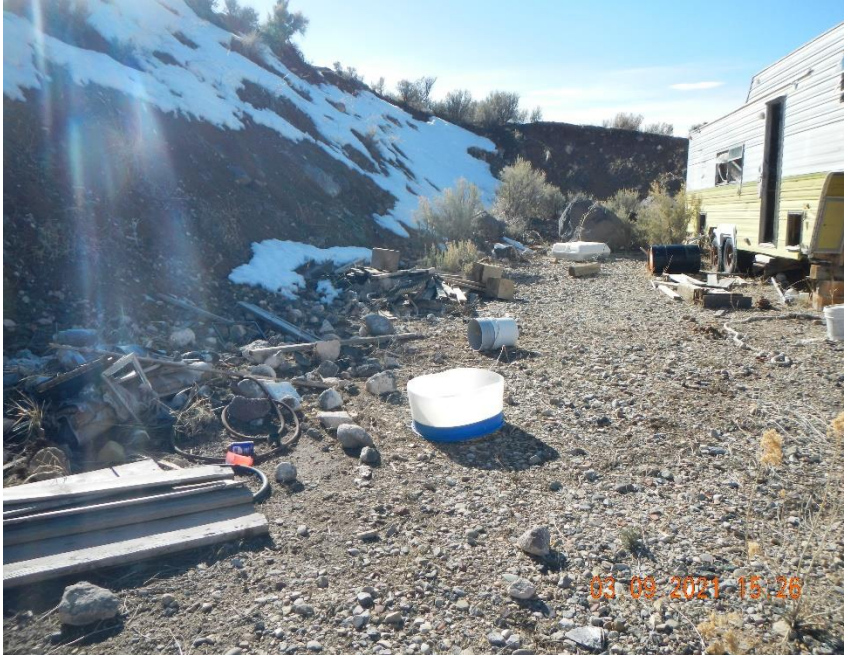
Trash and Debris in the South corner of this pad

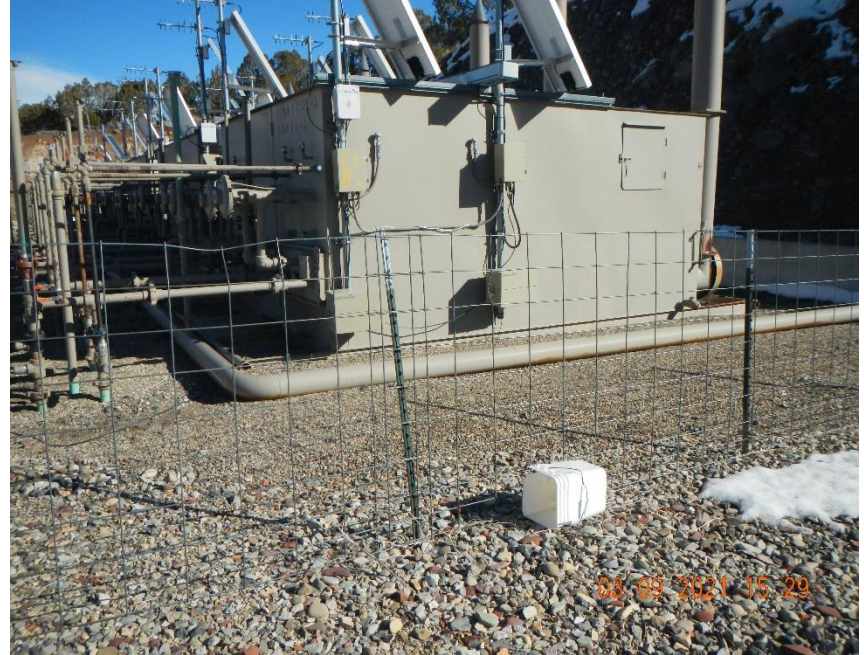
Trash near production equipment.

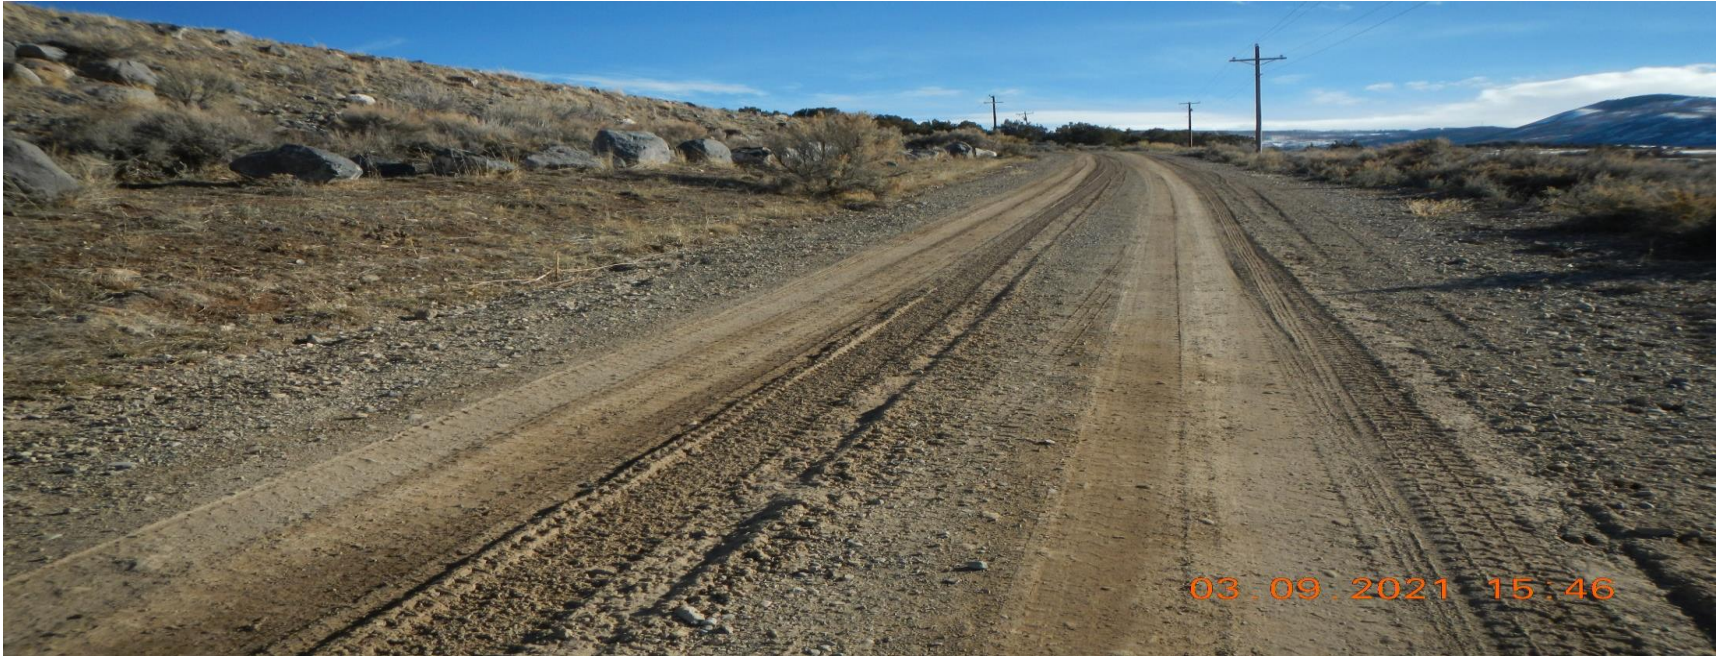
Lease road not stabilized
