Inspection Photos

API: 071-06128

Operator: OGRIS OPERATING LLC

Inspection Date: 3/8/2021

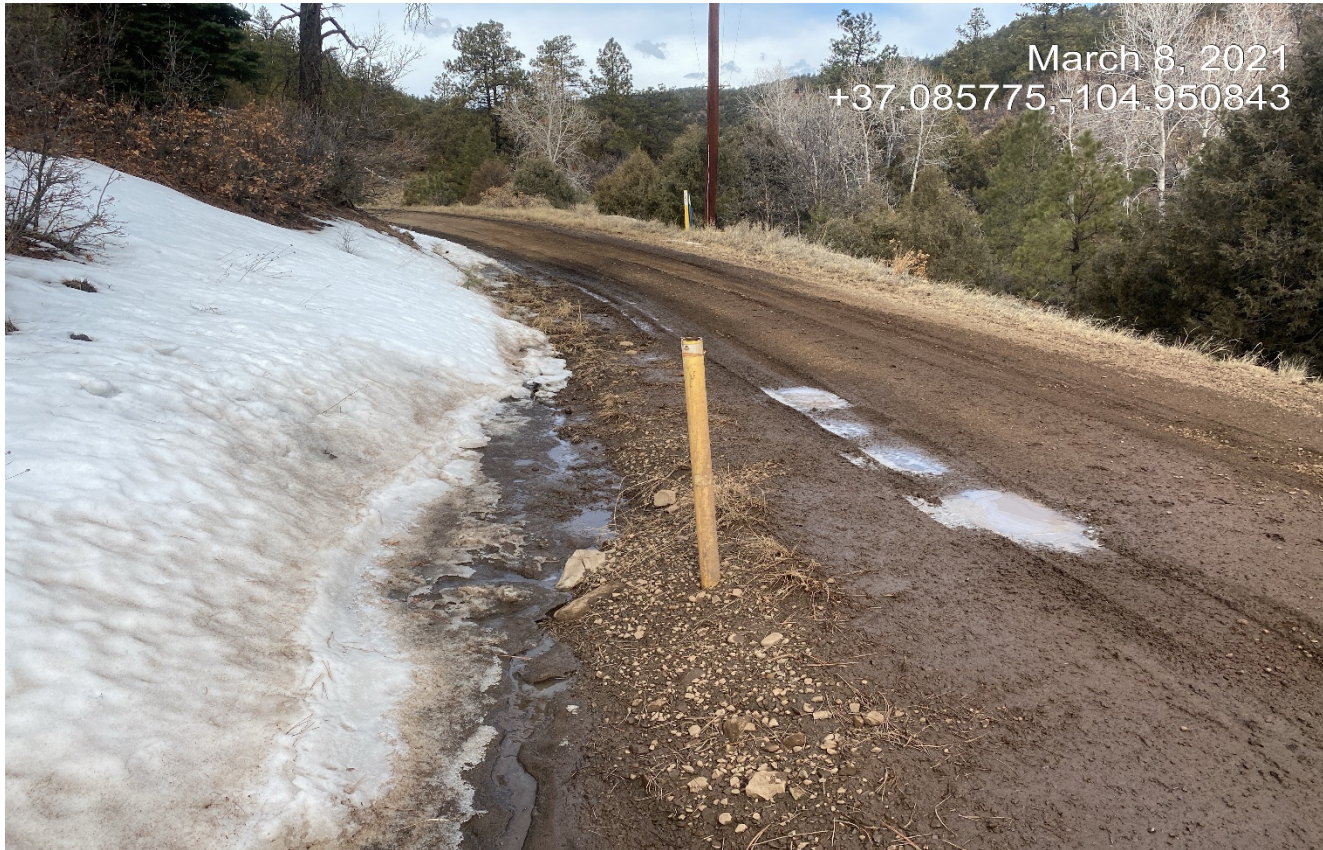
Photo 1. This culvert along the main road is filled in with sediment.

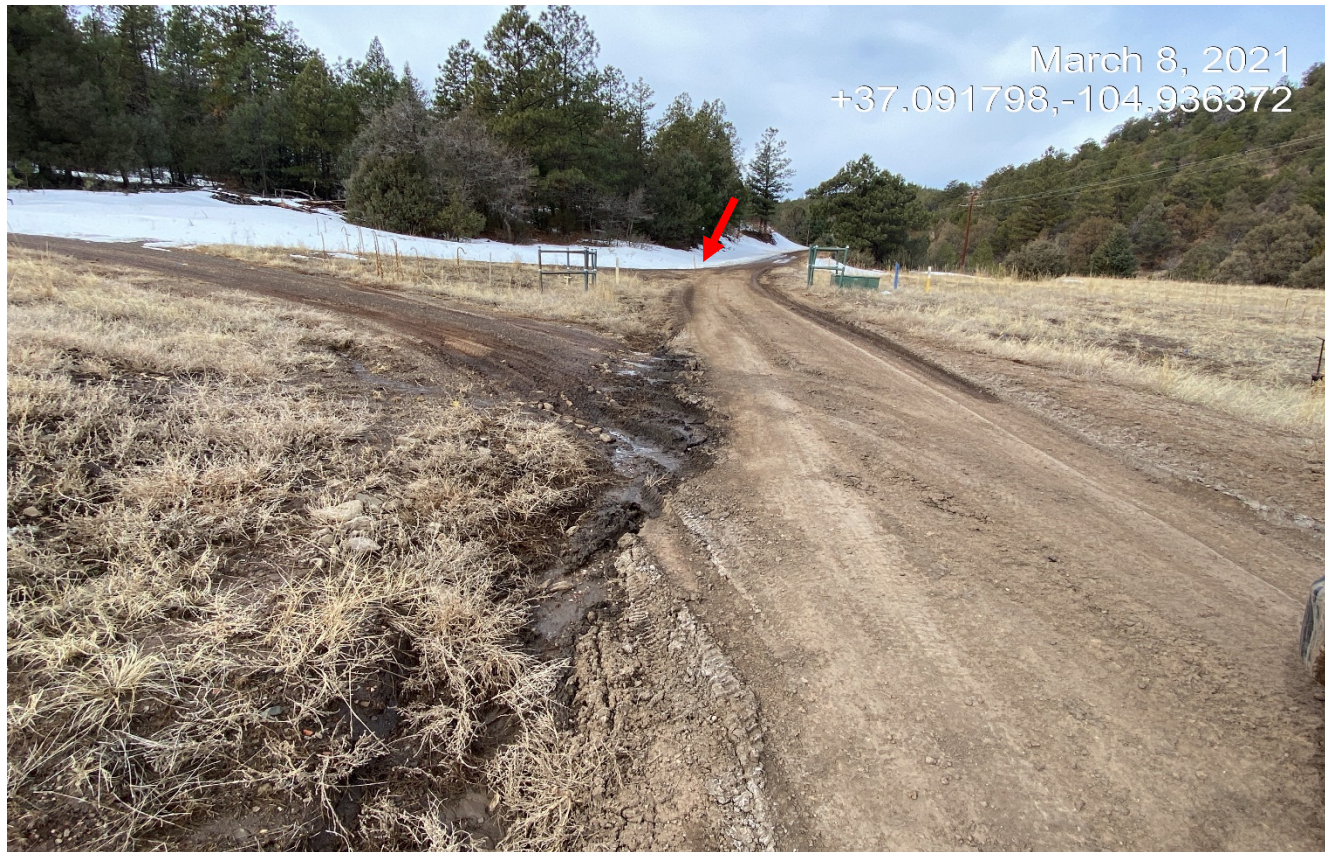
Photo 2. There is a plugged culvert along the main road (red arrow) causing stormwater to flow down the road. Lat/Long:37.09178,-104.93688. Previous corrective action was not performed.

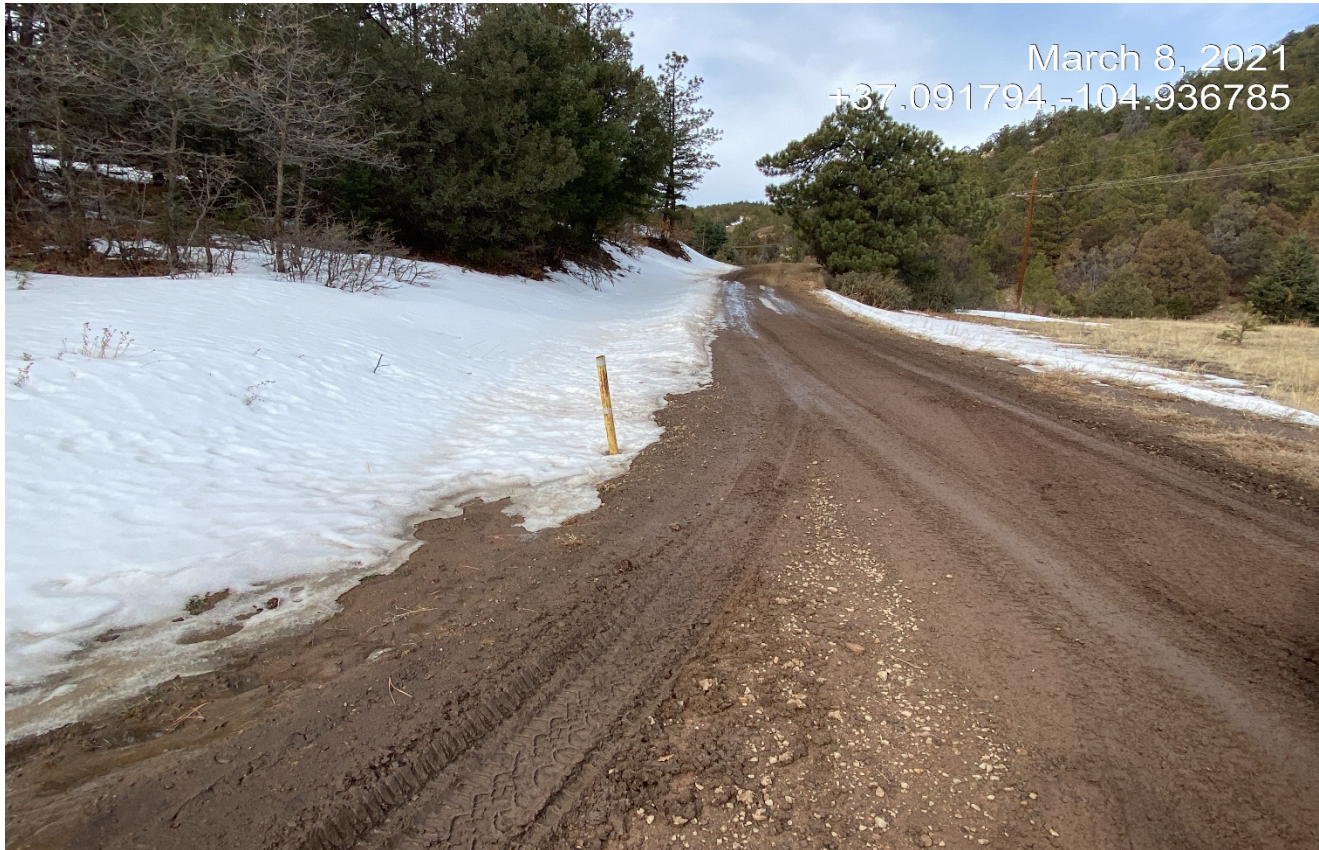
Photo 3. The culvert is filled in with sediment causing stormwater to flow down the road. All culverts need to be maintained. Previous corrective action was not performed. The culverts need to be cleaned out once snow melts.

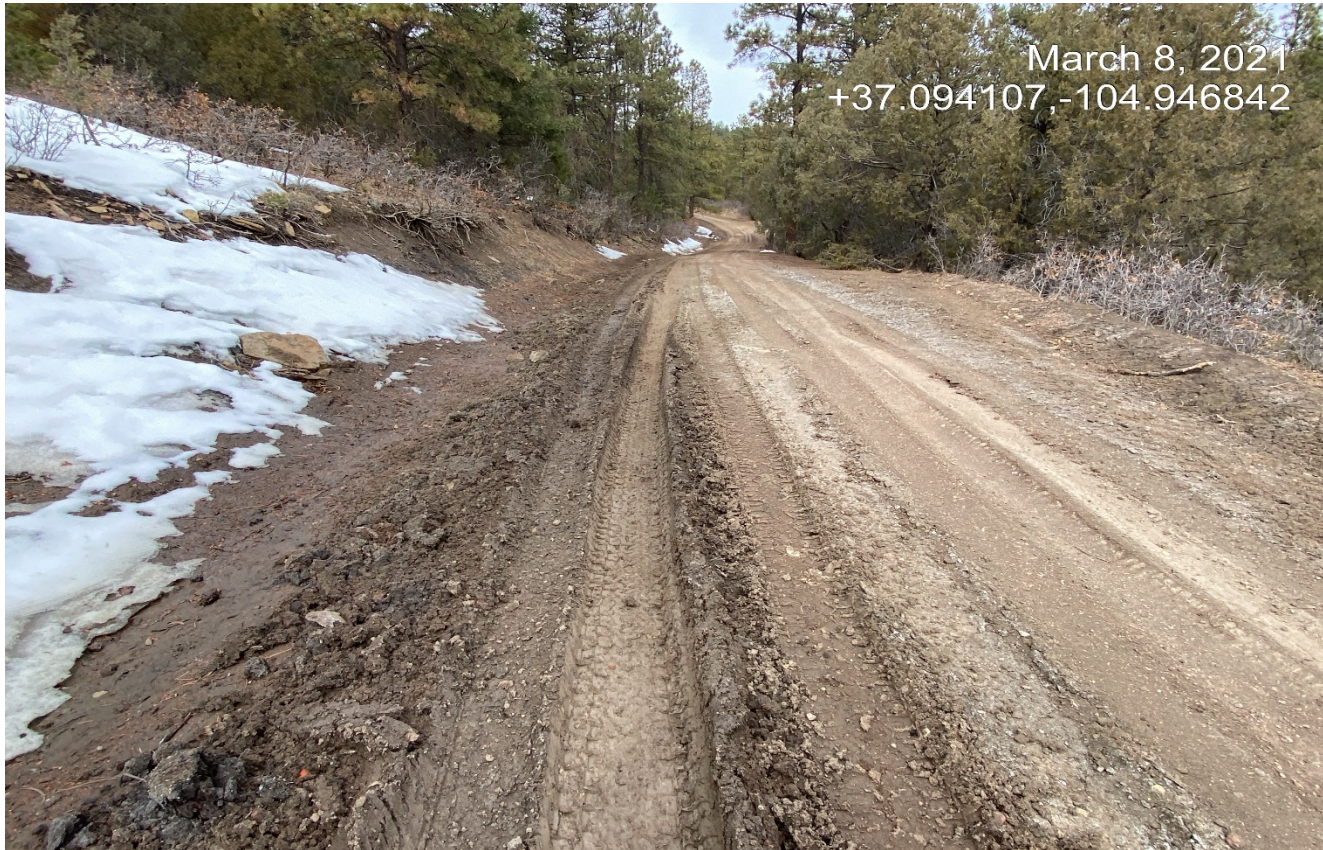
Photo 4. There is vehicle ruts occurring after repairs had been performed. BMP's such as gravel is needed to prevent rutting and road degradation. Grading alone is not sufficient.
