Whiting Oil & Gas Corporation

WILDHORSE 18-1834H CORRECTIVE ACTION INSPECTION PHOTOS

Location ID: 430306
Section 18 T9N R59W

3-12-2021

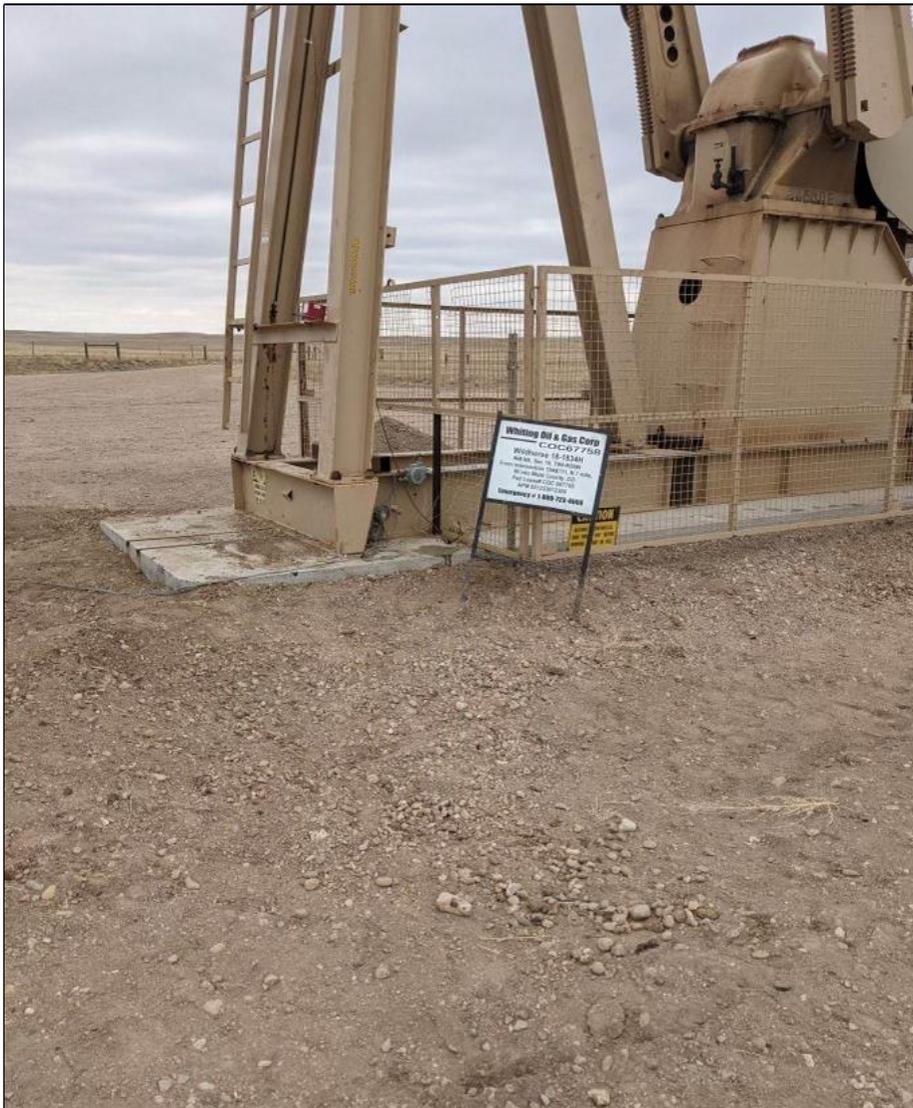
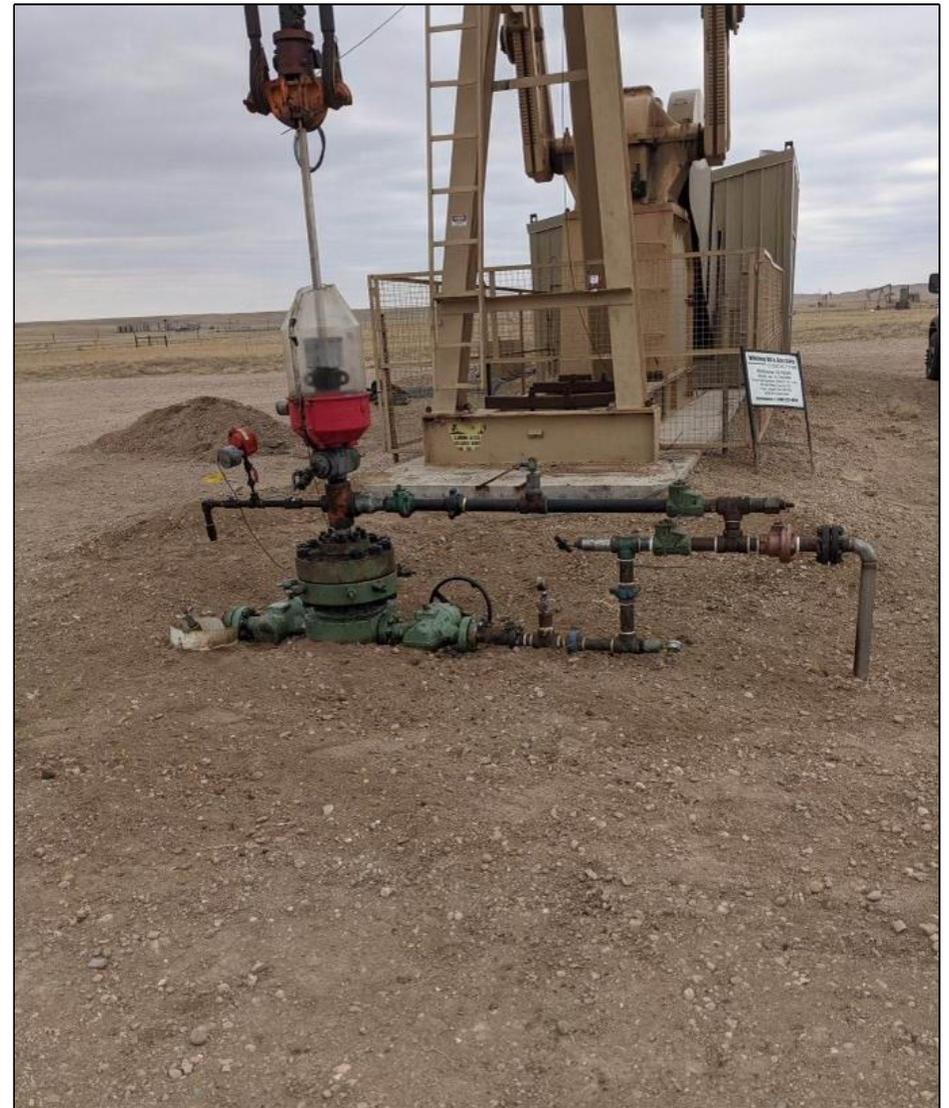
Unused Parts/Equipment at Wellhead Have Been Removed

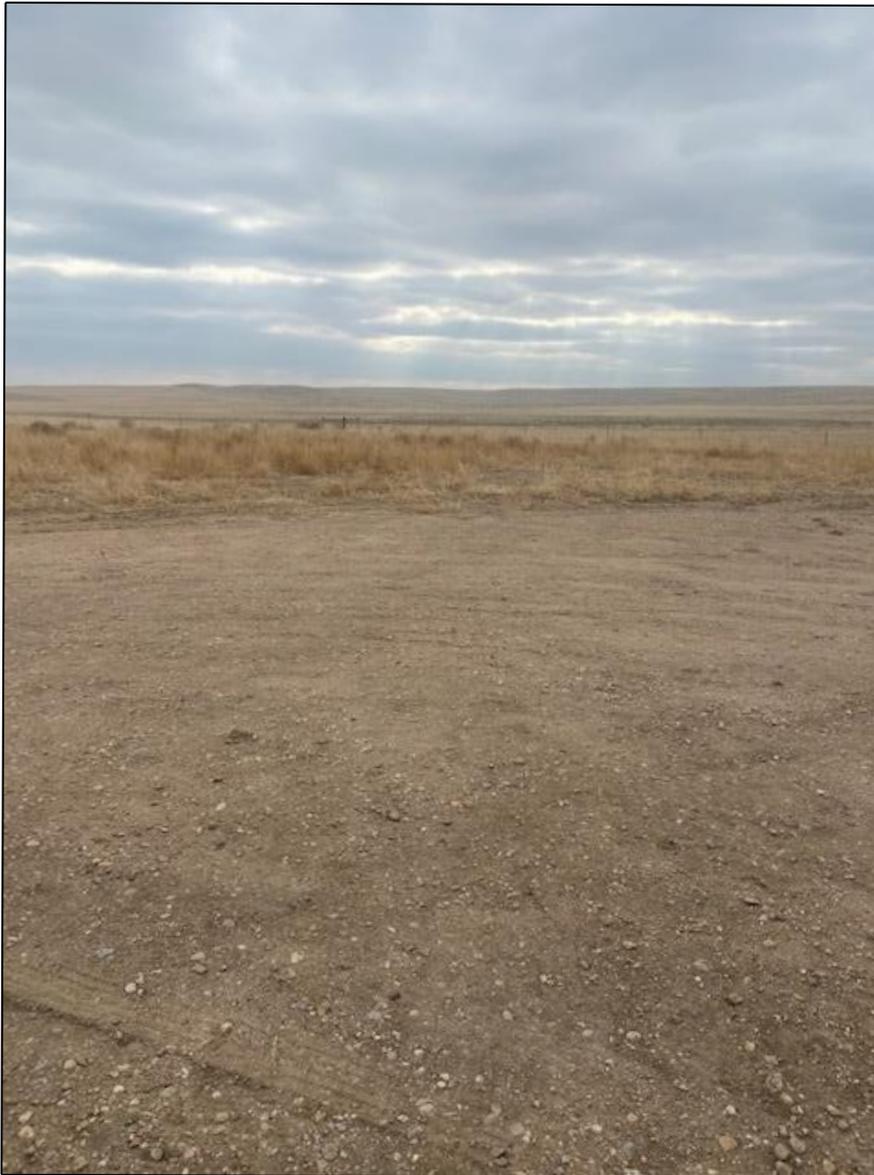
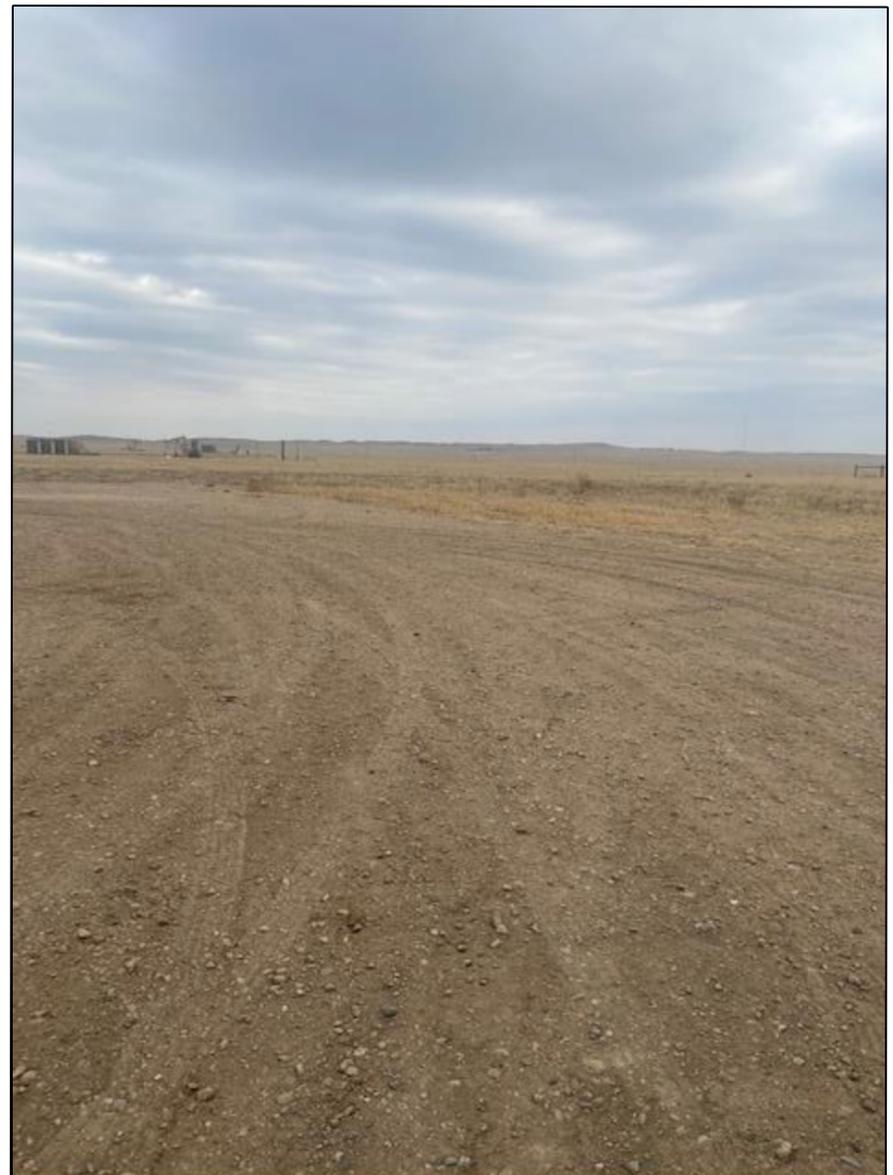
Workover Rig Equipment Removed
