Inspection Photos

Location Name: CAERUS PICEANCE LLC TIPPING-67S96W /34NWNW

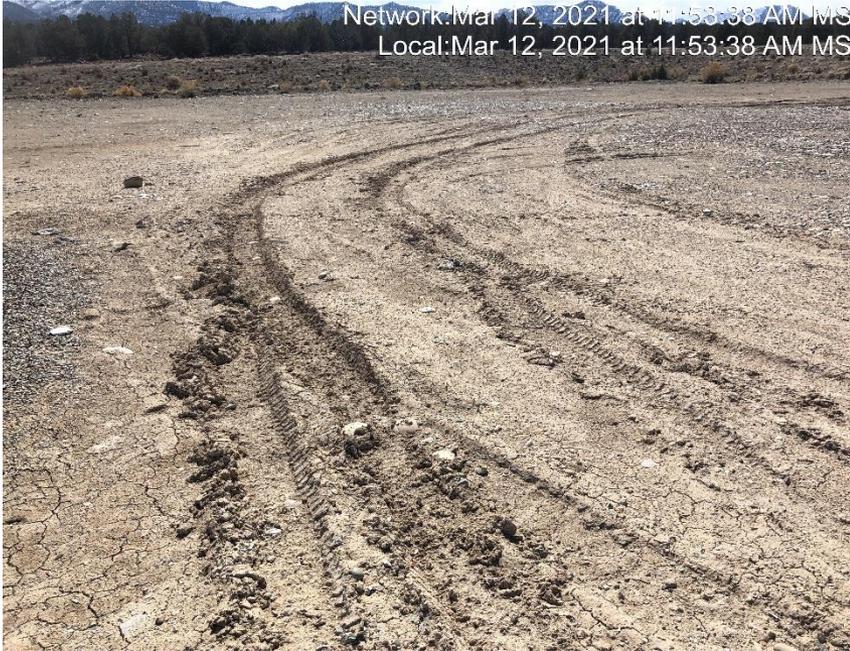
Photo #3129 Location lacks stabilization.

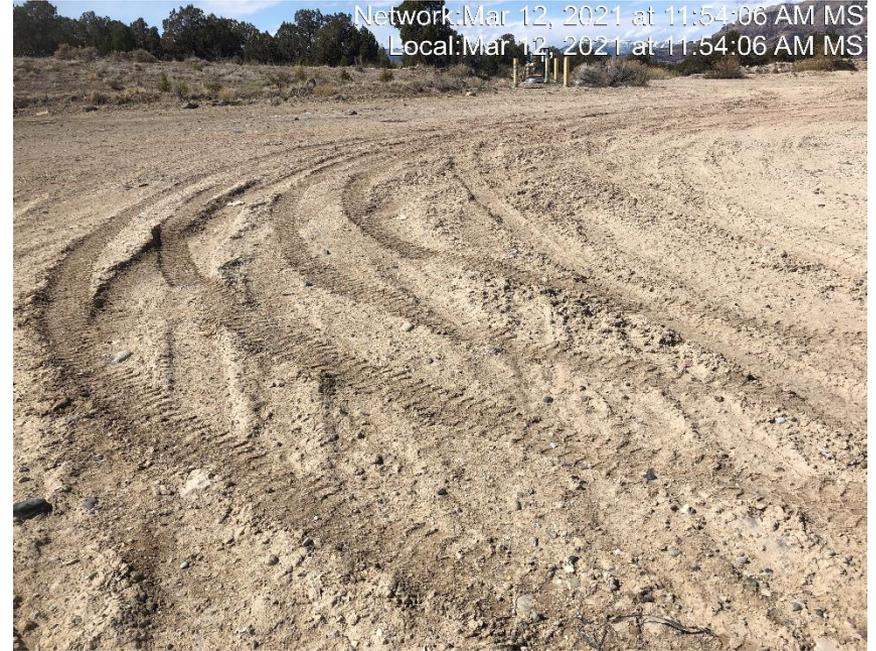
Photo #3130 Location lacks stabilization.

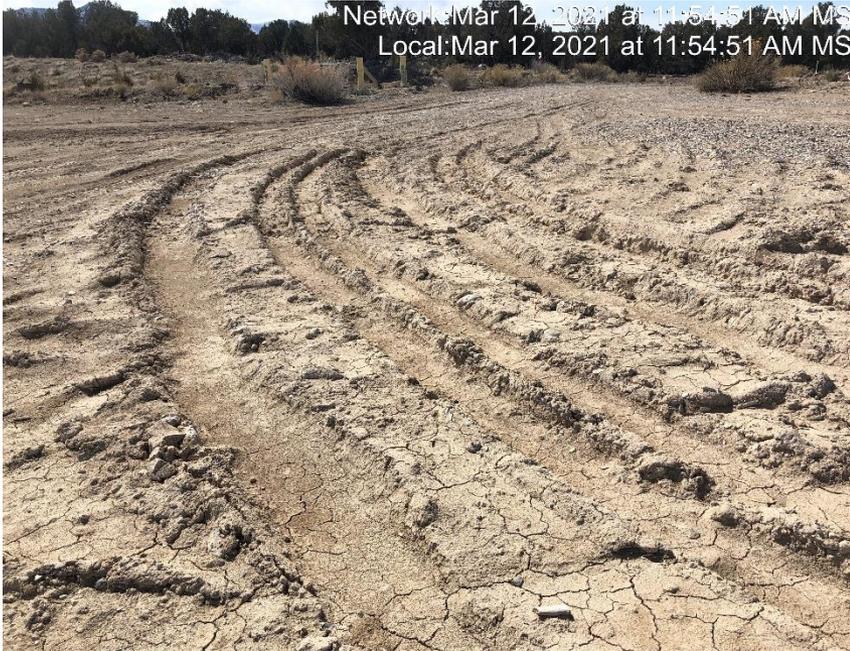
Photo #3131 Location lacks stabilization.

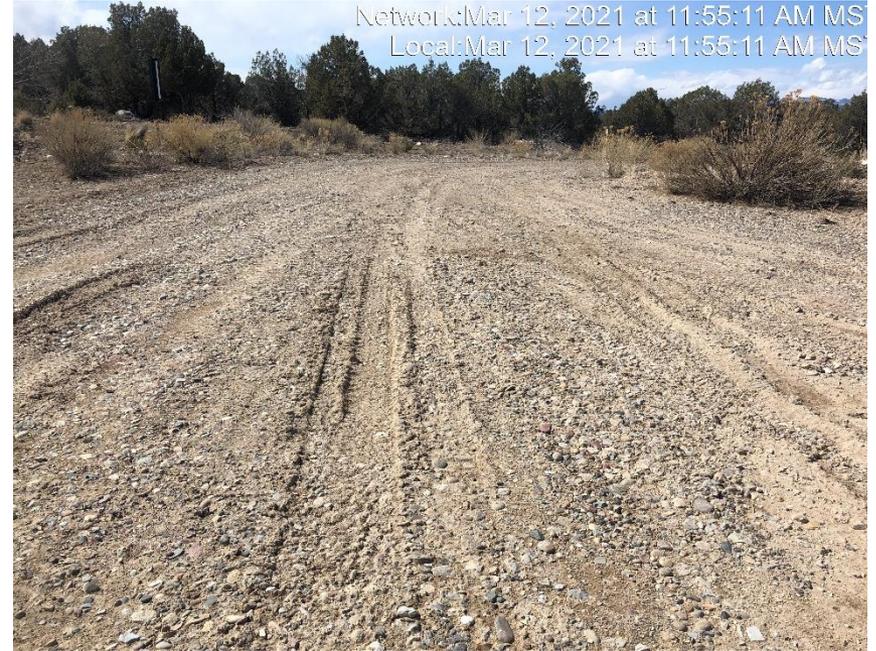
Photo #3132 No tracking control at entrance to location.
