Inspection Photos
Operator: Simcoe
API: 067-08883
Date: 3/10/2021

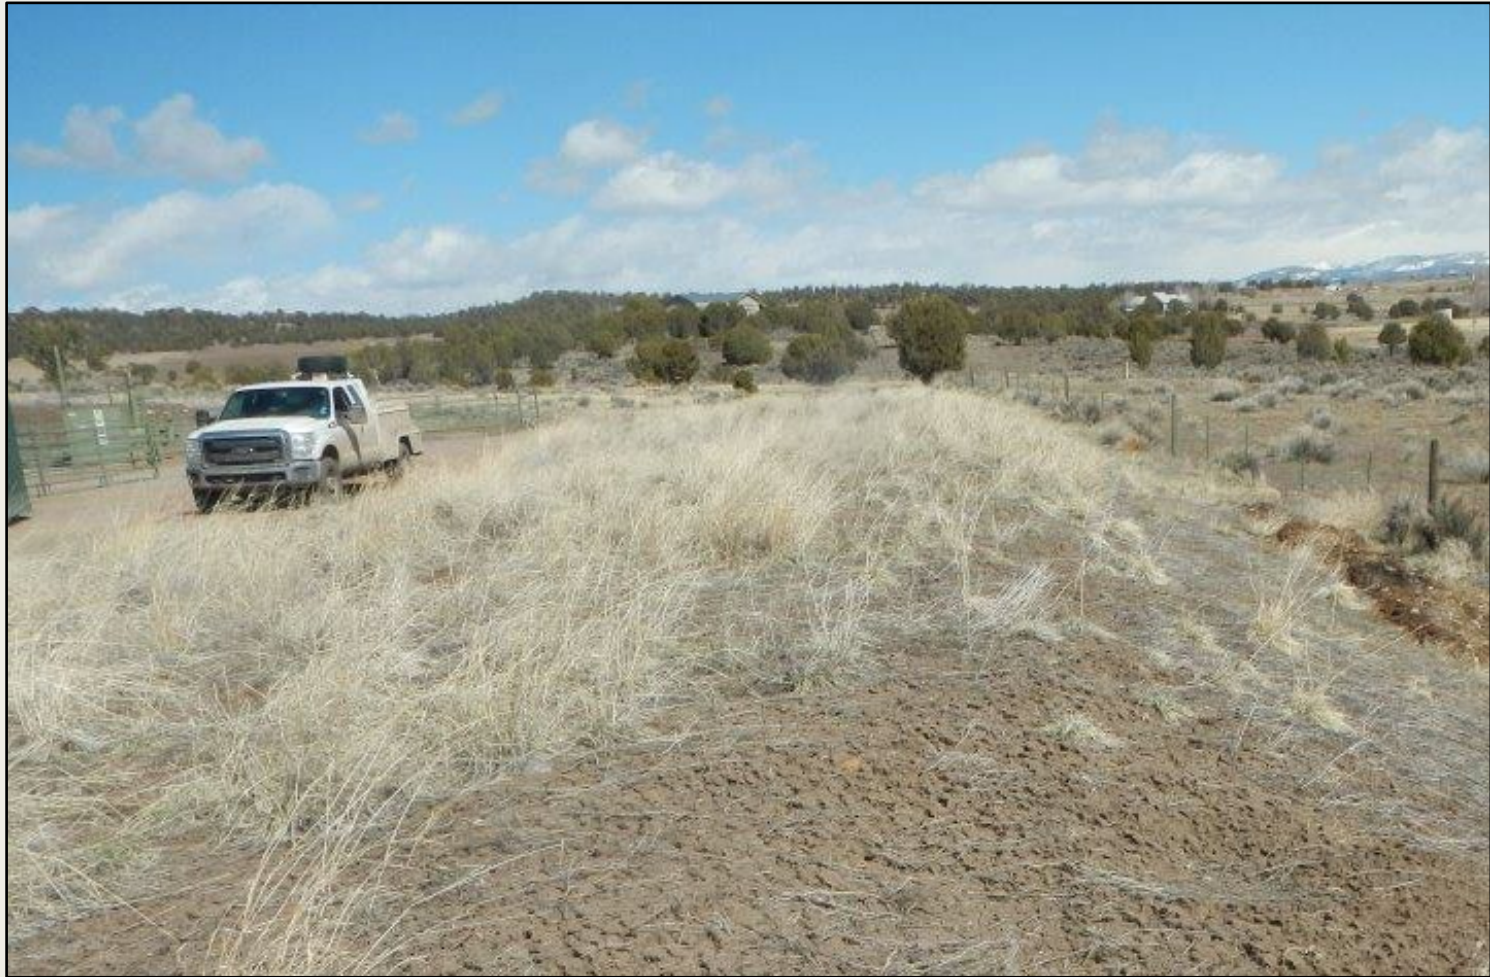
Photo 1. View of the eastern project area from the southeastern corner facing northward. Revegetation appears to be progressing with grasses such as crested wheatgrass, intermediate wheatgrass, and western wheatgrass.

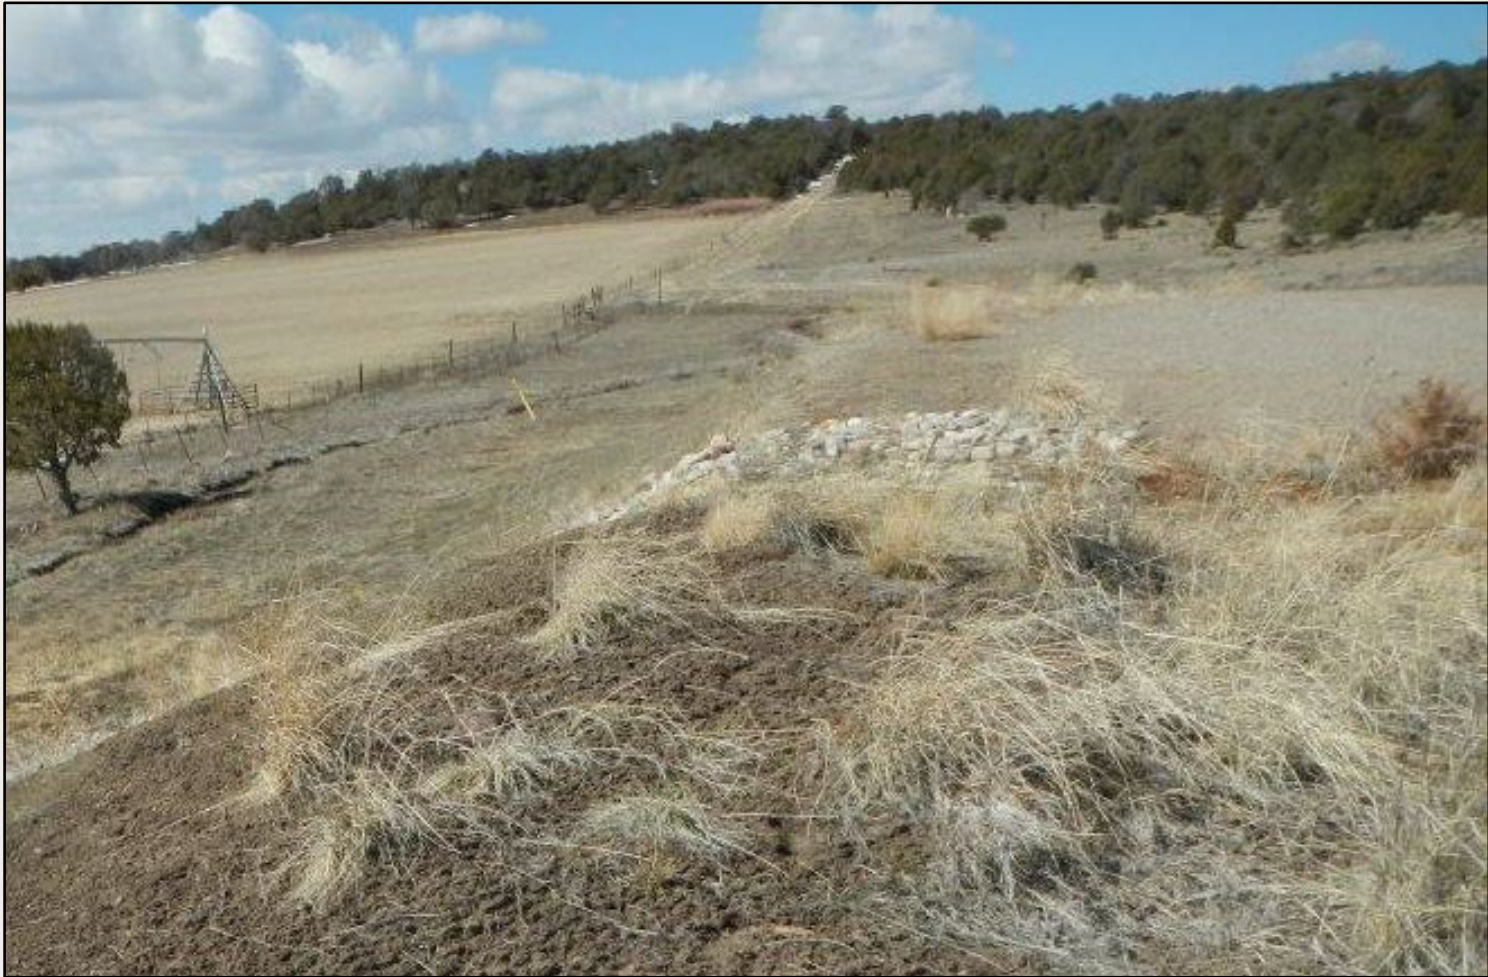
Photo 2. View of the southern project area from the southeastern corner facing westward. Sparse revegetation observed in portions of the fill slope where spot seeding may be needed.

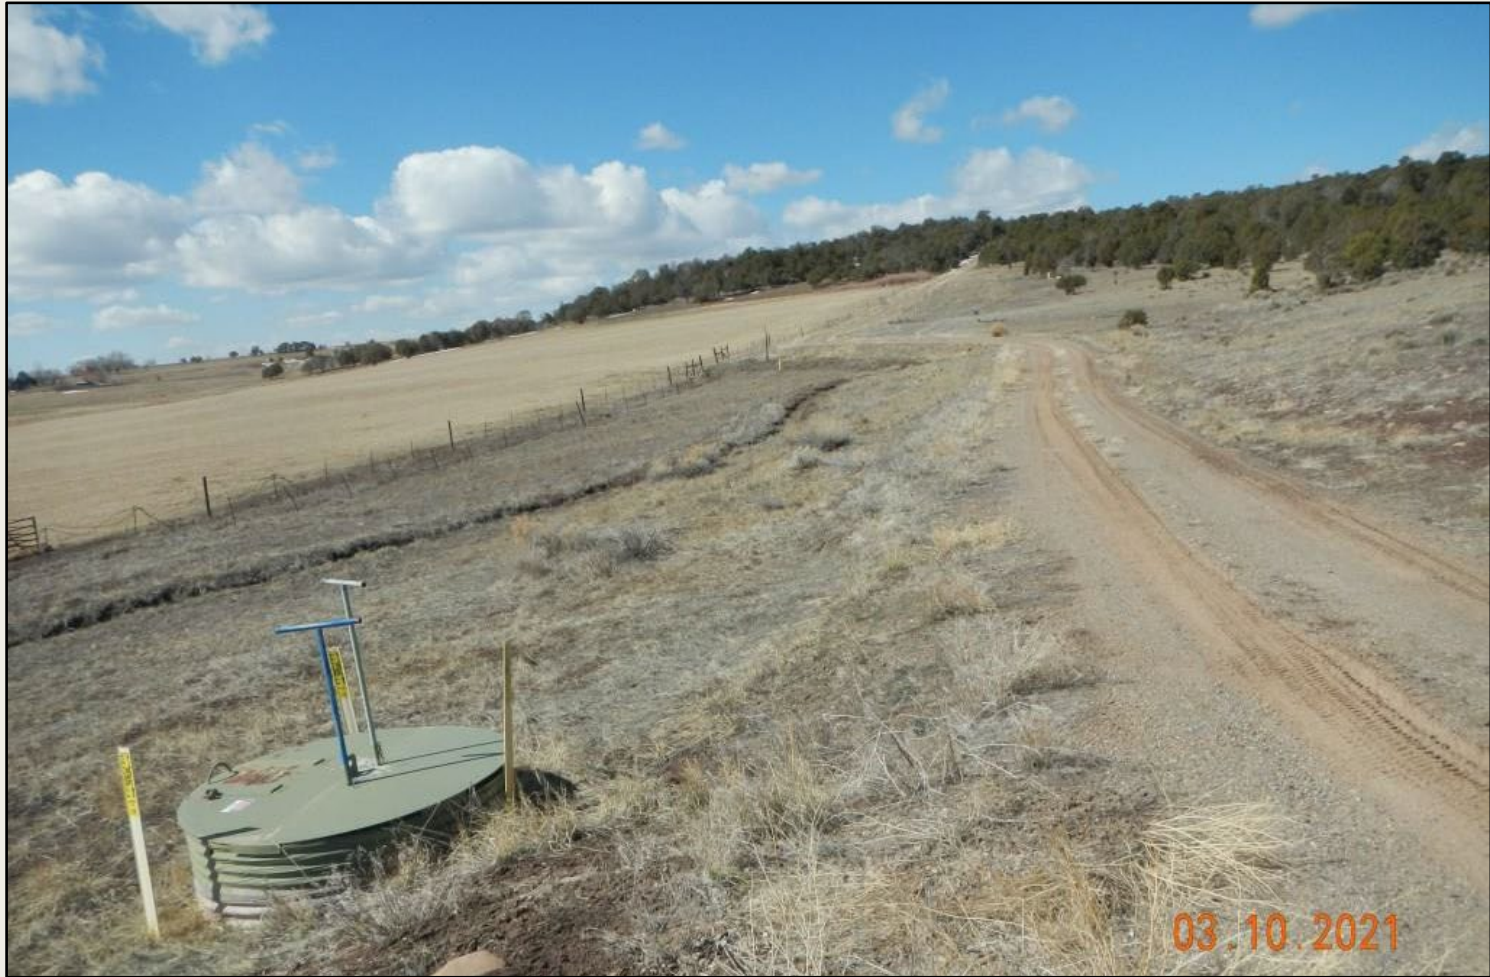
Photo 3. View of the access road facing westward.

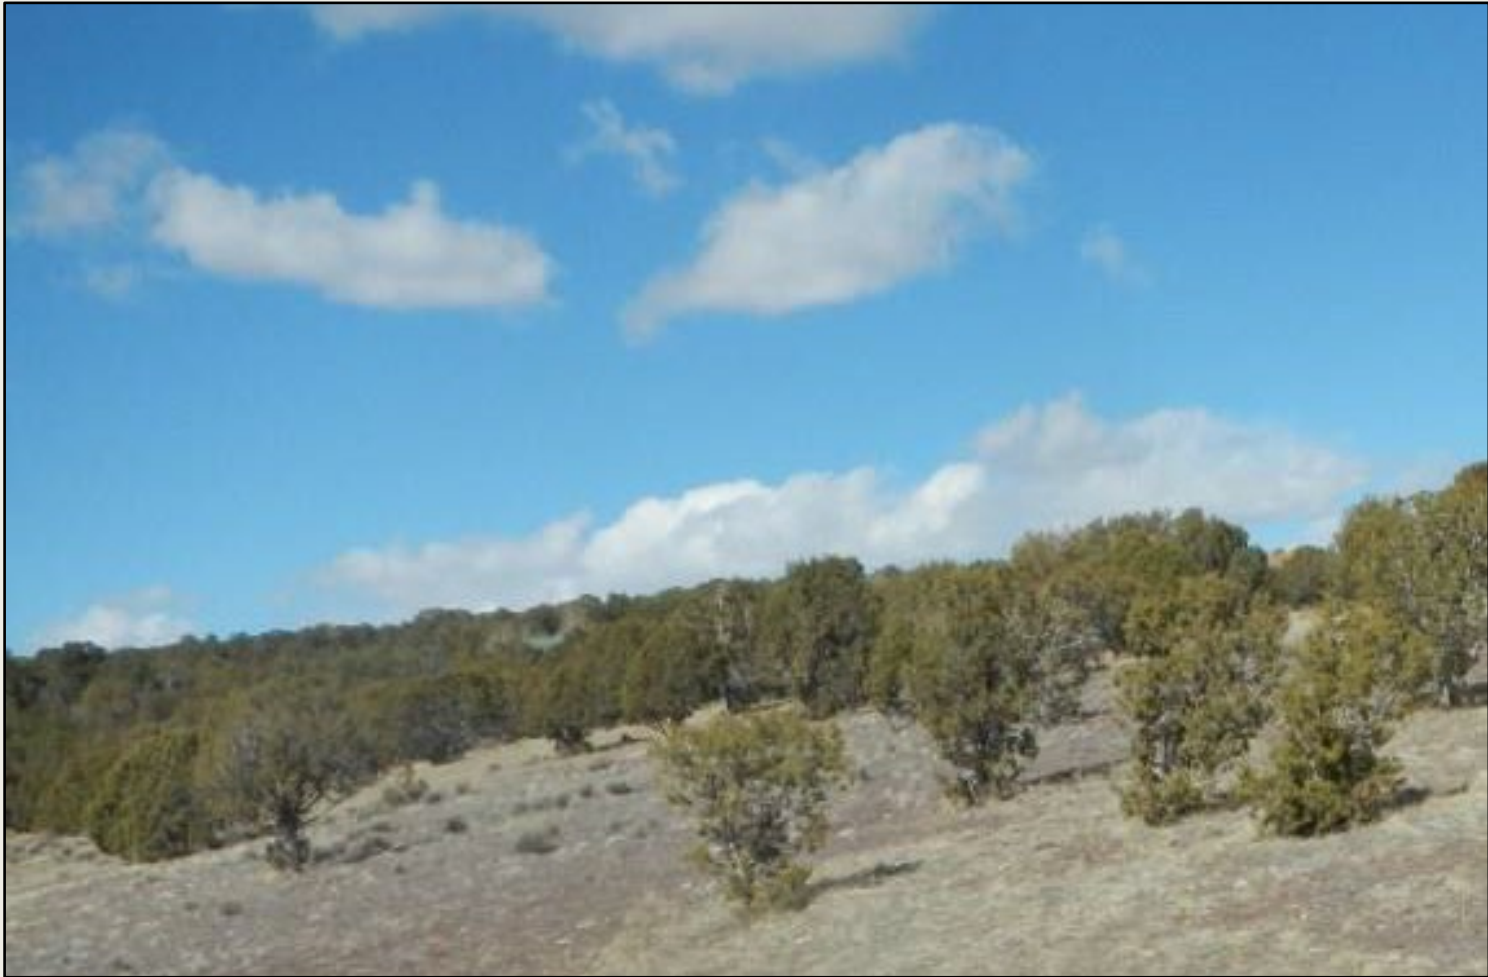
Photo 4. View of reference area comprised of open pinyon-juniper woodland with sagebrush and western wheatgrass, blue grama, and other grasses forbs in a dormant condition.

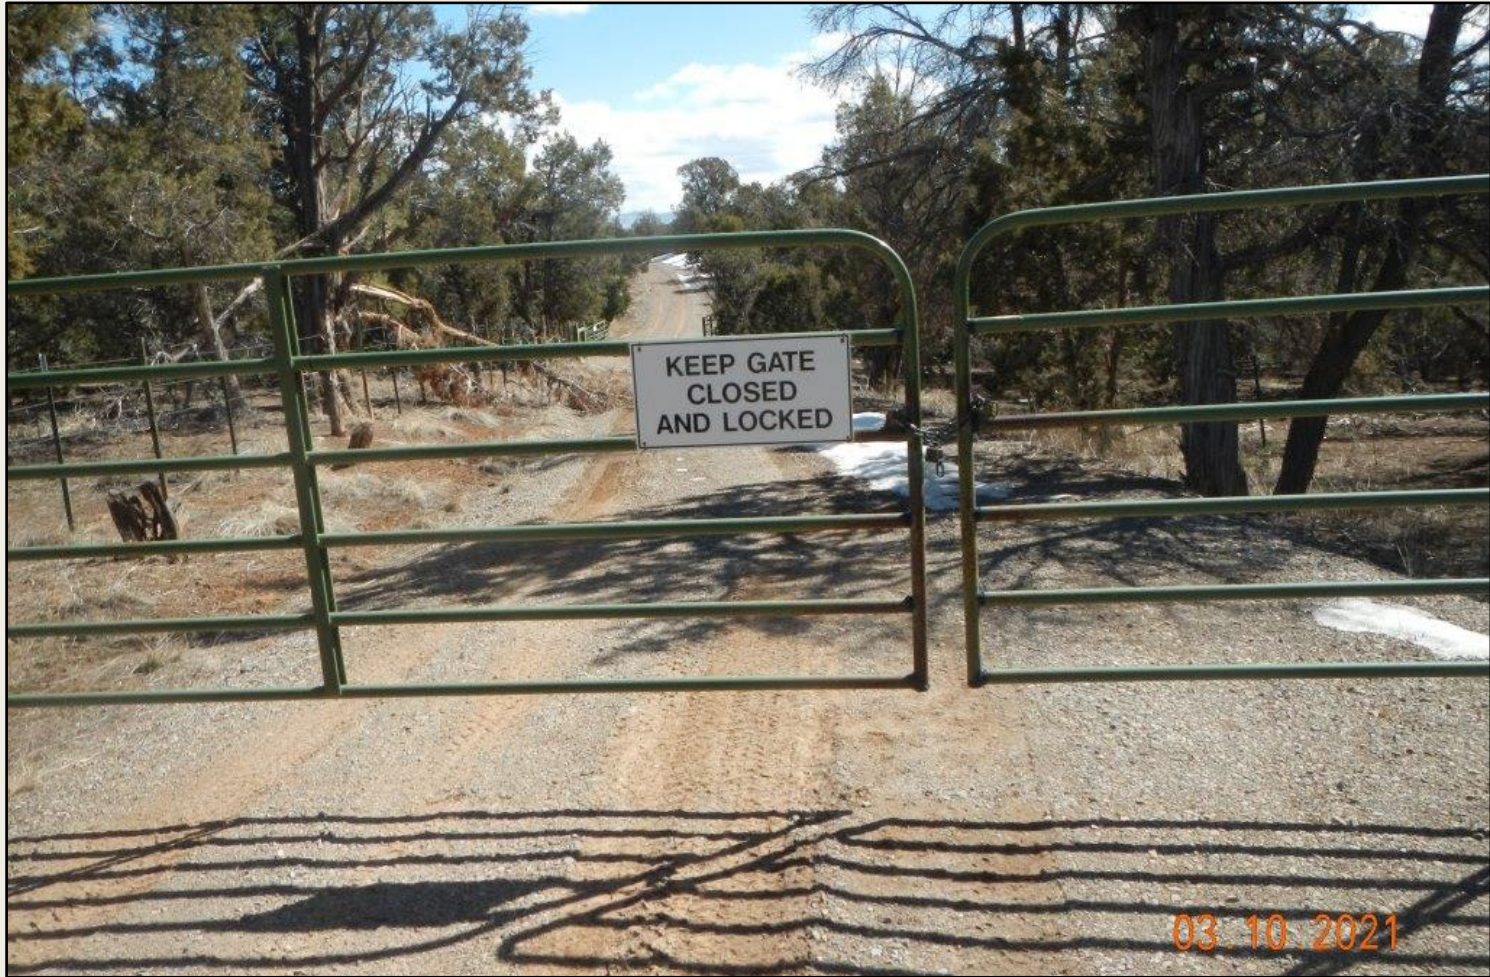
Photo 5. View of closed gate after leaving location.
