## Inspection Photos

Location Name: CAERUS PICEANCE LLC KEINATH FEDERAL-68S96W /8SENW

Location ID: 334106

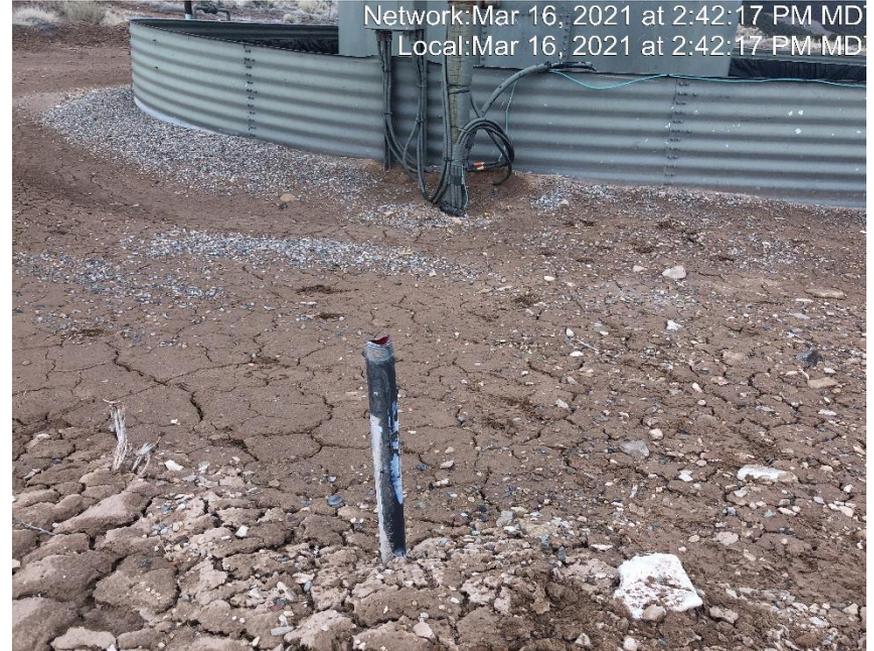
Photo #3165 1" flowline riser not LO/TO.

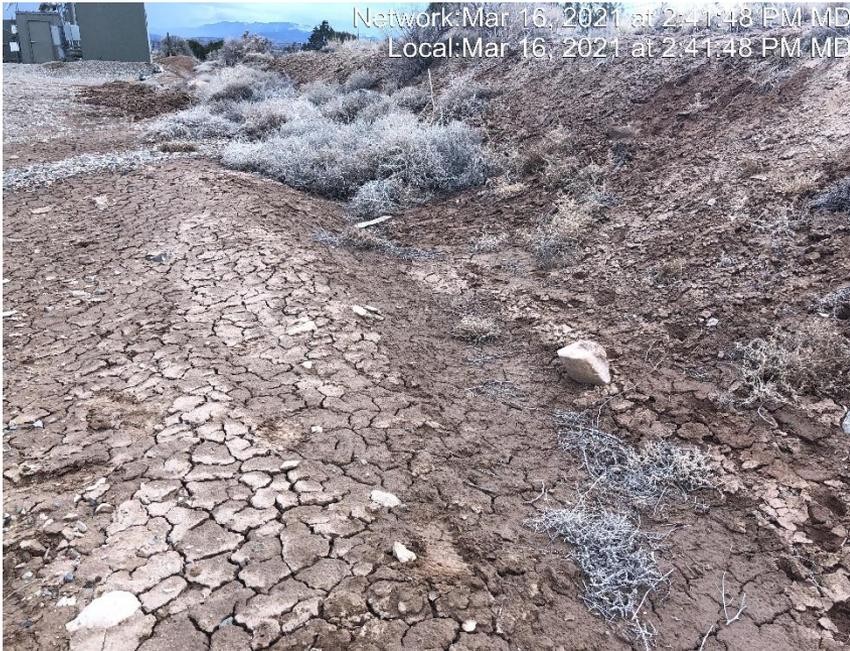
**Photo #3163 Debris in perimeter ditch on Eastside of location.**

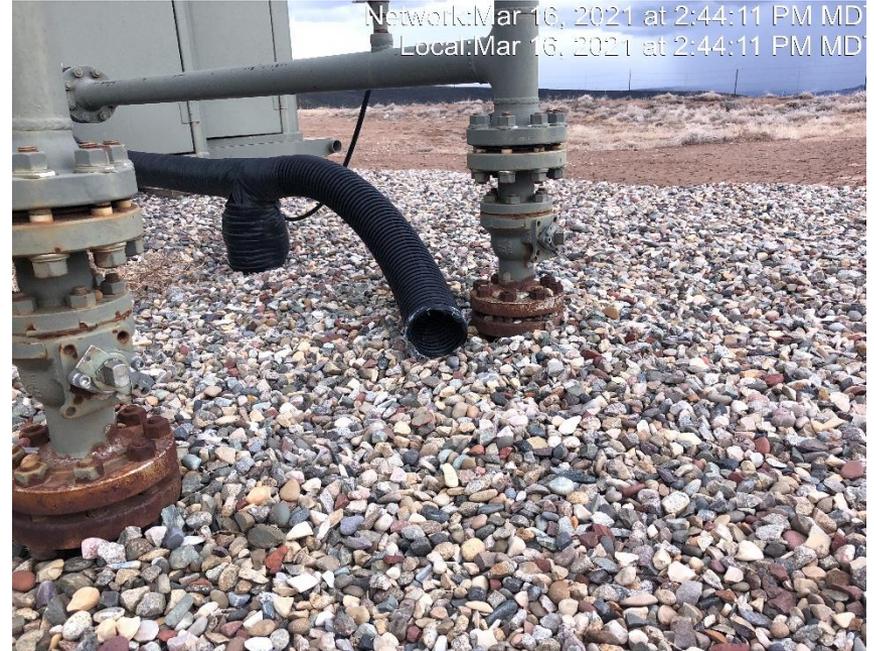
**Photo #3167 Flow line heating insulation open ended and not capped.**

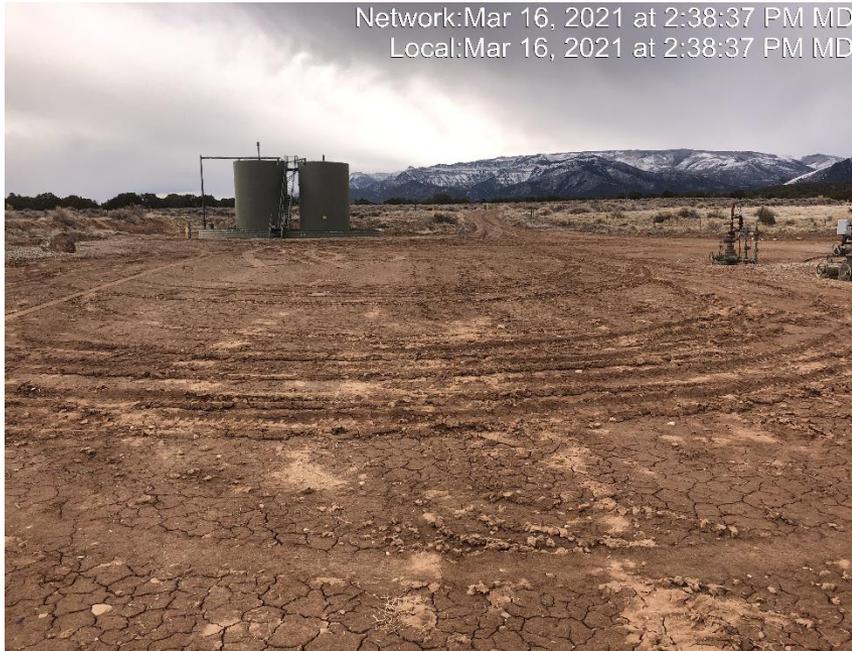
**Photo #3160 Location lacks stabilization.**

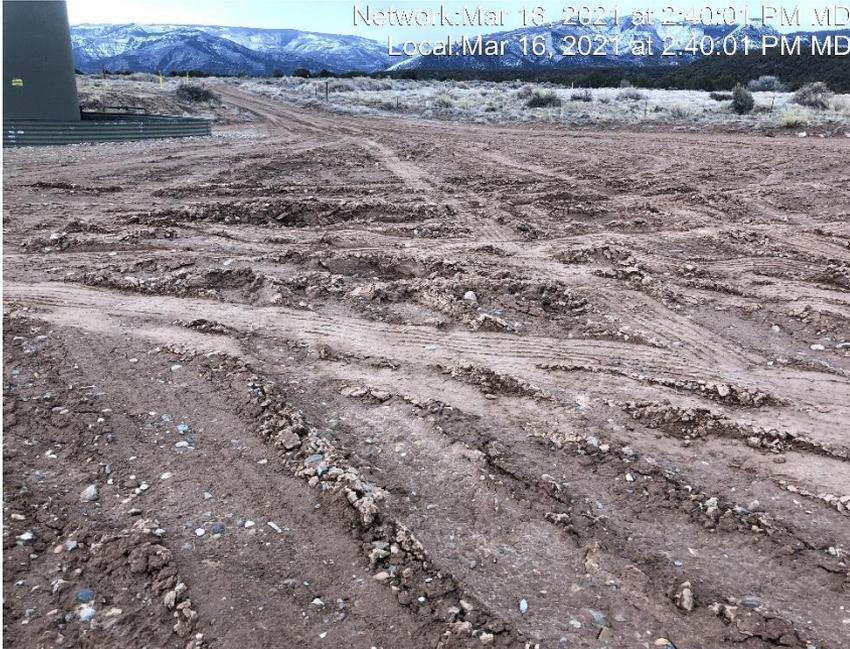
**Photo #3161 Location lacks stabilization.**

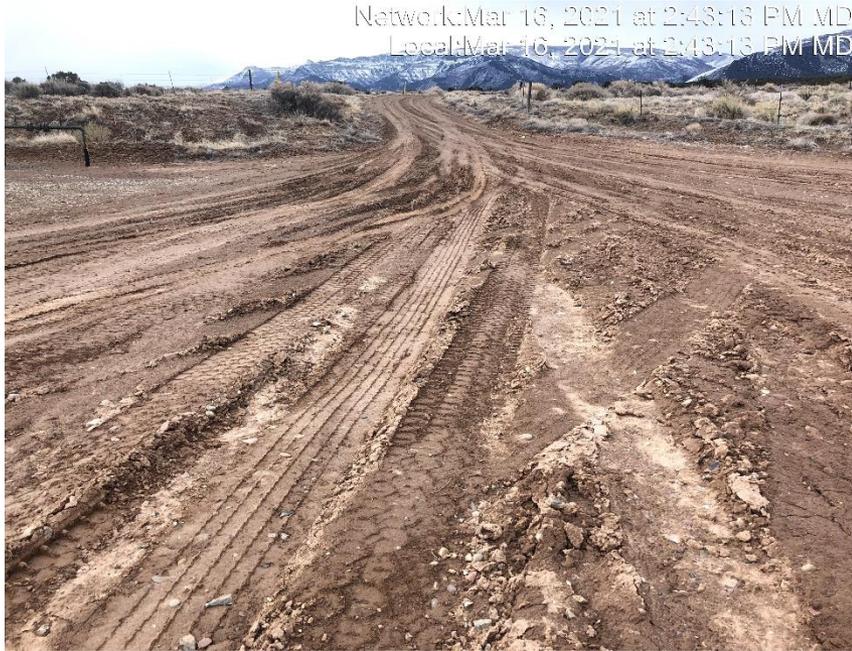
**Photo #3166 No form of tracking control at entrance to location.**

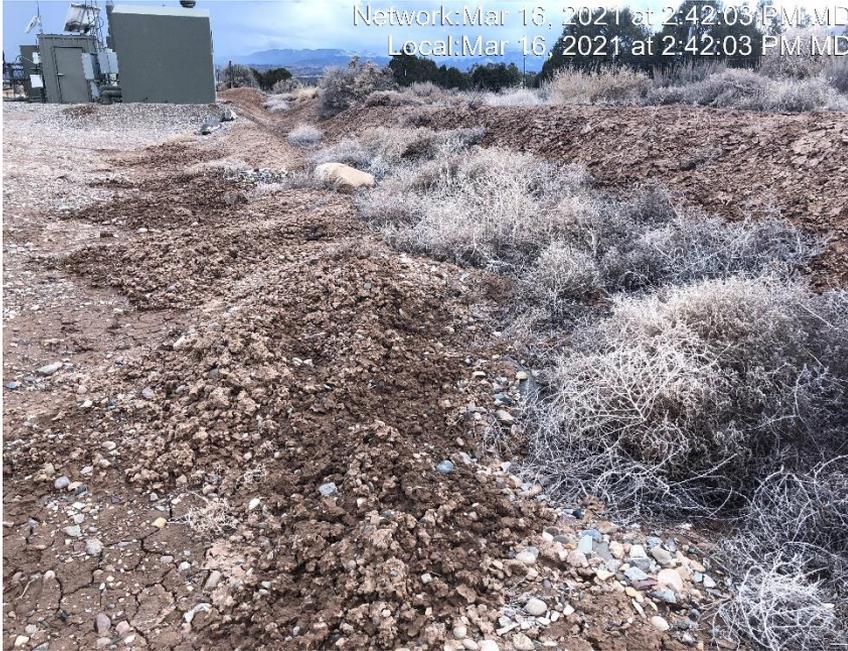
**Photo #3164 Sediment appears to have been plowed into ditch**

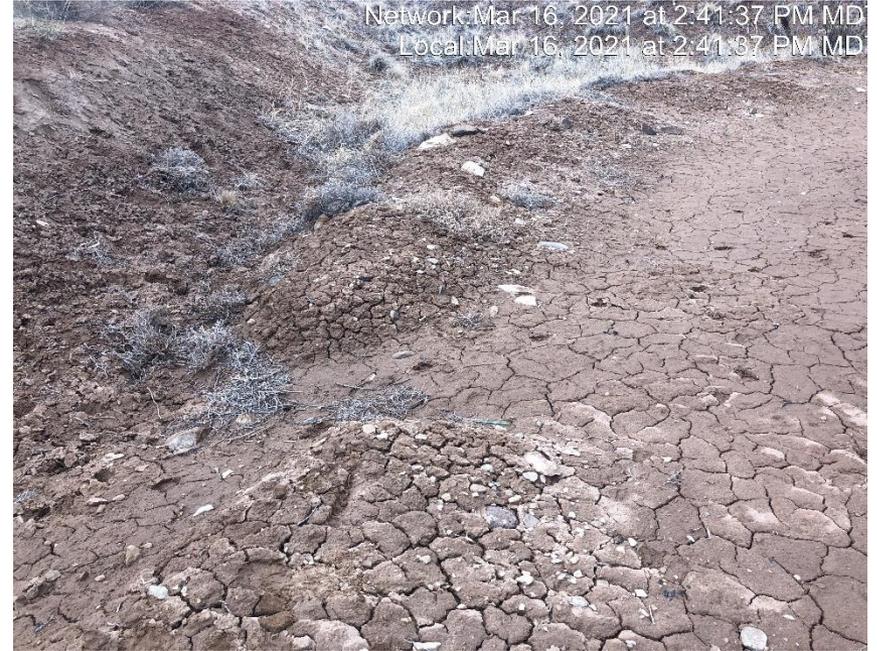
**Photo #3162 Perimeter berm has been compromised.**
