DATE: MARCH 19, 2021

IN REFERENCE TO THE FOLLOWING INSPECTION REPORT

**Inspected Facilities: SKR MAN CAMP (CHEVRON SHALE W 11-34)**

**Current Status as of 3/18/2021 of the Storm Water controls on the SKR MAN CAMP(CHEVRON SHALE 11-34):**

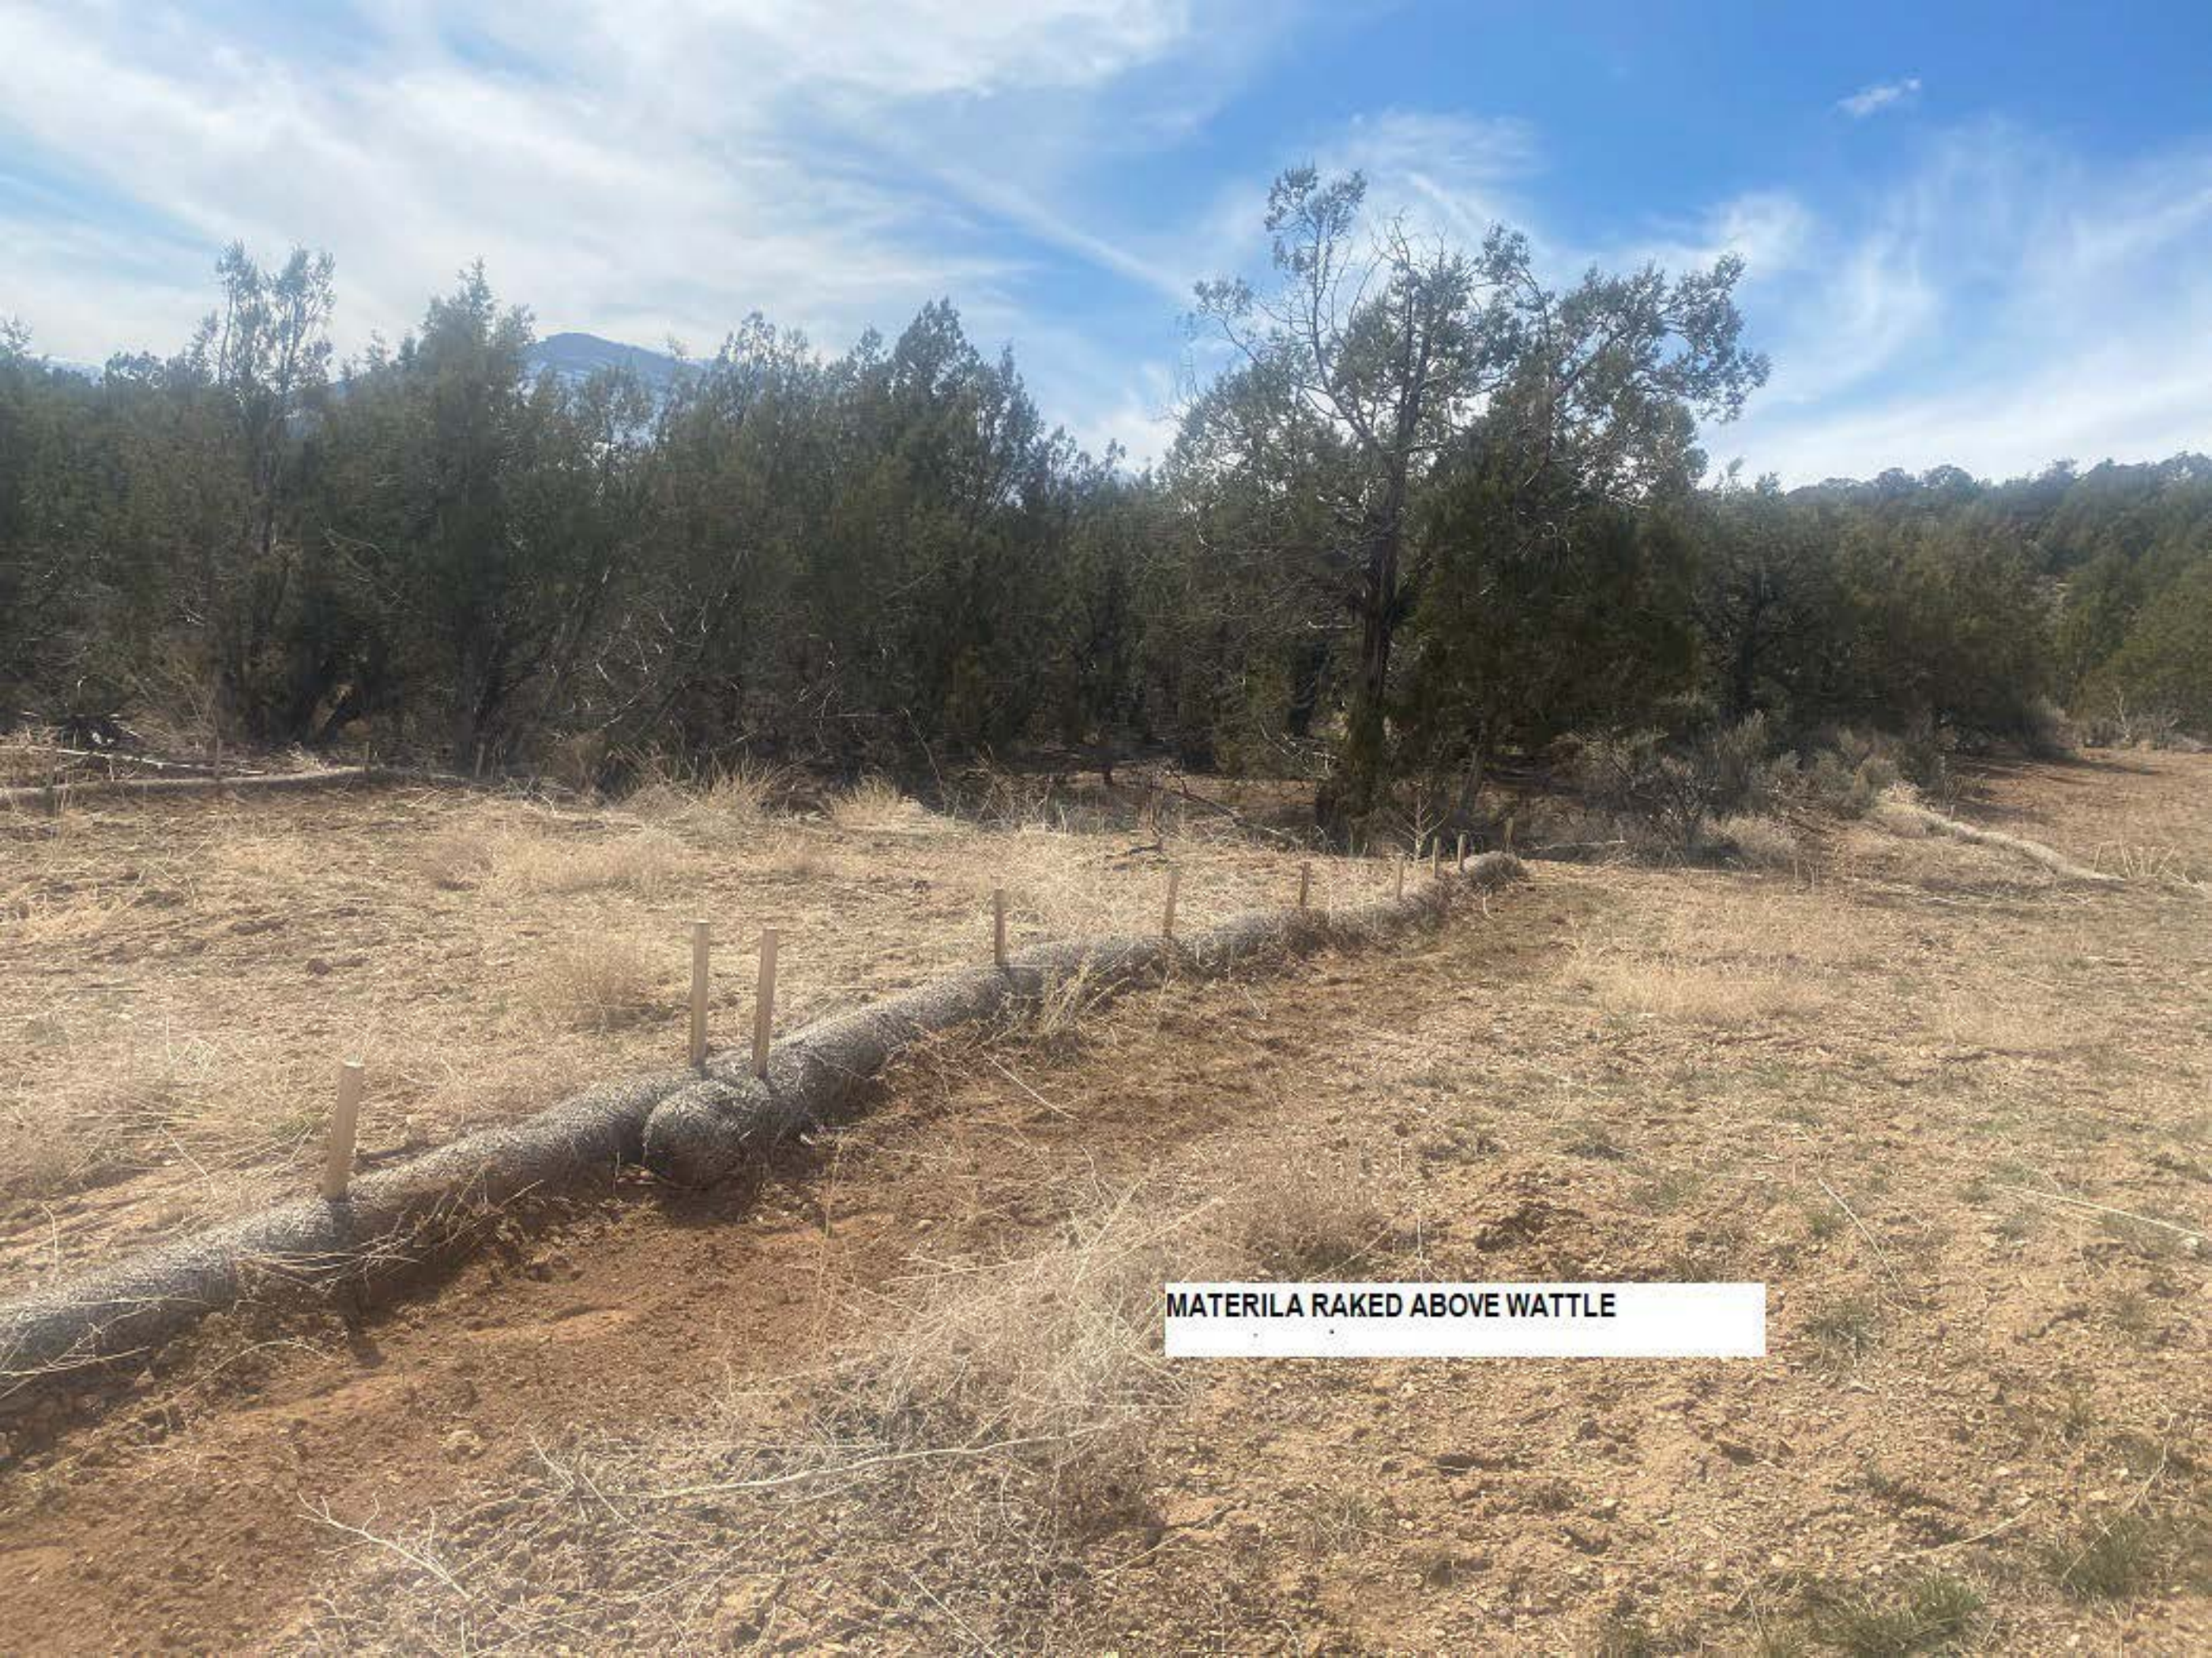
MATERILA RAKED ABOVE WATTLE

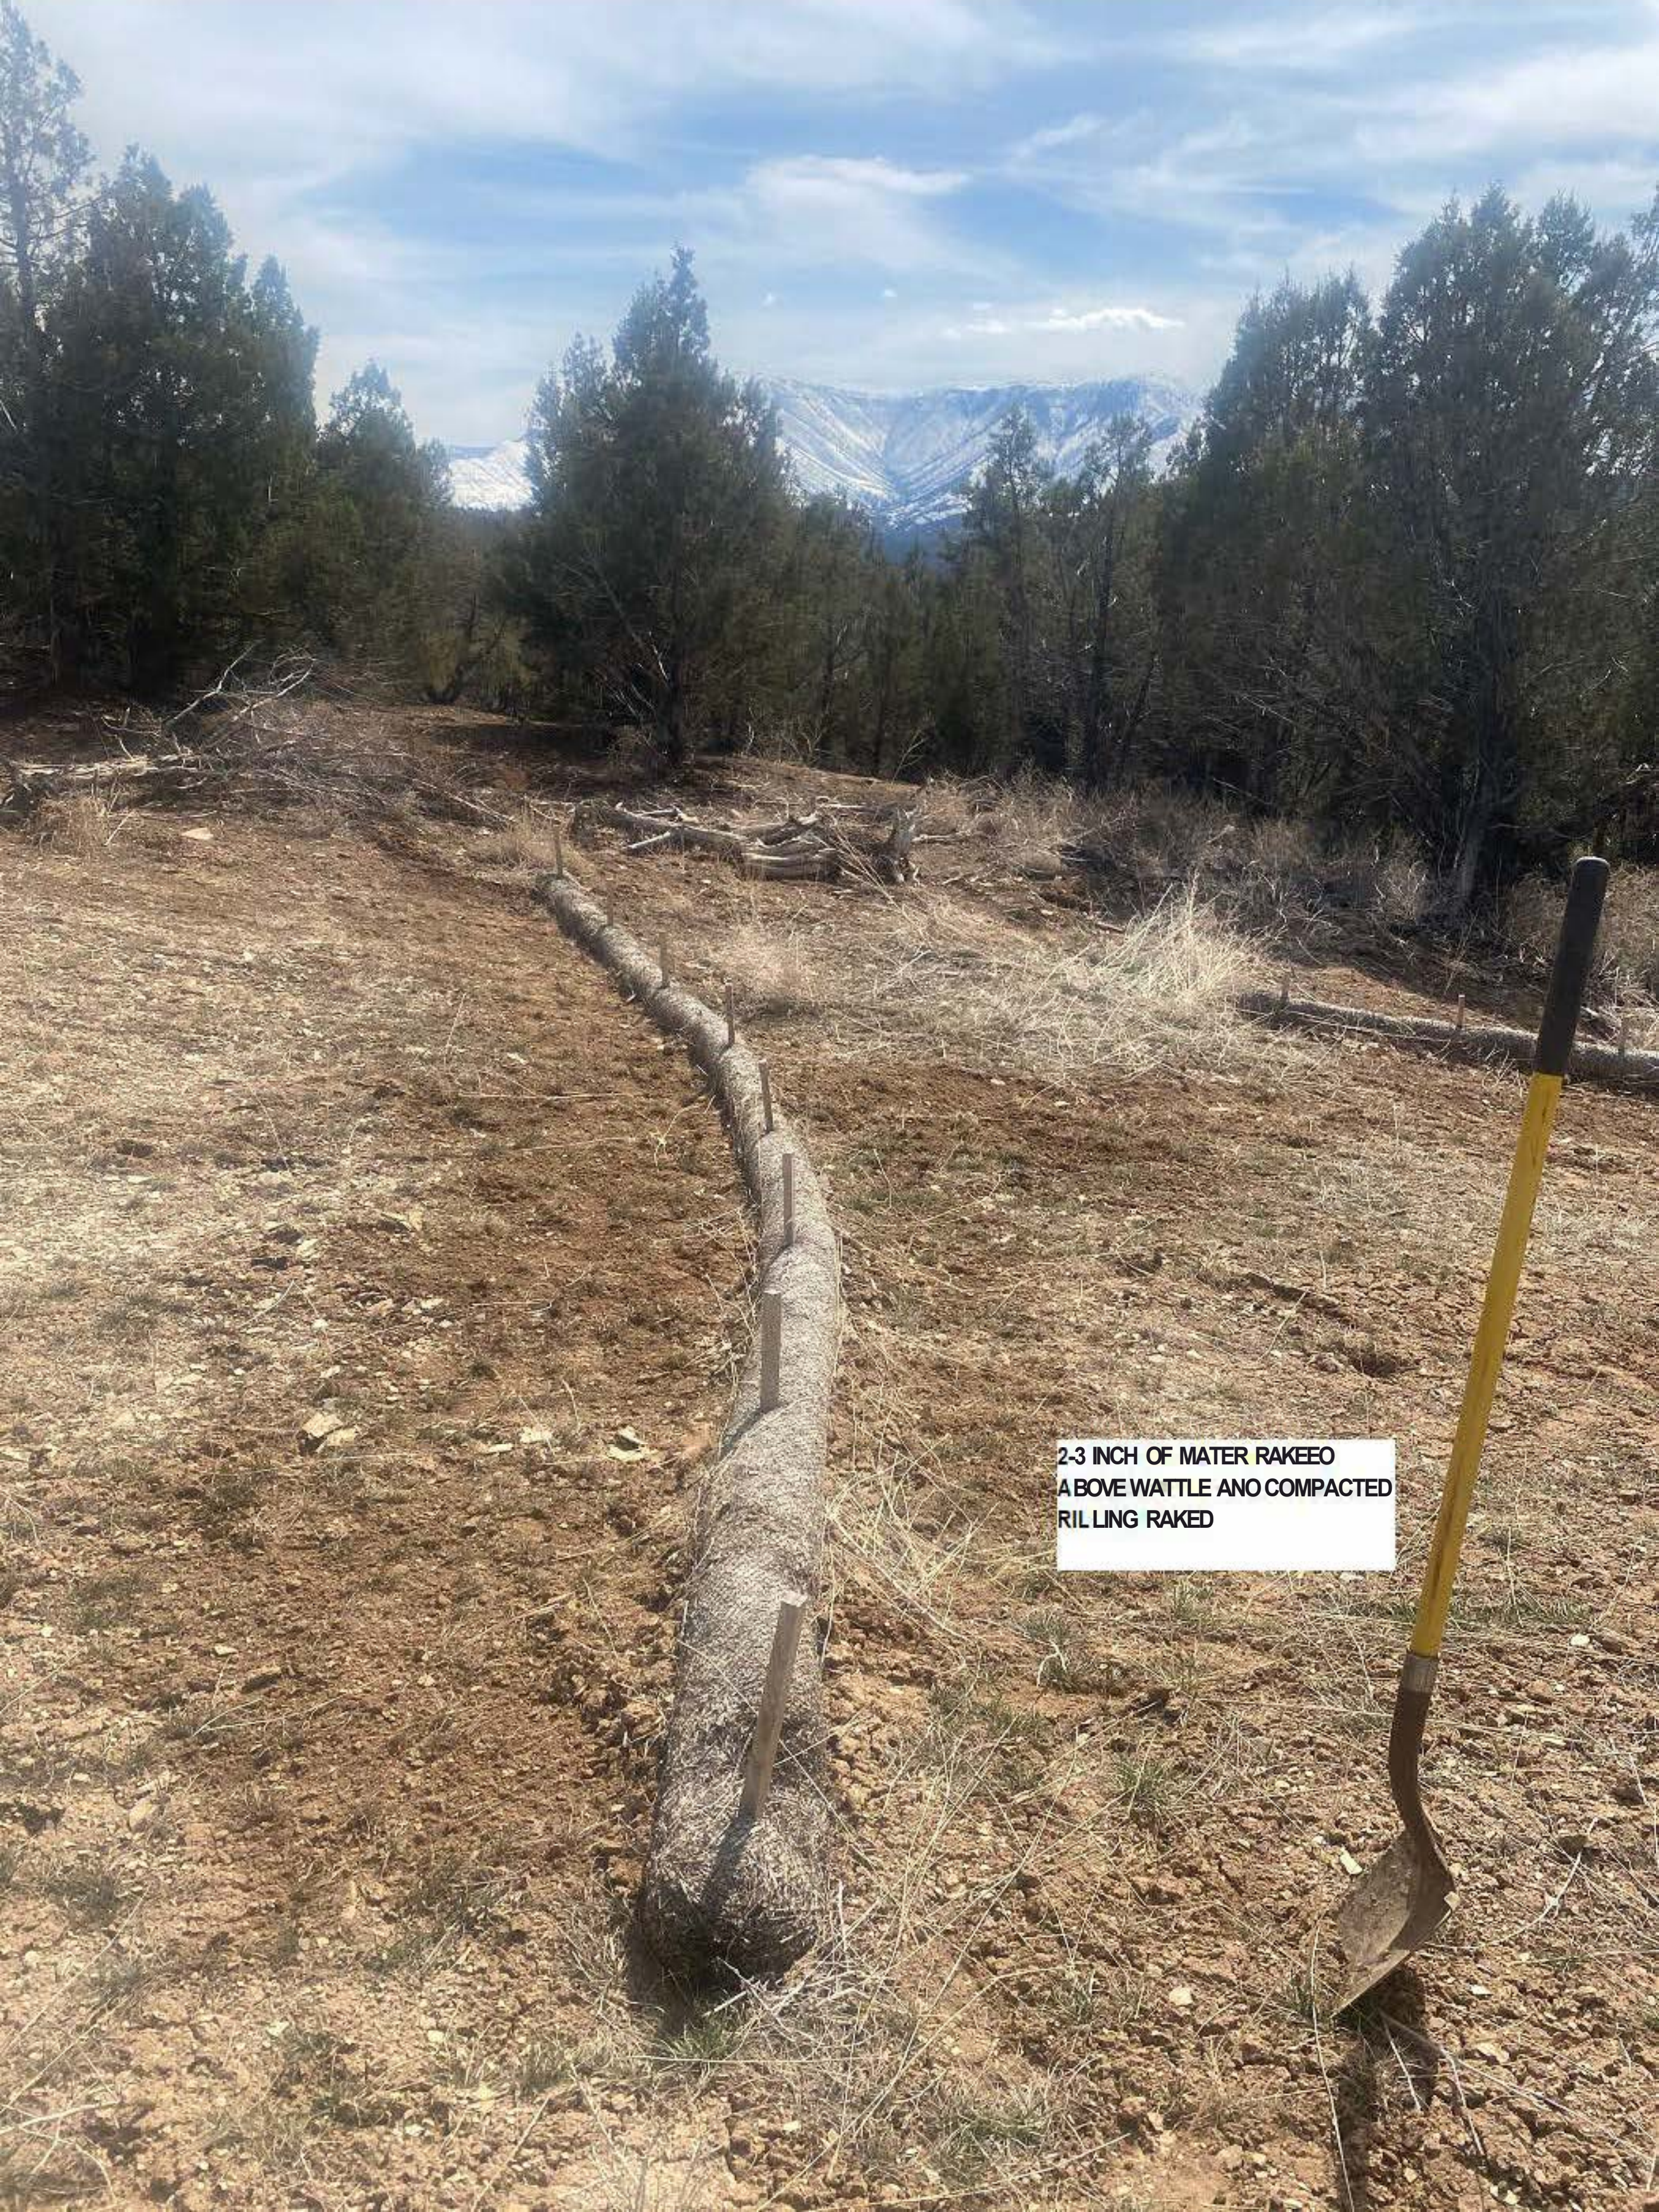
2-3 INCH OF WATER RAKEED  
ABOVE WATTLE AND COMPACTED  
RILLING RAKED

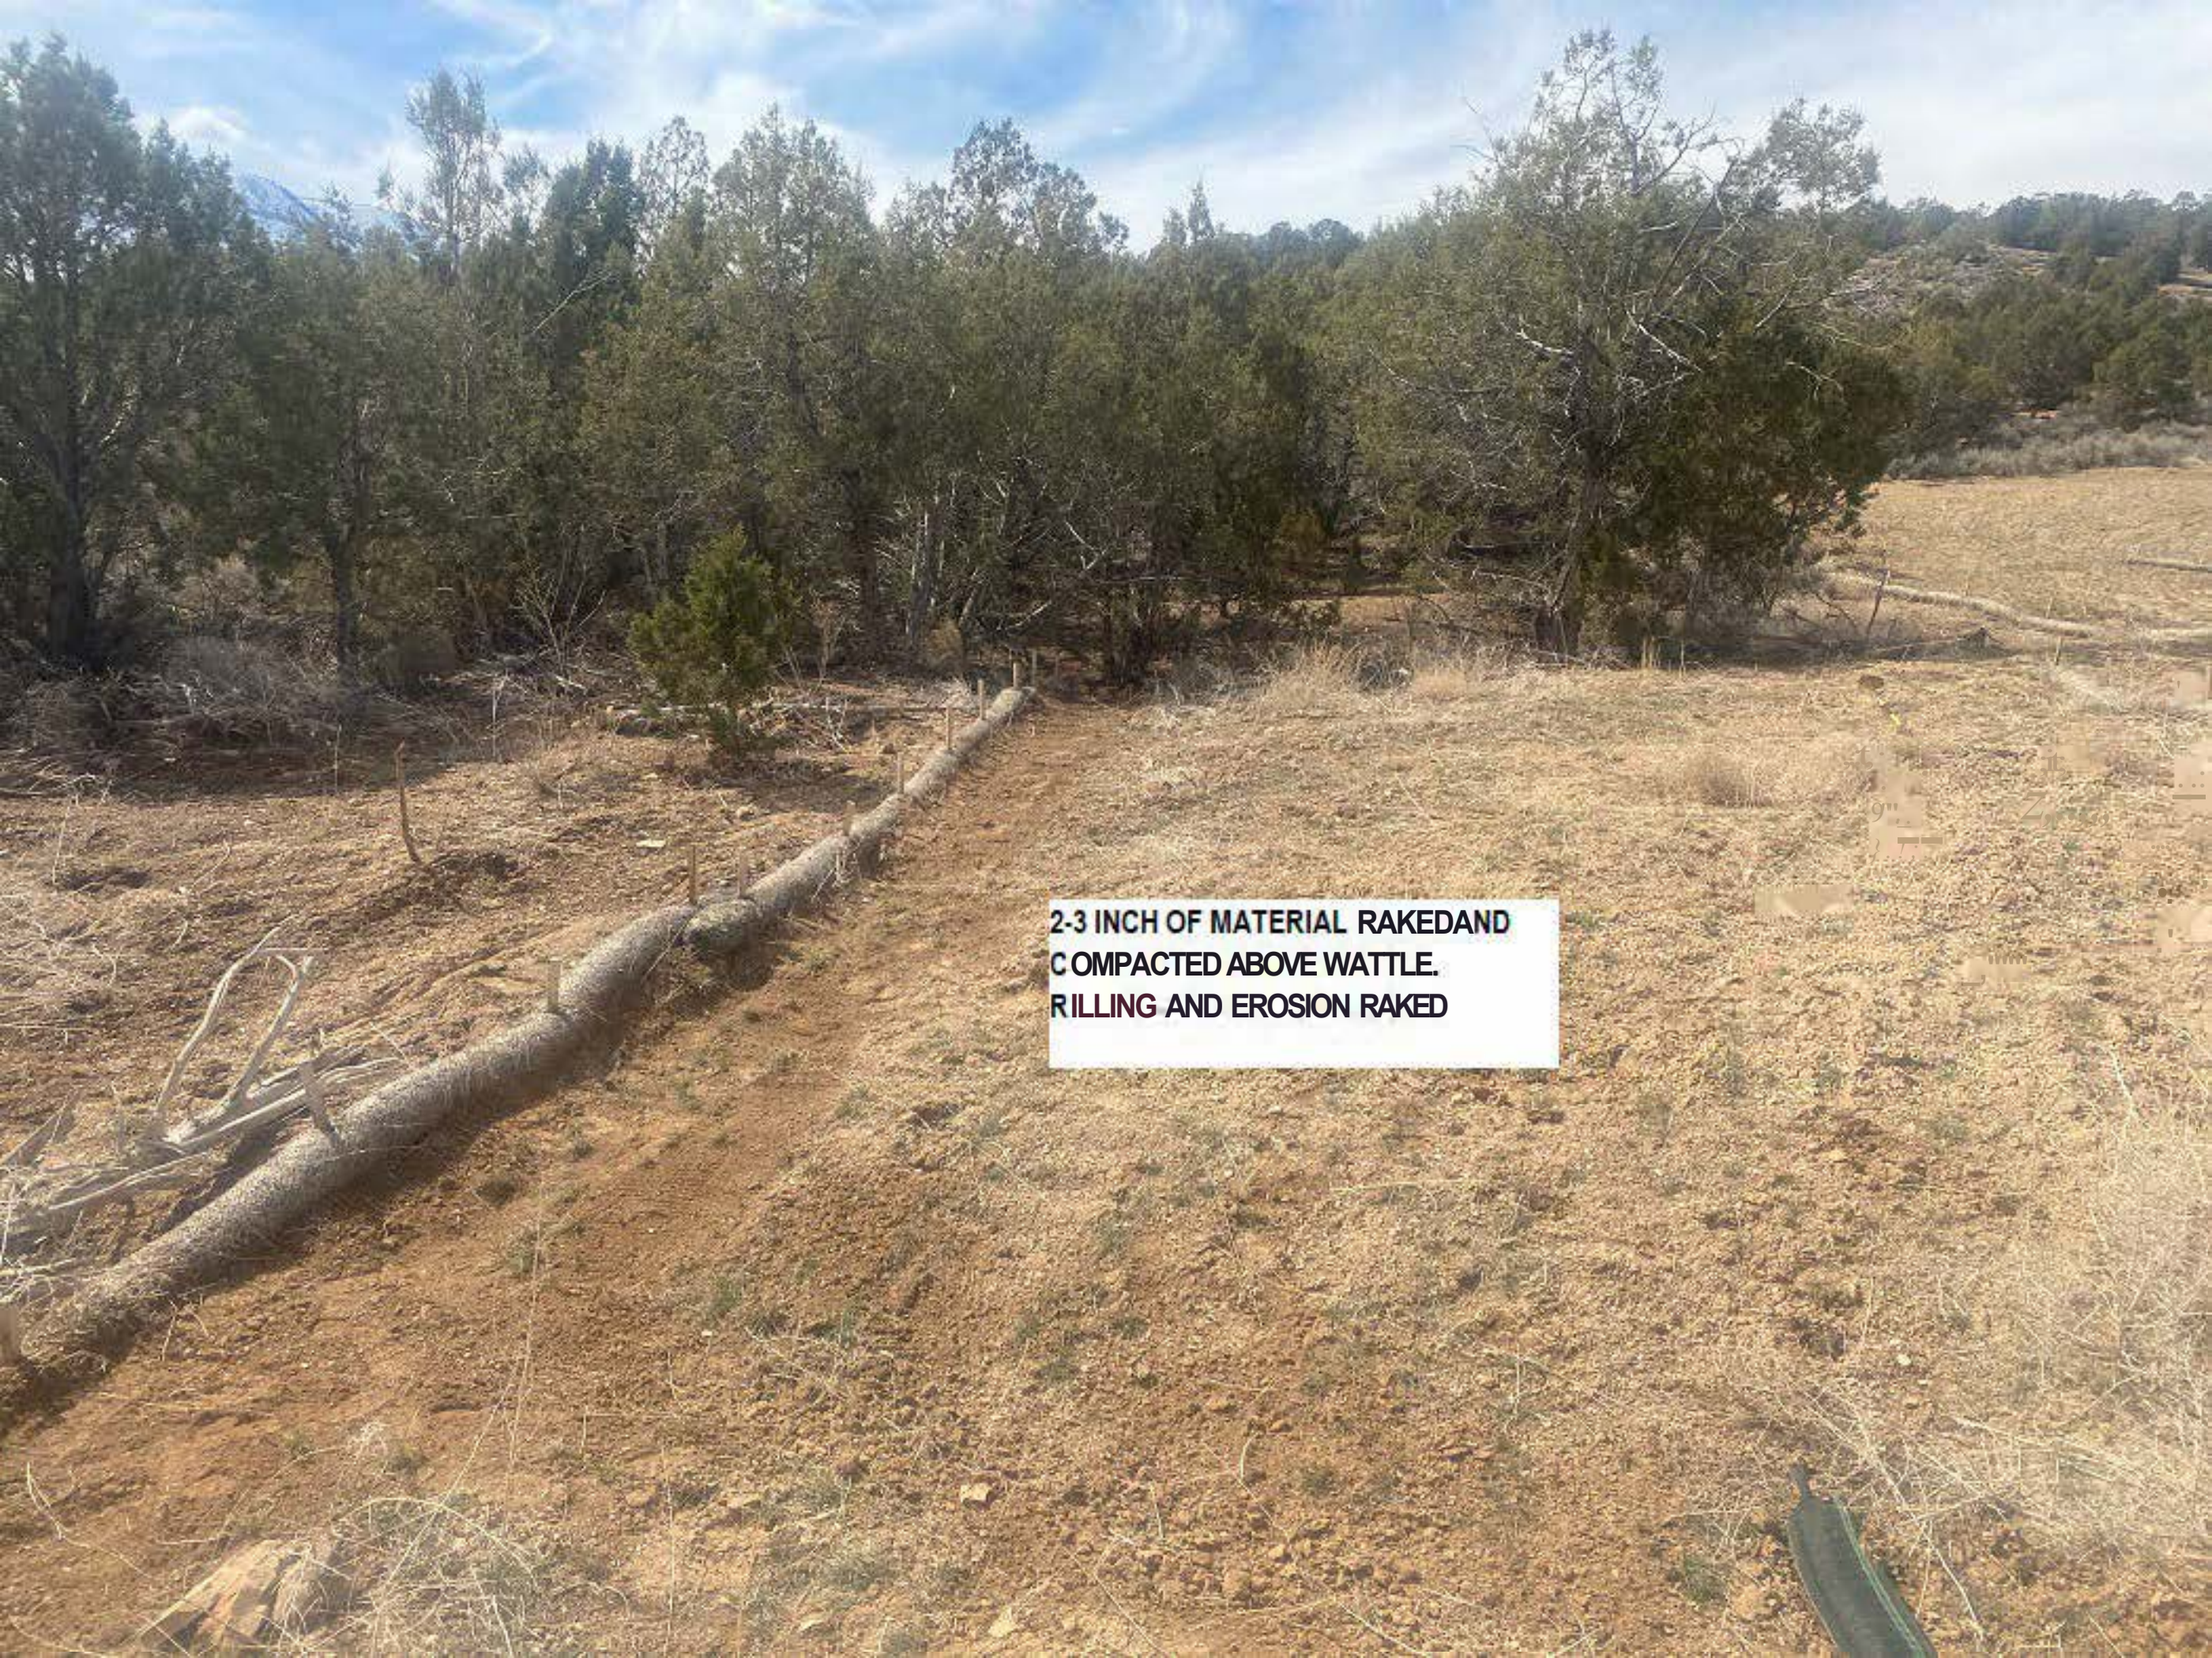
2-3 INCH OF MATERIAL RAKED AND  
COMPACTED ABOVE WATTLE.  
RILLING AND EROSION RAKED

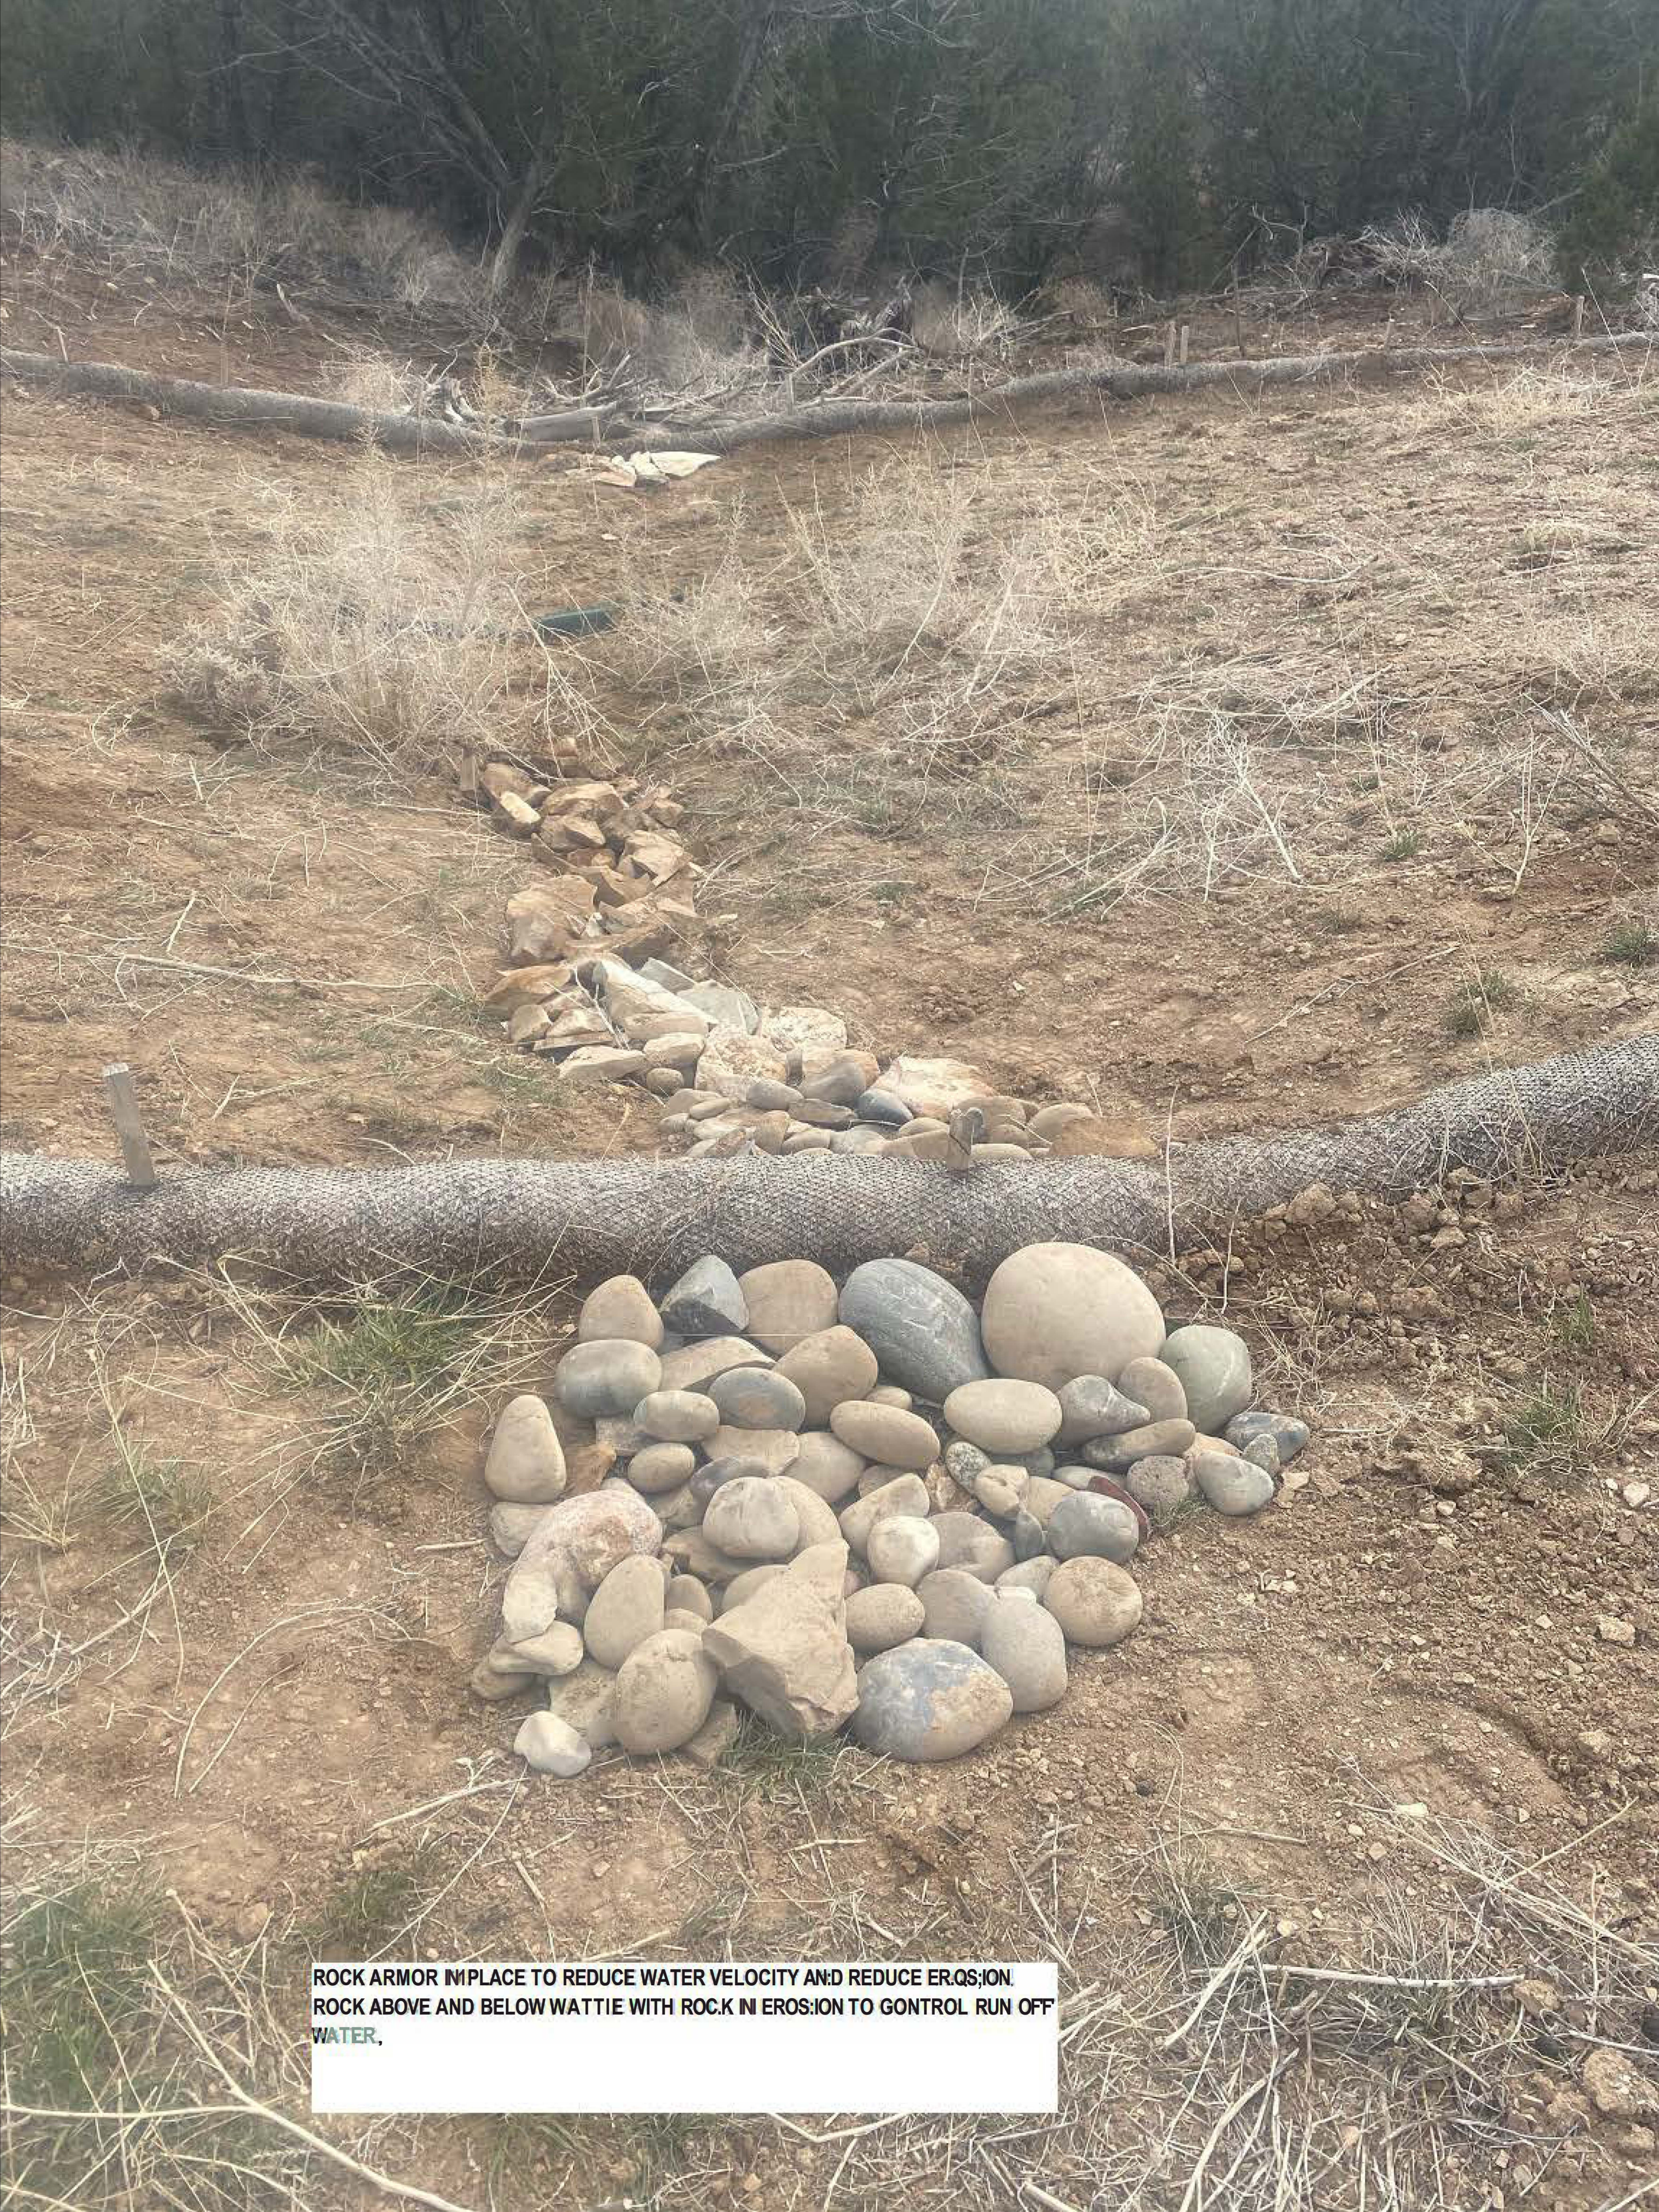
ROCK ARMOR IMPLACE TO REDUCE WATER VELOCITY AND REDUCE EROSION.  
ROCK ABOVE AND BELOW WATTIE WITH ROCK IN EROSION TO GONTROL RUN OFF  
WATER,

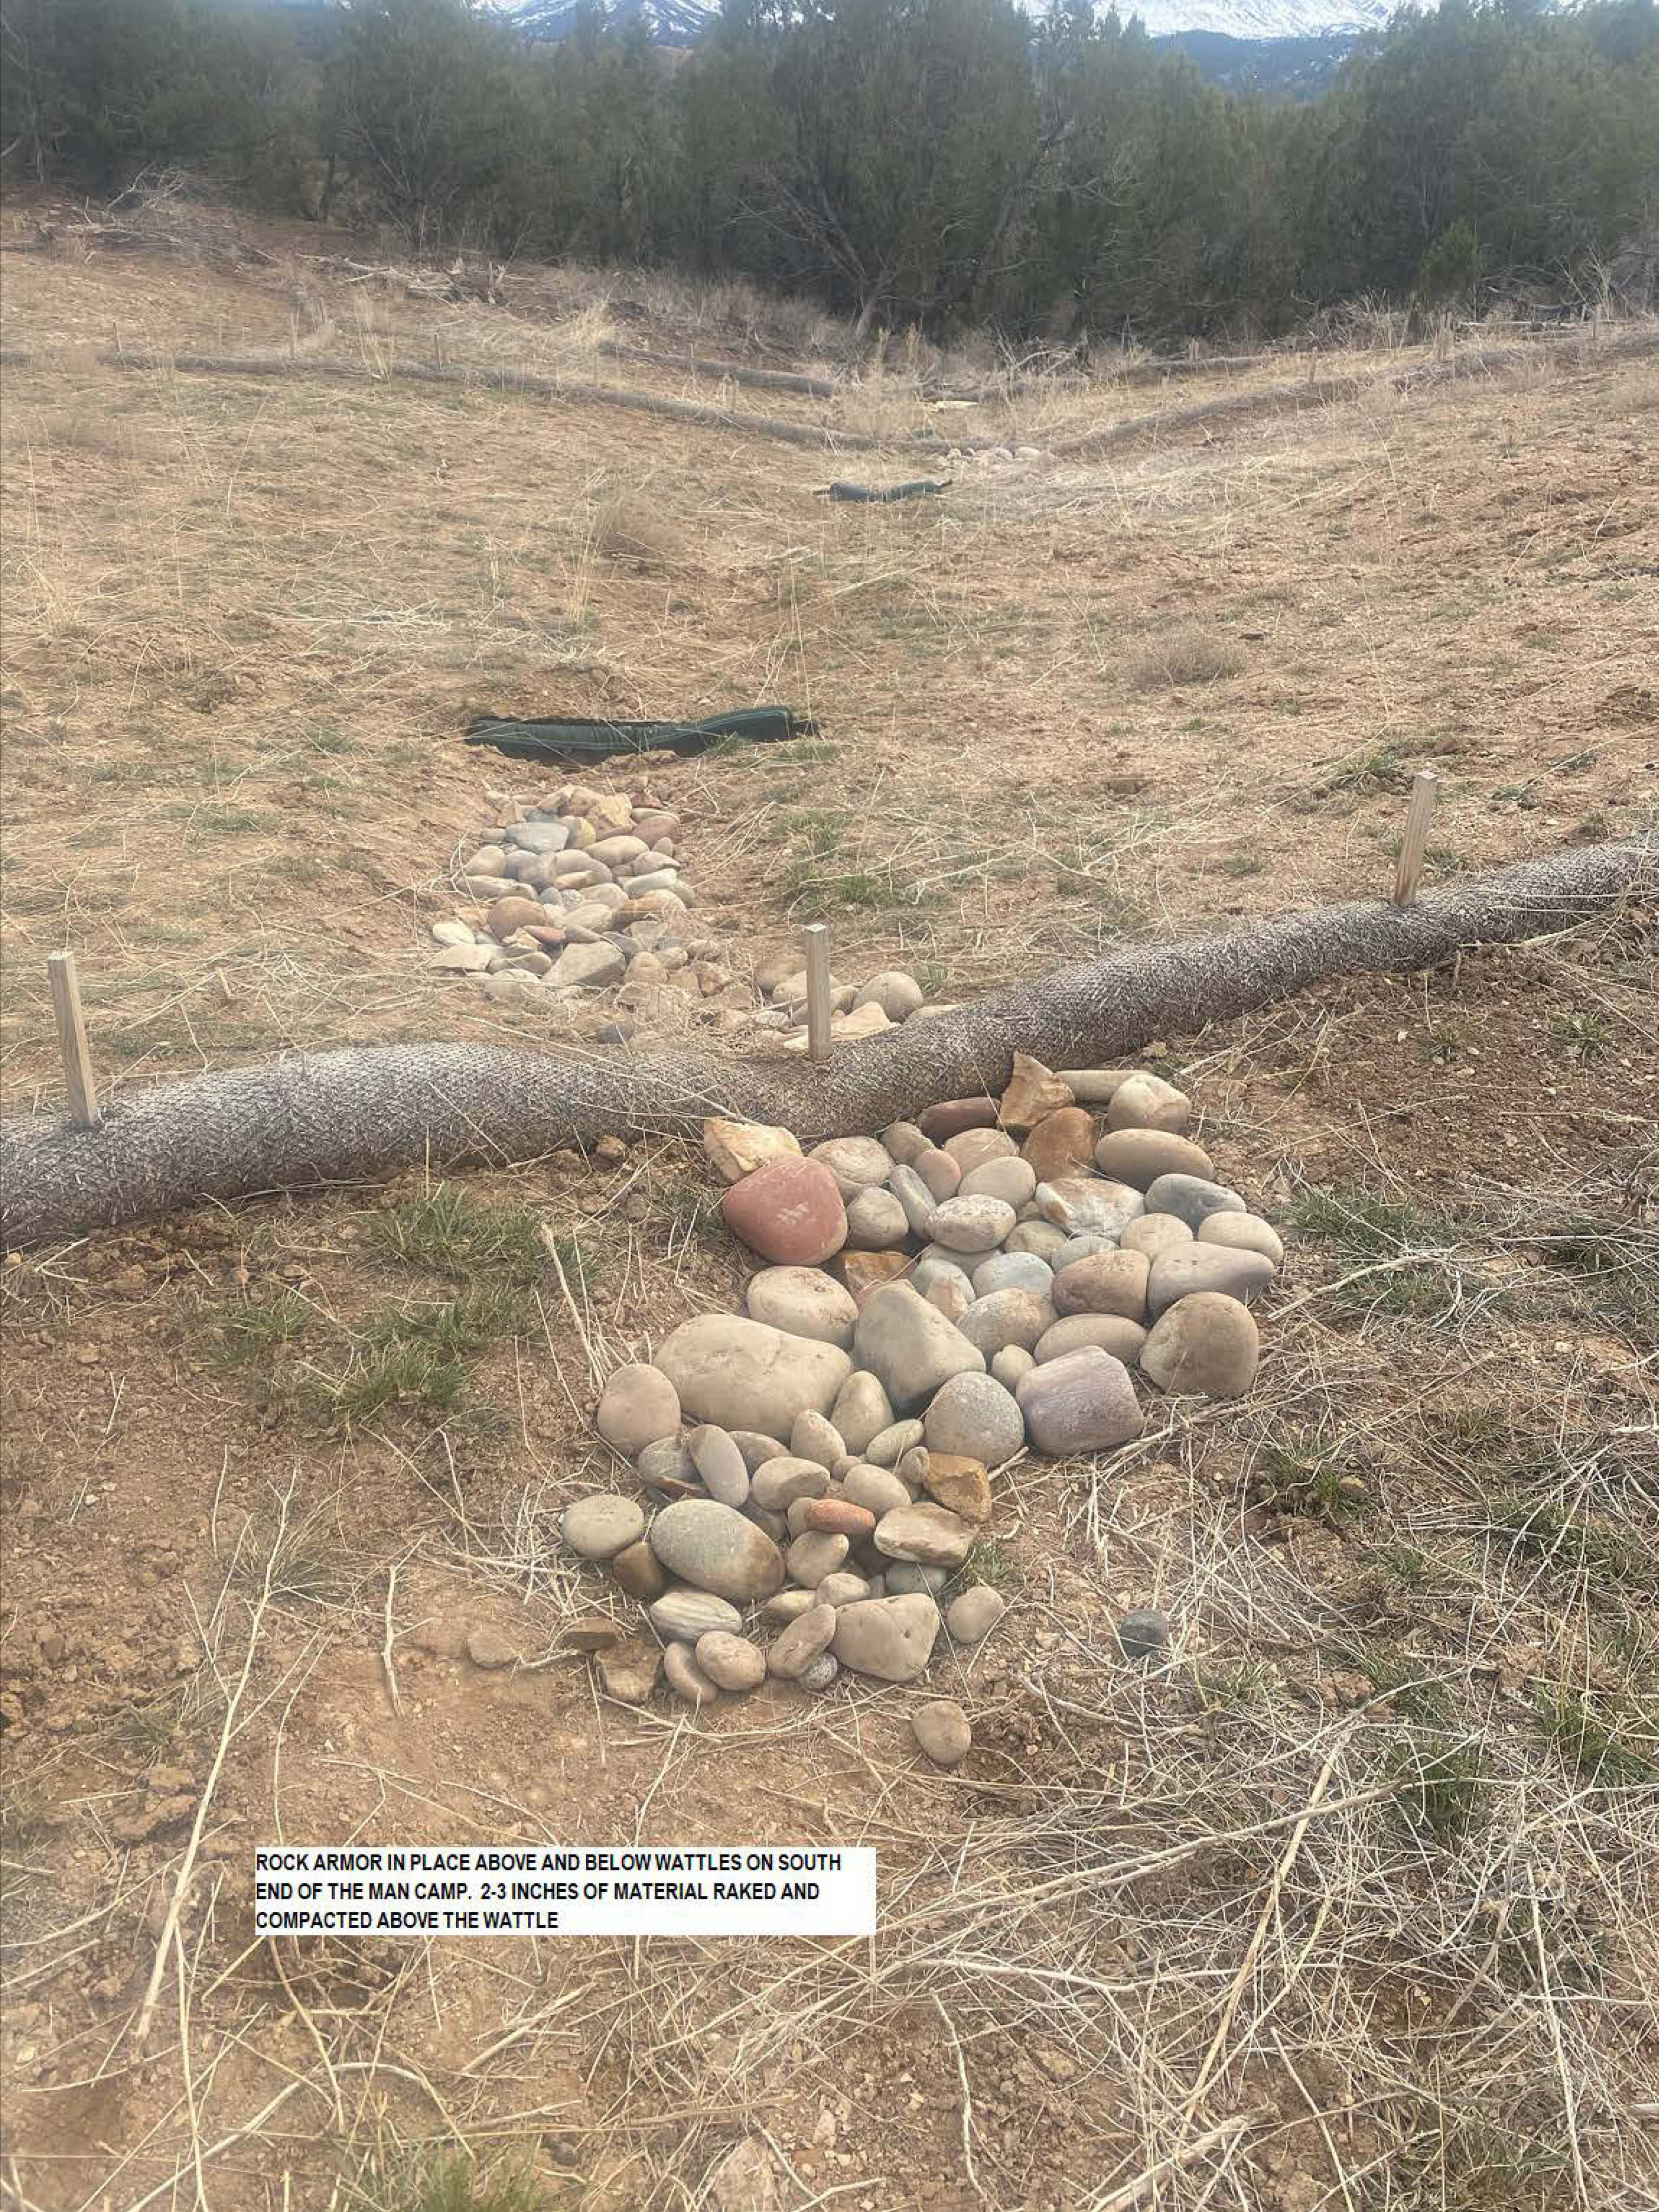
ROCK ARMOR IN PLACE ABOVE AND BELOW WATTLES ON SOUTH  
END OF THE MAN CAMP. 2-3 INCHES OF MATERIAL RAKED AND  
COMPACTED ABOVE THE WATTLE
