Inspection Photos

API: 073-06743

Operator: K3 OIL & GAS OPERATING

Inspection Date: 3/17/2021

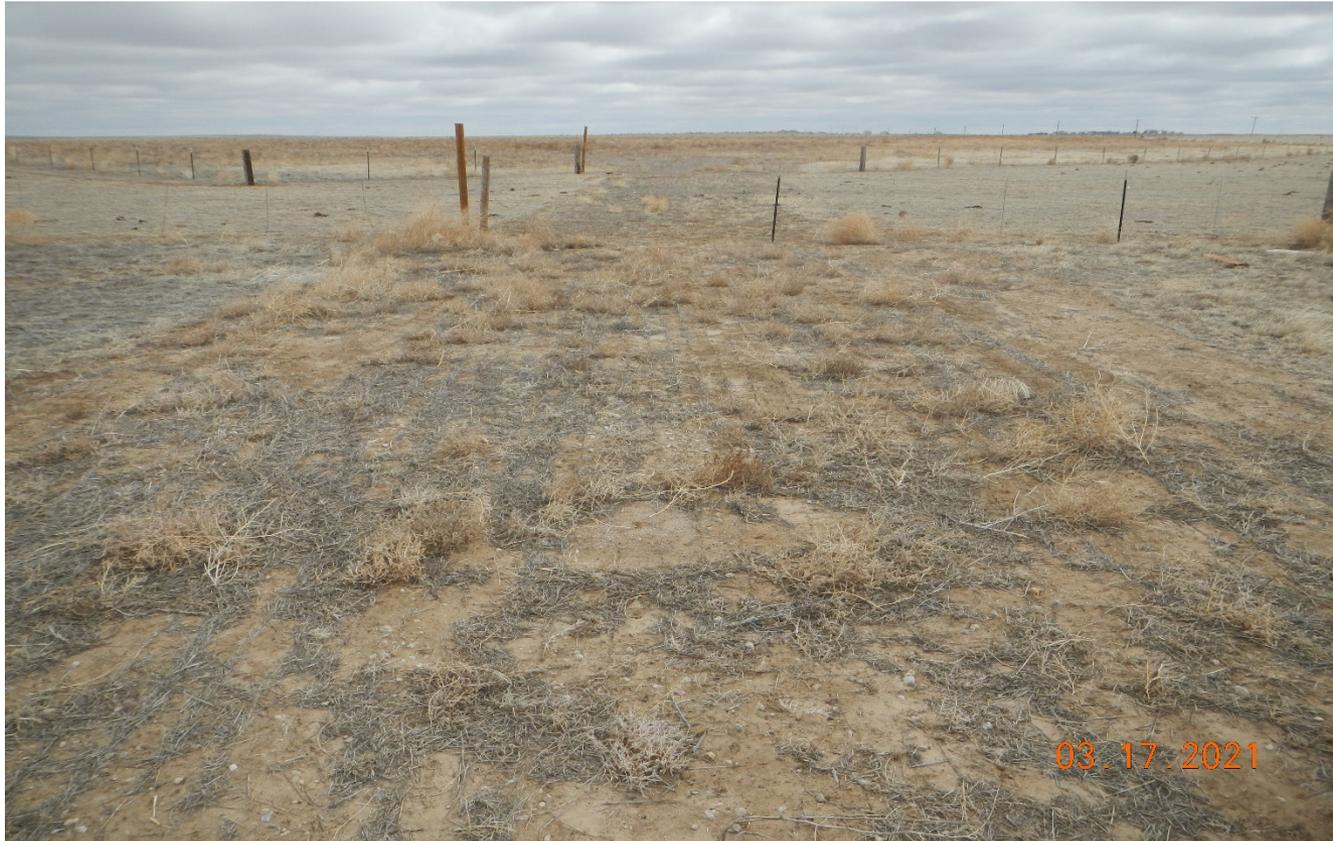
Photo 1. Facing east at the former access road. The fence will need to be reinstalled to the where it originally existed.

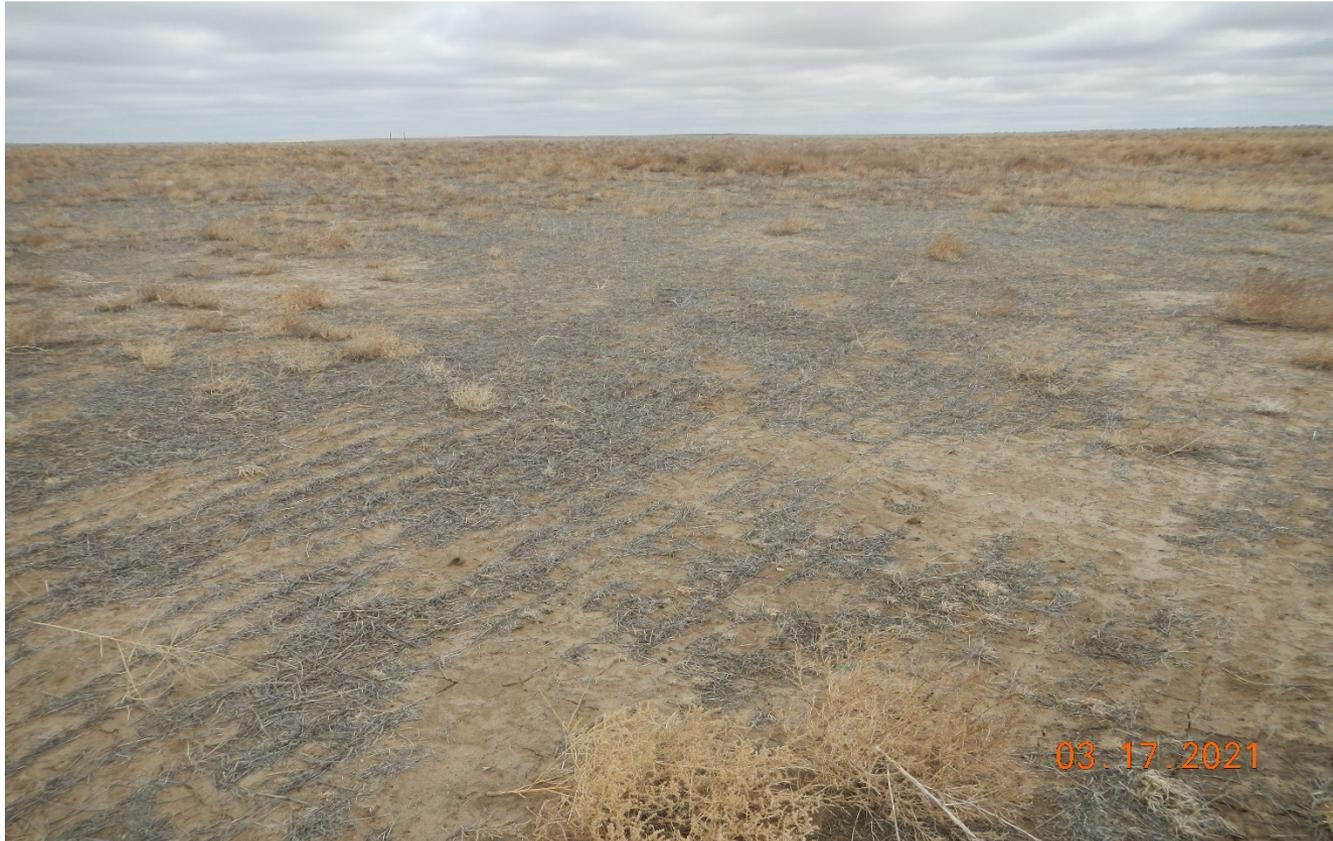
Photo 2. . Facing east toward the location. It does not appear vegetation is establishing and there are undesirable weed debris throughout the location.

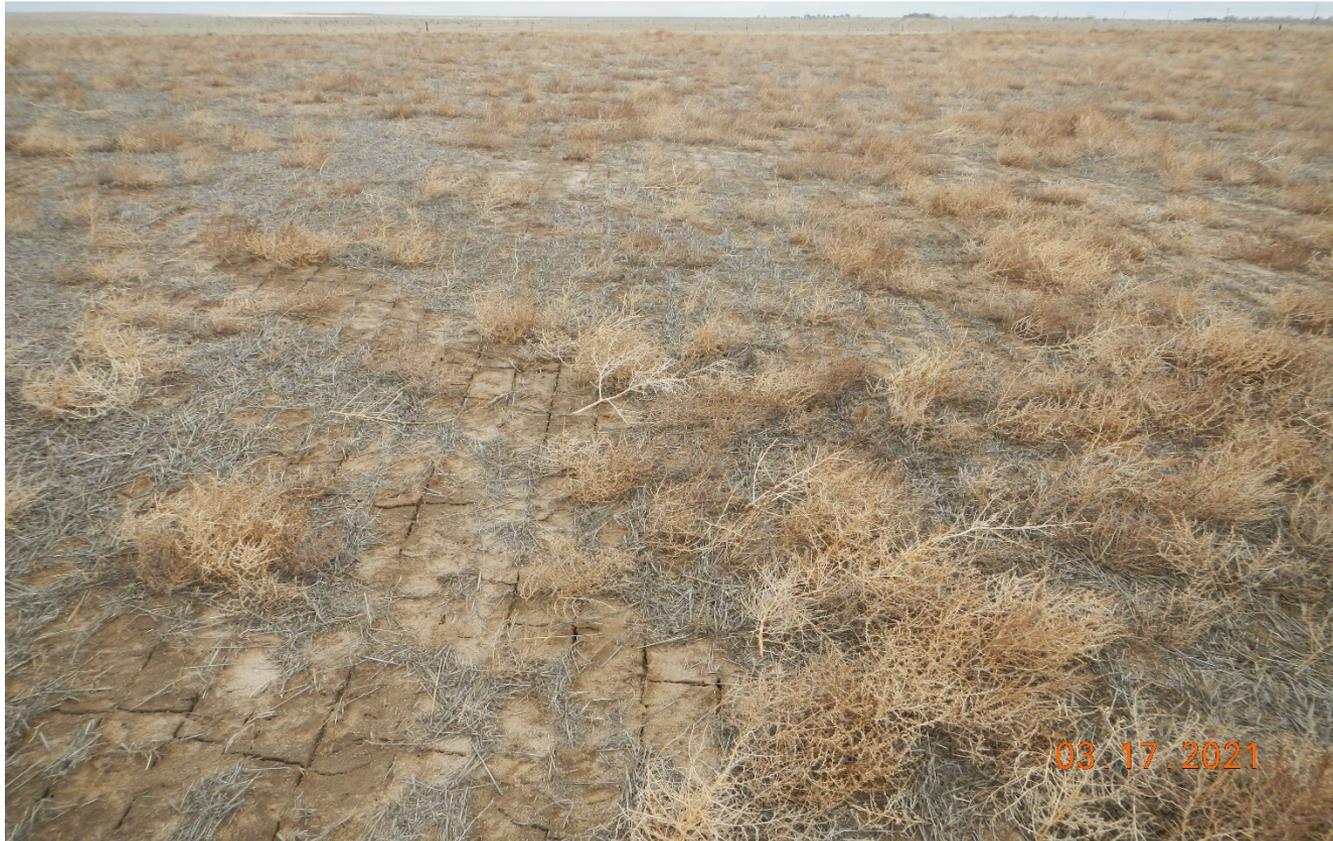
Photo 3. Center of the location facing east.

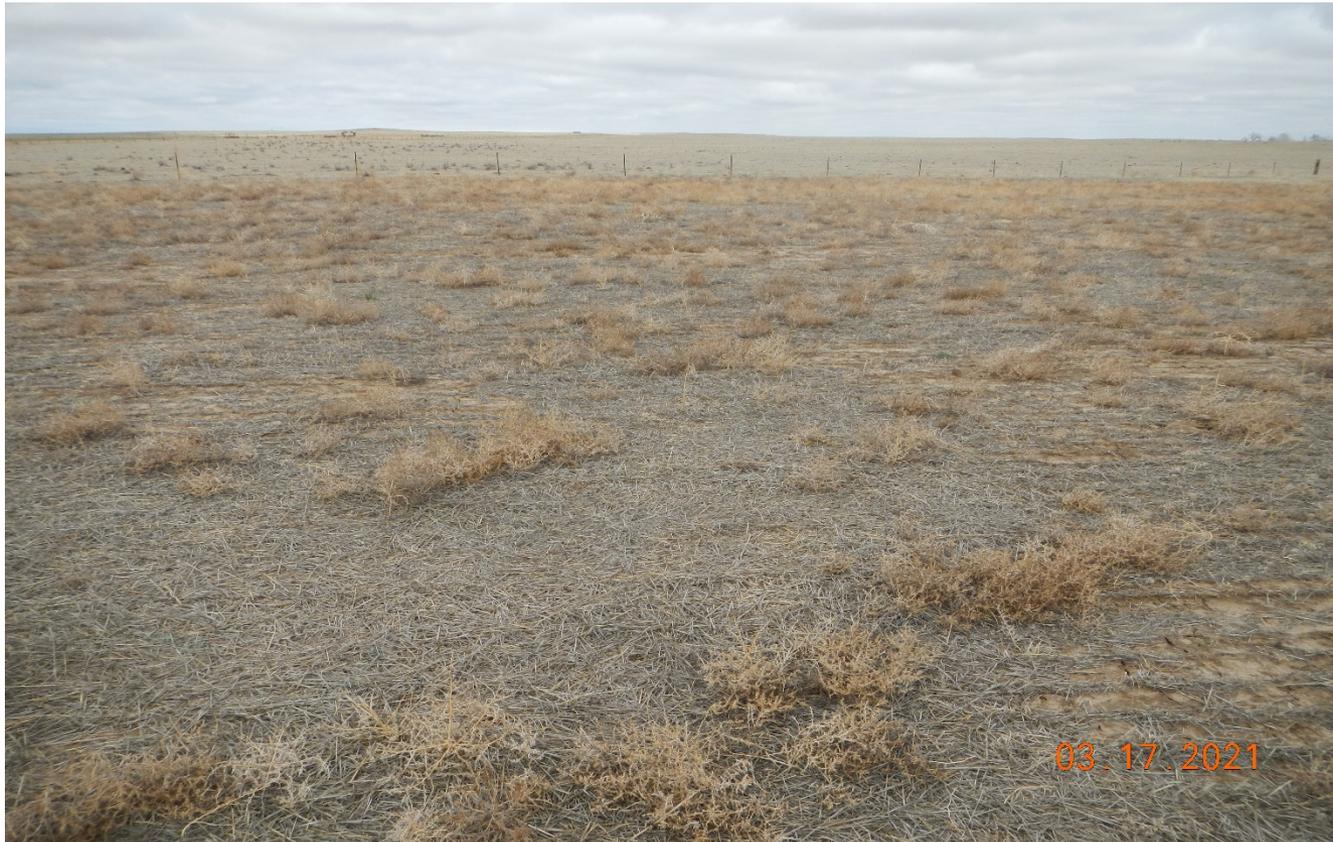
Photo 4. Center of the location facing north.

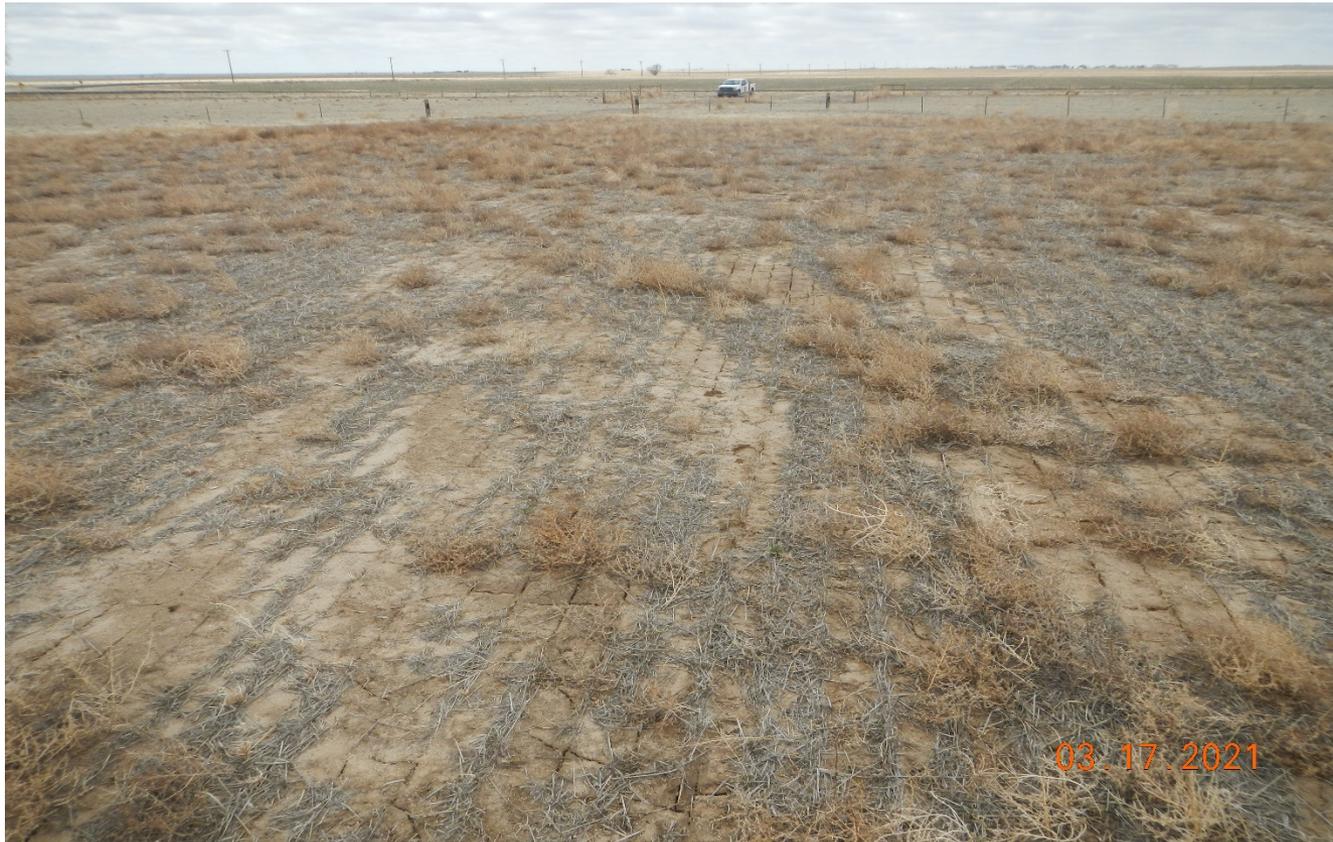
Photo 5. Center of the location facing west.

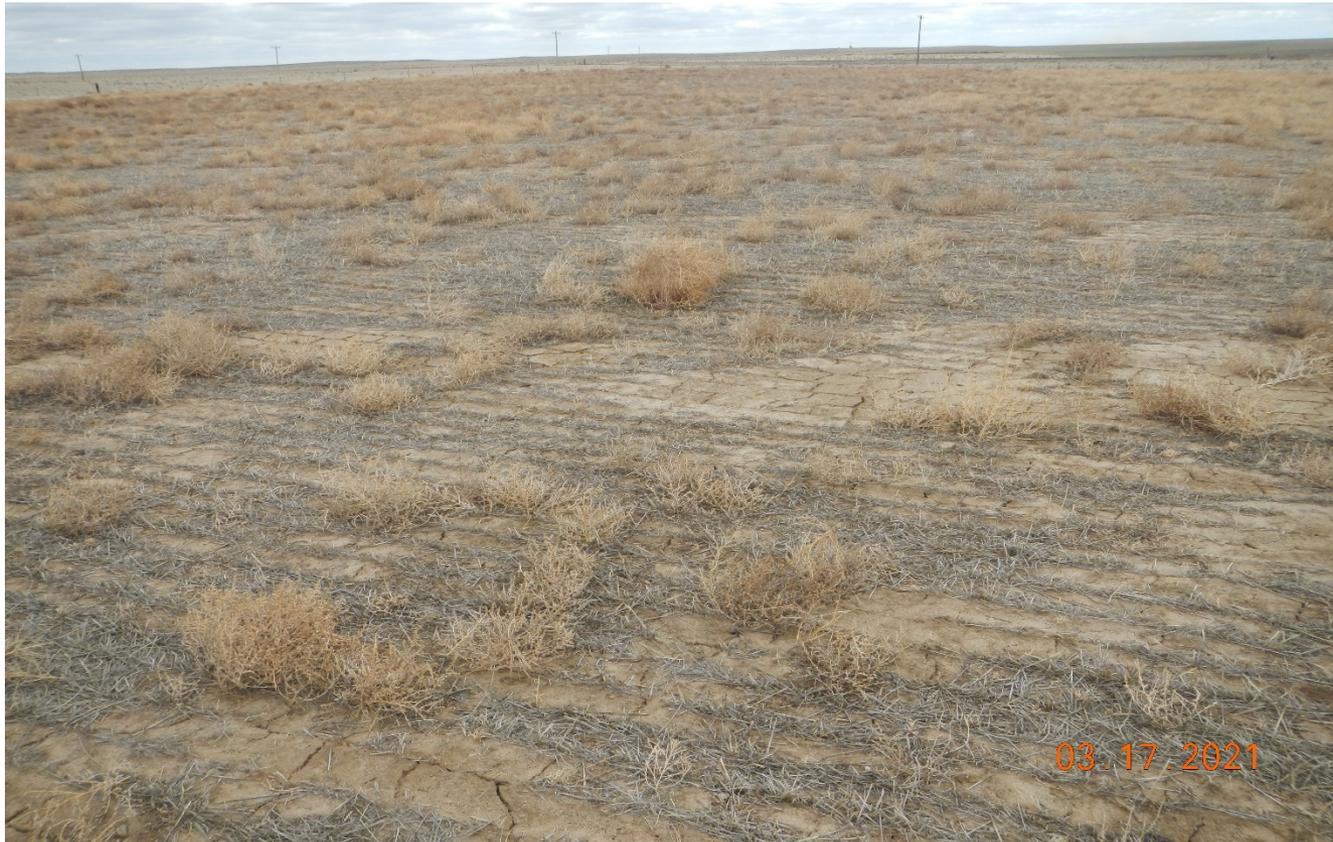
Photo 6. Center of the location facing south.

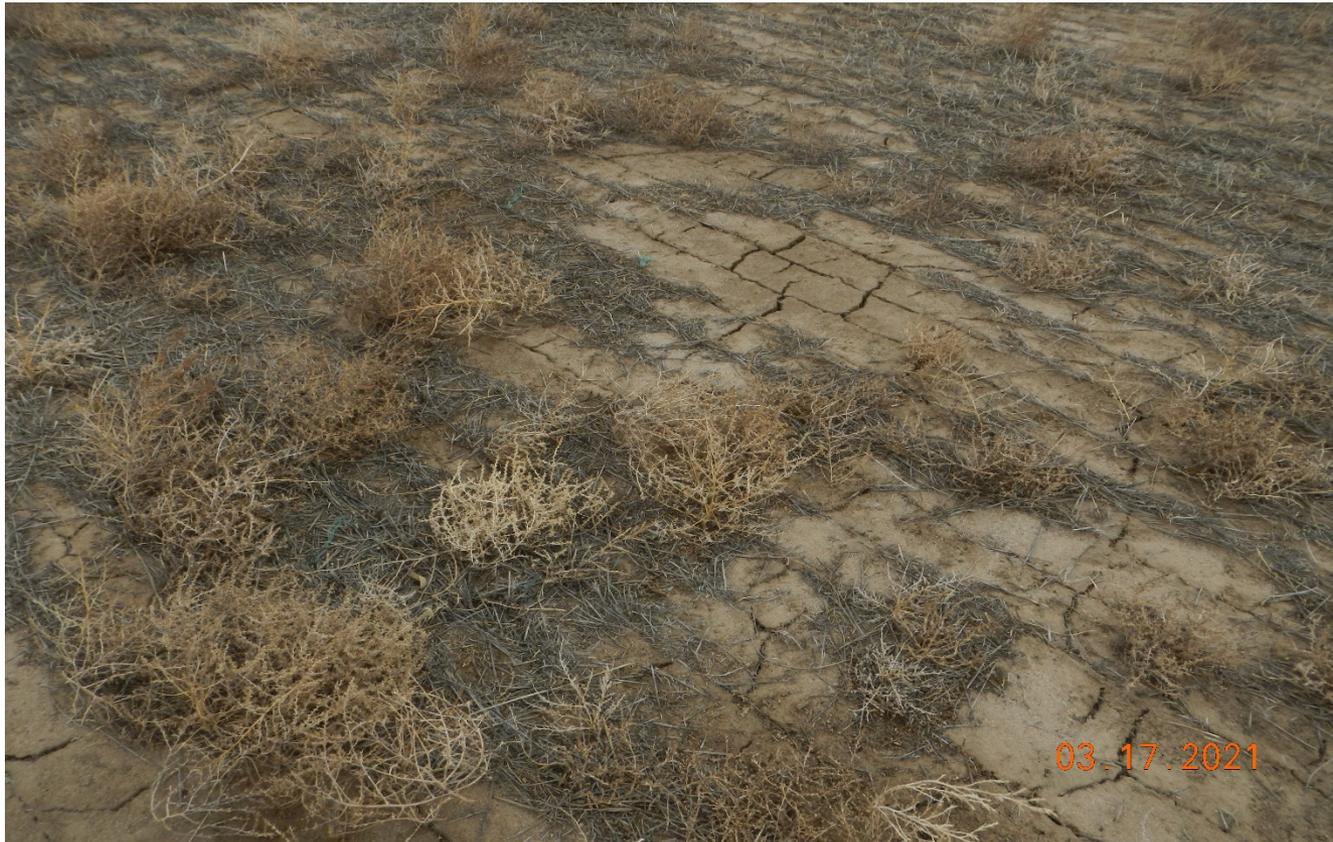
Photo 7. View of groundcover shows insufficient desirable vegetation establishment.

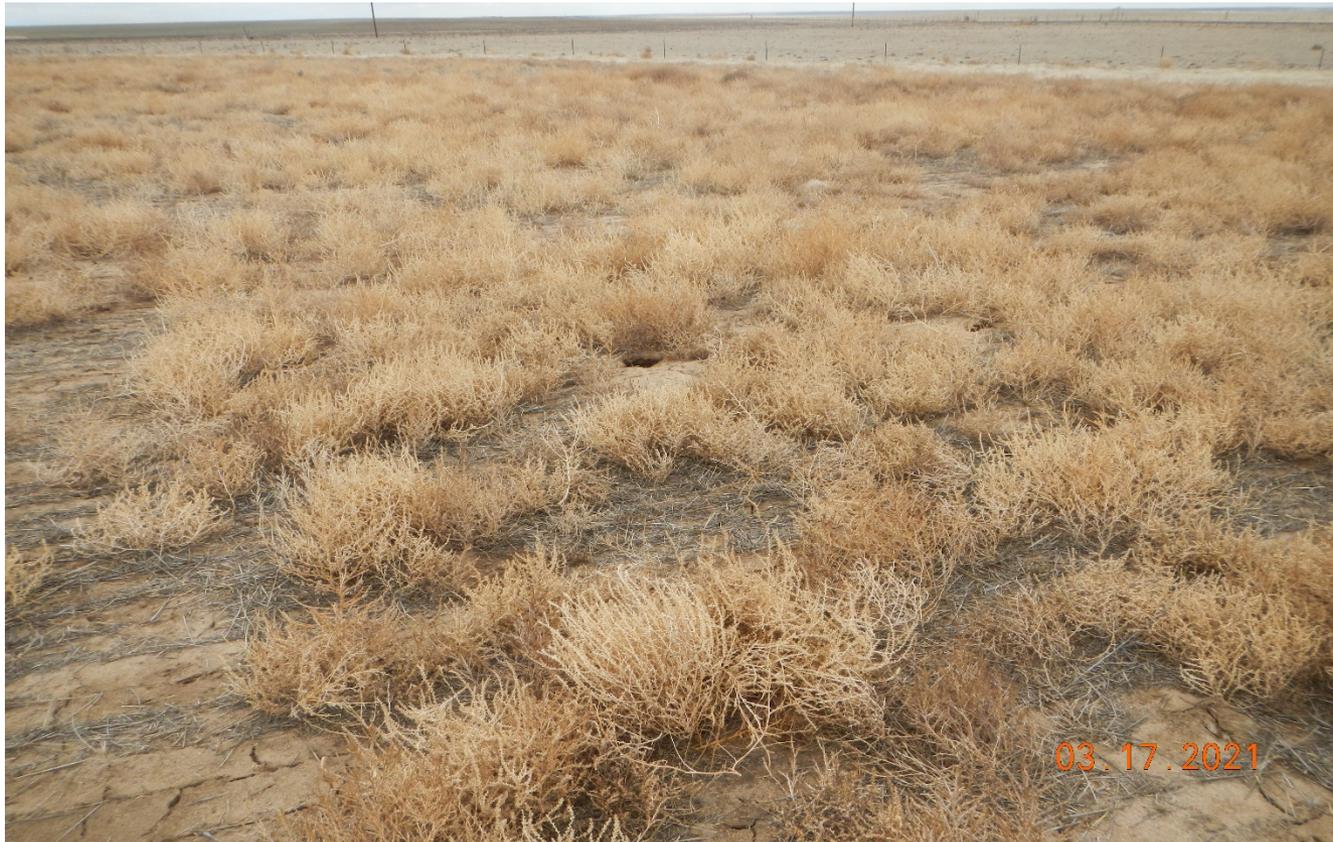
Photo 8. Facing toward the south side of the location. The vegetation shown in the photo is undesirable weeds (Russian thistle). The weeds and debris need to be controlled and removed.
