Inspection Photos
Operator: Simcoe
Facility: 067-08524
Date: 3/16/2021

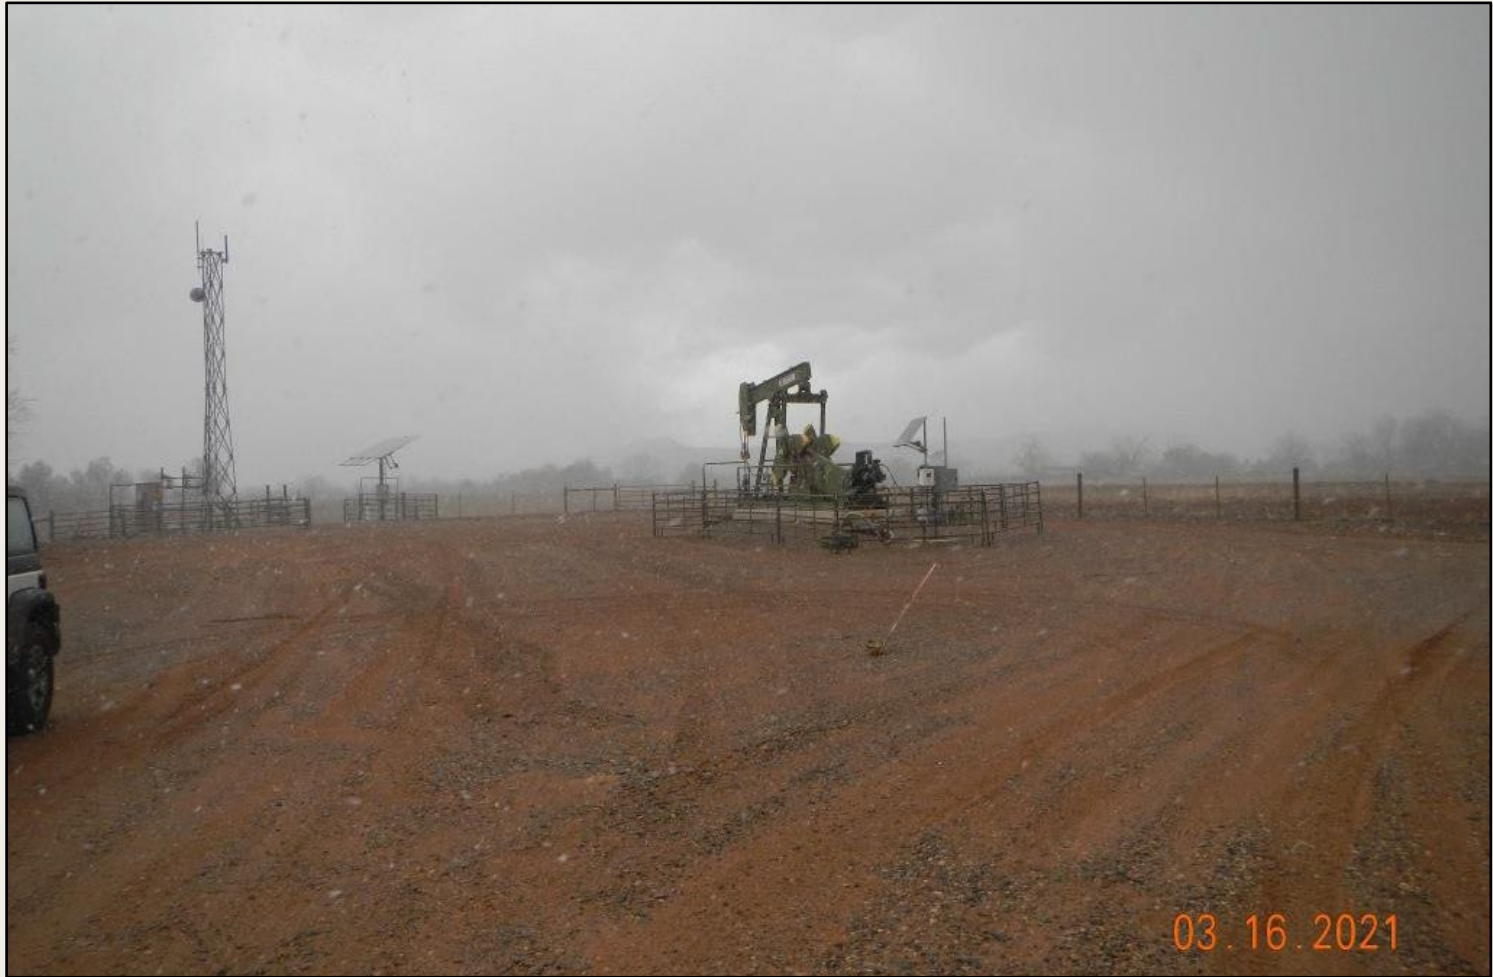
Photo 1. View of the project area from the well pad entrance facing center.

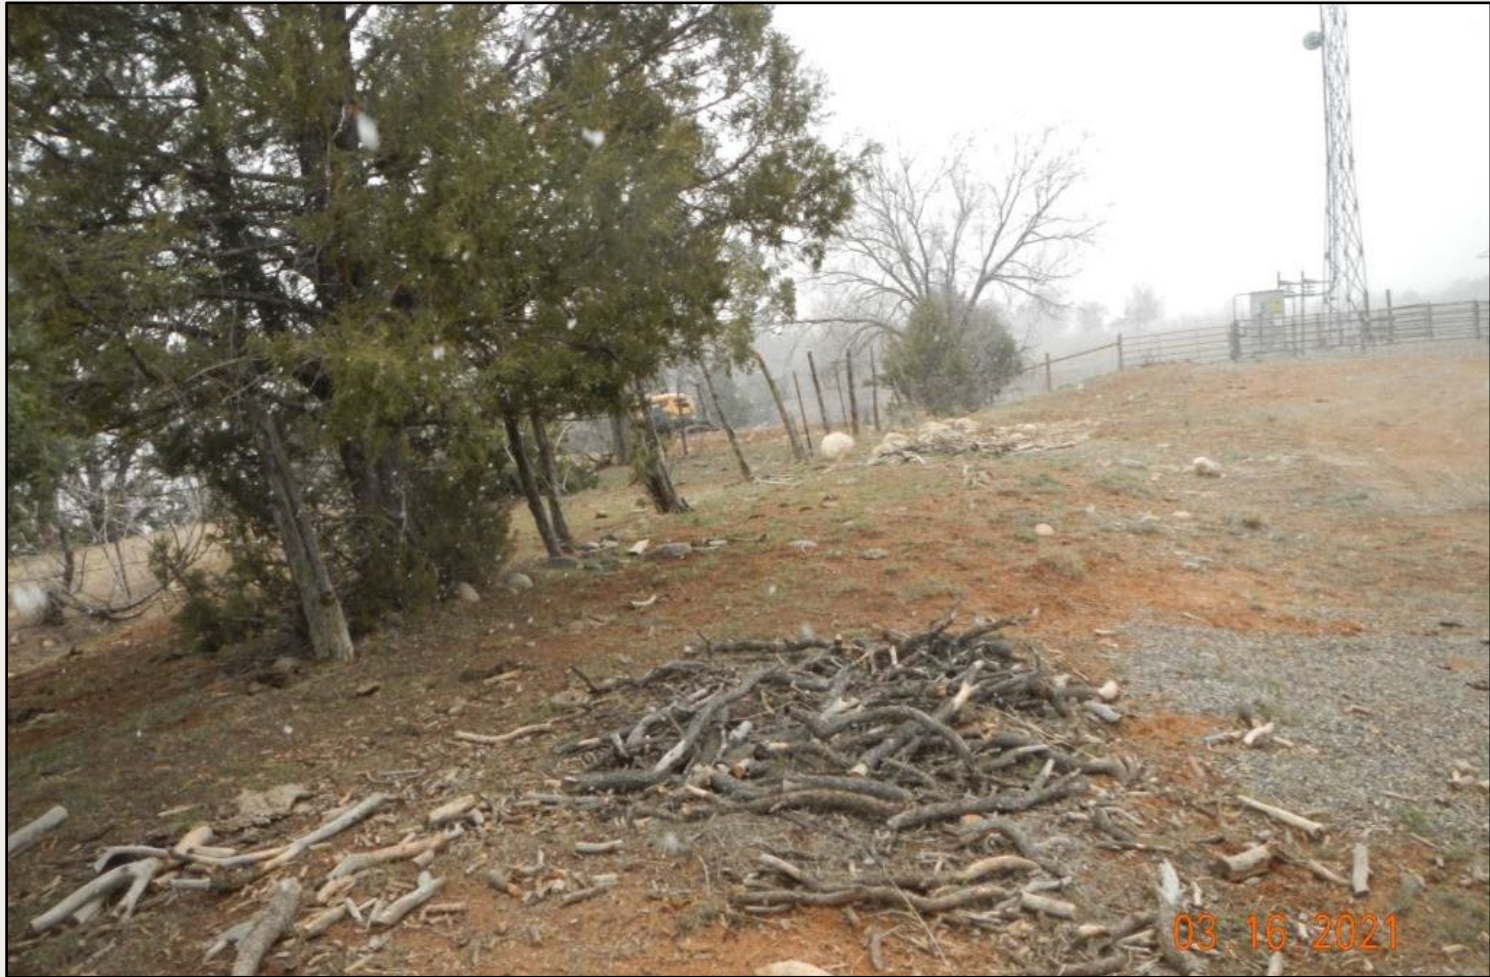
Photo 2. View of the eastern project area facing southward.

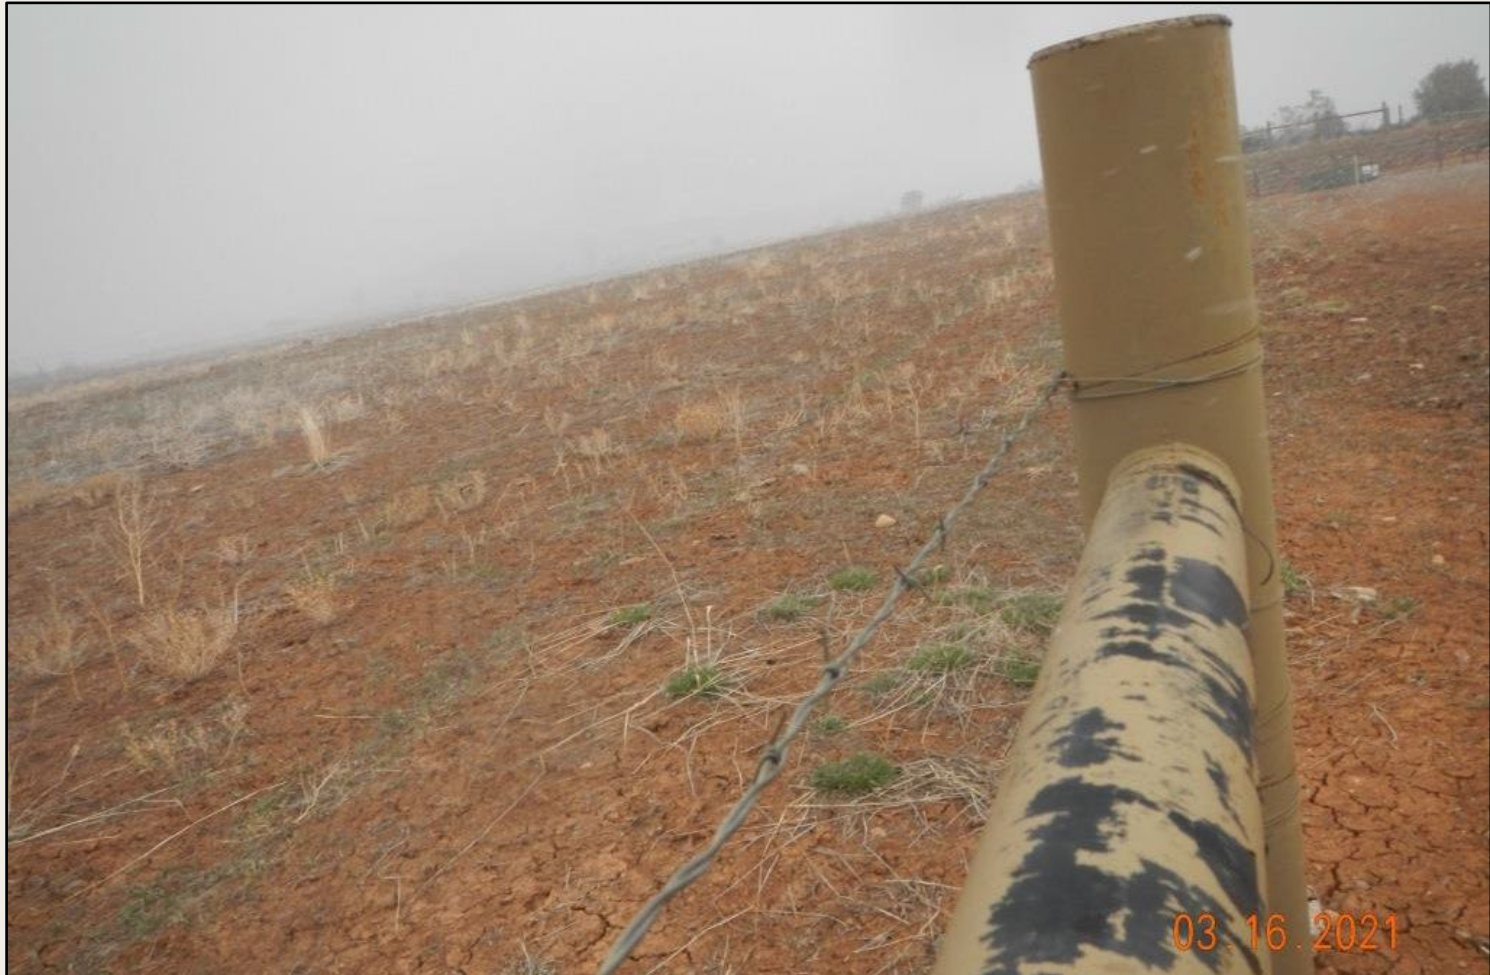
Photo 3. View of the western project area from the southwestern corner facing northward. Working area is fenced. Interim reclamation areas are similar to surrounding cultivated field. Vegetation is largely dormant and appears sparse at this time.

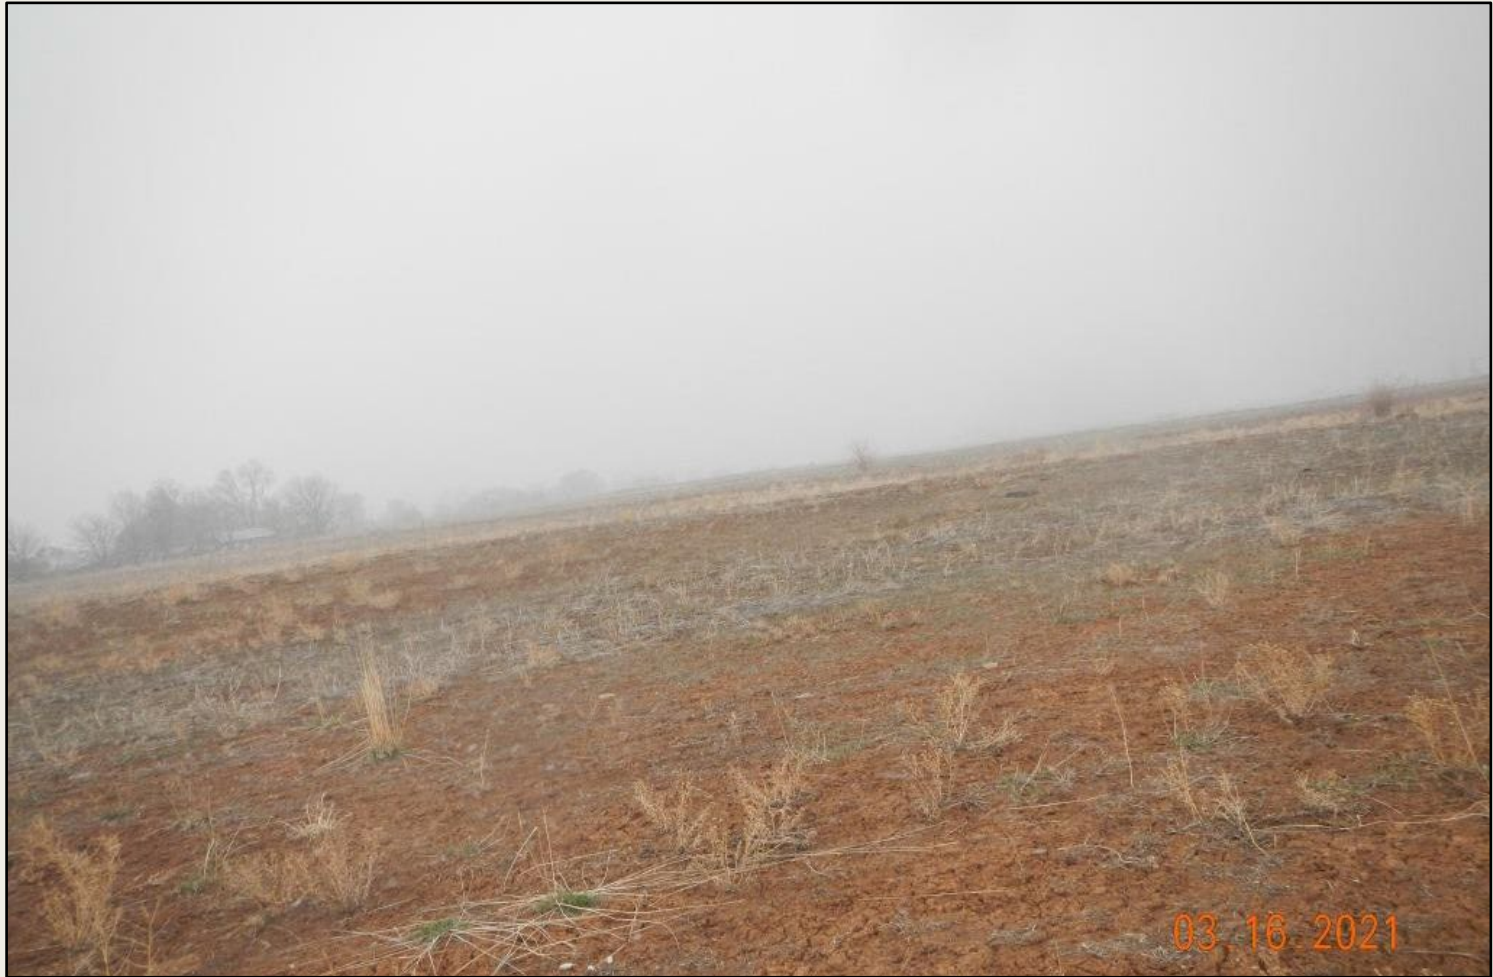
Photo 4. View of reference area comprised of open grass field, largely dormant at this time.
