Caerus Piceance LLC
H15
Location # 334617

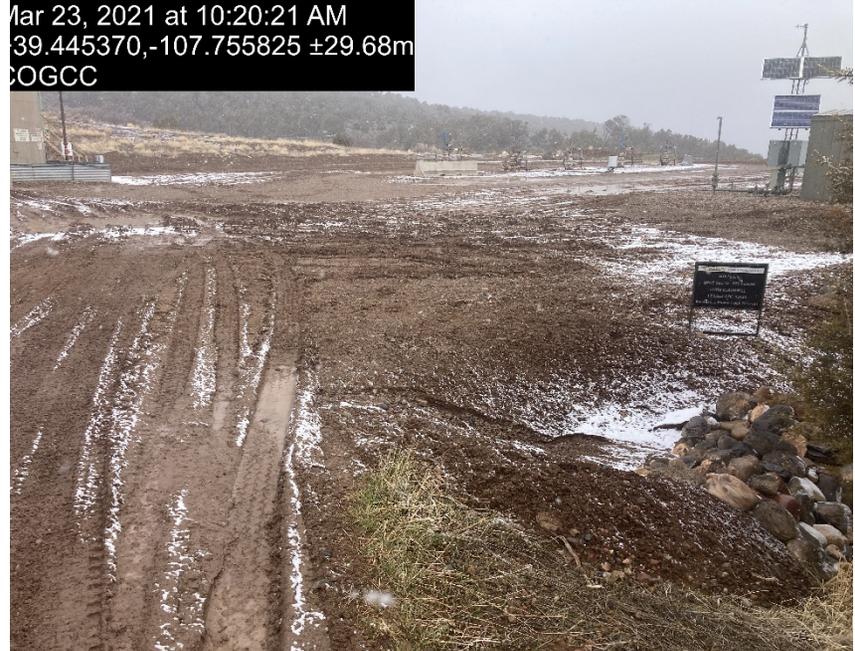
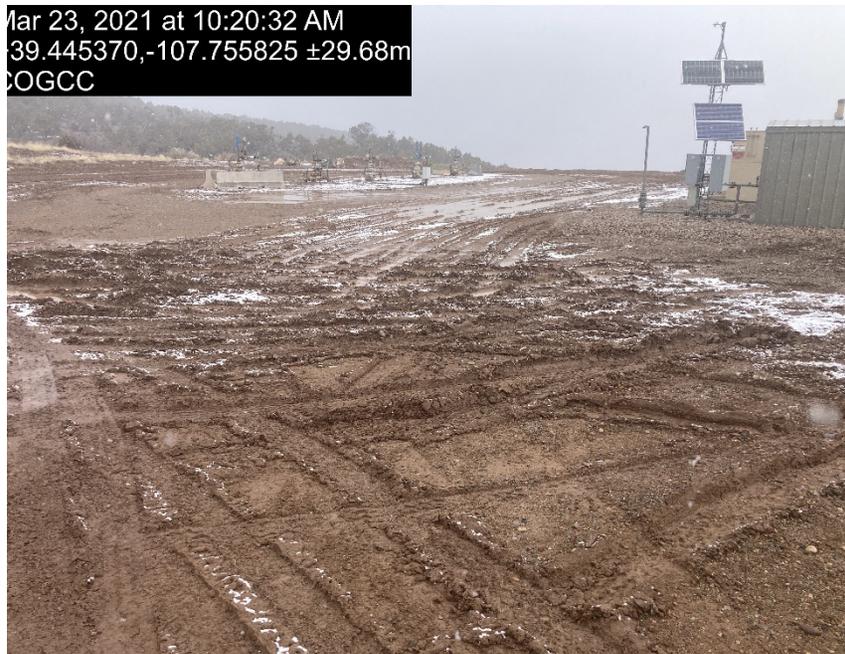
location entrance / Lack of stabilization /
compaction

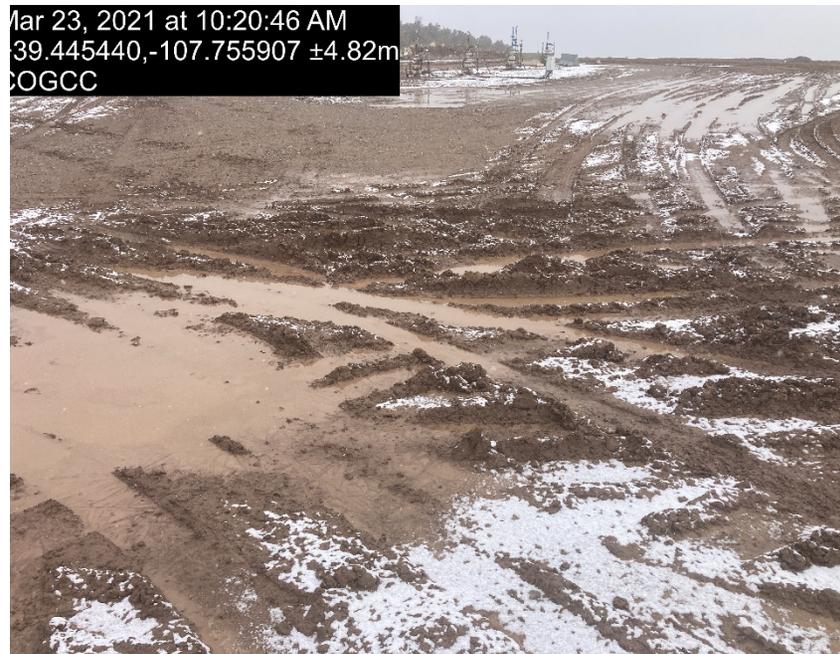
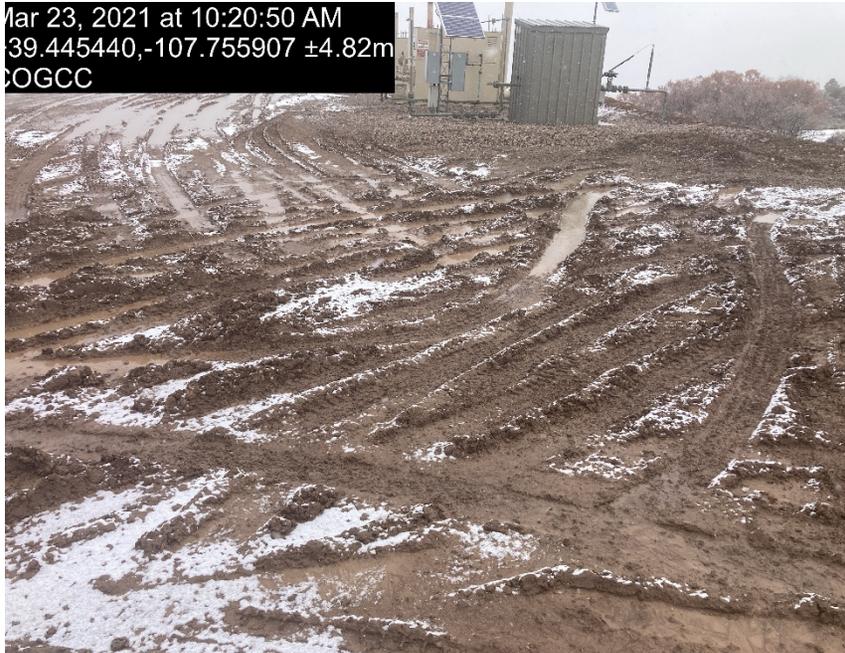
Lack of stabilization / compaction

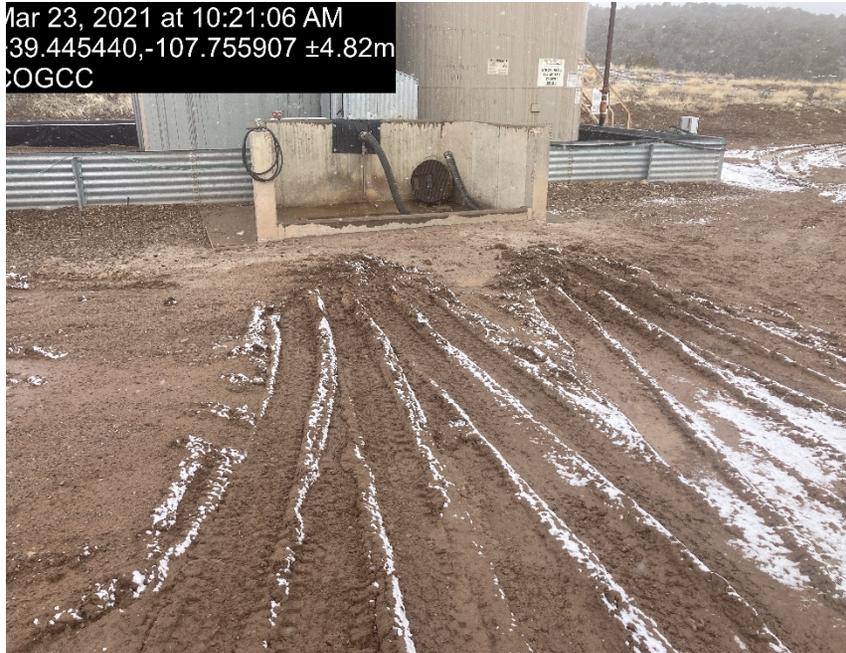
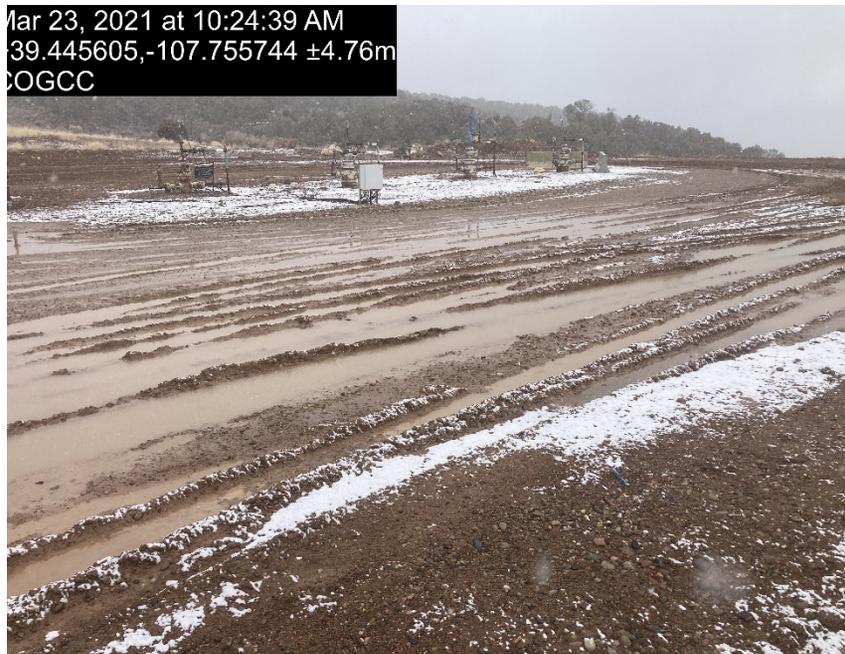
Lack of stabilization / compaction

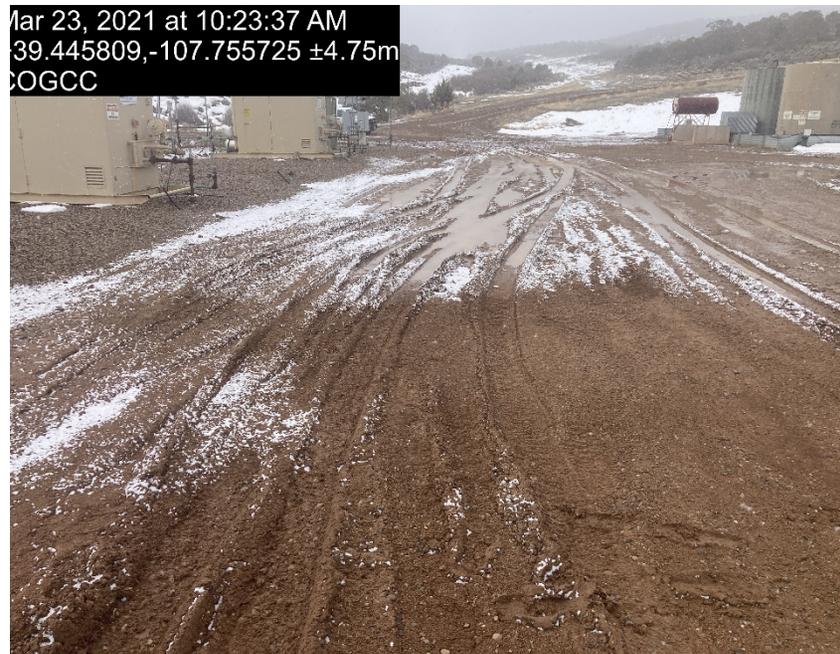
Lack of stabilization / compaction

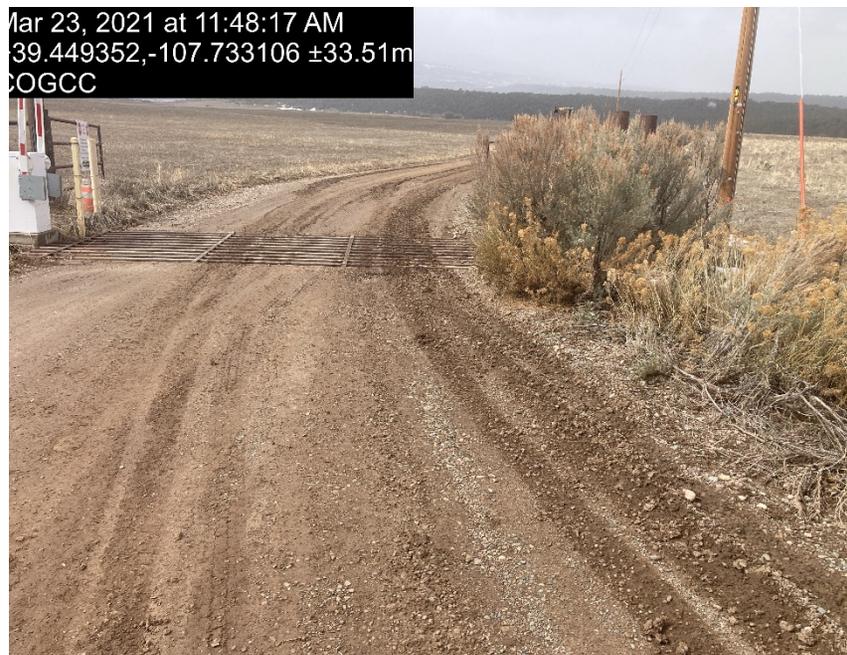
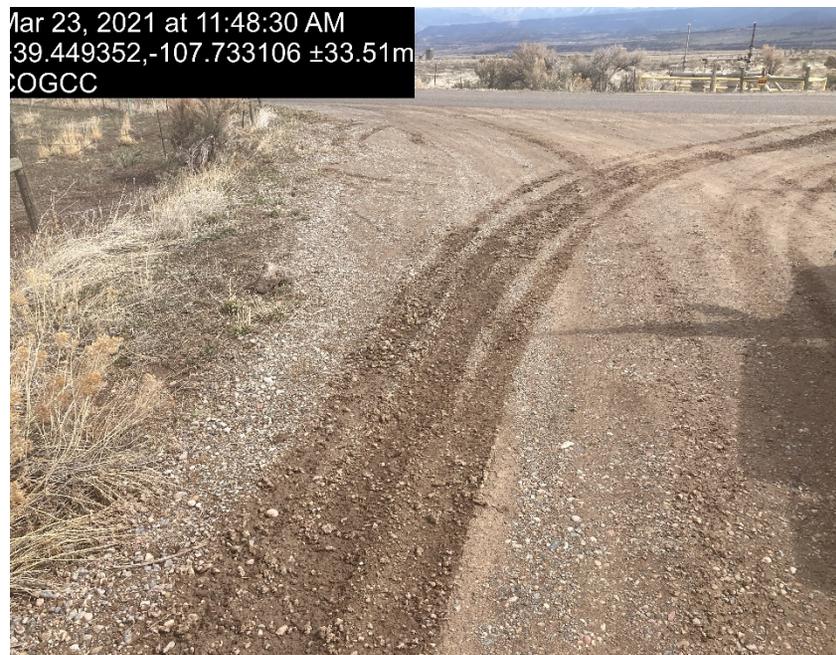
Access road entrance from CR 319 shows signs of tracking

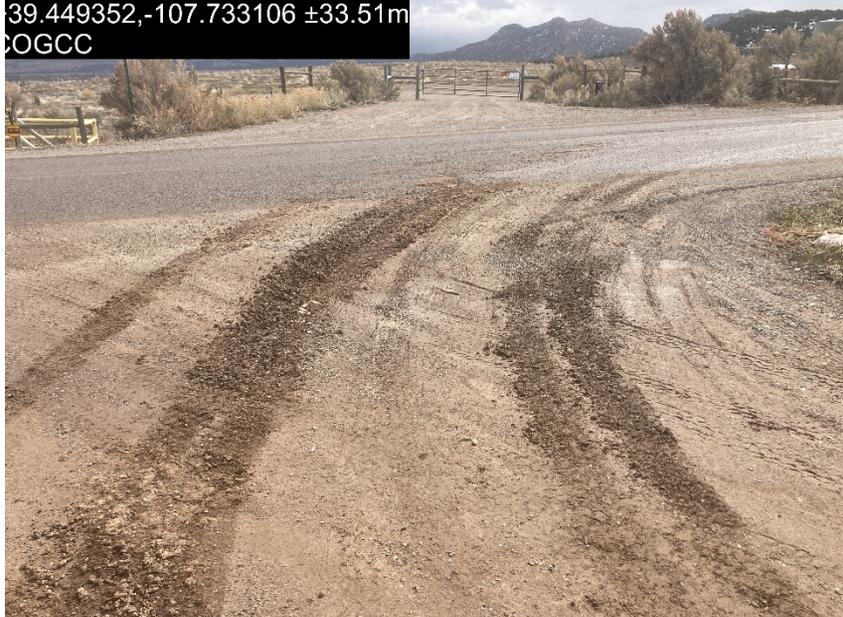
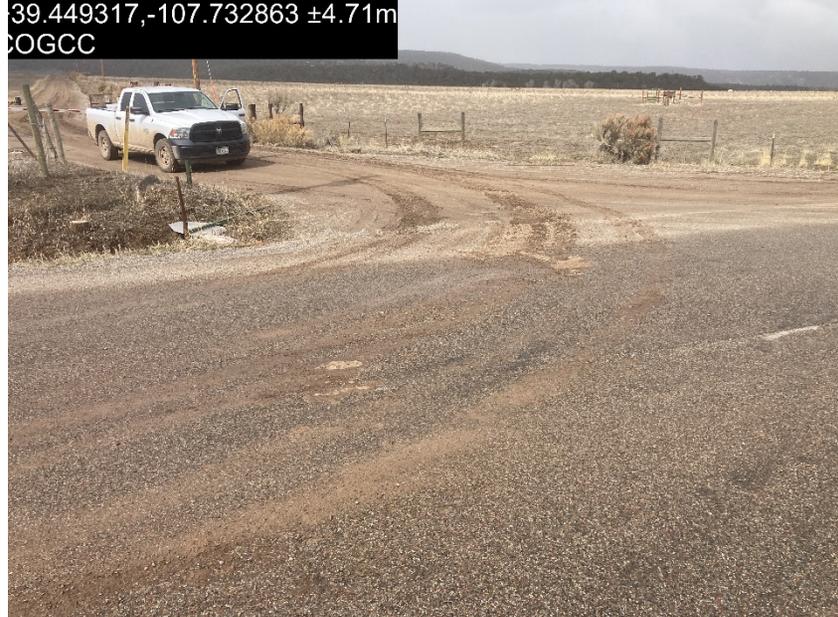
Access road entrance from CR 319 shows signs of tracking

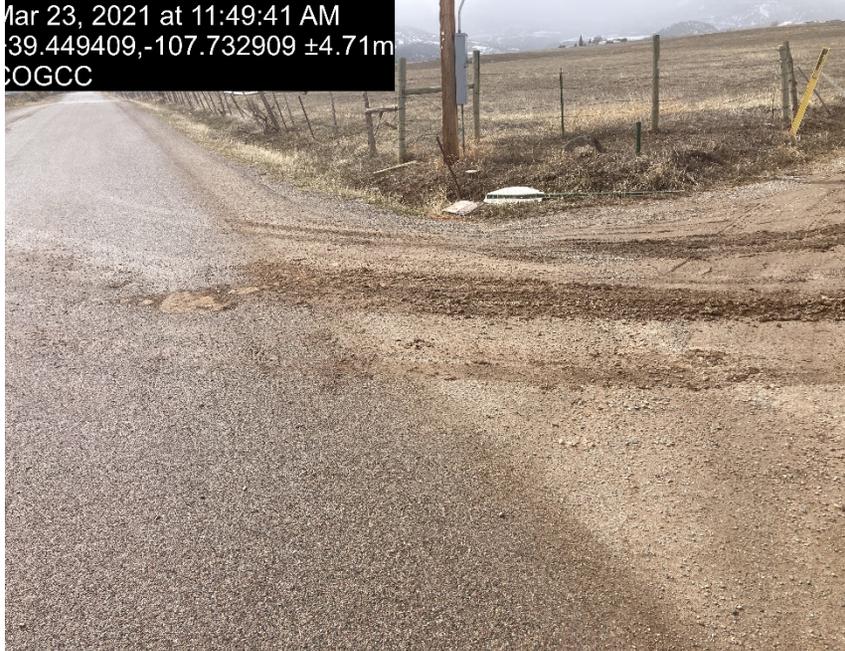
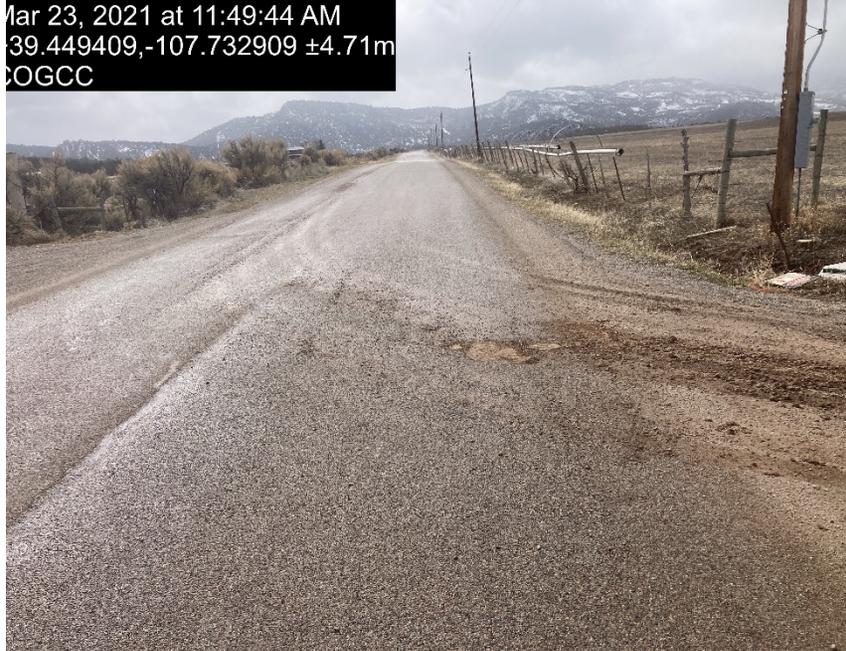
Access road entrance from CR 319 shows signs of tracking
