Inspection Photos
Operator: R. Bayless Producer
Facility: 067-06289
Date: 3/16/2021

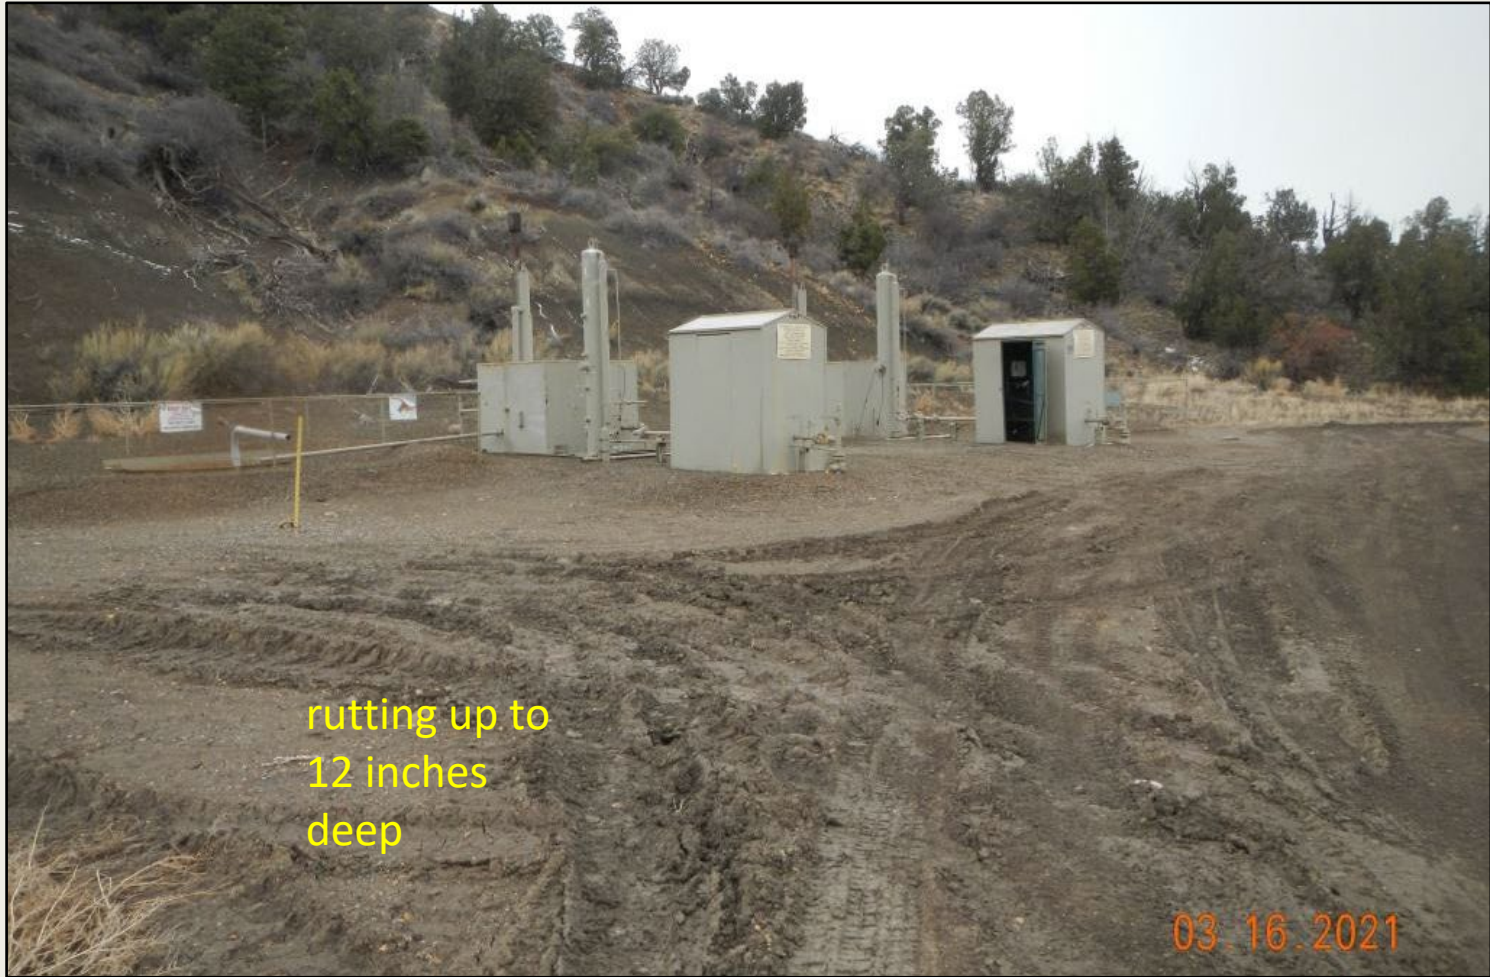
Photo 1. View of the project area from the well pad entrance facing center.

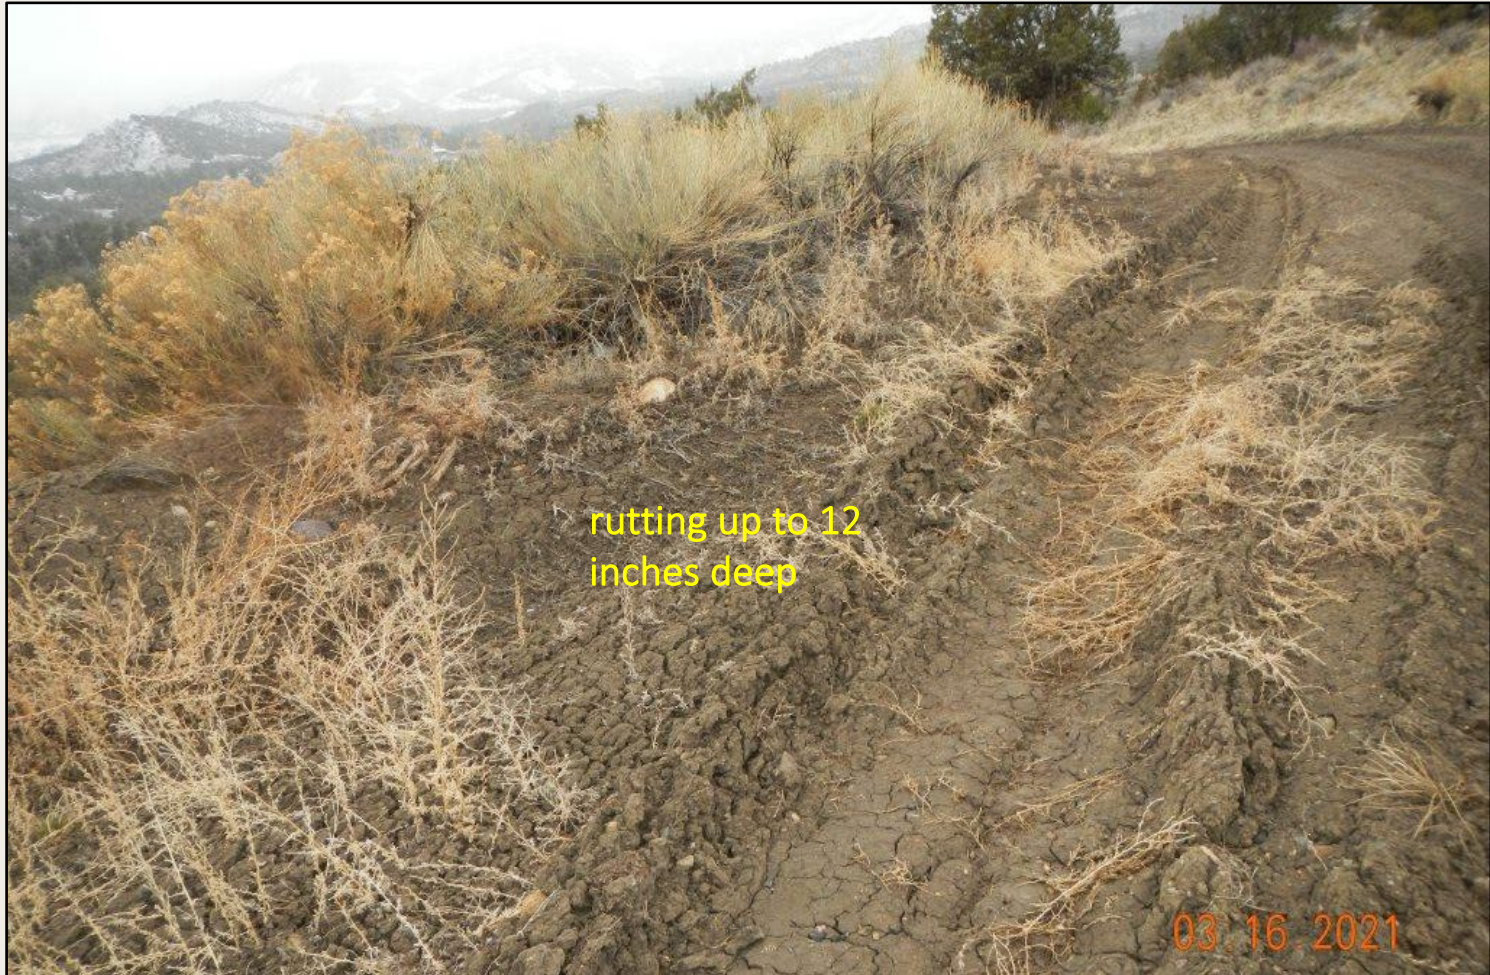
Photo 2. View of rutting along the access road up to 12 inches deep.

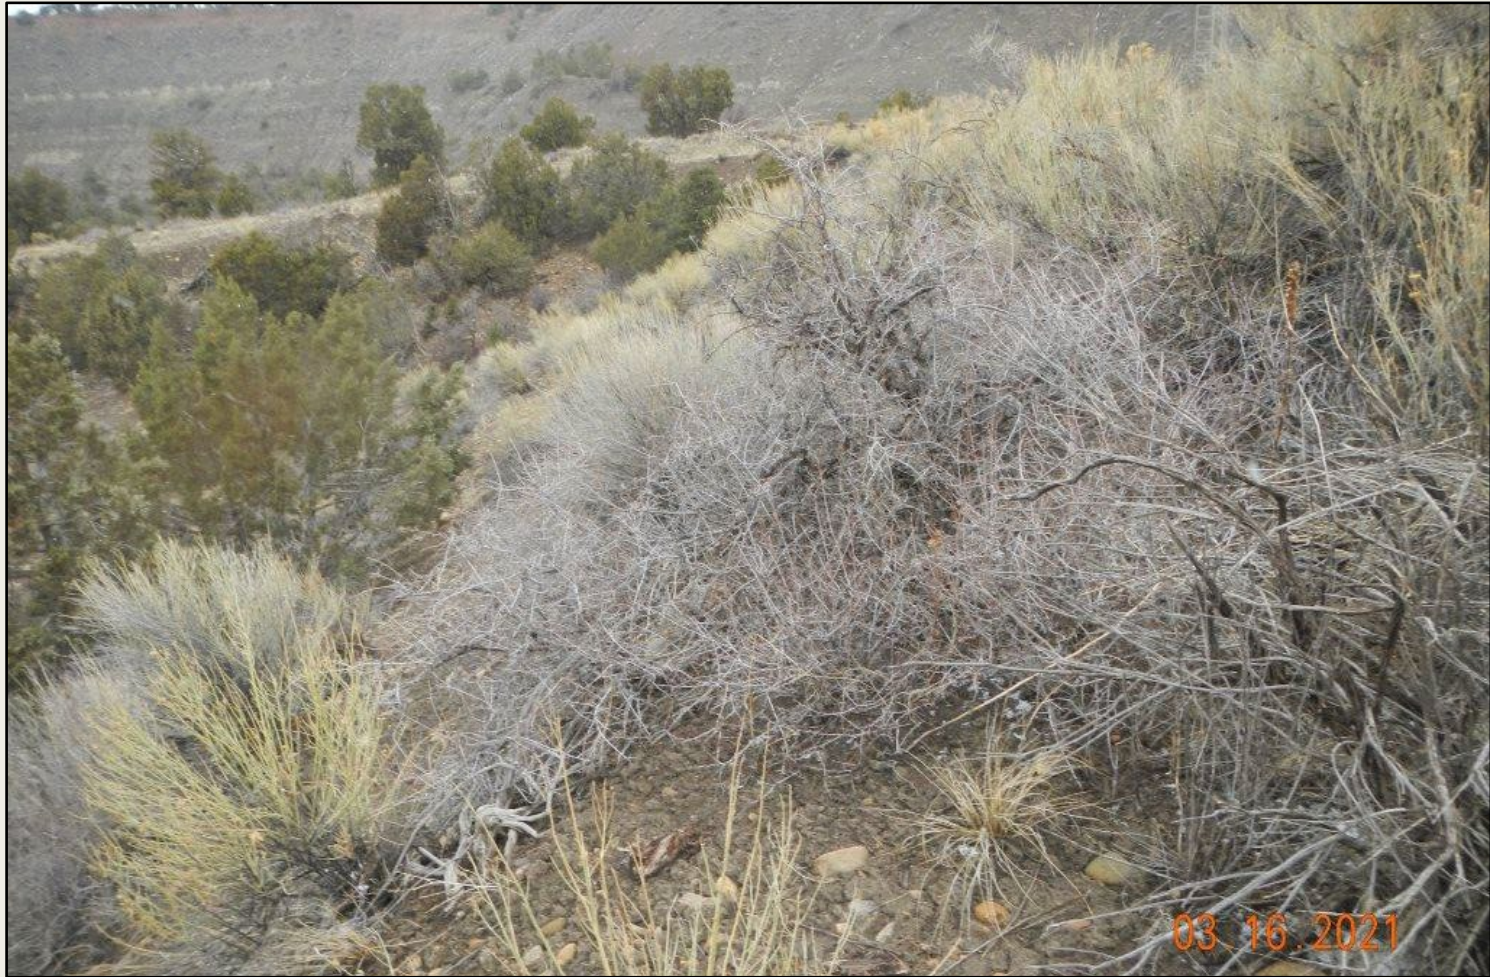
Photo 3. View of the southern fill slope facing westward from the southeastern corner.

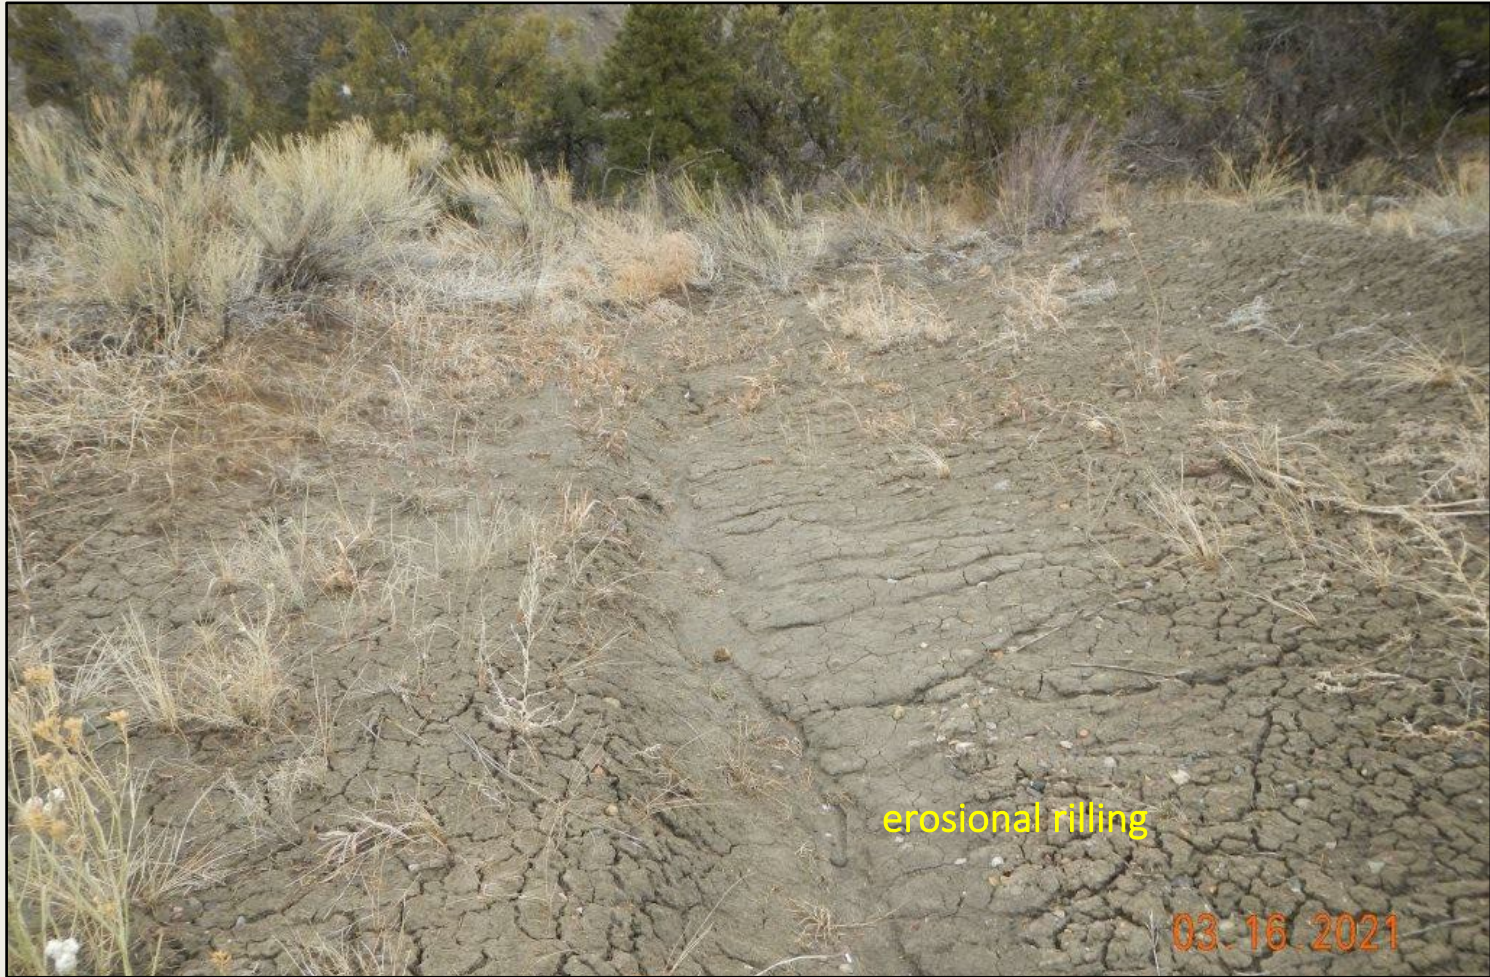
Photo 4. View of erosional rilling within the northwestern diversion channel facing downslope.

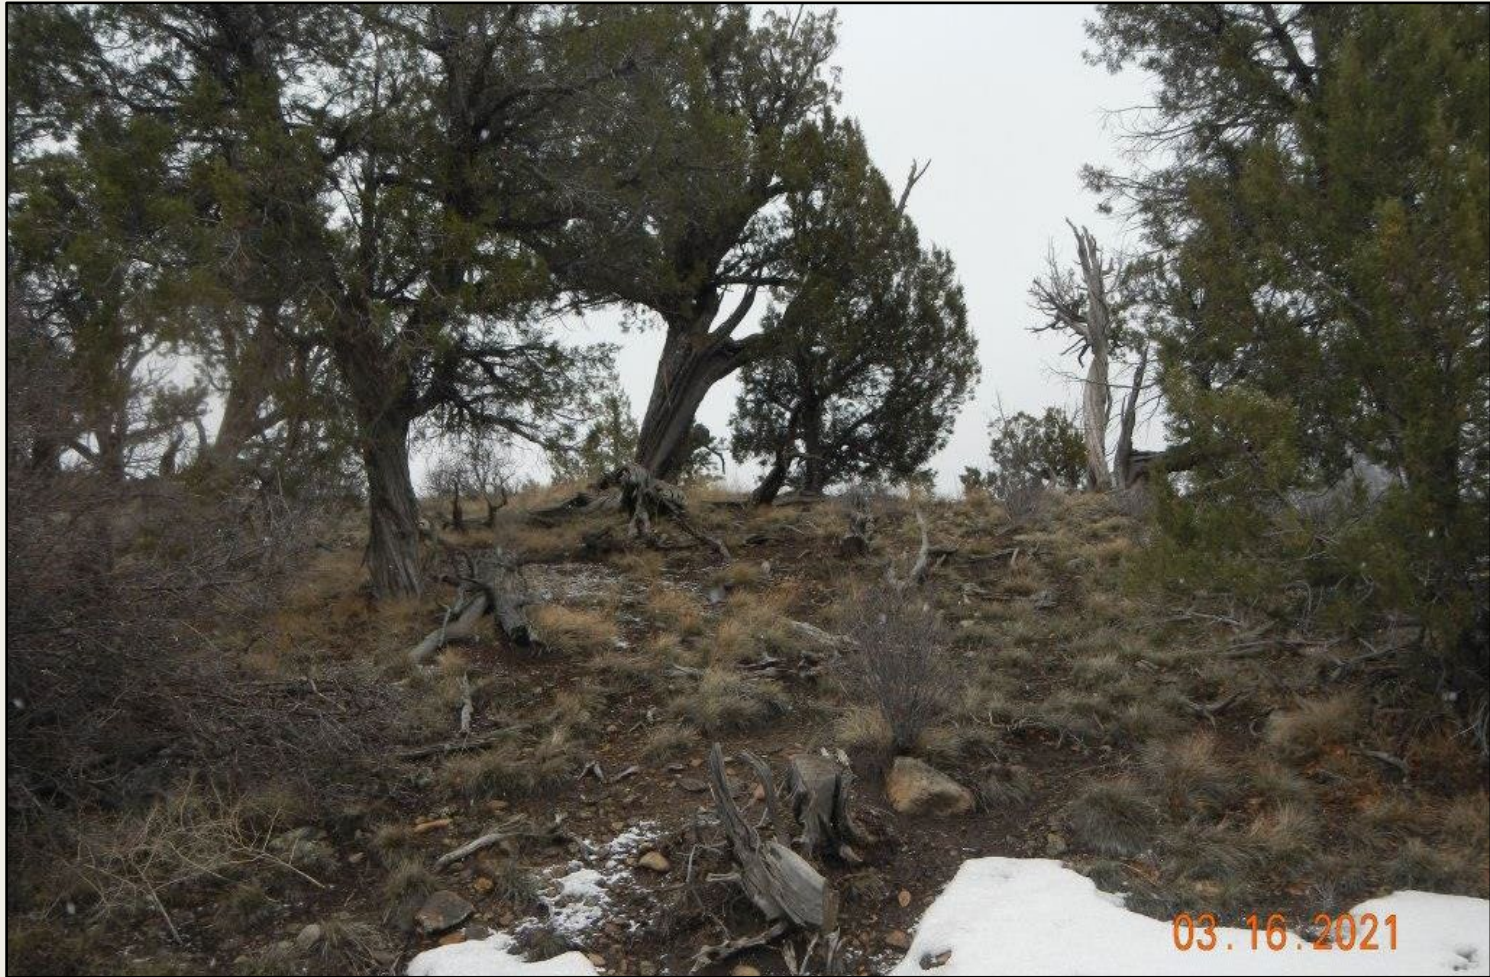
Photo 5. View of reference area comprised of pinyon and juniper woodland with understory of shrubs such as serviceberry, mountain mahogany, antelope bitterbrush, as well as grasses and forbs such as muttongrass and penstemon.
