Inspection Photos
Operator: Hilcorp Energy
Facility: 067-08128
Date: 3/16/2021

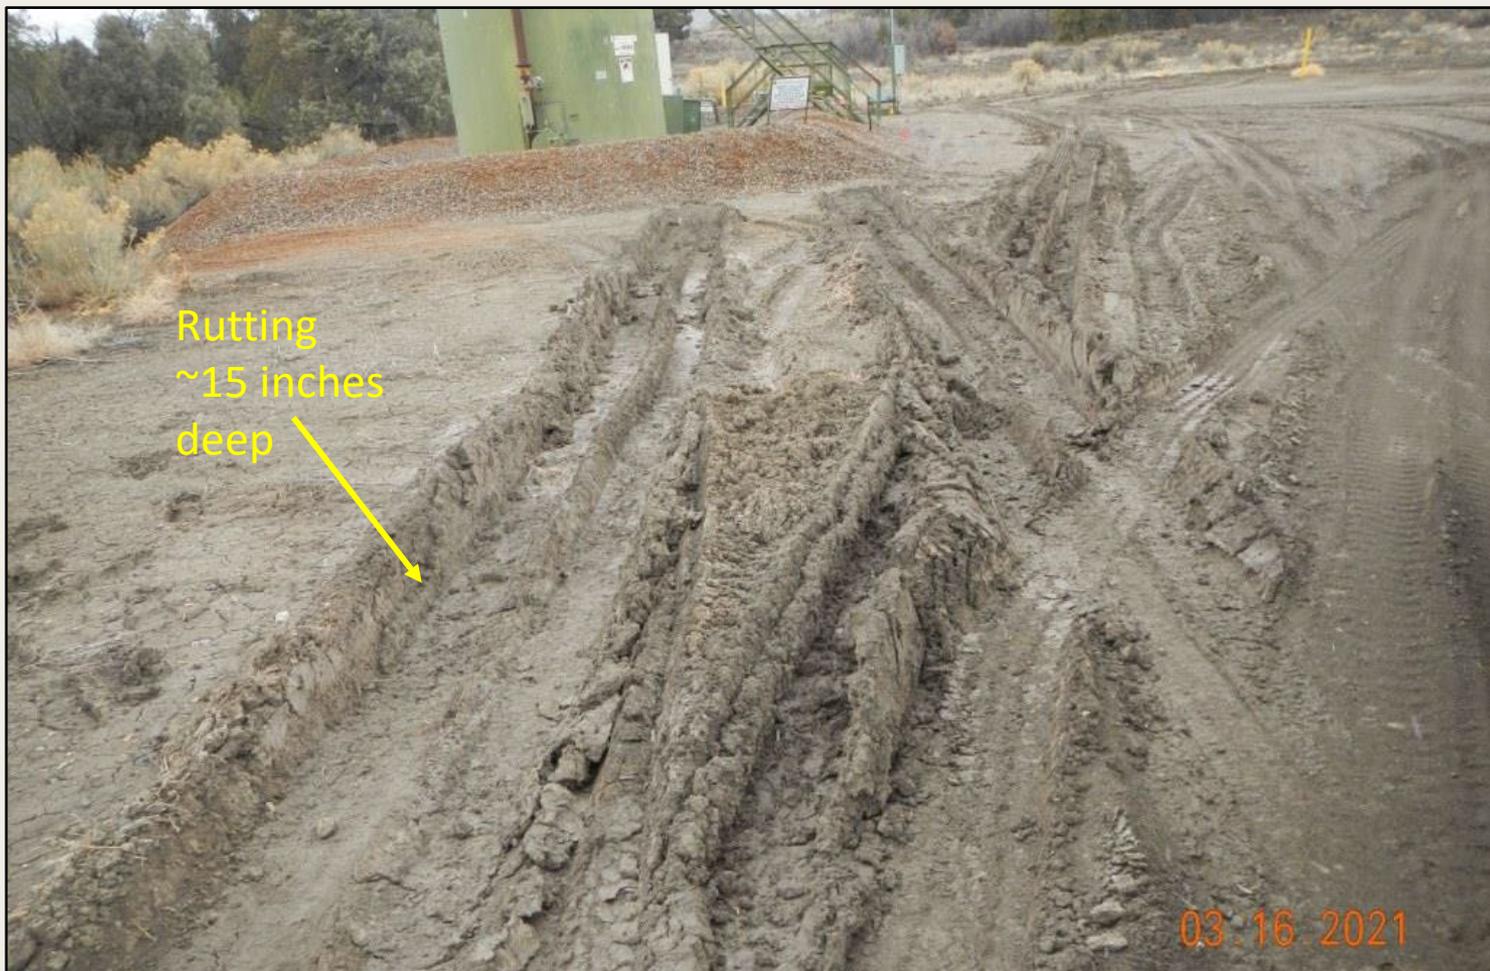
Photo 1. View of deep rutting on the well pad up to approx. 15 inches deep. Stabilization measures need to be installed to prevent site degradation.

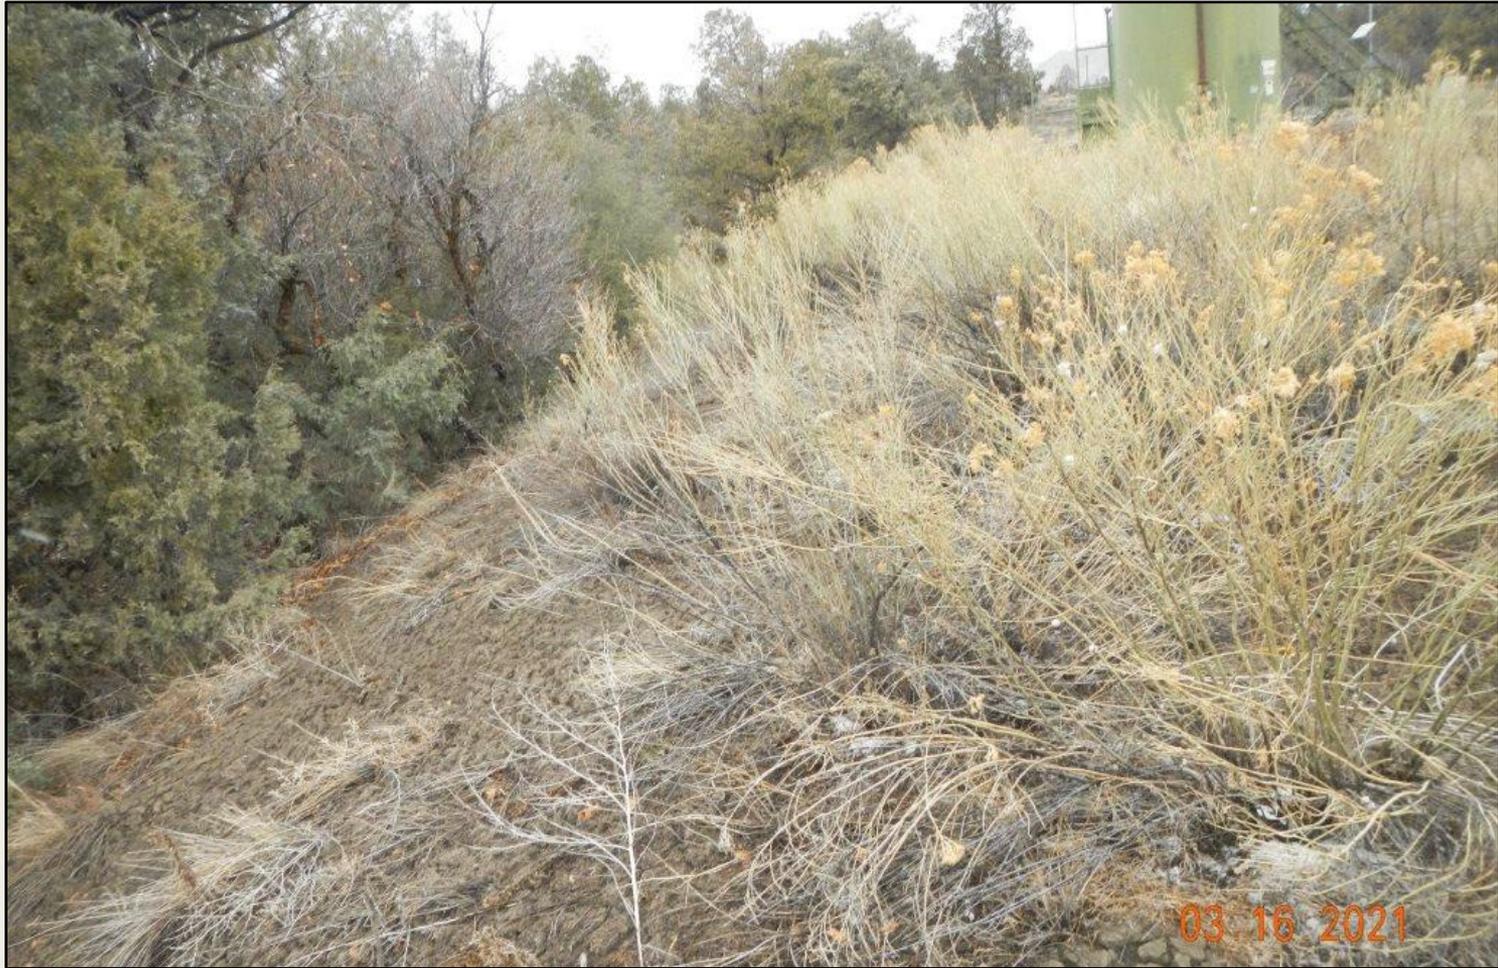
Photo 2. View of the southern project area facing westward. Revegetation appears to be progressing on the slope.

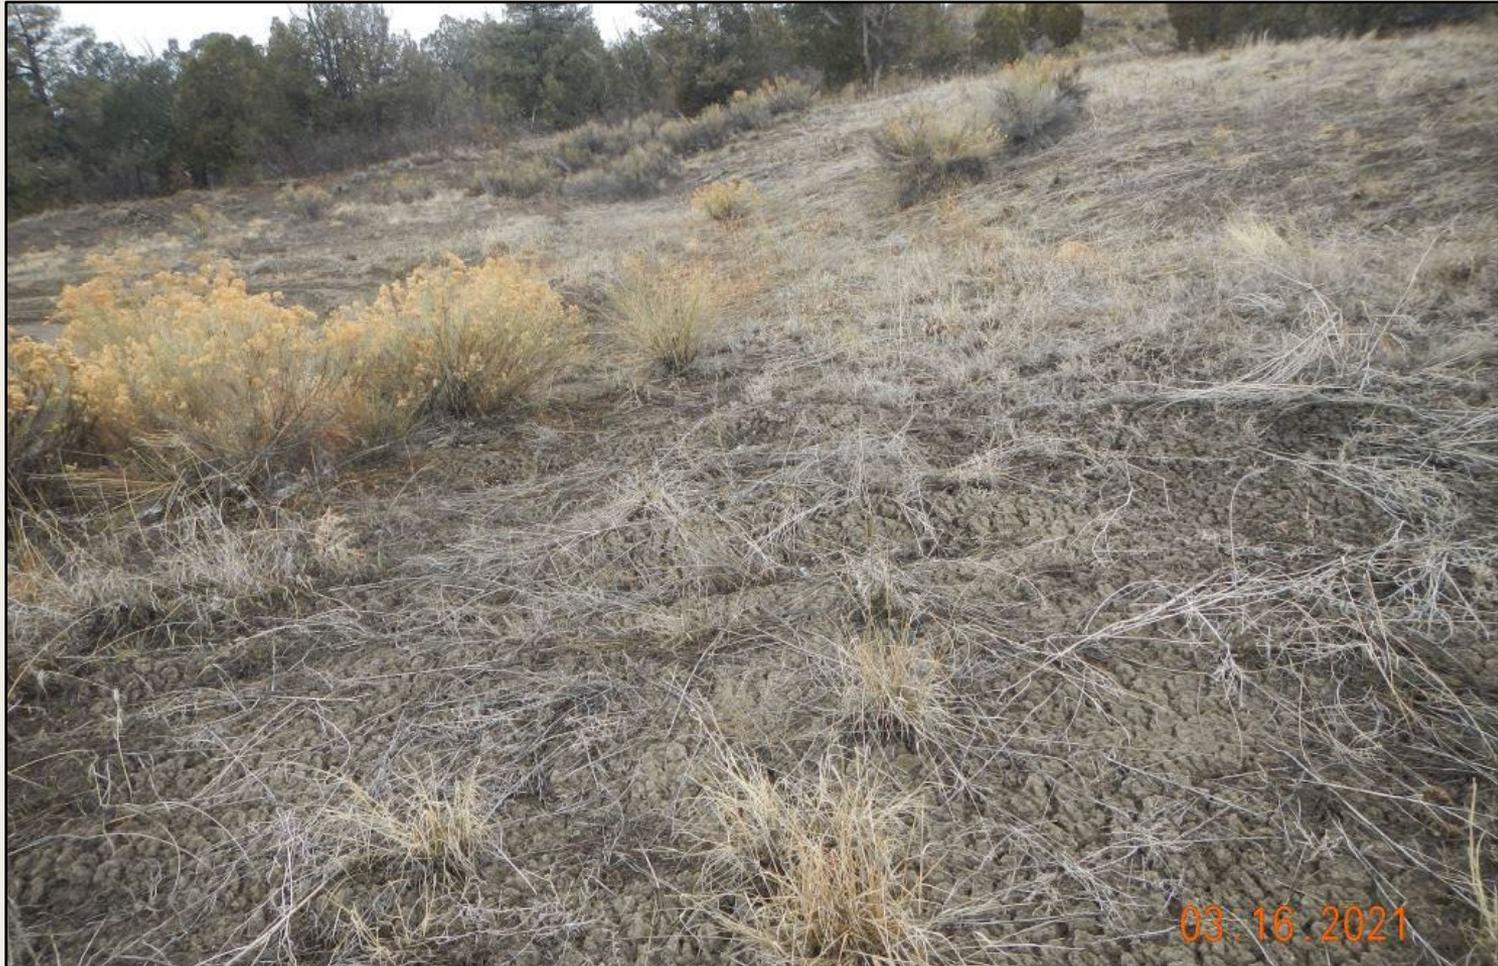
Photo 3. View of the northern project area from the northeastern corner facing westward. Revegetation is largely dormant with grasses such as sand dropseed and smooth brome, as well as rubber rabbitbrush.

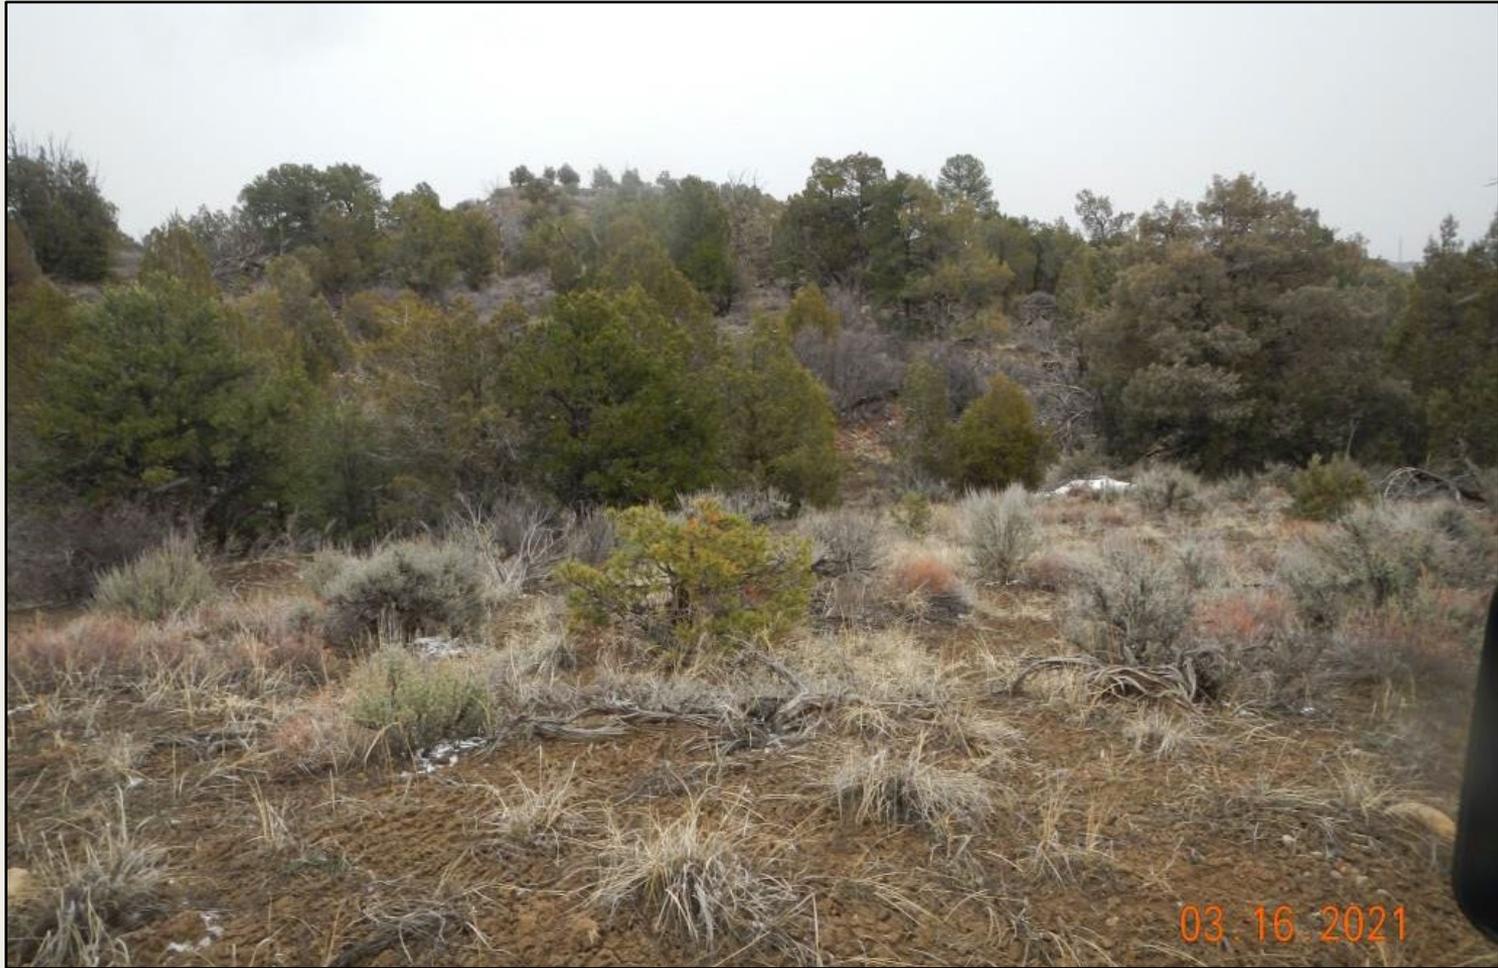
Photo 4. View of reference area comprised of pinyon and juniper woodland with understory of shrubs such as serviceberry, mountain mahogany, sagebrush, as well as grasses and forbs such as Indian ricegrass and penstemon.
