Inspection Photos

Location Name: CAERUS PICEANCE LLC ENCANA-68S96W /32SENW

Location ID: 334187

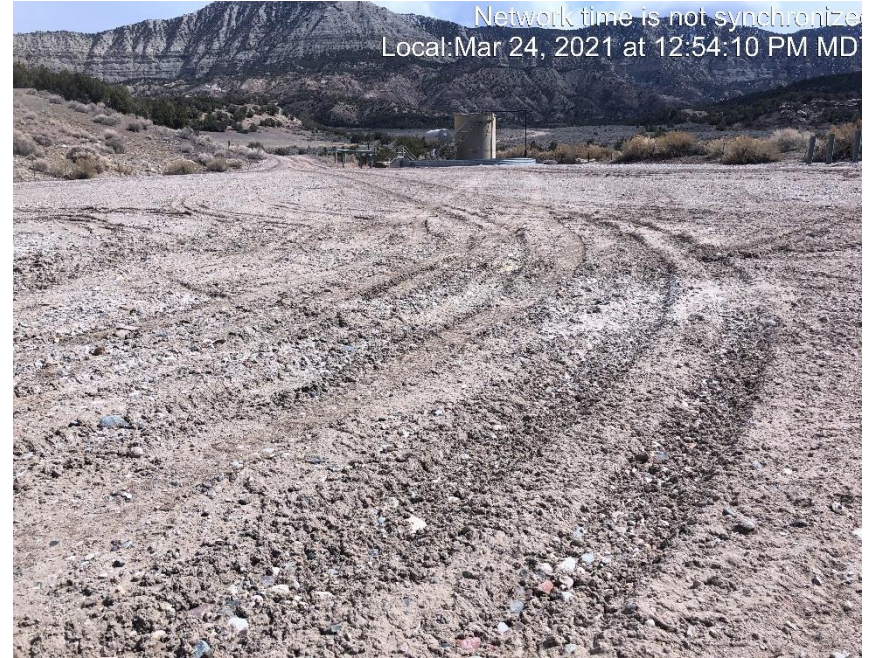
Photo #3264 Location lacks stabilization.

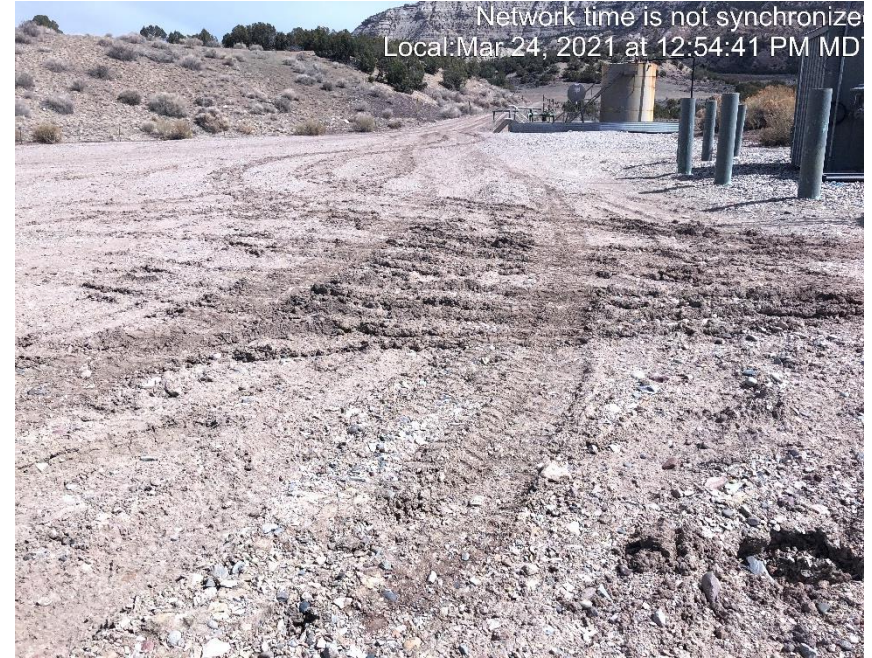
Photo #3265 Location lacks stabilization.

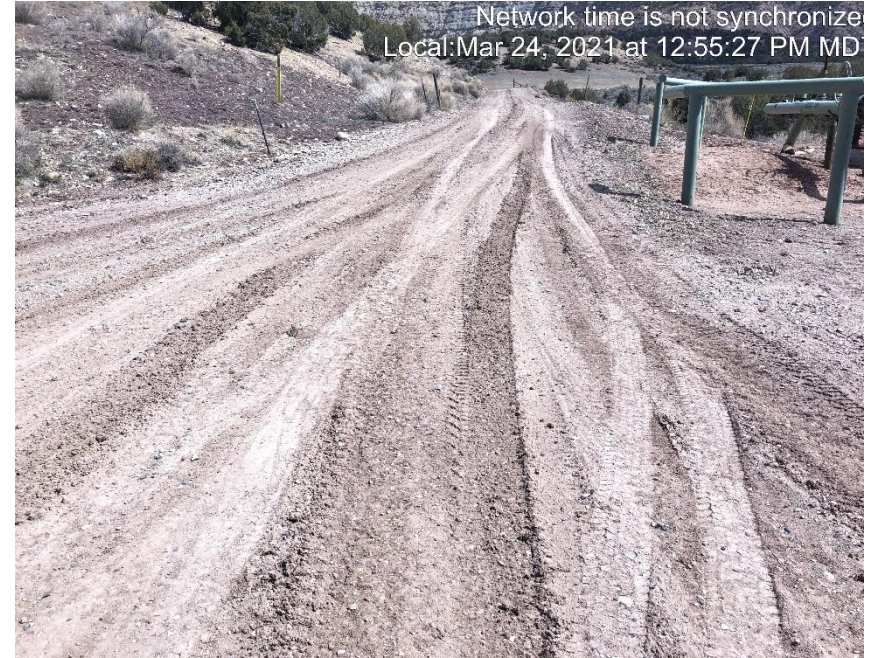
Photo #3266 No form of tracking control at entrance to location
