Inspection Photos
Operator: Logos Operating
Facility: 067-08119
Date: 3/23/2021

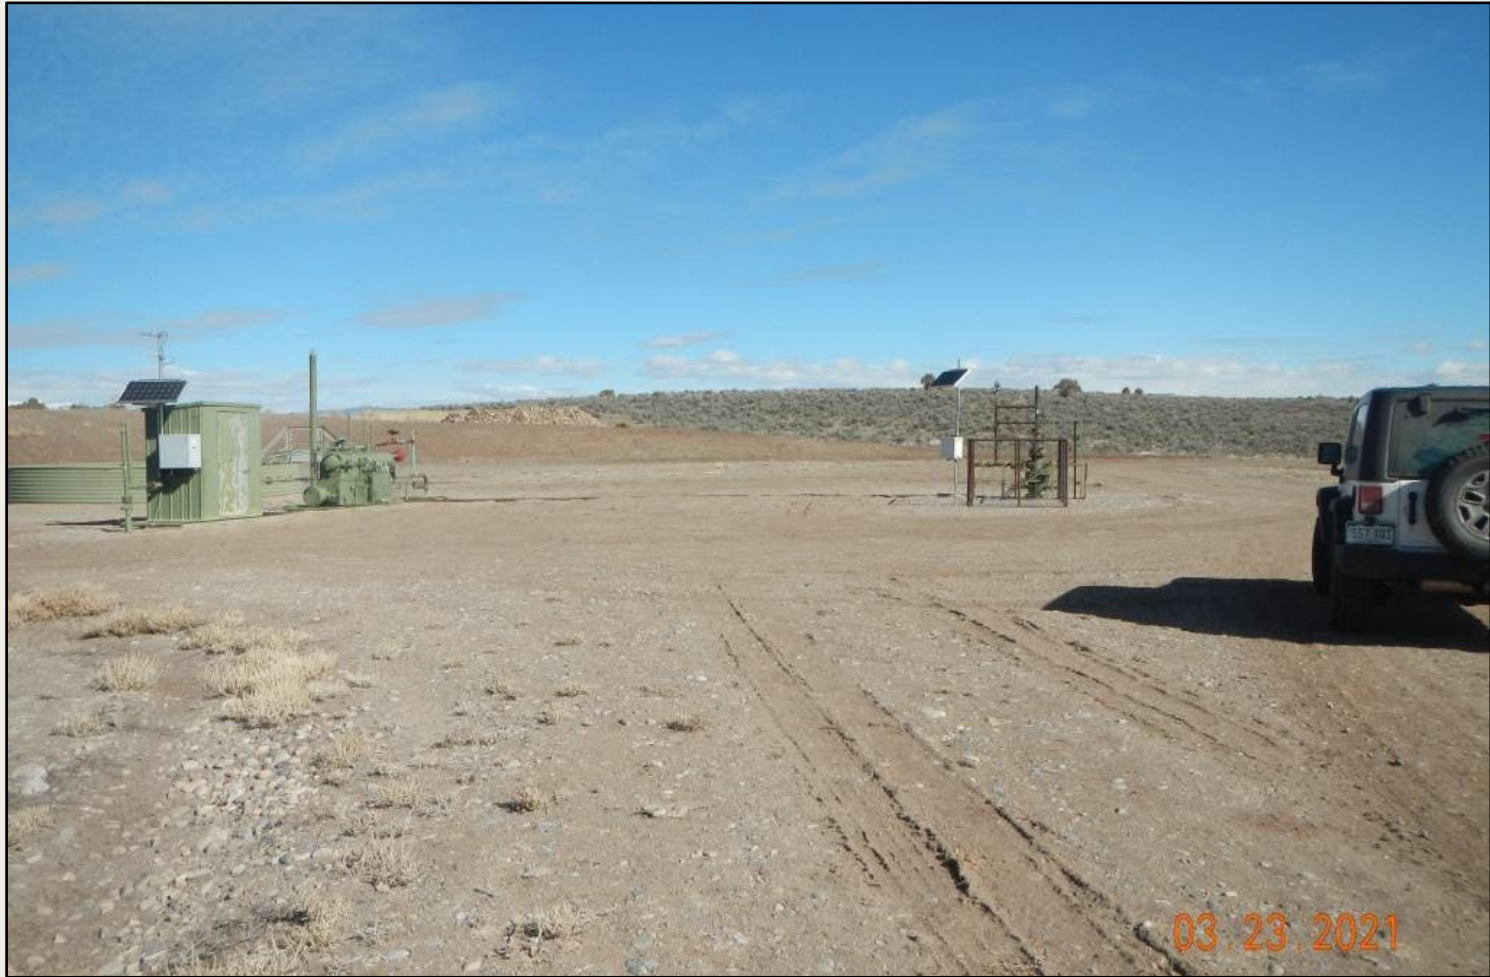
Photo 1. View of the project area from the well pad entrance facing center.

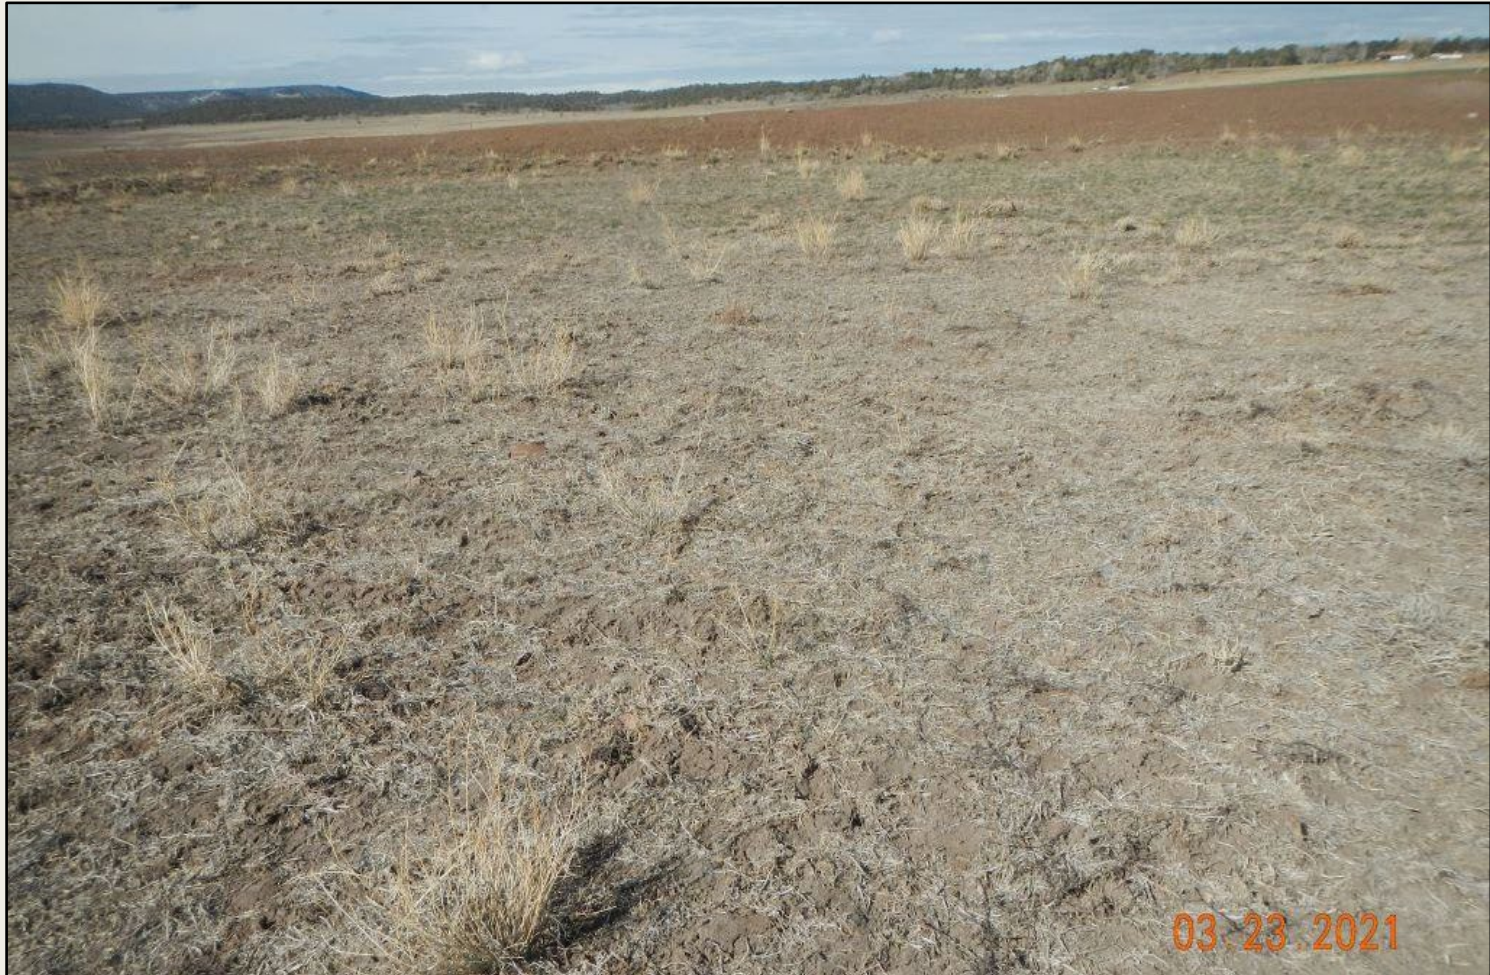
Photo 2. View of the southern project area facing westward from the southern entrance. Revegetation was conducted and is in an early seral vegetative condition. Weed debris not observed.

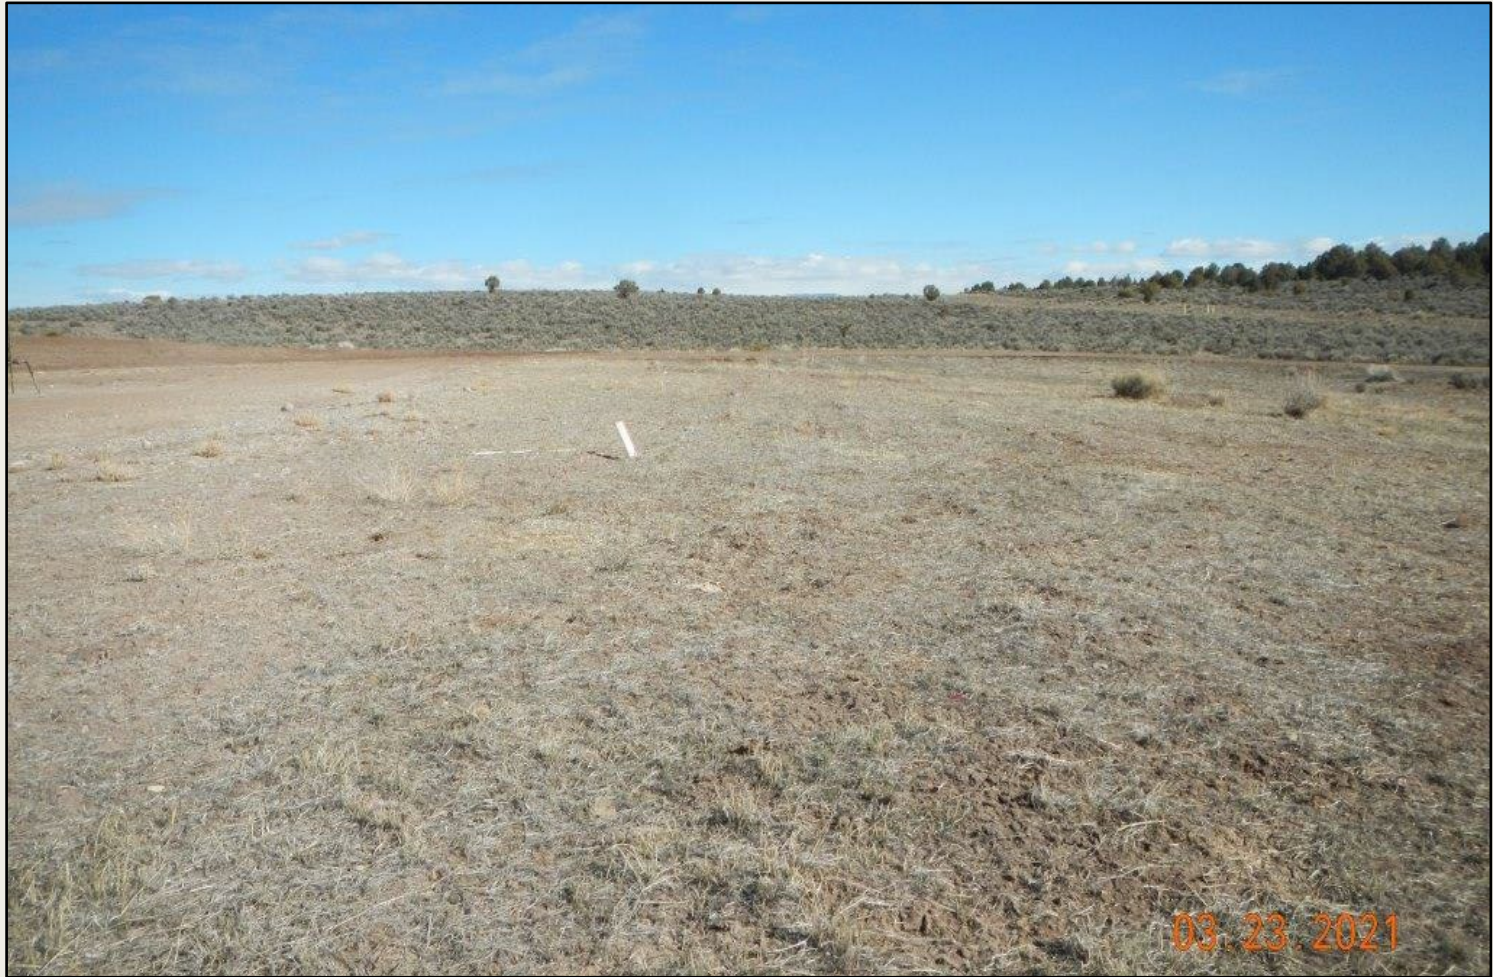
Photo 3. View of the eastern project area facing northward from the southeastern corner.

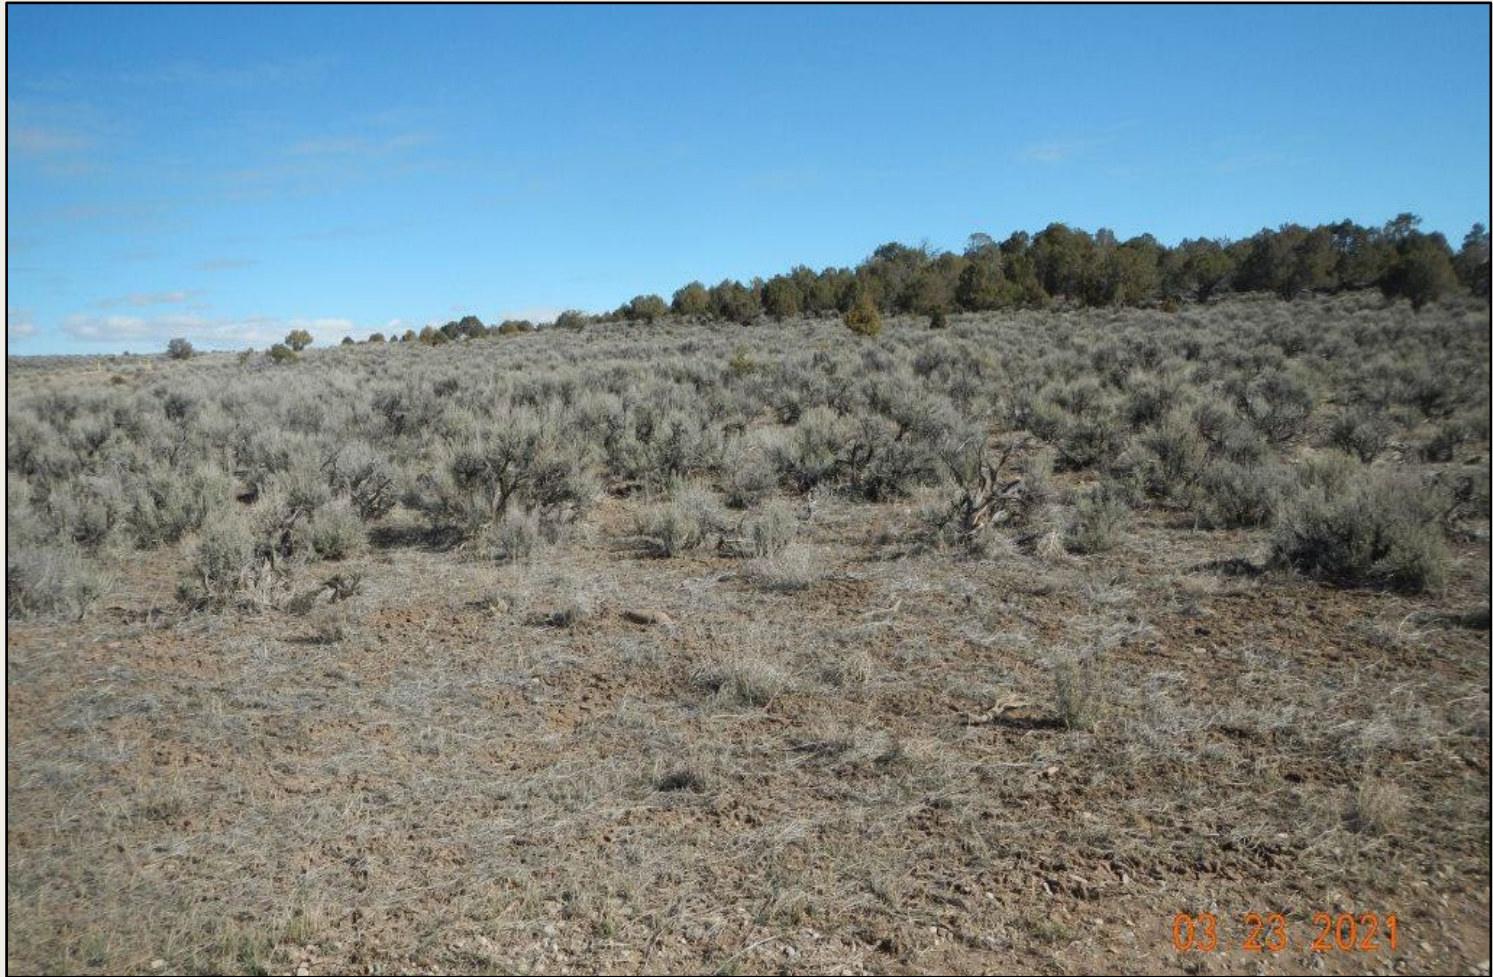
Photo 4. View of reference area comprised of sagebrush shrubland with understory of grasses and forbs such as western wheatgrass and James galleta, as well as other dormant species not identified at this time.

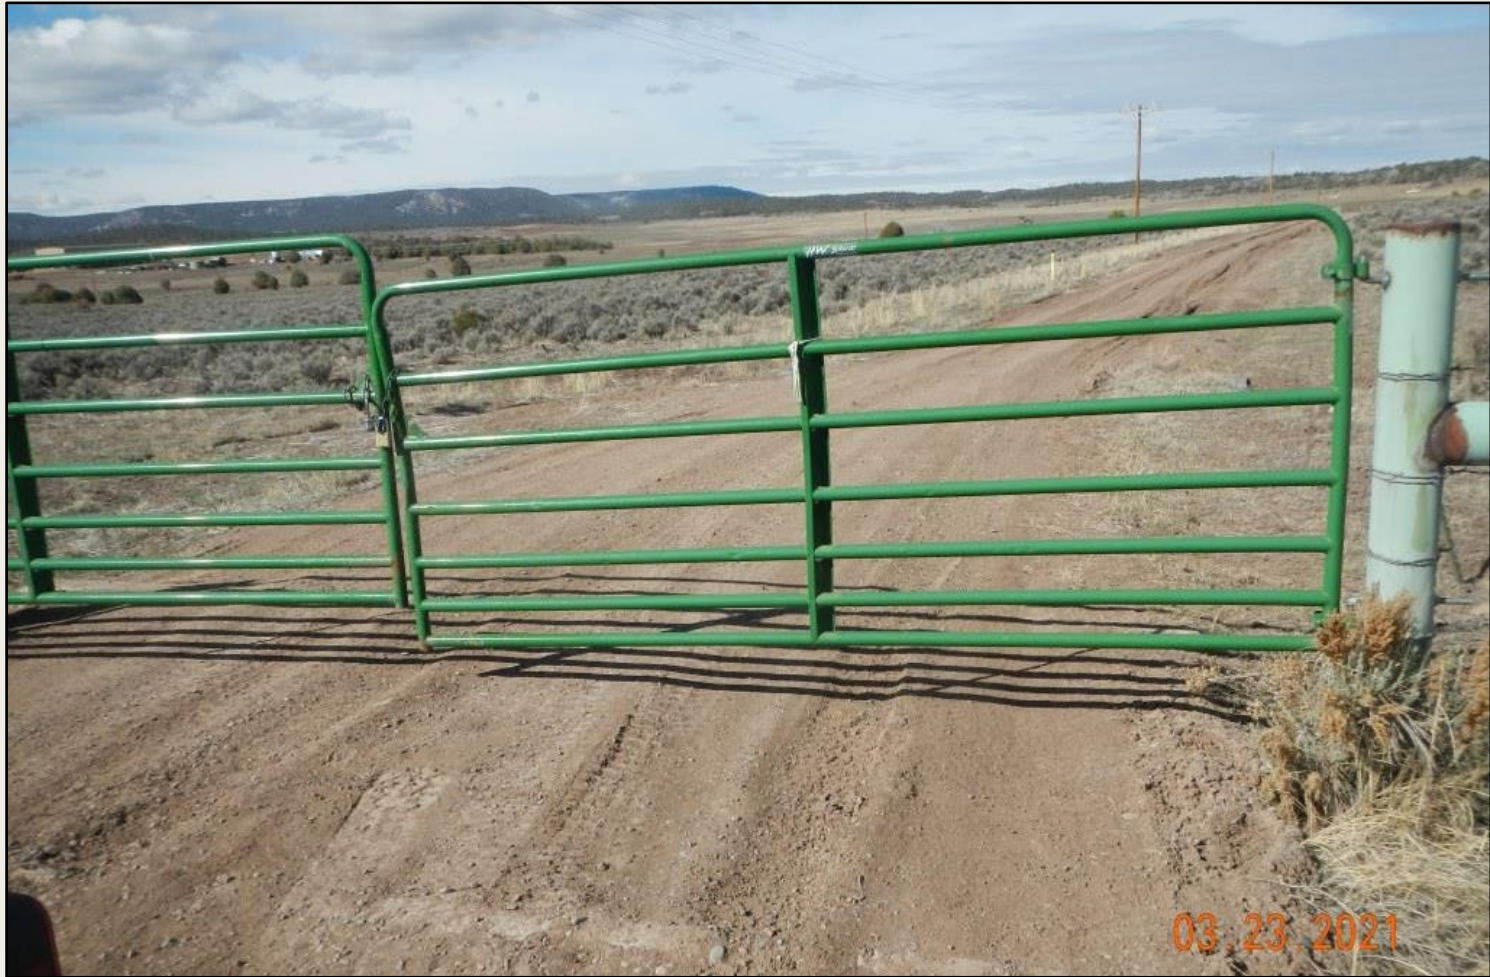
Photo 5. View of closed gate after leaving location.
