**Inspection Photos**  
**Operator: Simcoe**  
**Facility: 067-07861**  
**Date: 3/23/2021**

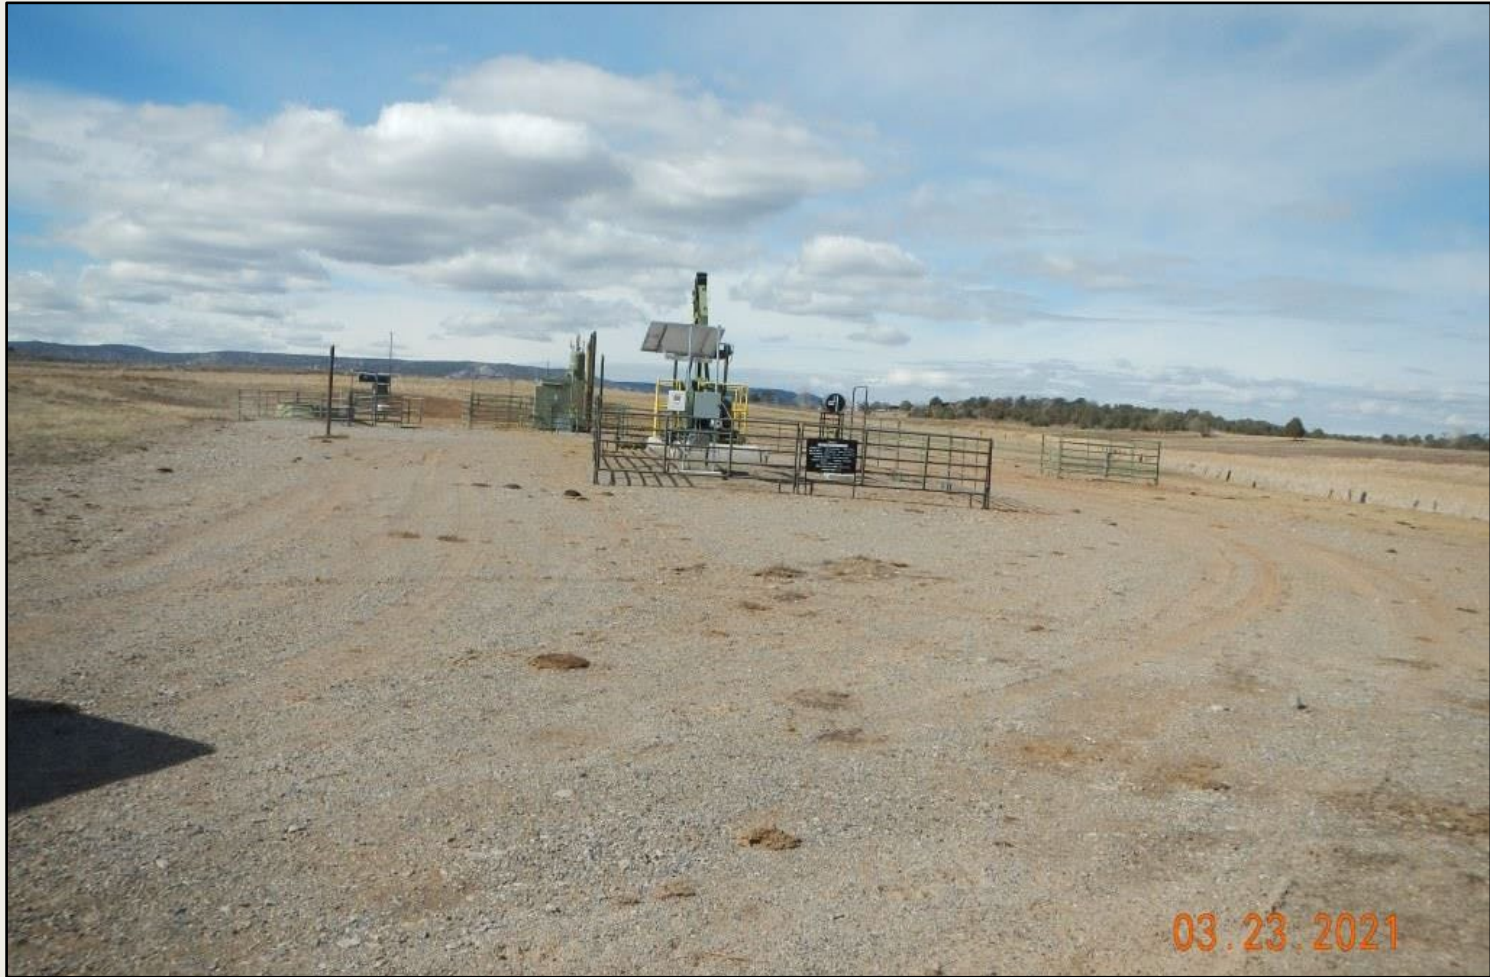
Photo 1. View of the project area from the well pad entrance facing center.

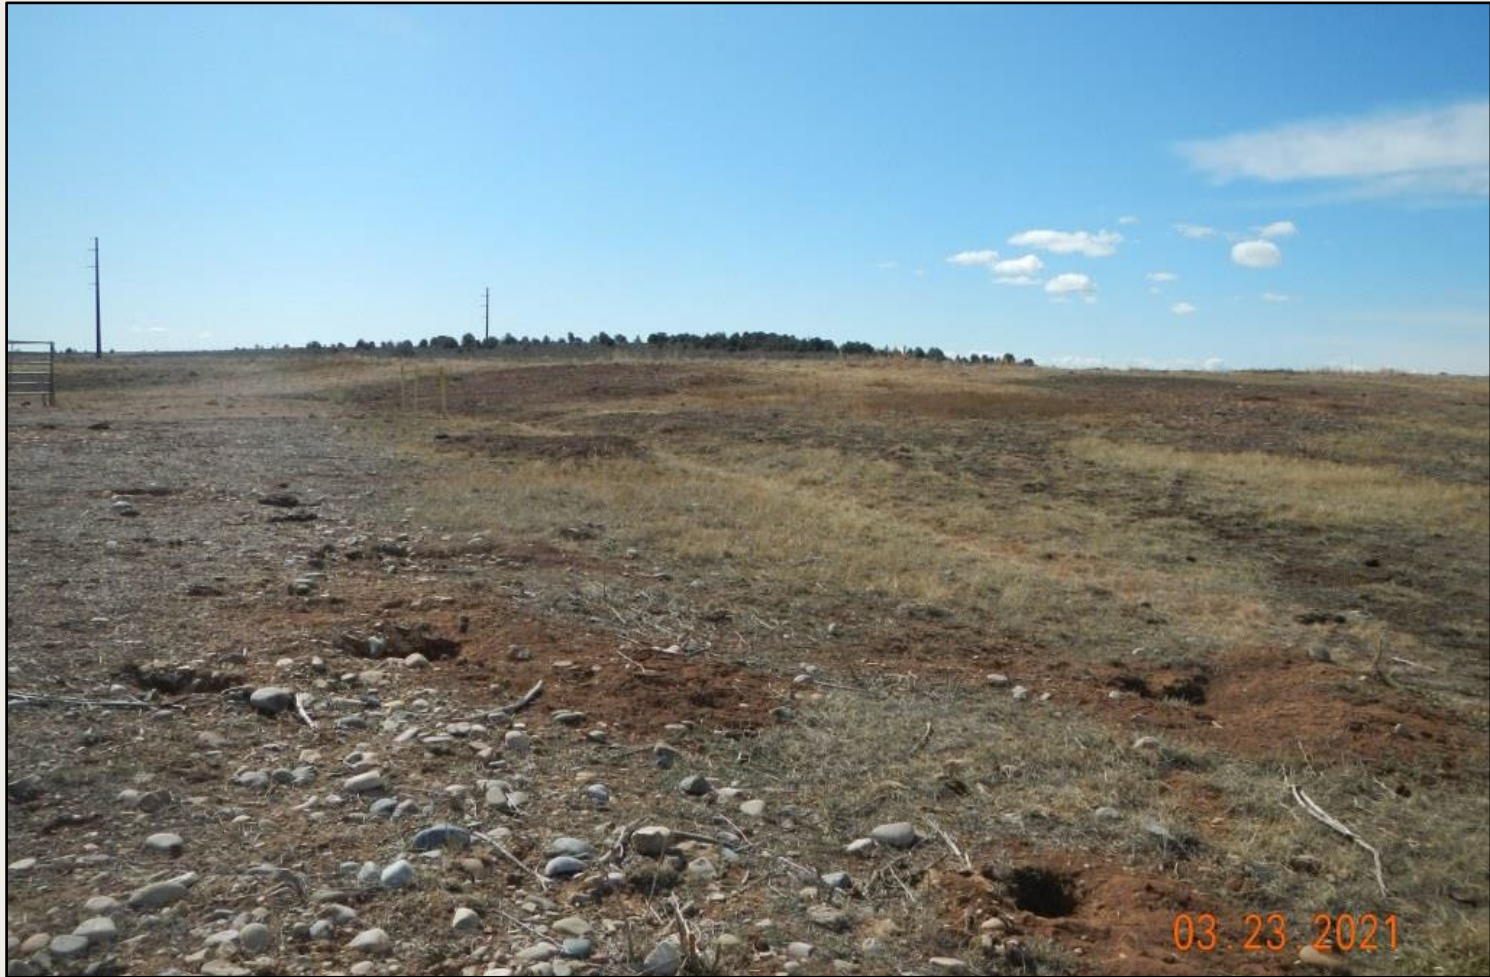
Photo 2. View of the southwestern fill slope facing southeastward from the western corner. Revegetation appears to be progressing in a dormant/grazed condition with crested wheatgrass and western wheatgrass observable.

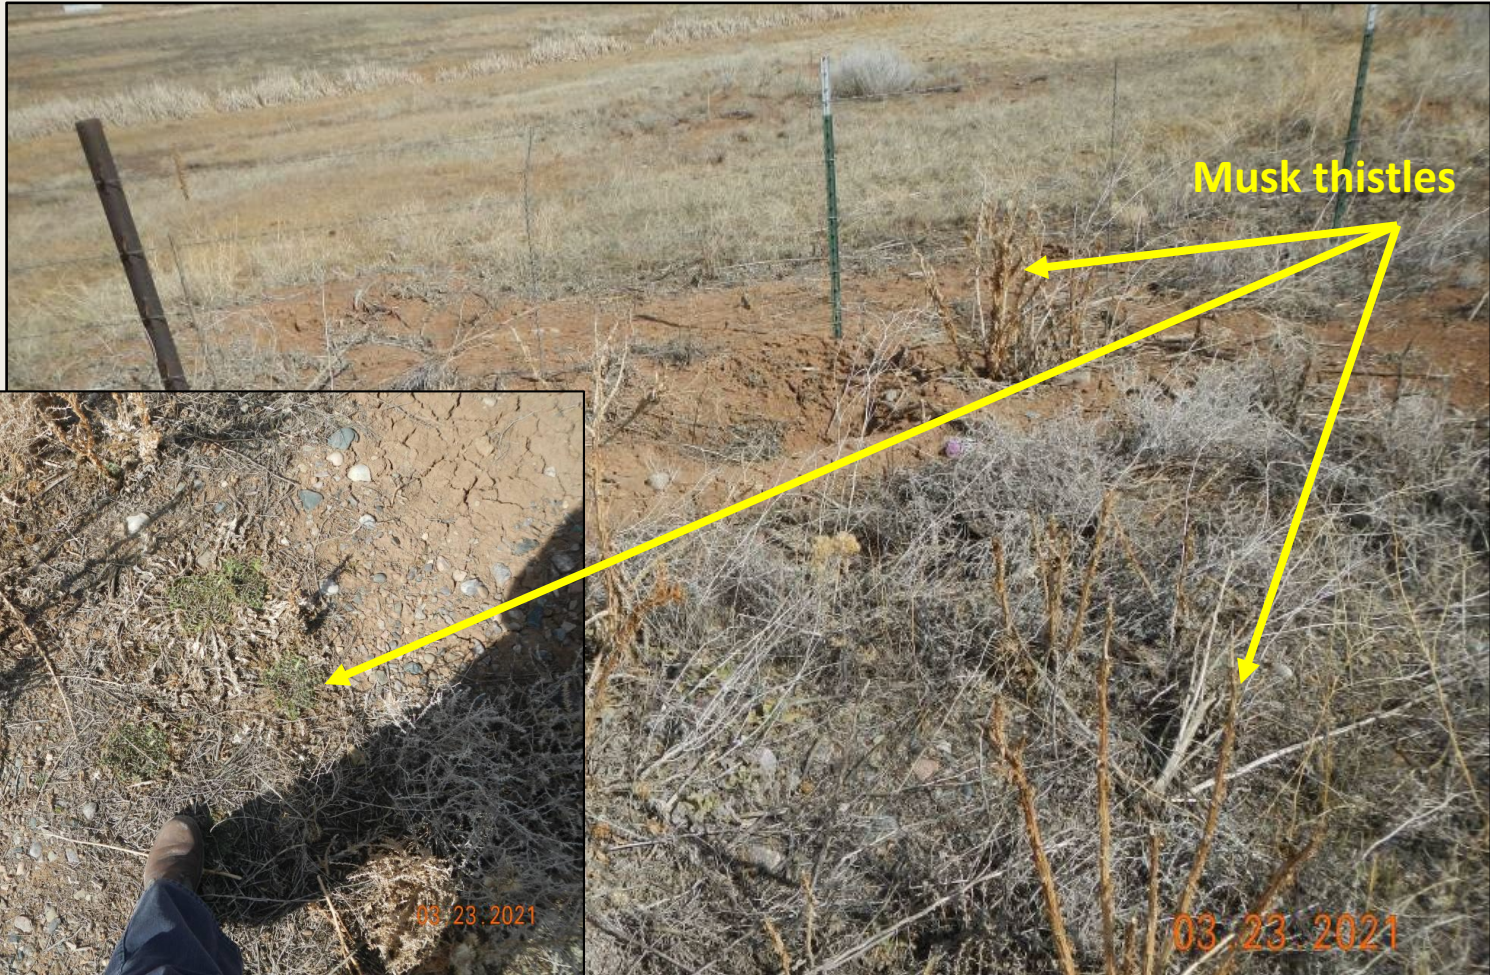
Photo 3. View of musk thistles at the access road entrance. Approximately 150 musk thistles observed here and along the access road. Inset shows living rosettes.

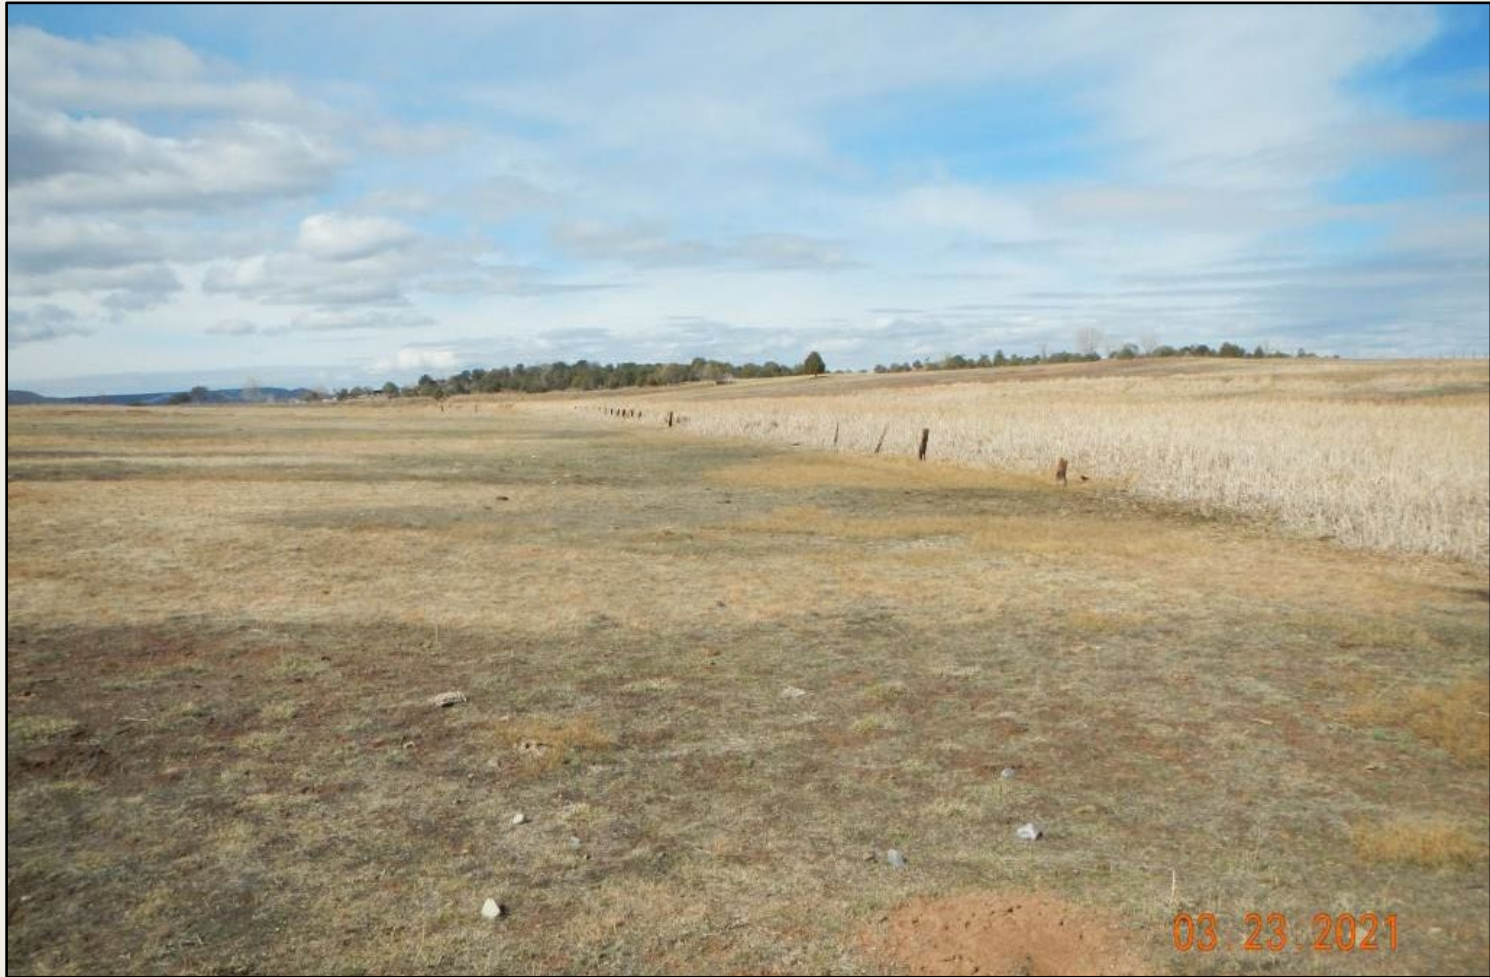
Photo 4. View of reference area comprised of irrigated grass fields. Grasses are largely dormant at this time and not in identifiable condition.

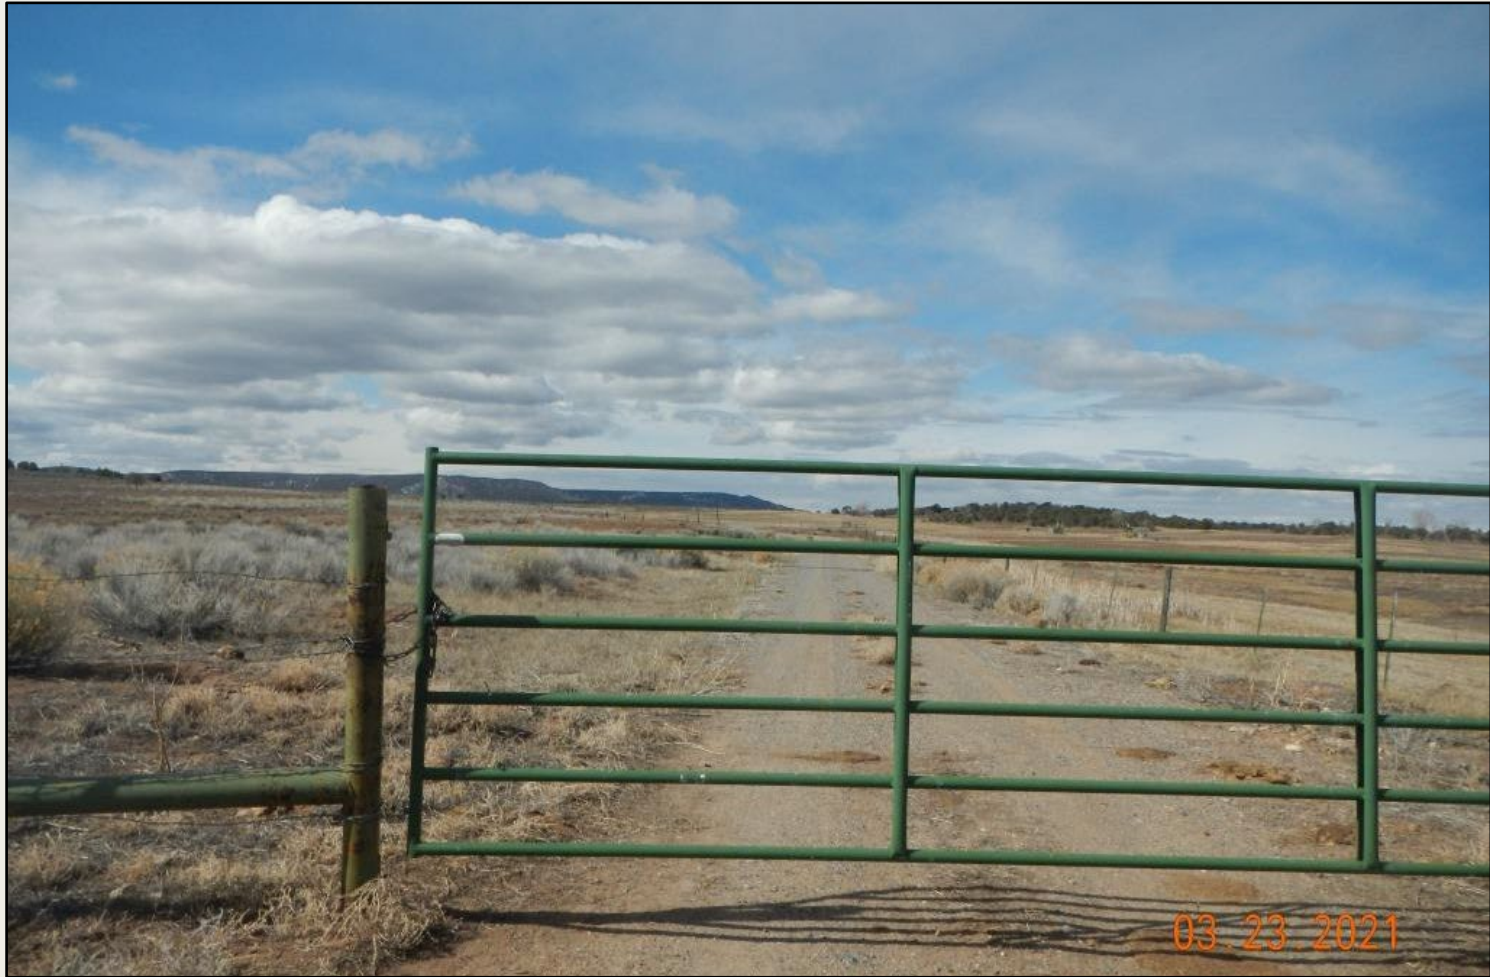
Photo 5. View of closed gate after leaving location.
