**Inspection Photos**  
**Operator: Simcoe**  
**Facility: 067-09312**  
**Date: 3/23/2021**

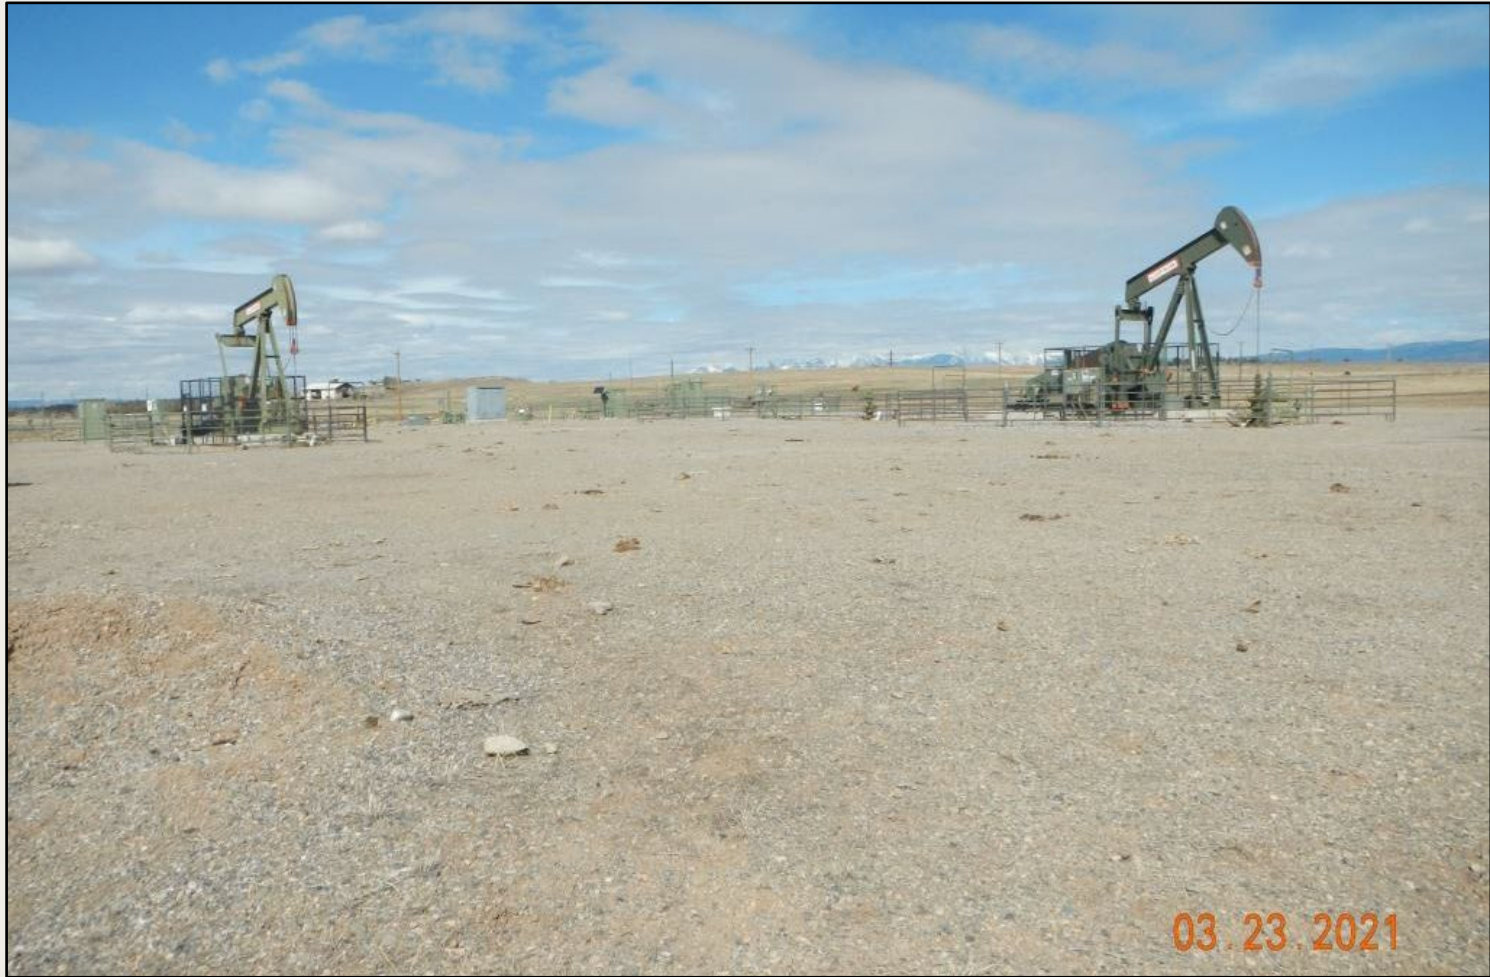
Photo 1. View of the project area from the well pad entrance facing center.

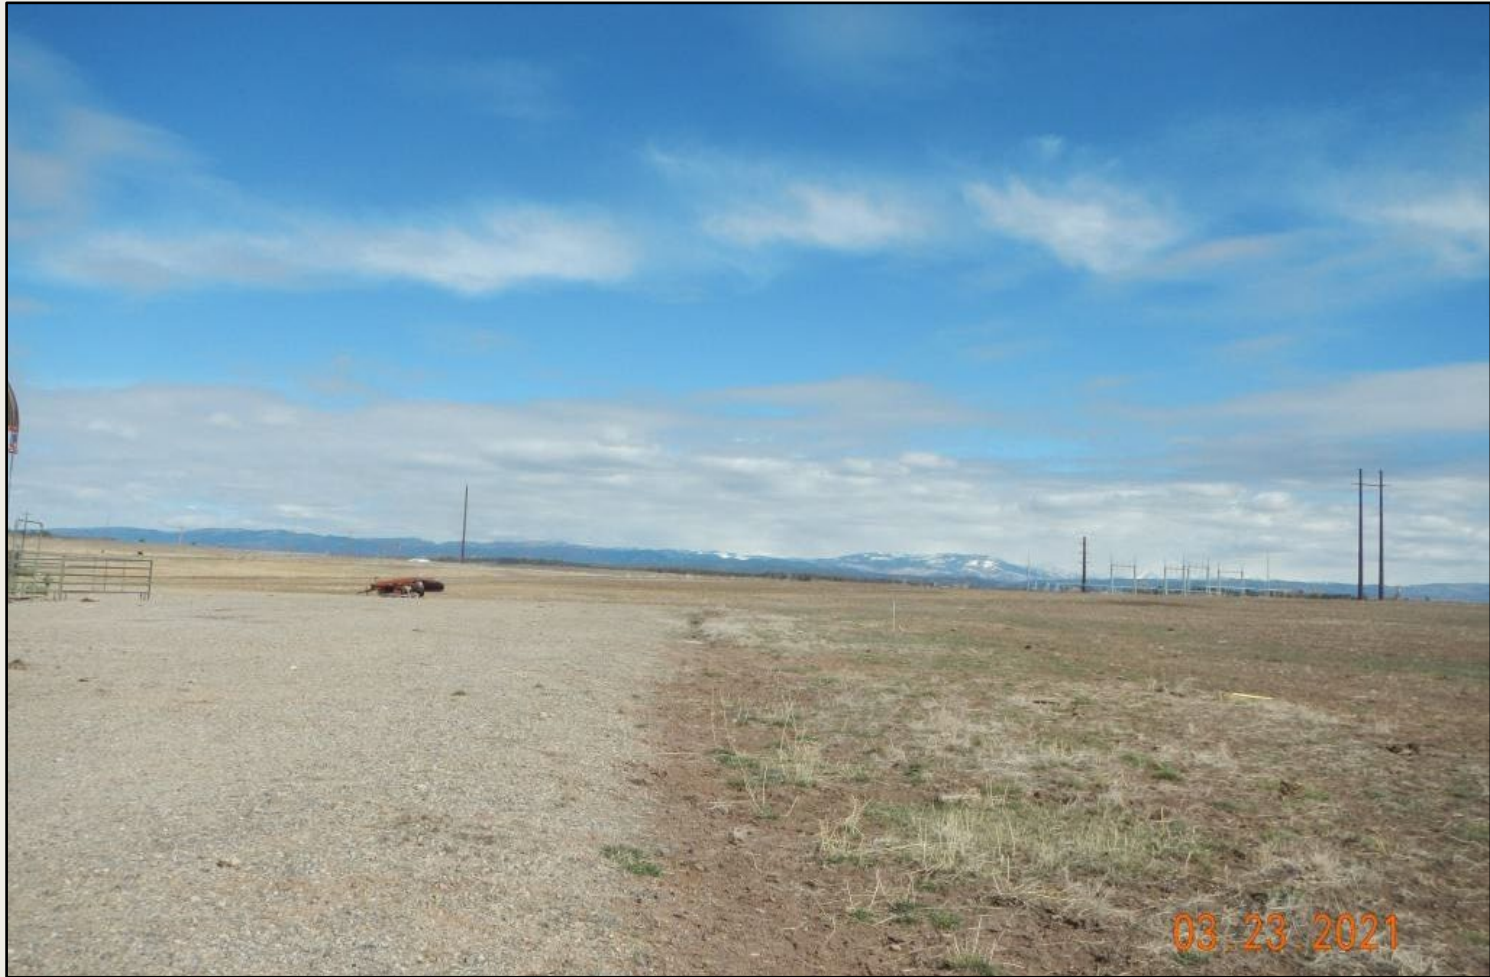
Photo 2. View of the eastern project area facing northward from the southeastern corner. Revegetation appears to be progressing in a dormant/grazed condition with crested wheatgrass and western wheatgrass observable.

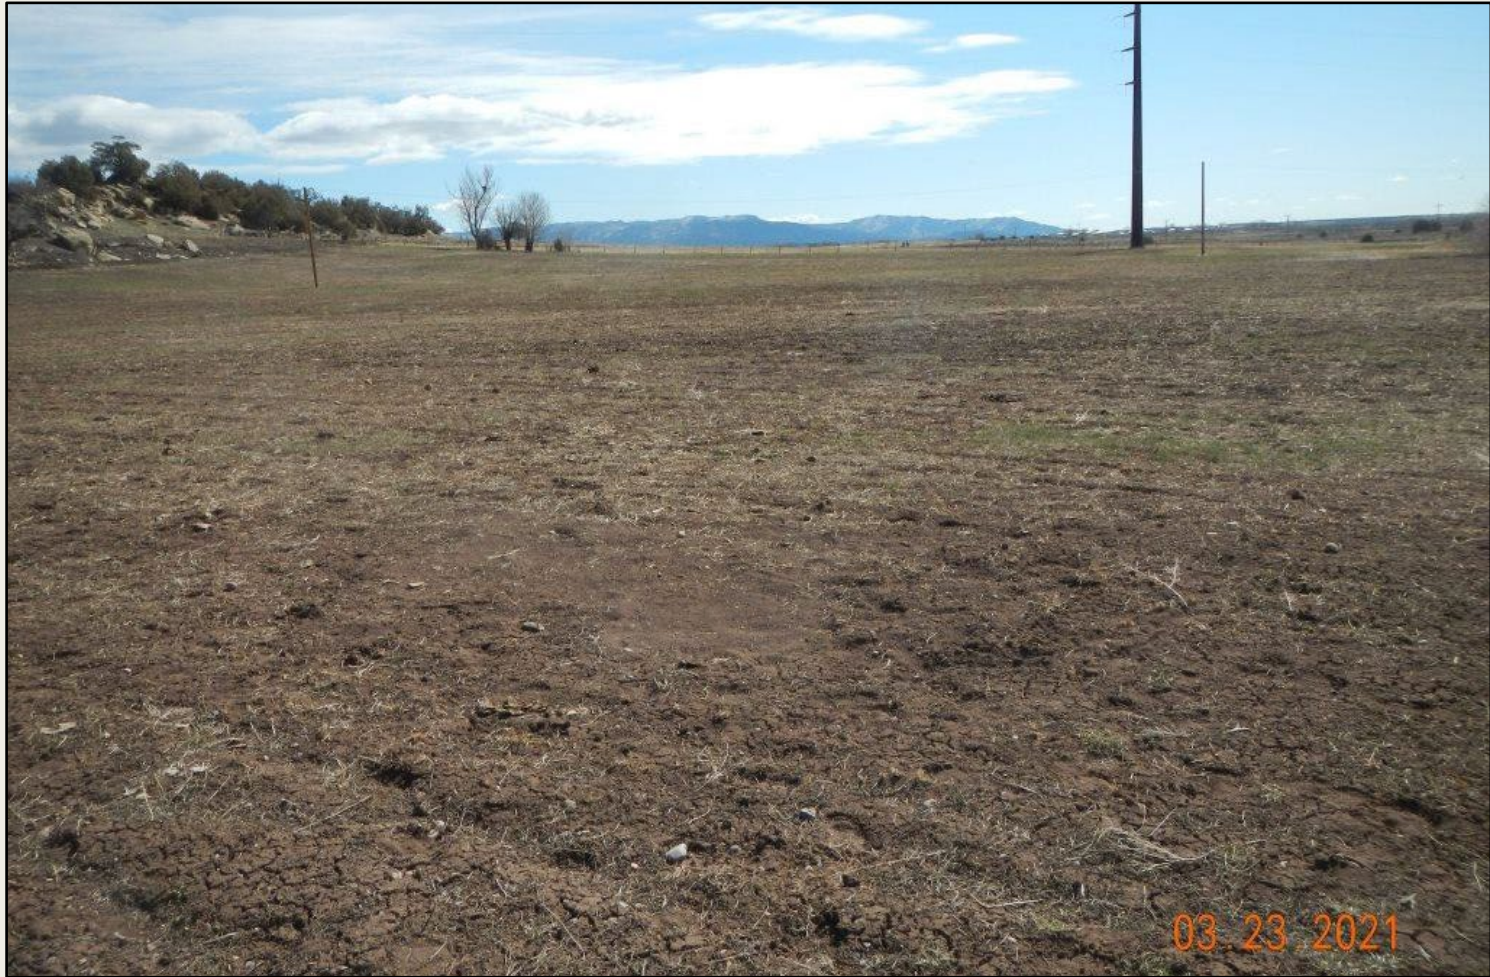
Photo 3. View of reference area comprised of grass field in a dormant/grazed condition. Perennial grasses are not identifiable at this time.
