**Inspection Photos**  
**Operator: Logos**  
**Facility: 067-08370**  
**Date: 3/23/2021**

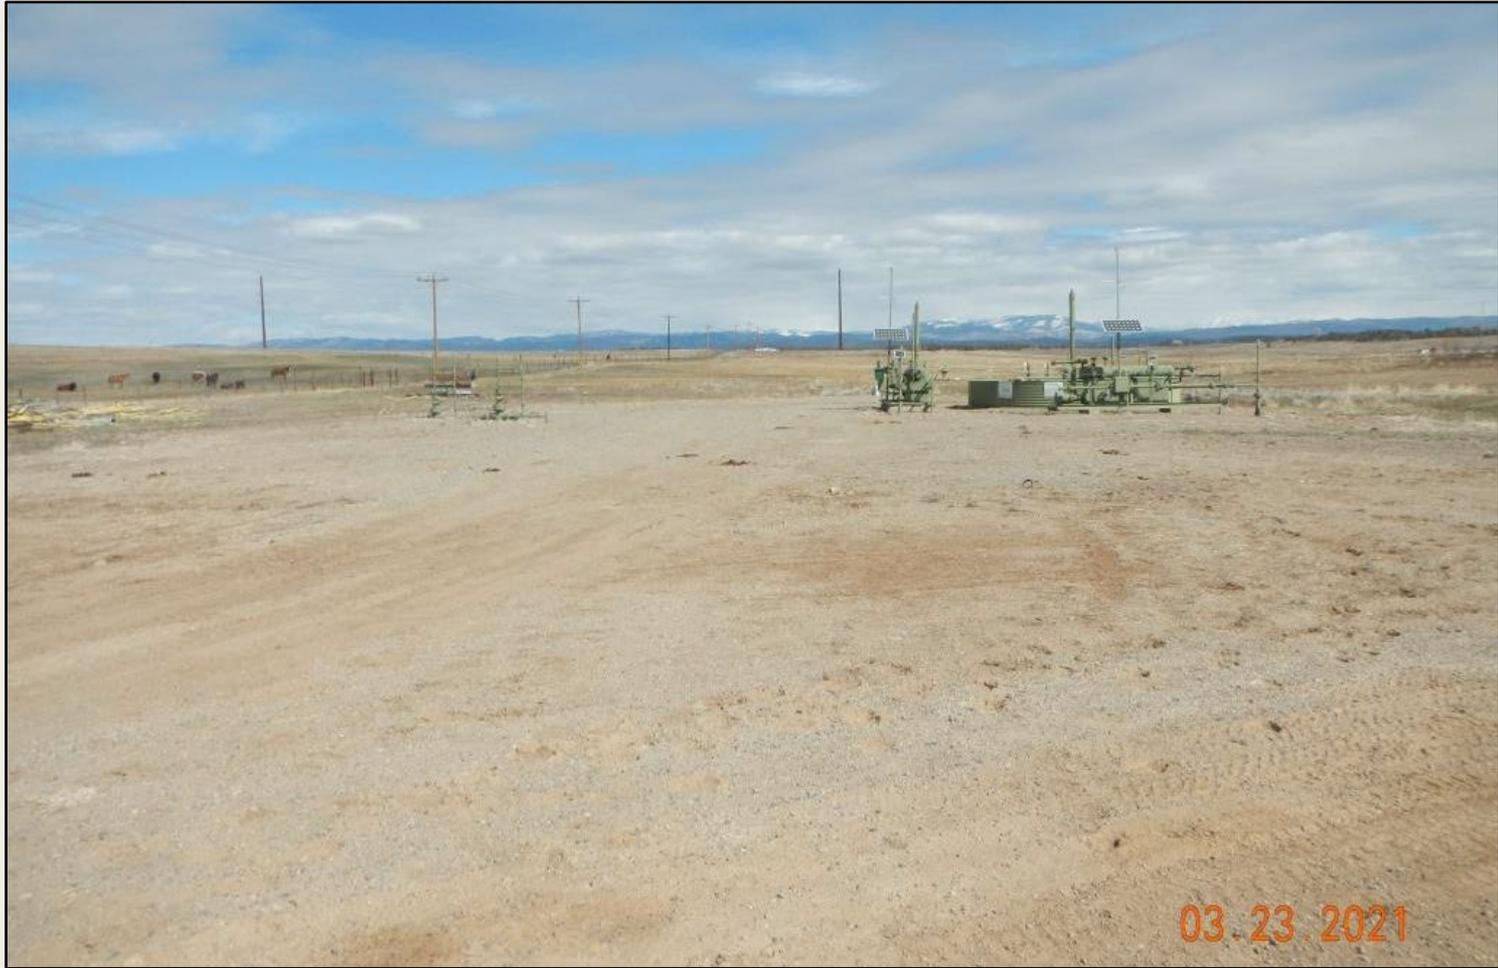
Photo 1. View of the project area from the well pad entrance facing center.

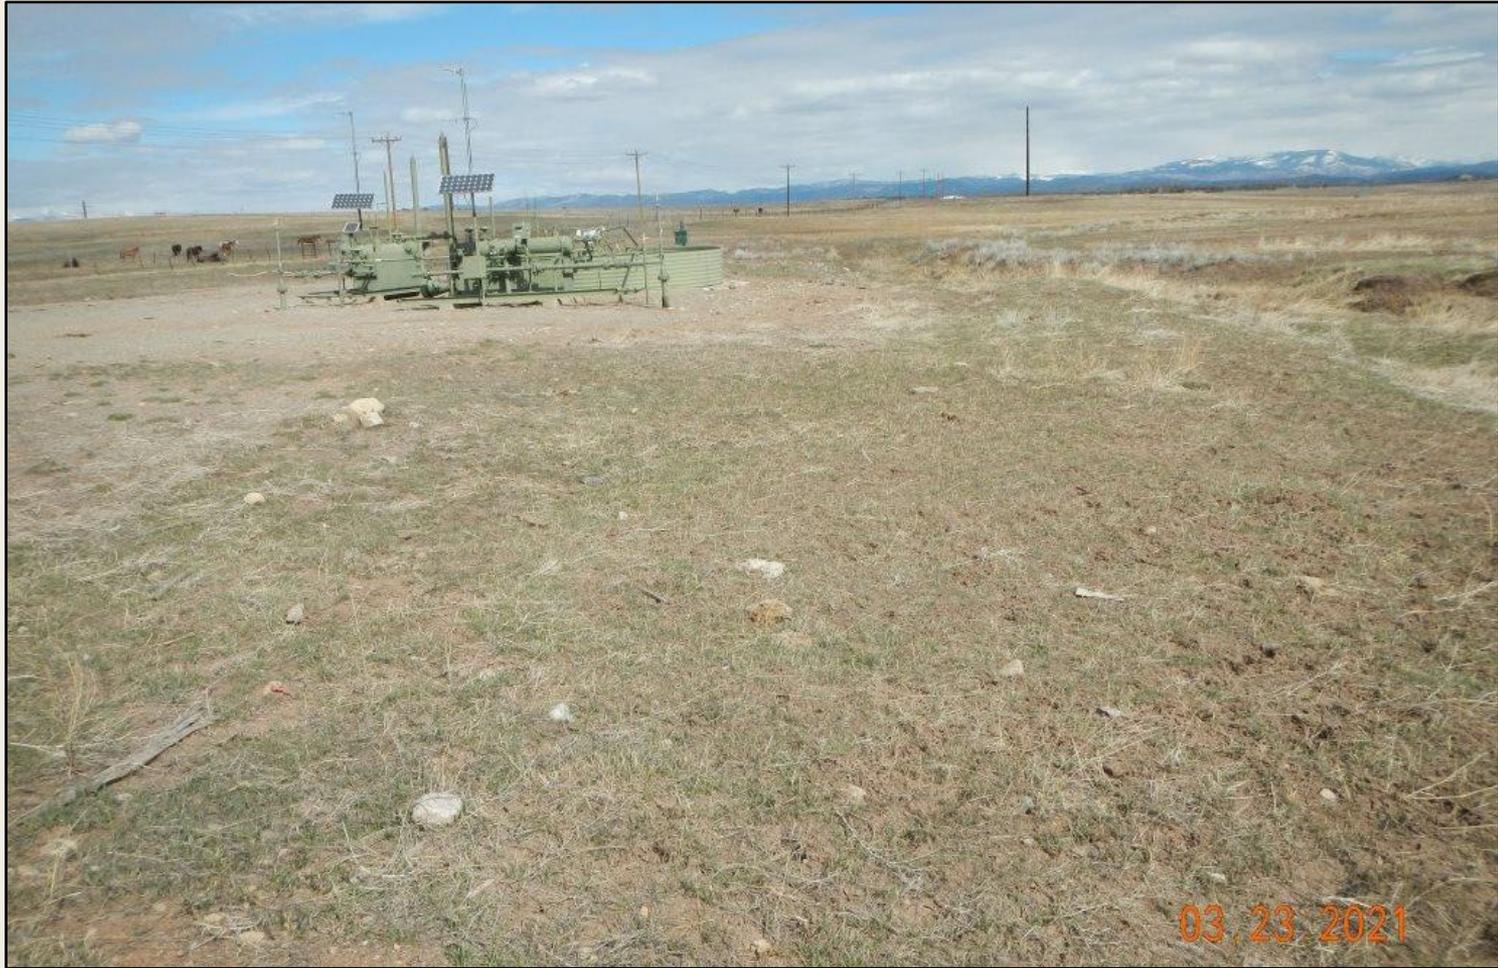
Photo 2. View of the eastern project area facing northward from the southeastern corner. Revegetation appears to be progressing in a dormant/grazed condition with crested wheatgrass and western wheatgrass observable.

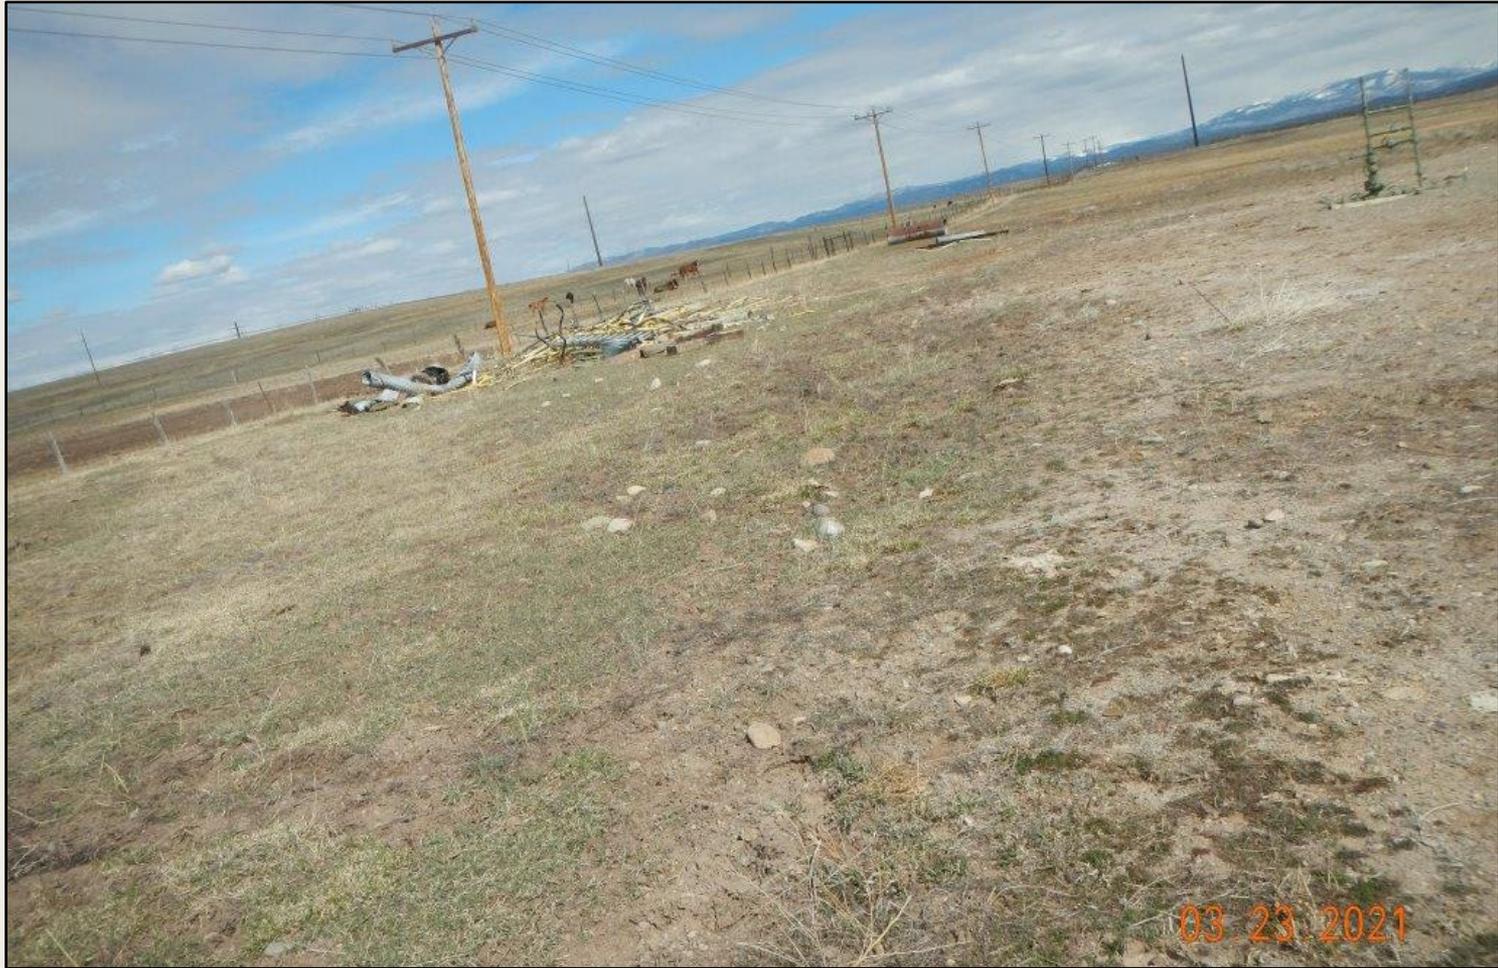
Photo 3. View of the western project area facing northward from the southwestern corner. What appears to be surface owner debris is stored just outside the project boundary.

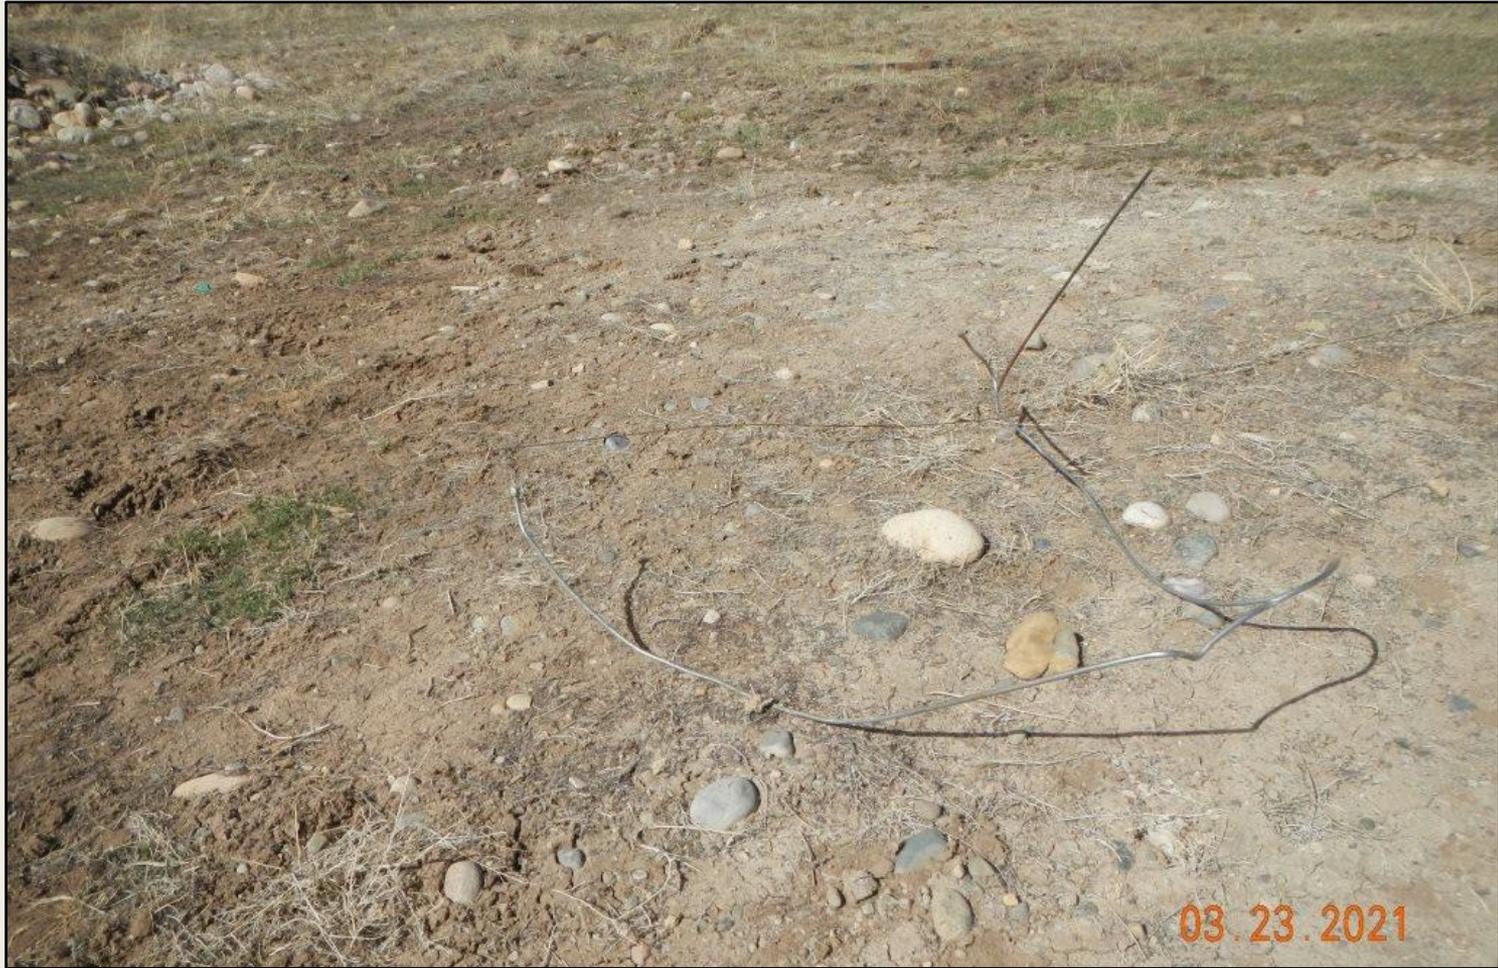
Photo 4. View of wire debris on the well pad, needs to be removed.

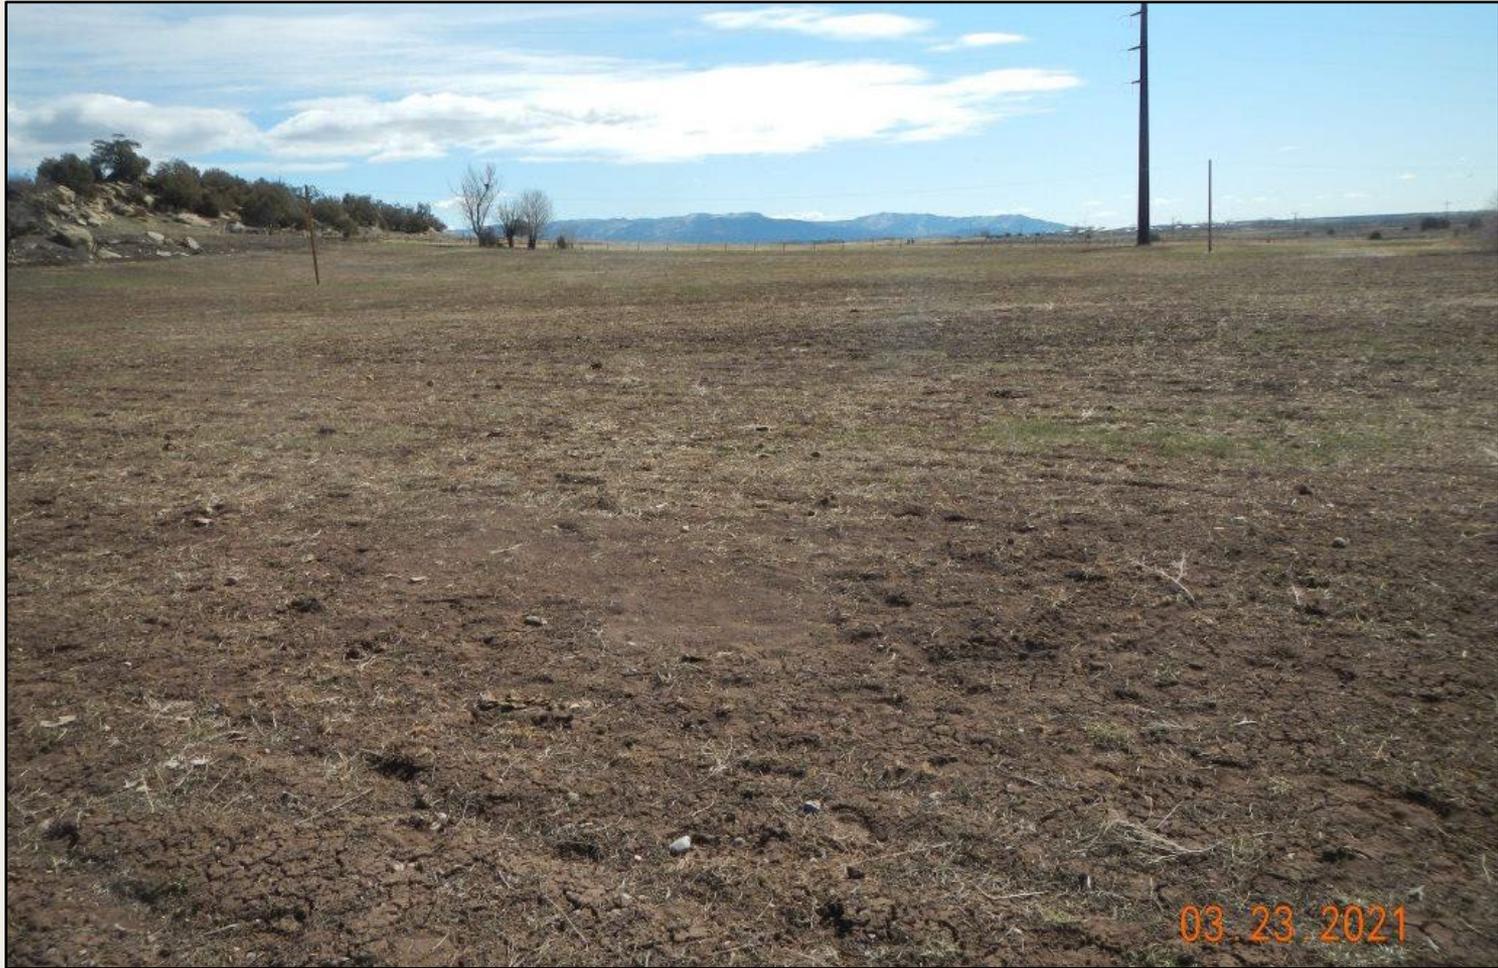
Photo 5. View of reference area comprised of grass field in a dormant/grazed condition. Perennial grasses are not identifiable at this time.
