COLORADO
Oil & Gas Conservation
Commission
Department of Natural Resources

McLaughlin SR 17
API: 05-103-40158

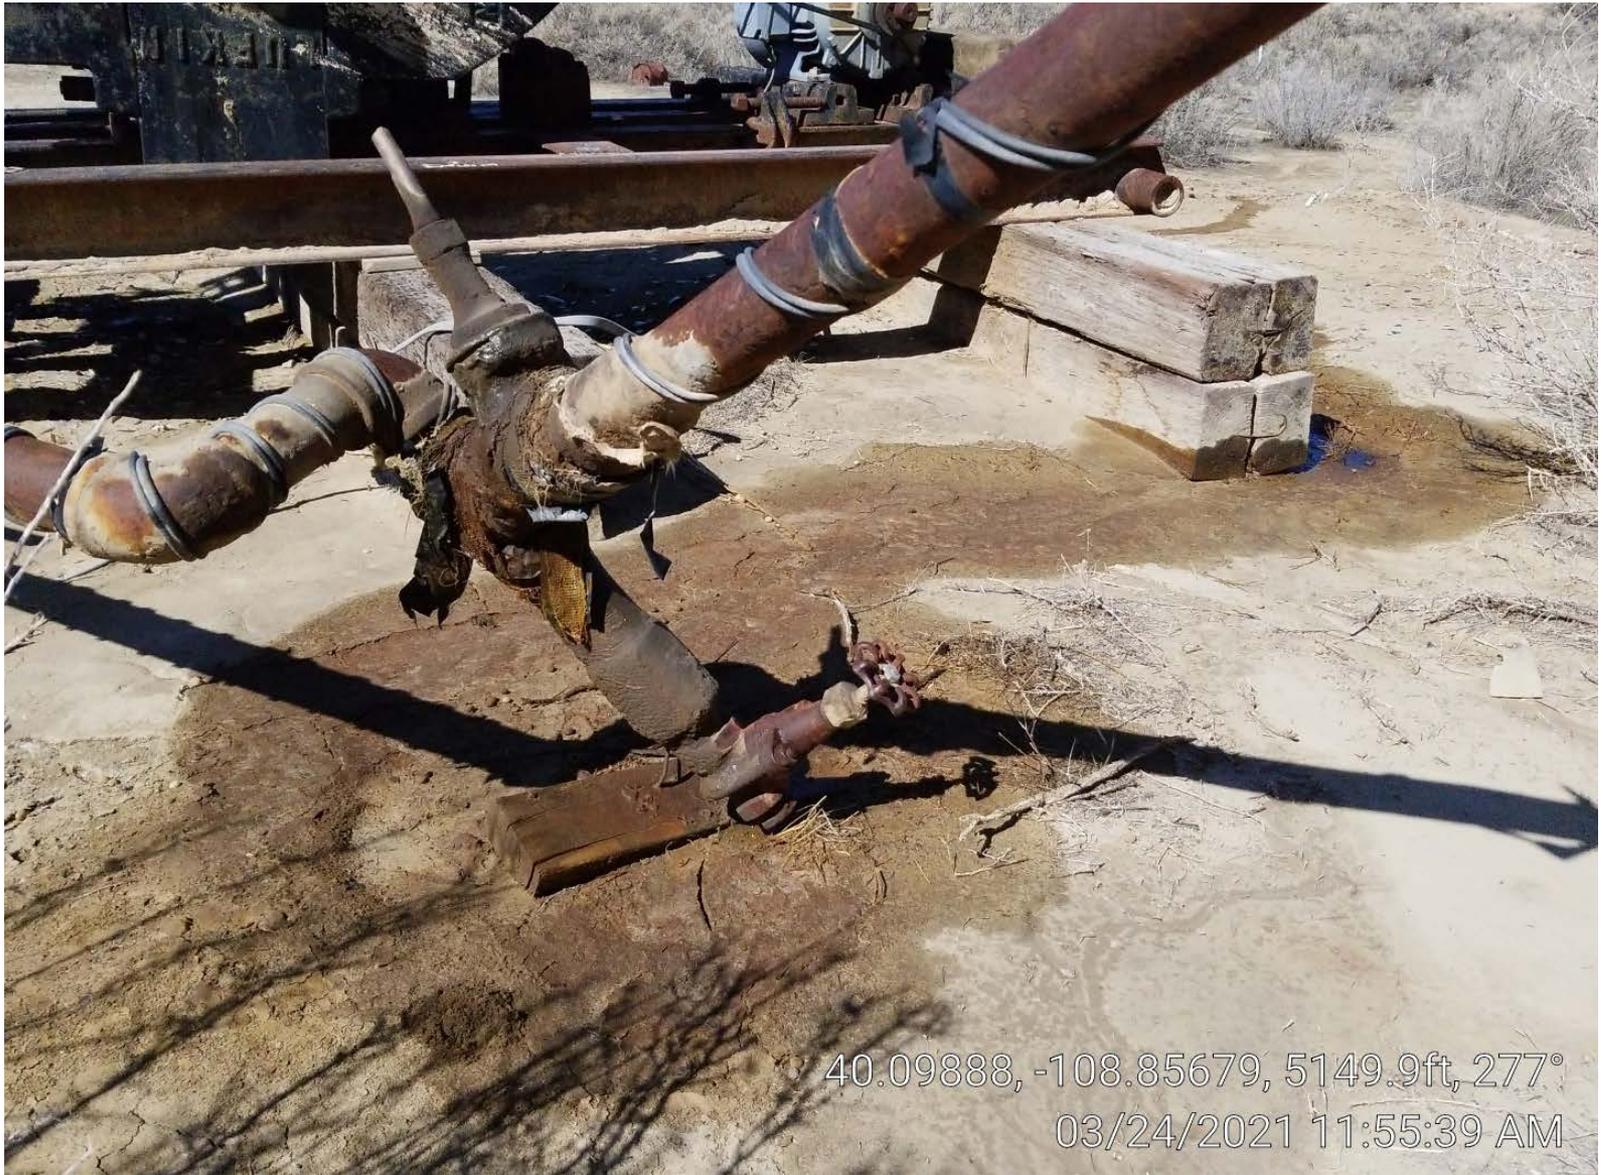
Photo 3. Oil spill originating from flow line next to pump jack.

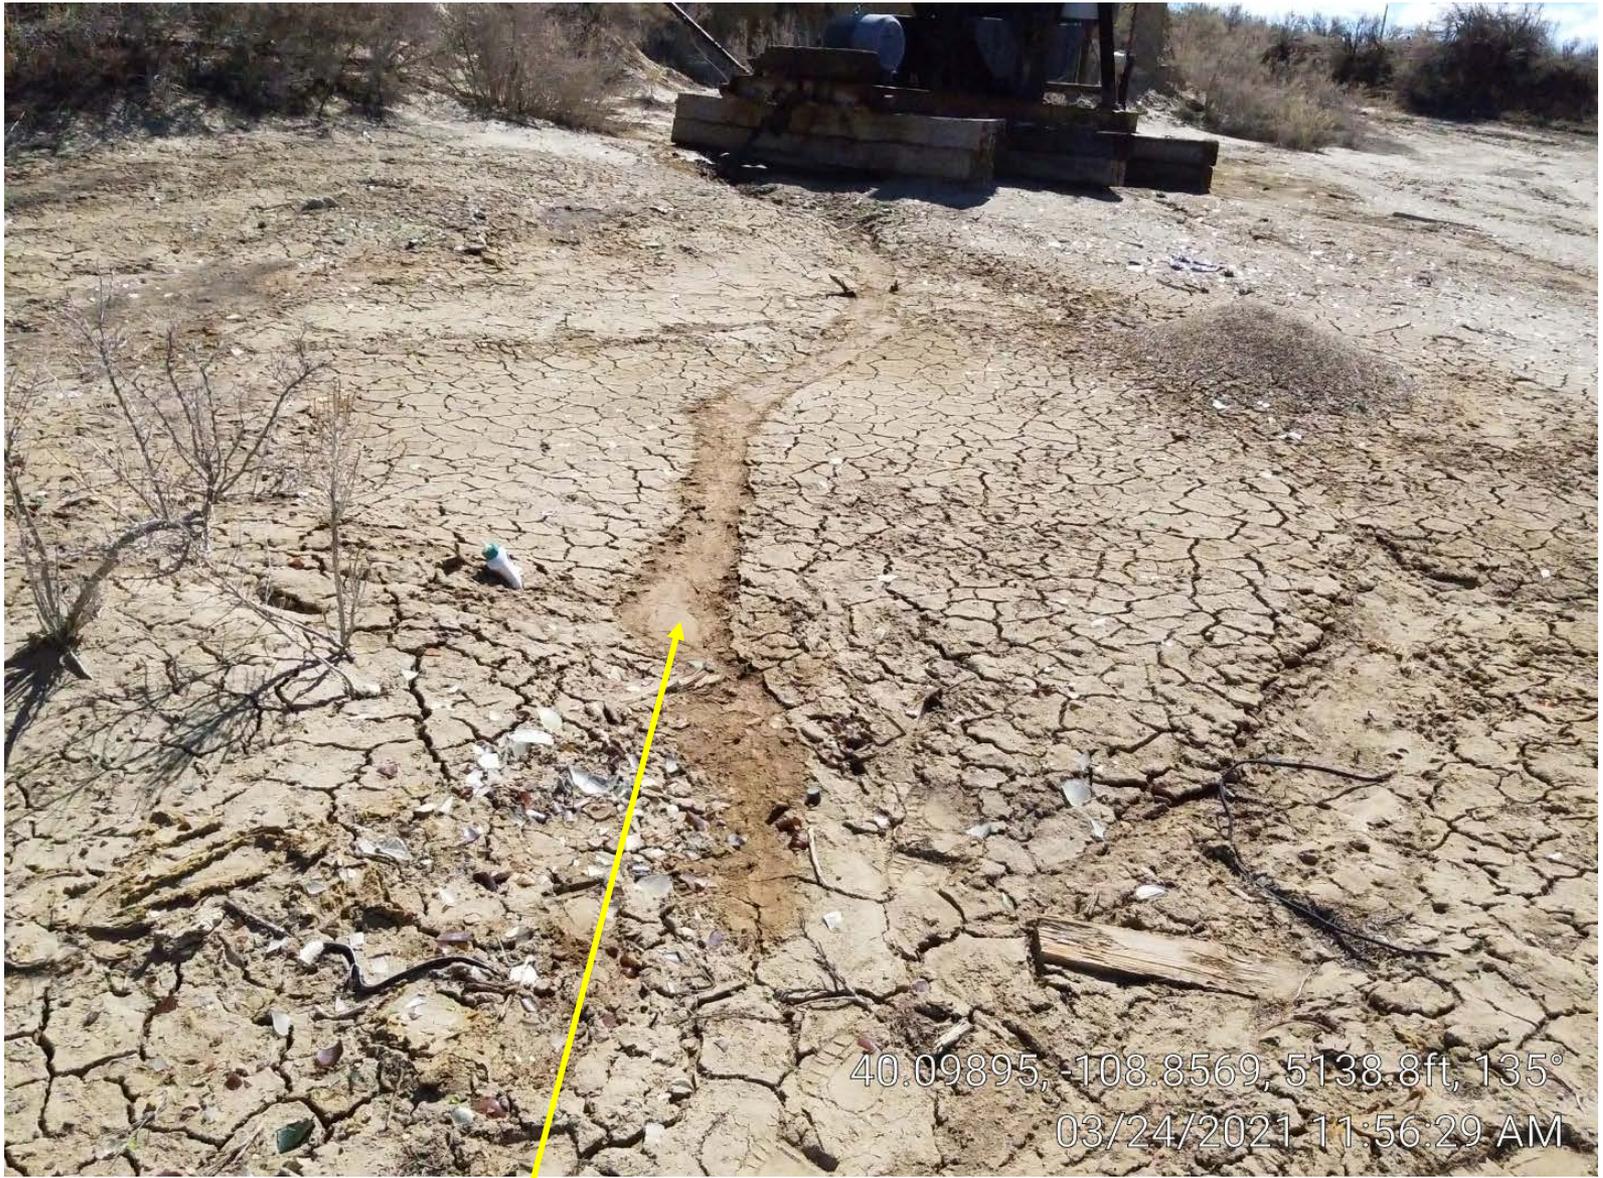
Photo 4. Oil spill channel.

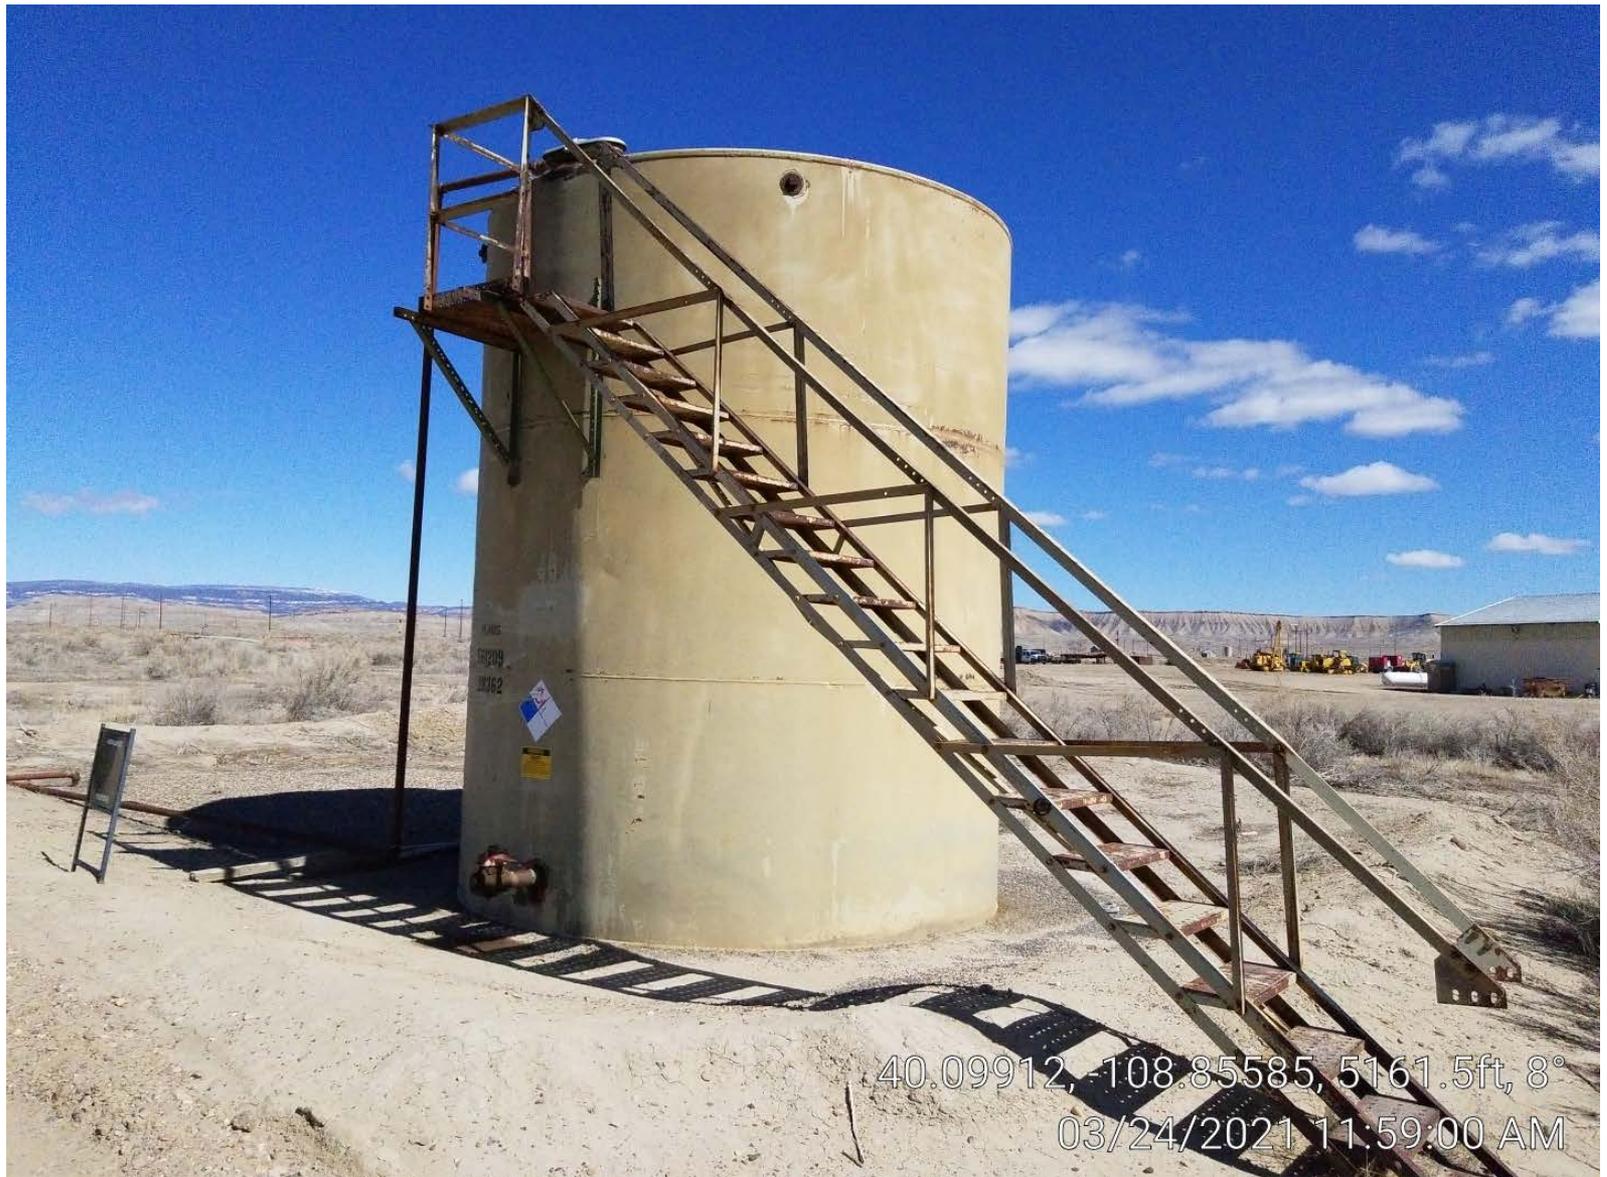
Photo 7. Tank.
