Inspection Photos

3/25/2021

Operator: TEP ROCKY MOUNTAIN LLC - 96850

Location ID: 430567

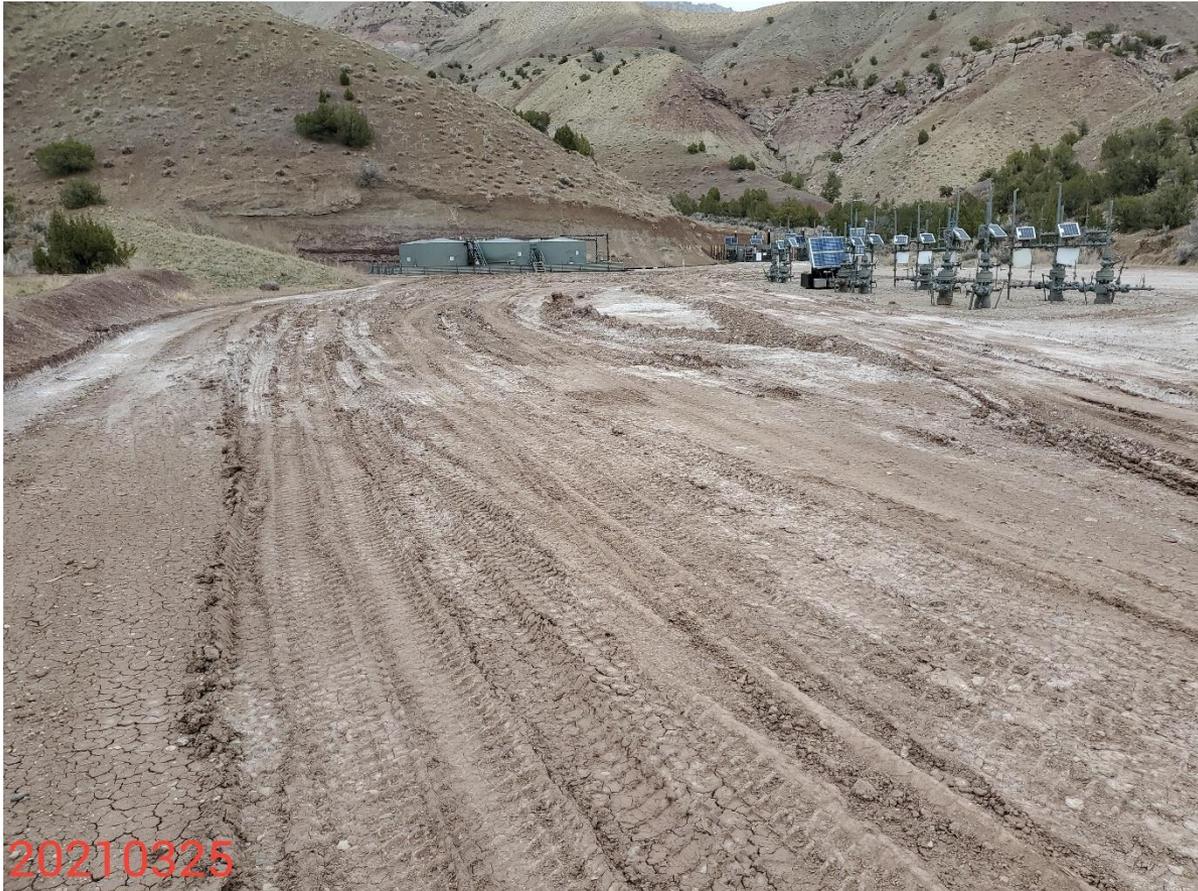
Photo 1: Photo taken from the south end of the Location, facing north. Photos 1-4 show that Pad stabilization concerns remain evident on Location, and appear to have worsened- control measures to stabilize/protect unpaved areas of the Location remain missing or insufficient.

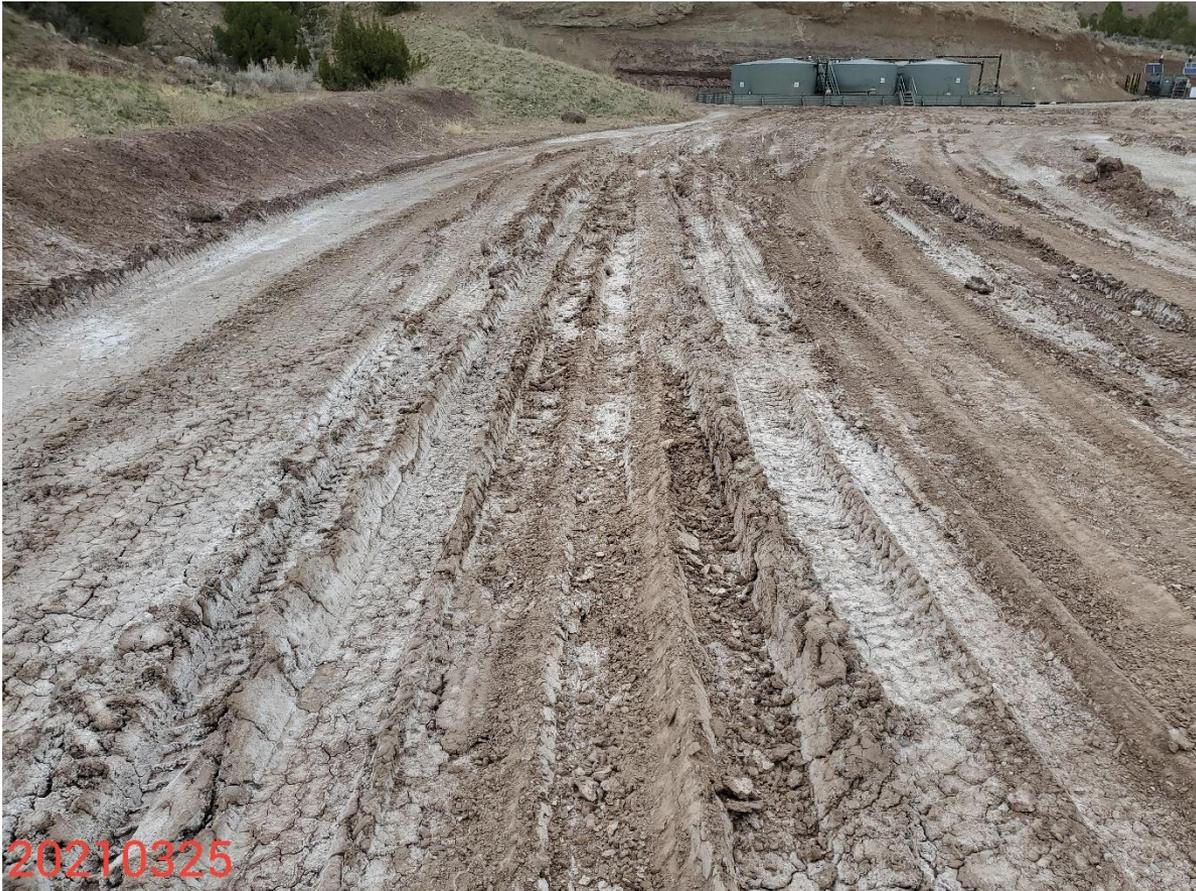
Photo 2: See comments under photo 1.

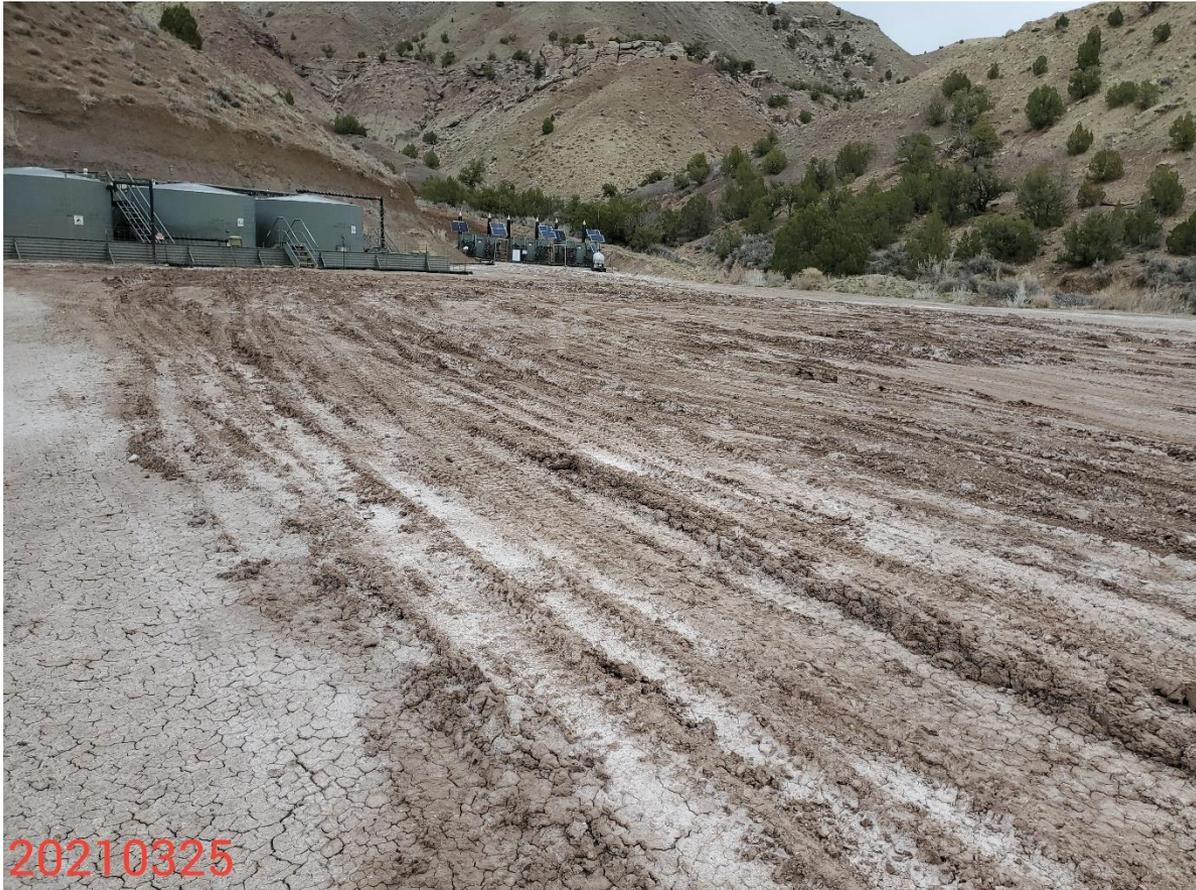
Photo 3: See comments under photo 1.

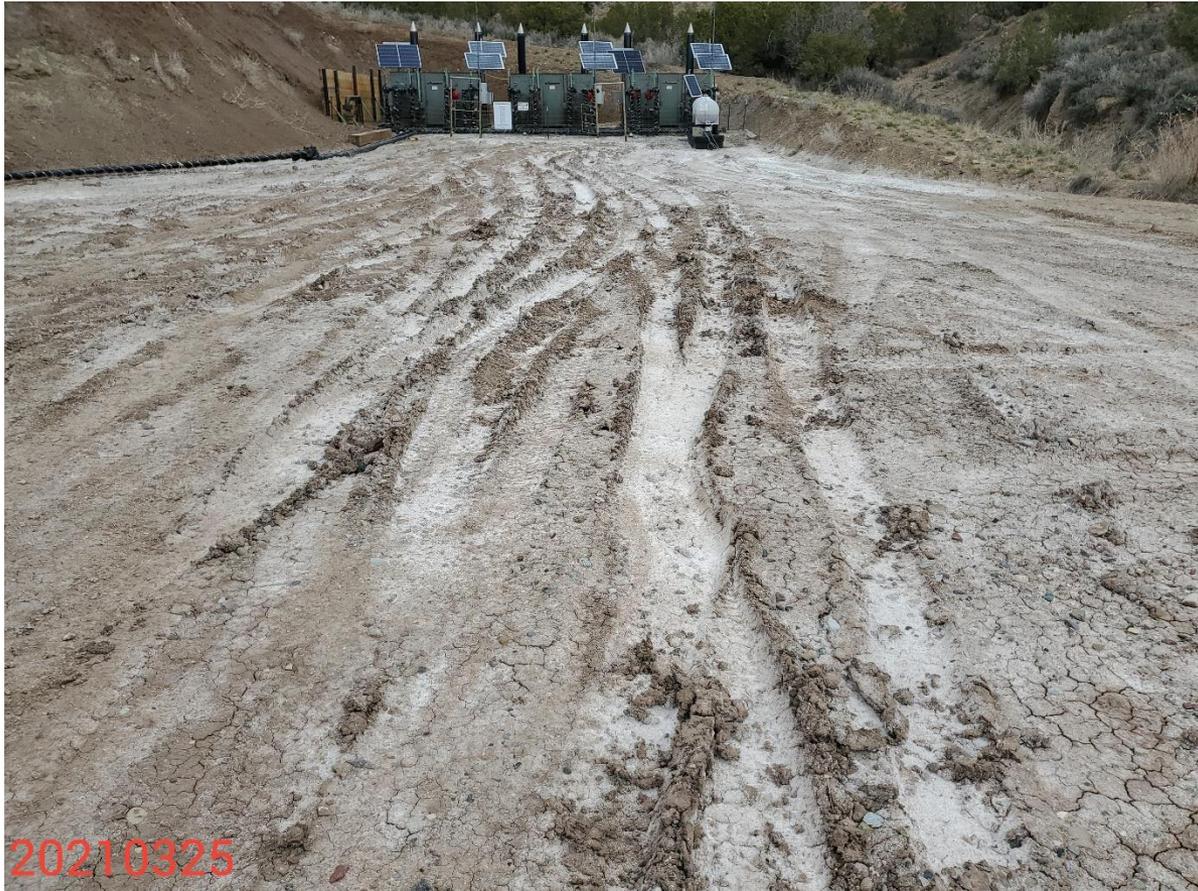
Photo 4: See comments under photo 1.

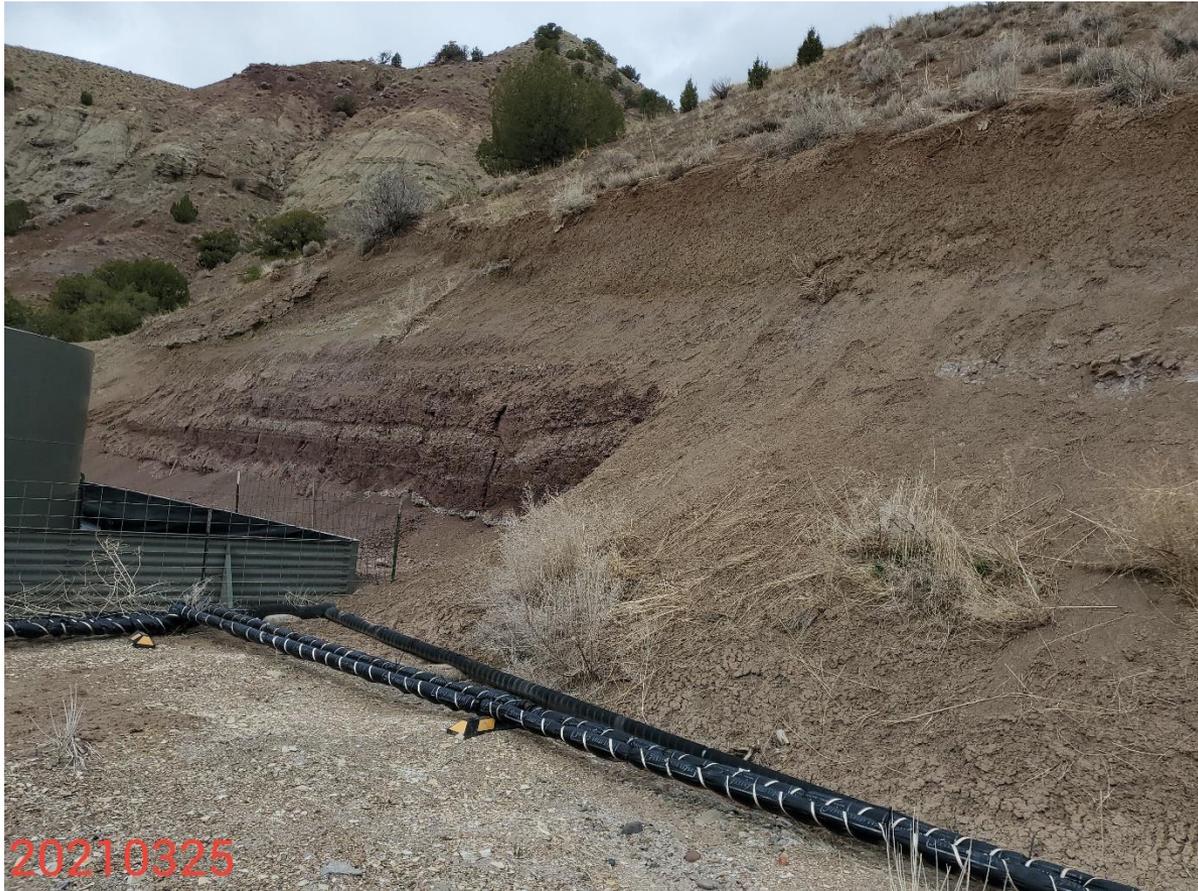
Photo 5: Photo taken from the north end of the Location. Photo shows that control measures to protect/stabilize the cut slopes on the Location remain missing or insufficient.

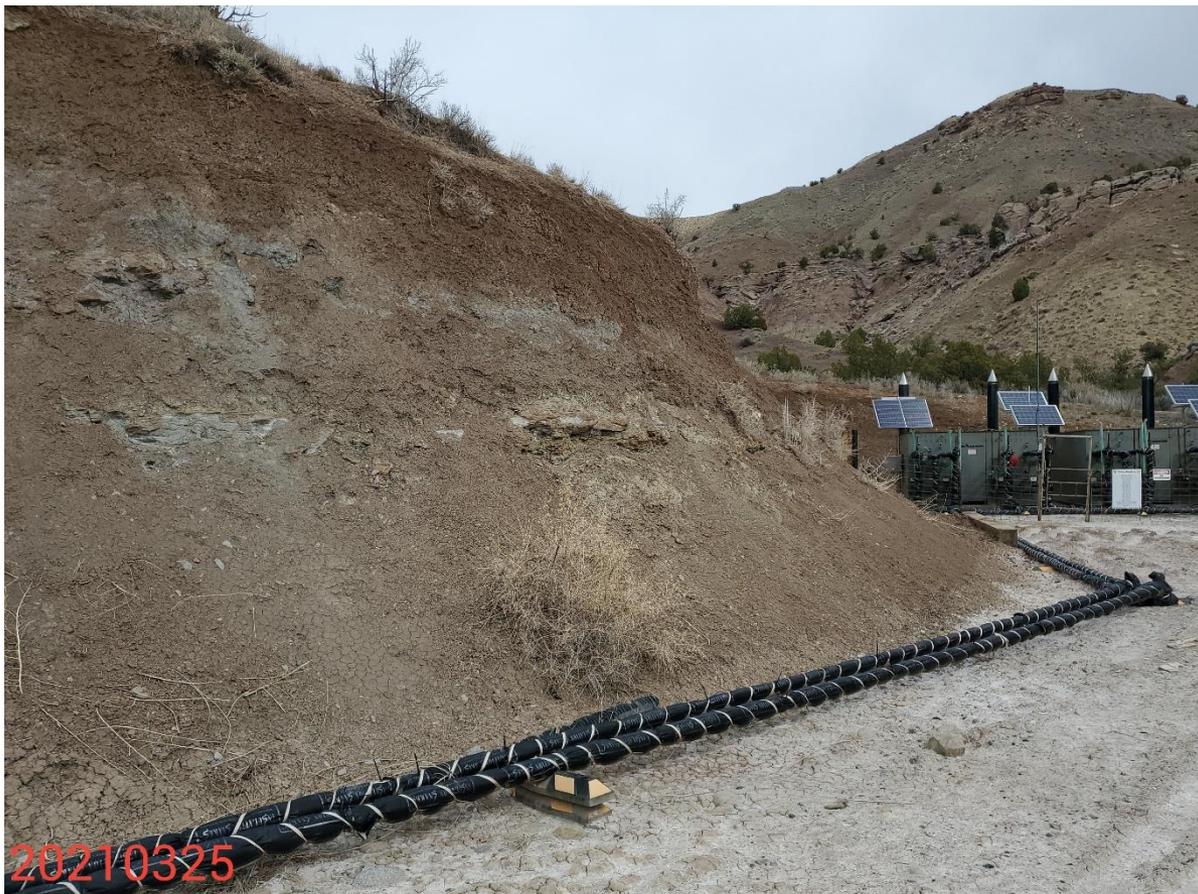
Photo 6: Photo taken from the north end of the Location. Photo shows that control measures to protect/stabilize the cut slopes on the Location remain missing or insufficient.

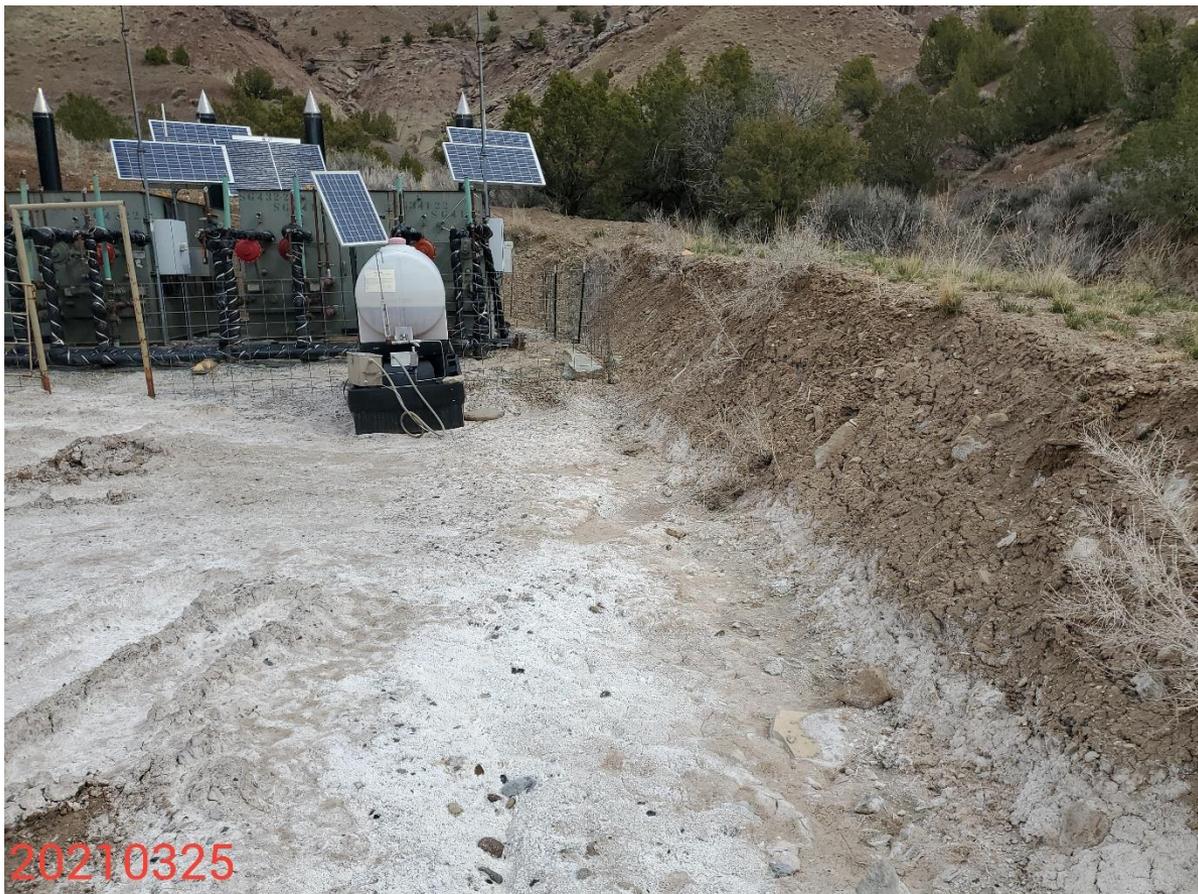
Photo 7: Photo taken from the north end of the Location. Photo shows that control measures to protect/stabilize the cut slopes on the Location remain missing or insufficient.

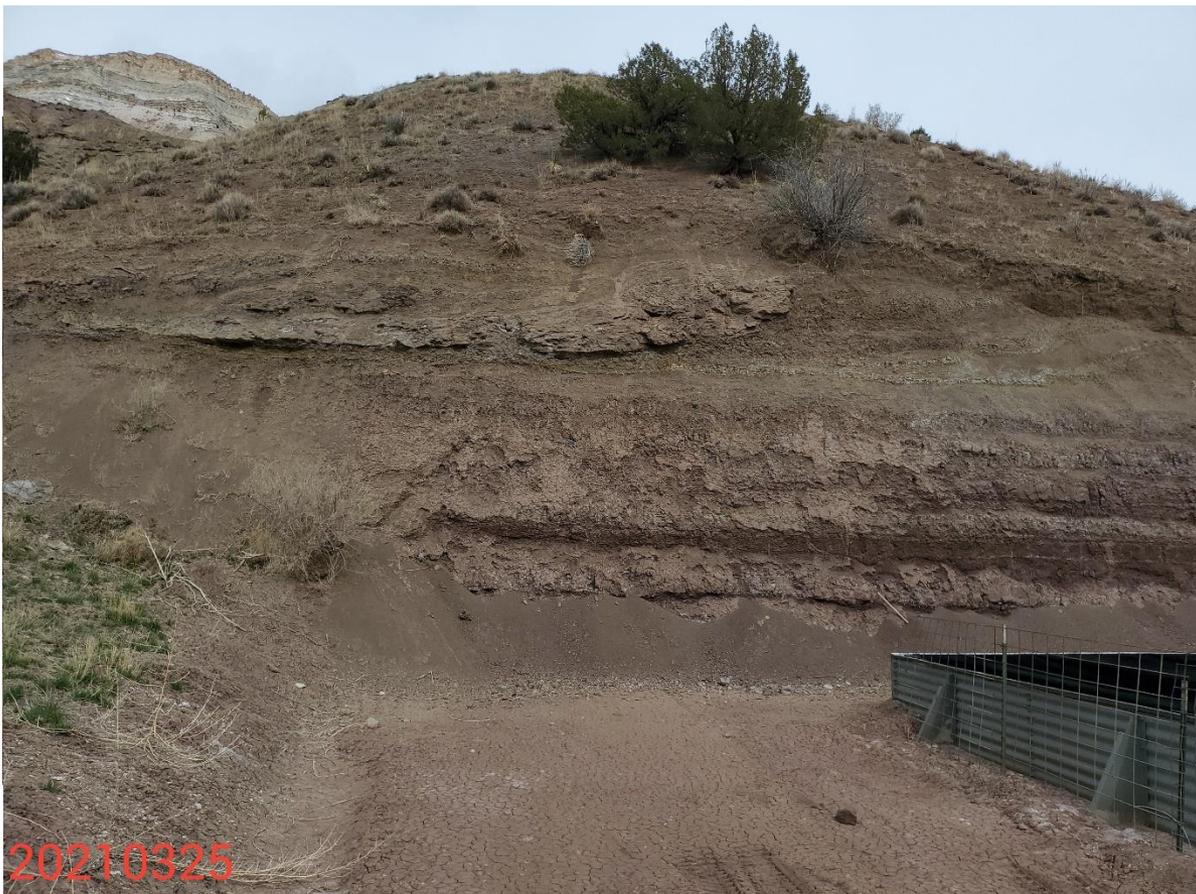
Photo 8: Photo taken from the north end of the Location. Photo shows that control measures to protect/stabilize the cut slopes on the Location remain missing or insufficient.

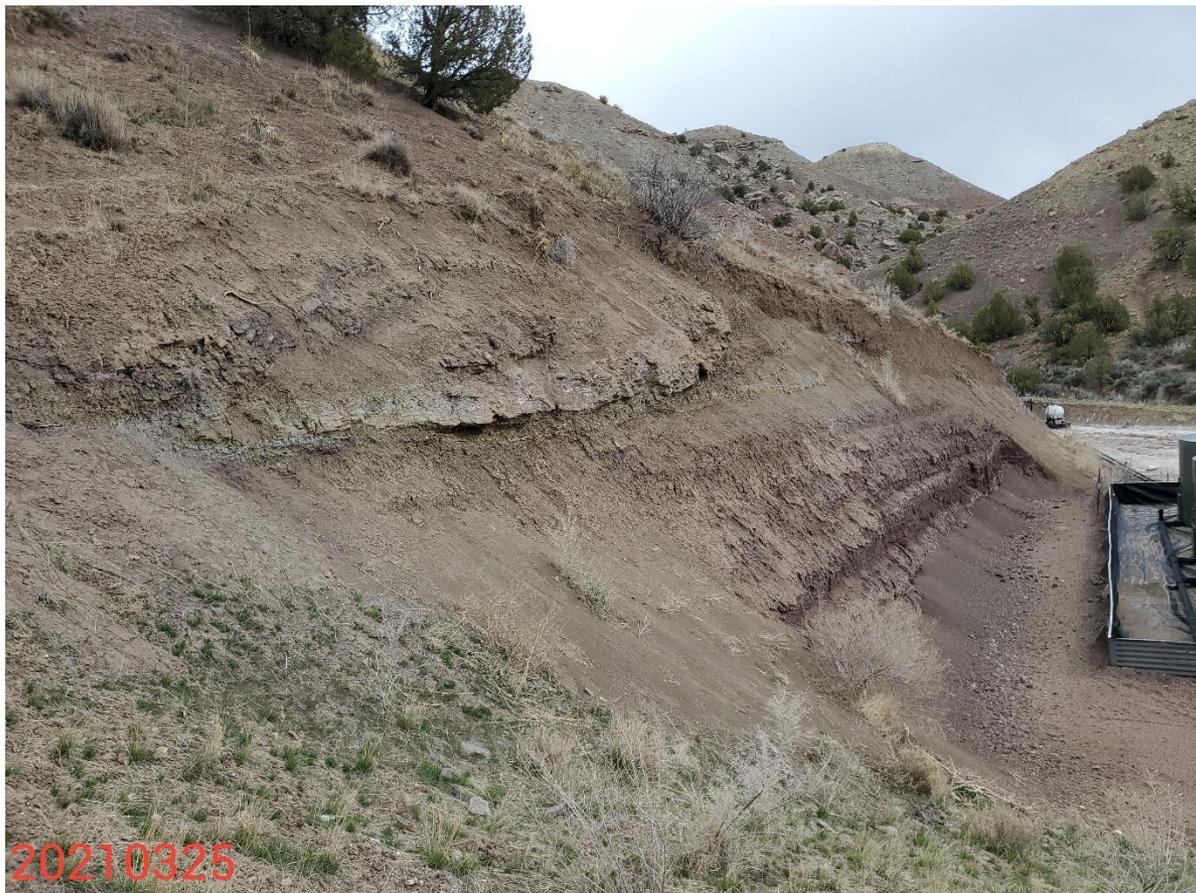
Photo 9: Photo taken from the north end of the Location. Photo shows that control measures to protect/stabilize the cut slopes on the Location remain missing or insufficient.

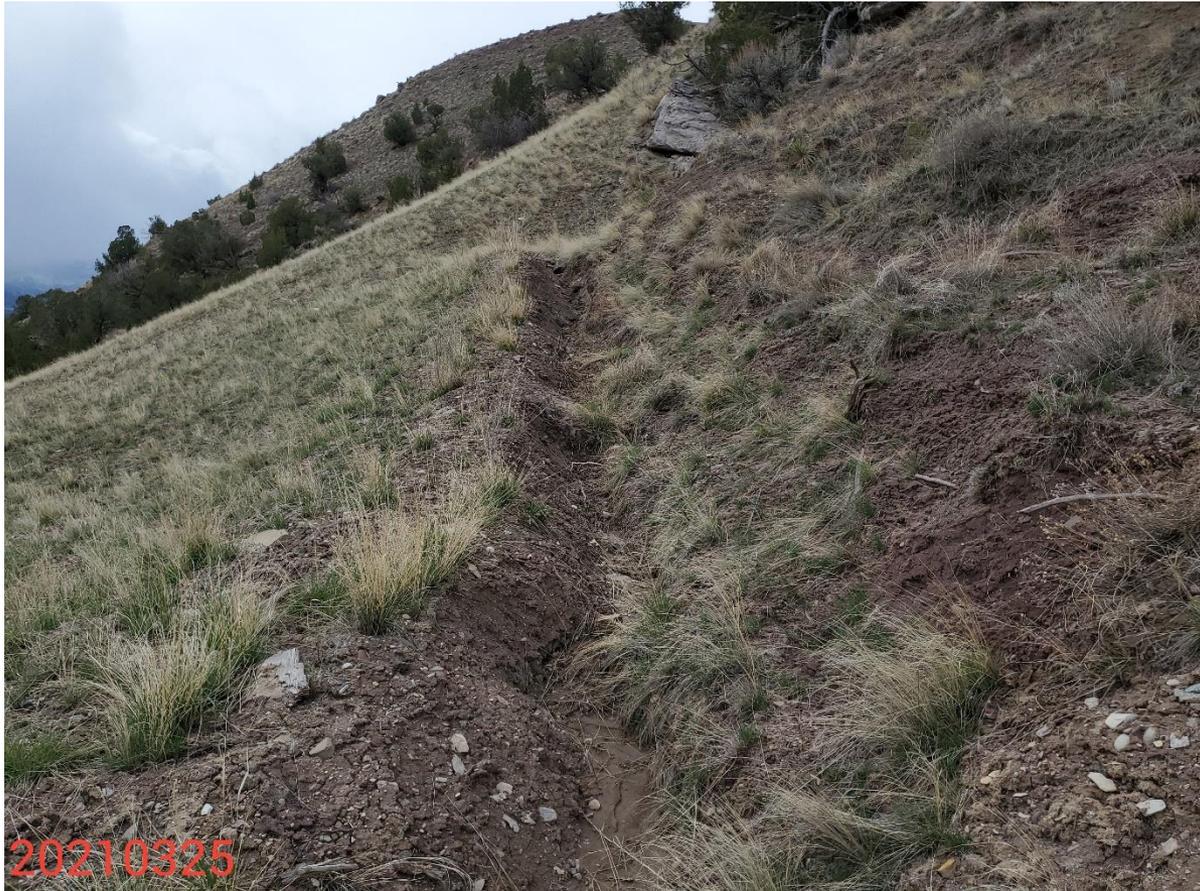
Photo 10: Photo taken from the west end of the Location, facing south. Photo shows stormwater run-on ditch has not been installed in accordance with good engineering practices, or maintained in proper functioning condition; stormwater incision within the ditch evident.

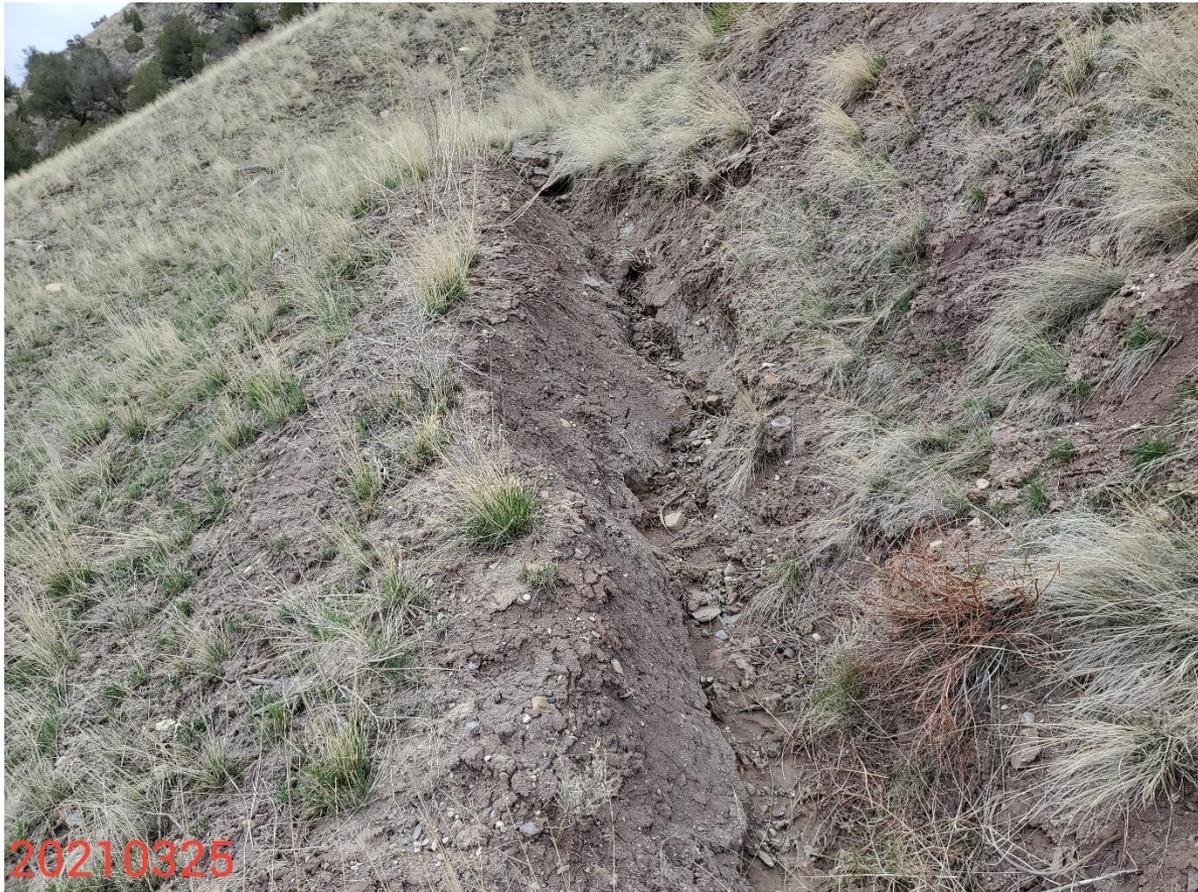
Photo 11: Photo taken from the west end of the Location. Photo shows stormwater run-on ditch has not been installed in accordance with good engineering practices, or maintained in proper functioning condition; stormwater incision within the ditch evident.

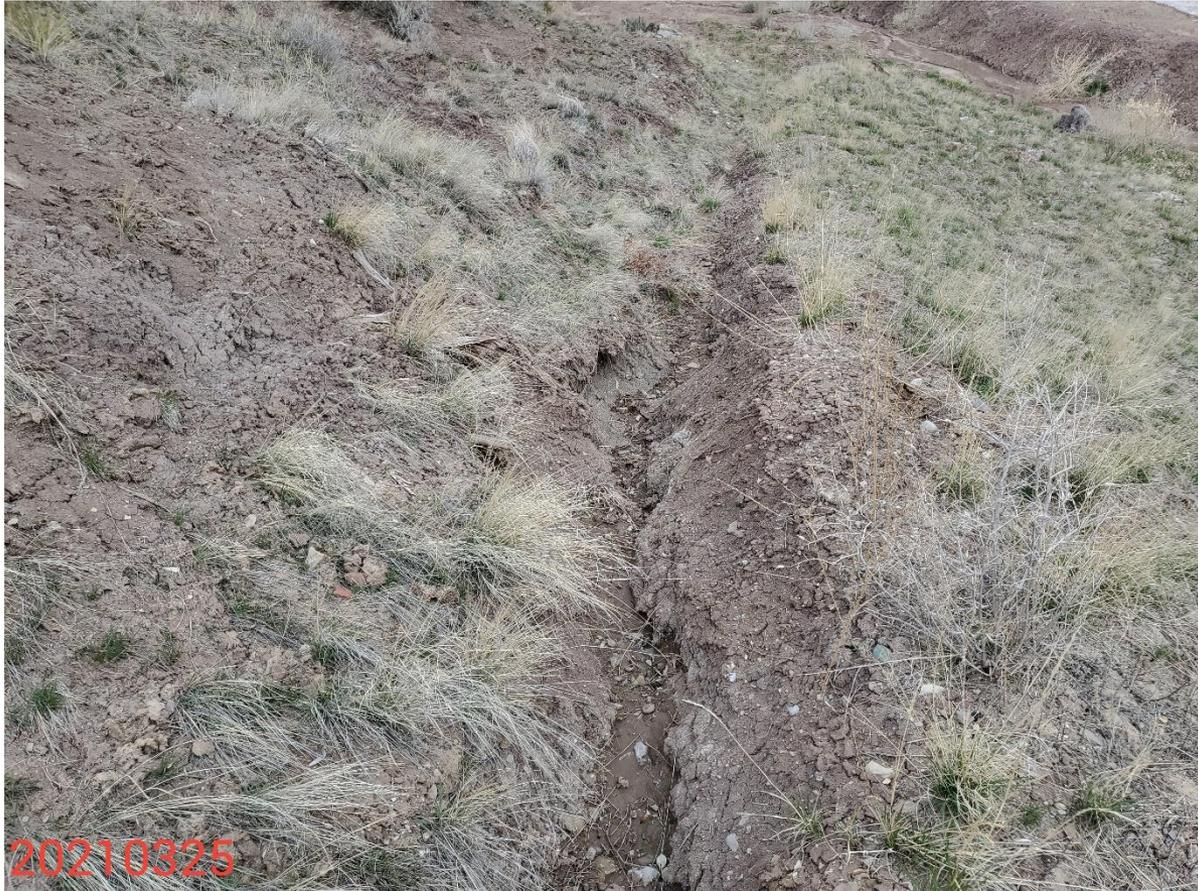
Photo 12: Photo taken from the west end of the Location. Photo shows stormwater run-on ditch has not been installed in accordance with good engineering practices, or maintained in proper functioning condition; stormwater incision within the ditch evident.

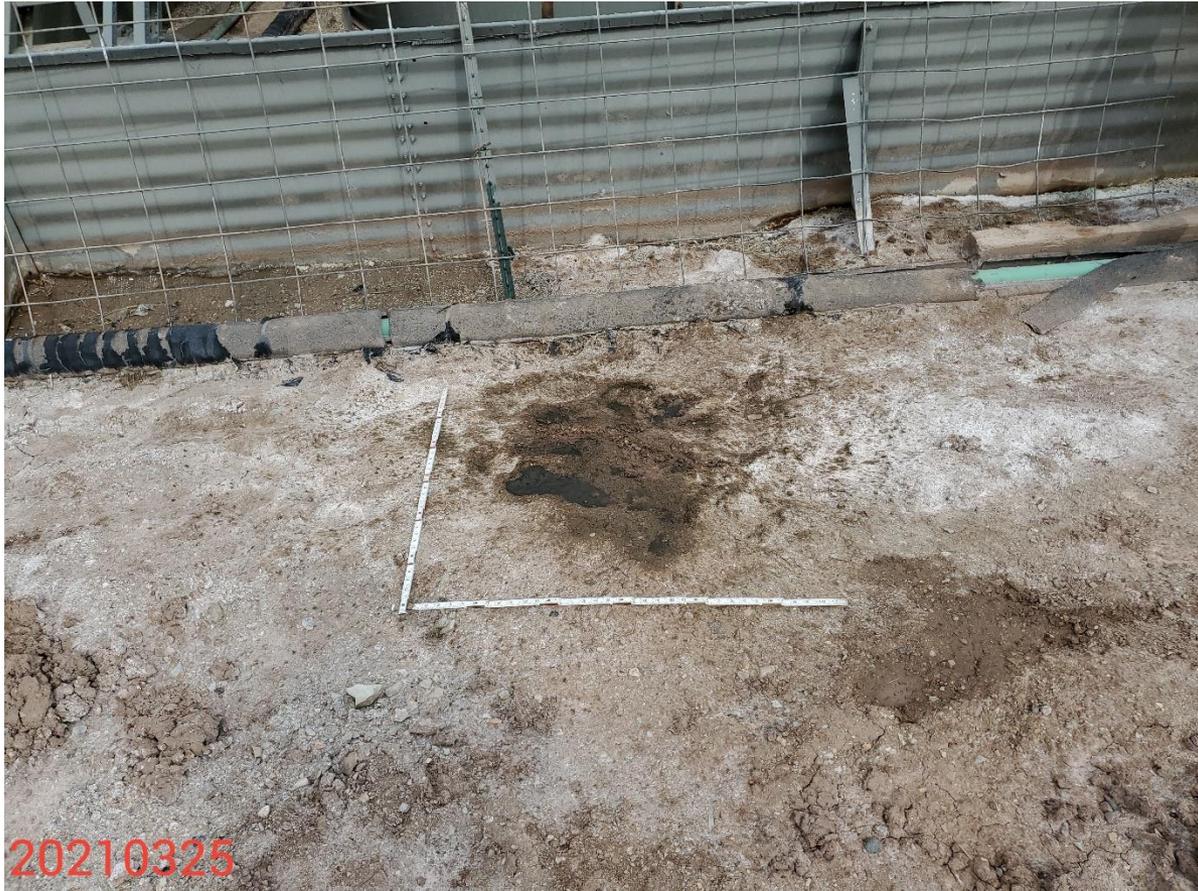
Photo 13: Photo taken from the south end of the tank battery. Photo shows stained soils. Control and contain spills/releases and clean up per Rule 912.a.
