Inspection Photos
Well 081-06588
Spill# 454583
REM #11176
Inspection Date: 3/11/2021
All Photos taken by Kris Neidel

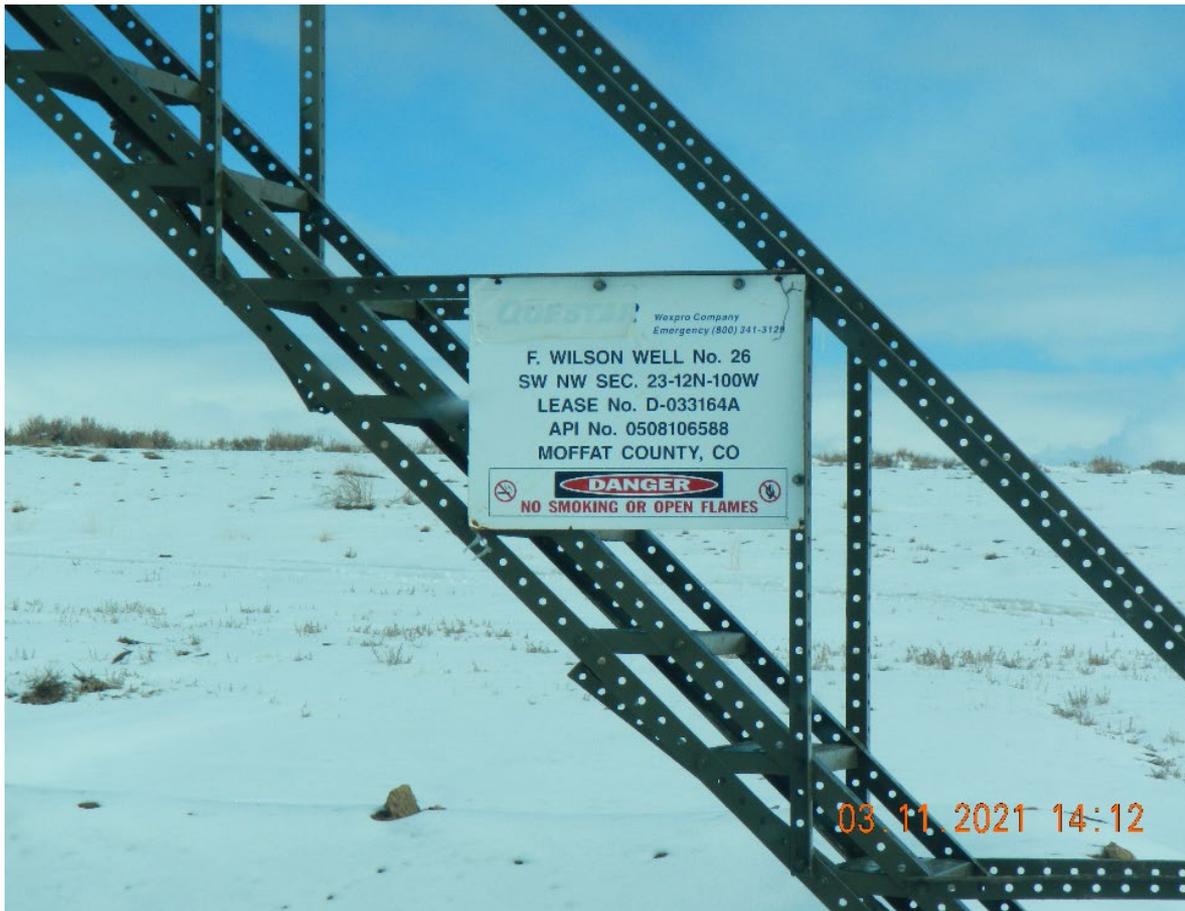
Photo #1 sign at tank battery

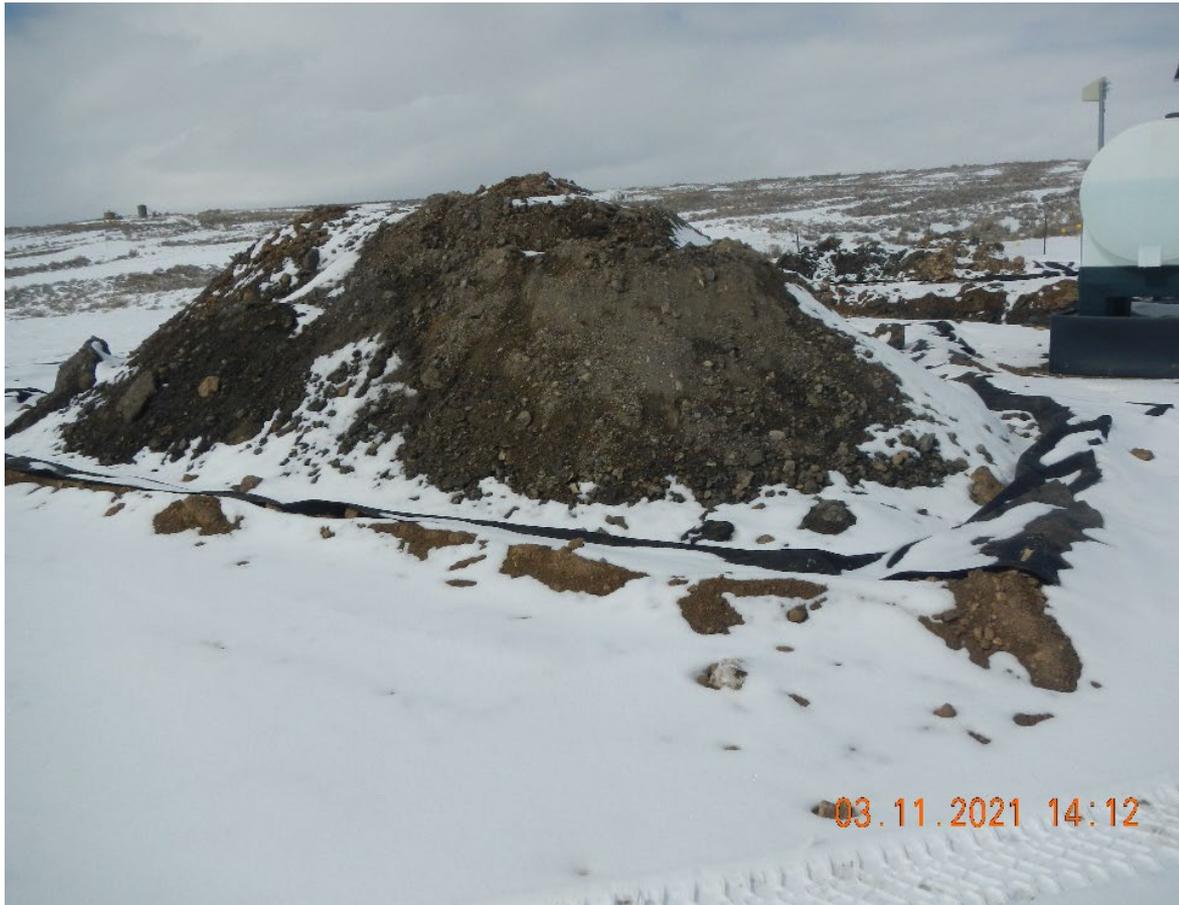
Photo #2 stockpiled soil from spill excavation.

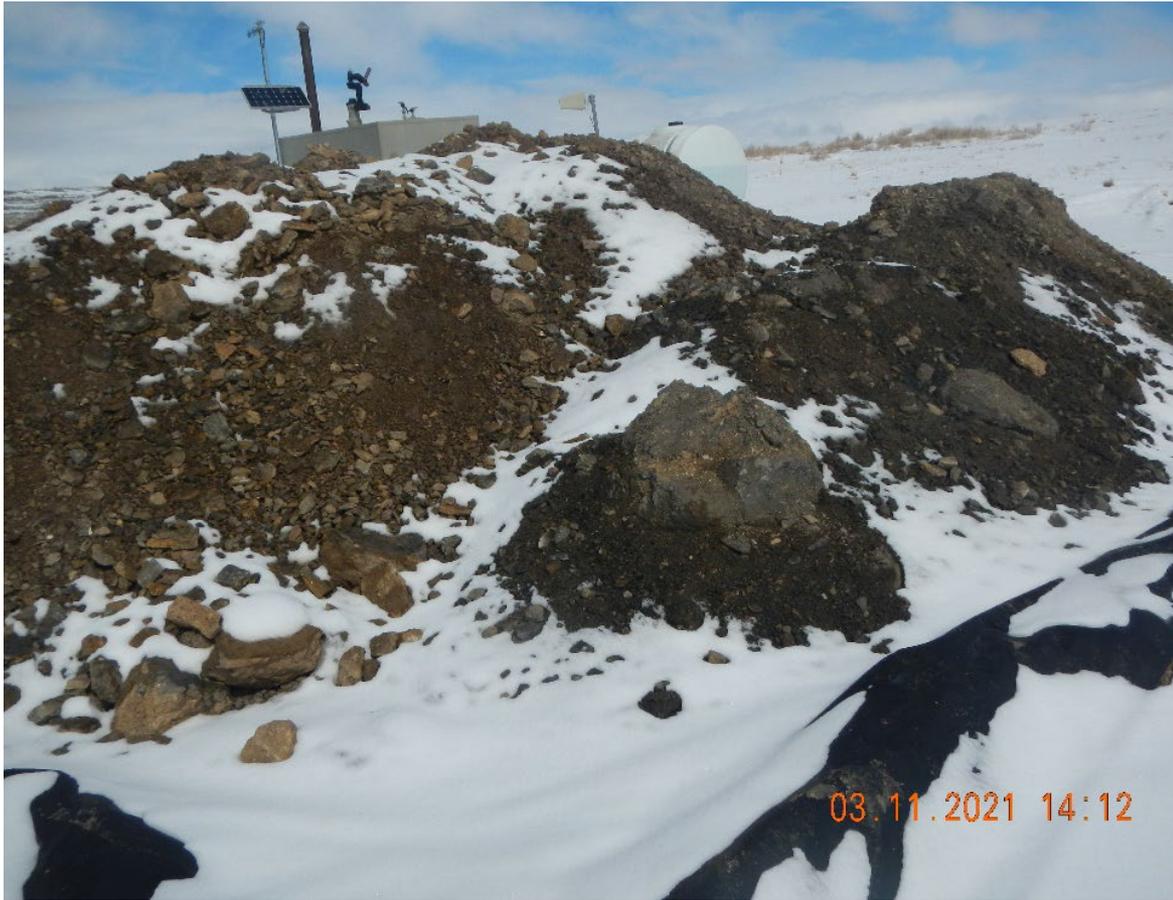
Photo #2 same as photo #2

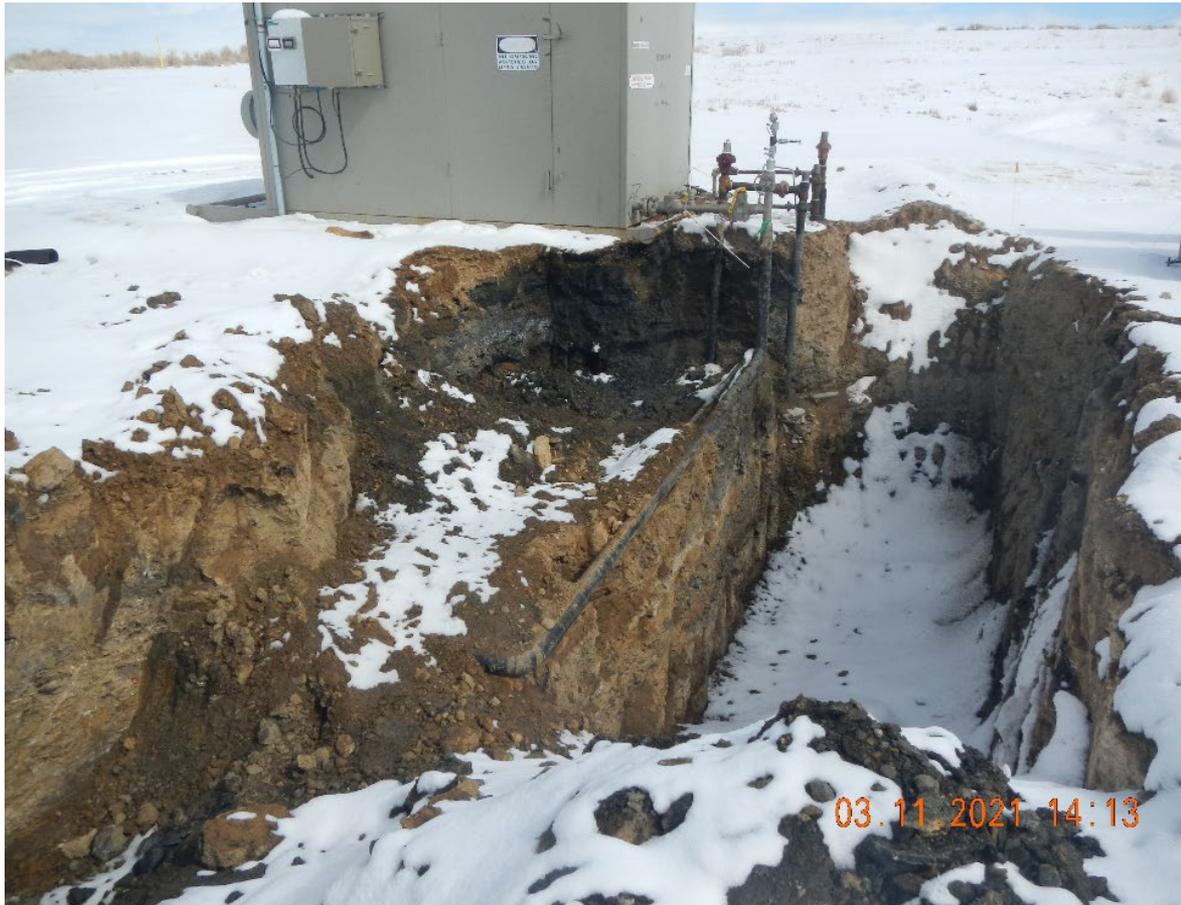
Photo #4. area where flowline failed on right of photo. Contamination also seen under Dehy.

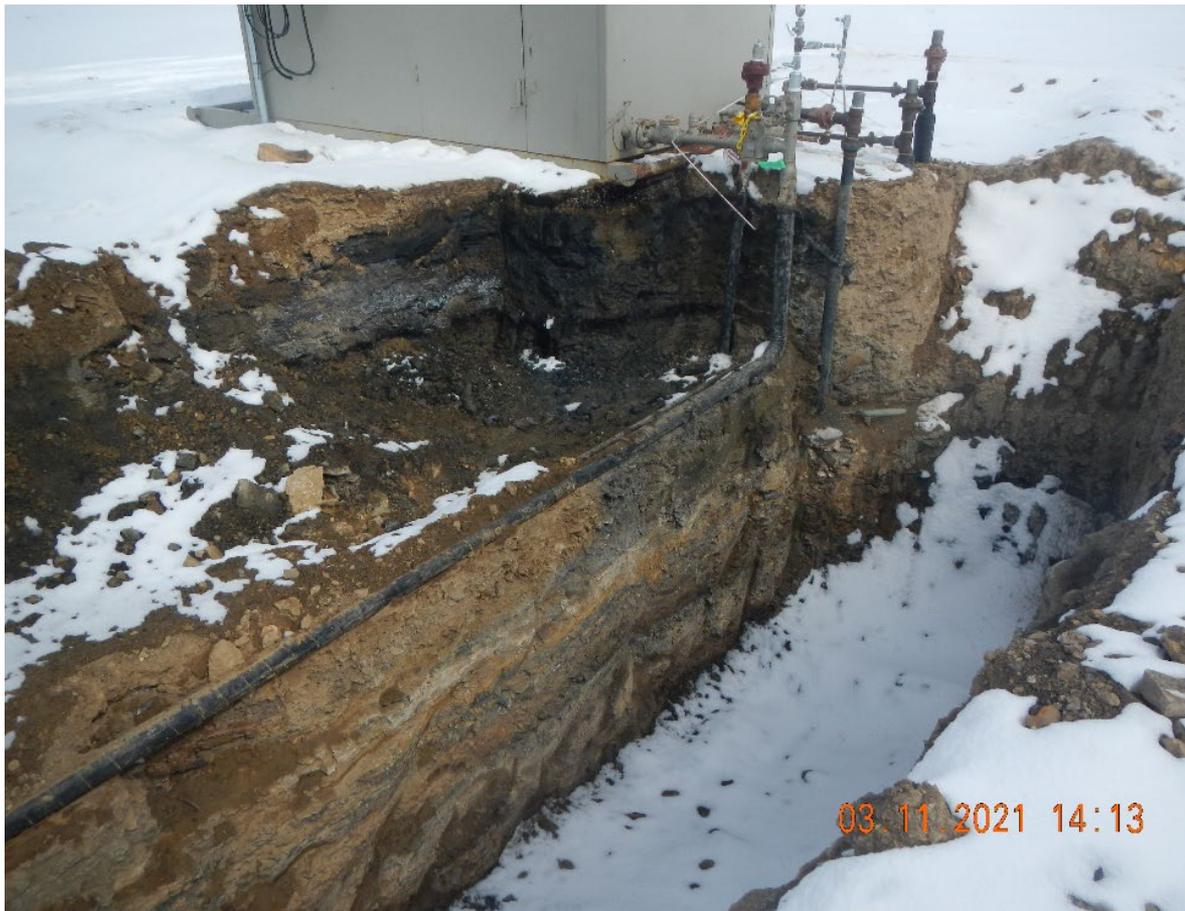
Photo #5 stained soil

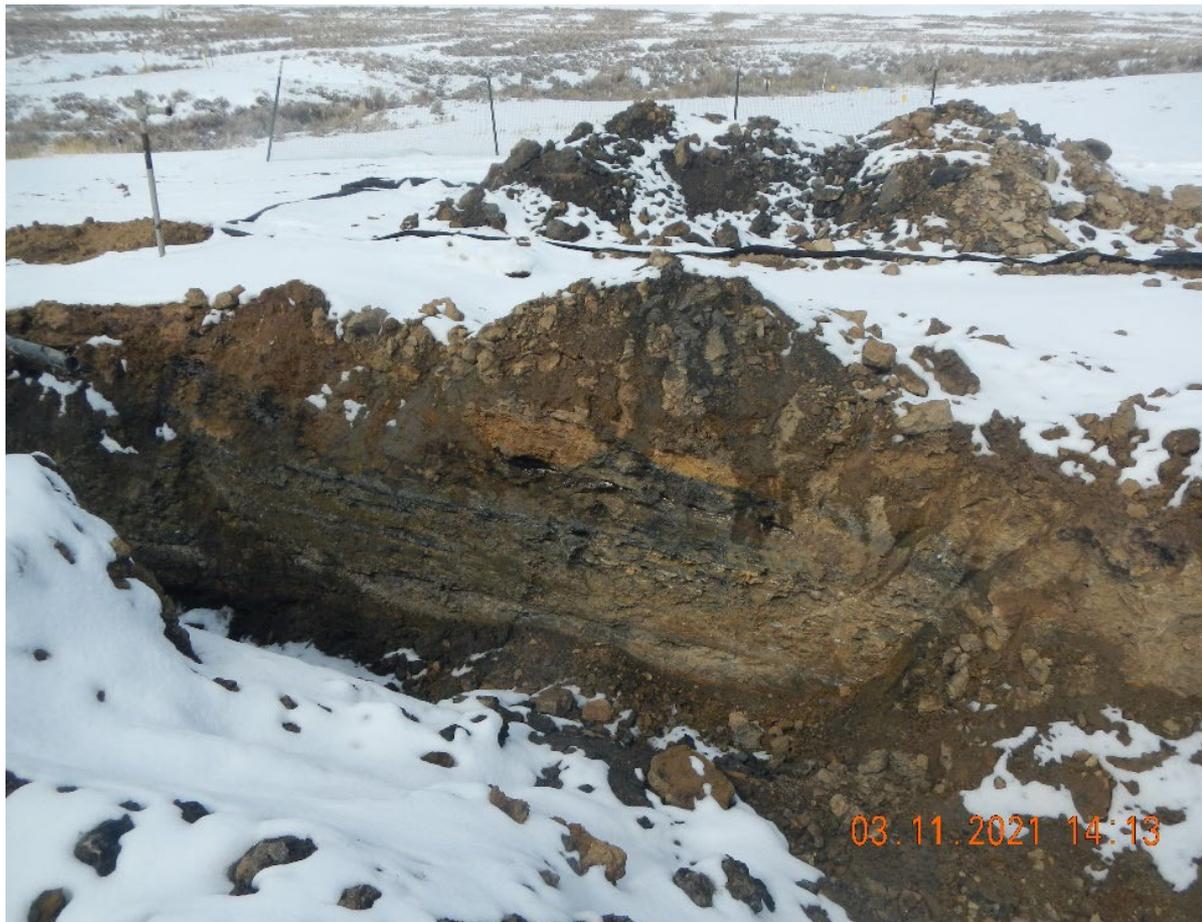
Photo #6 It appears there are shallow coal deposits that were exposed.

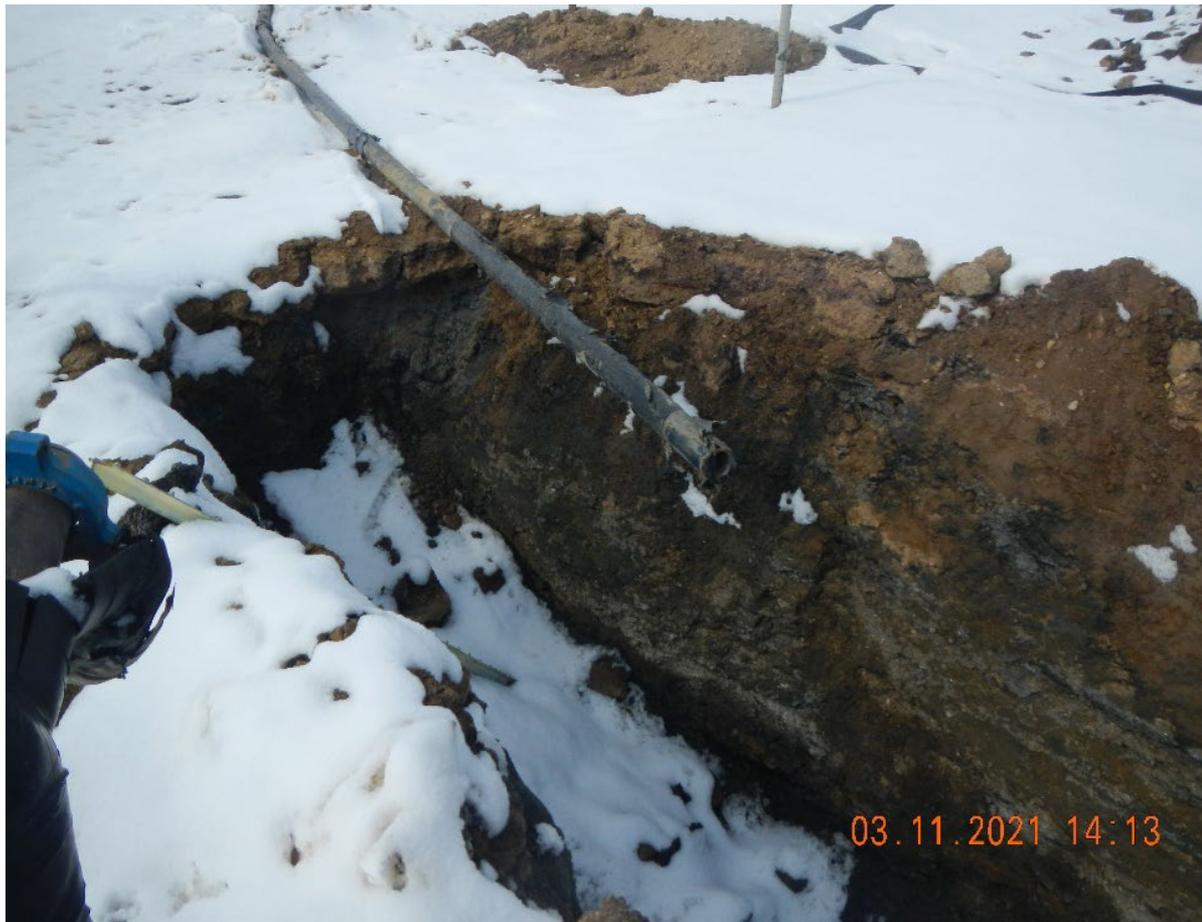
Photo #7 flowline to wellhead.

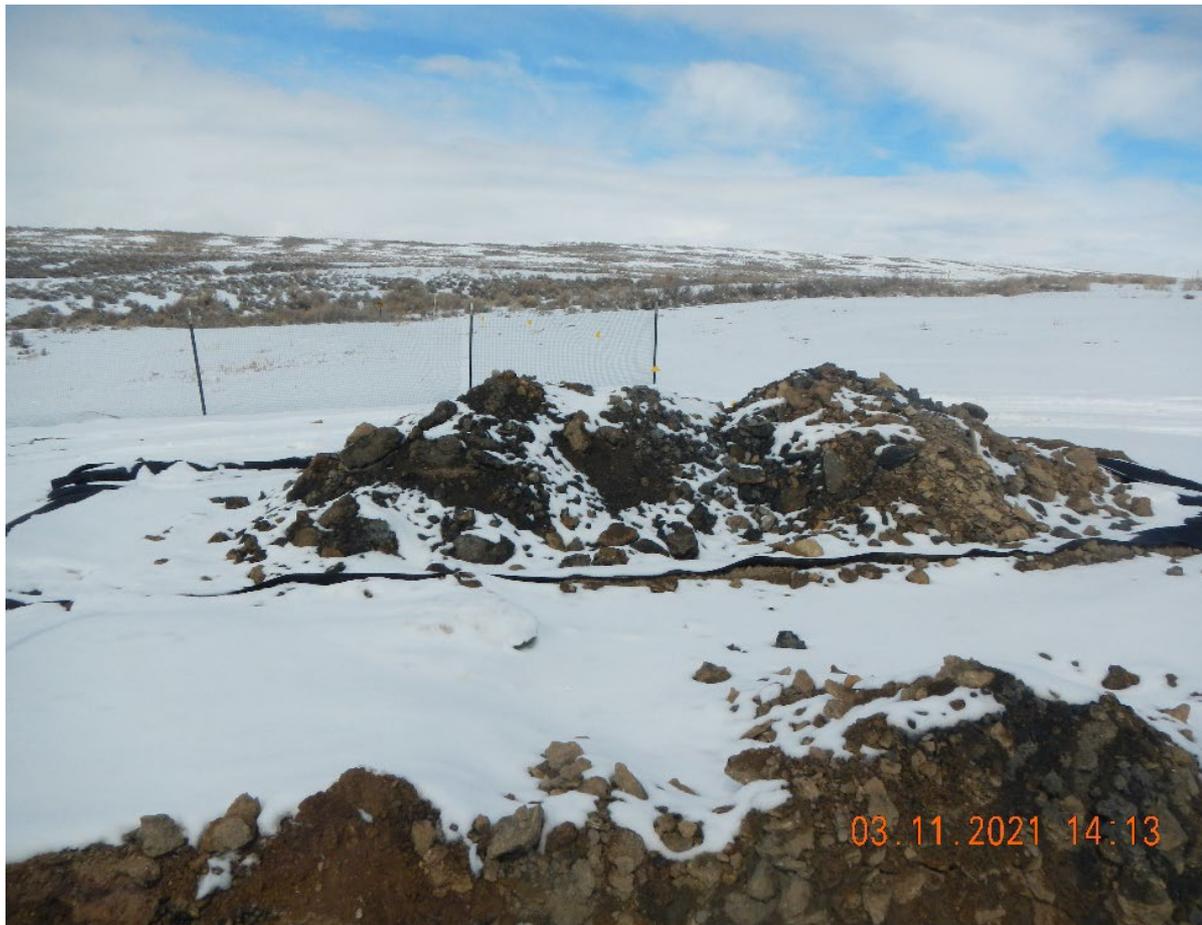
Photo #8 stockpiled soil from spill excavation.

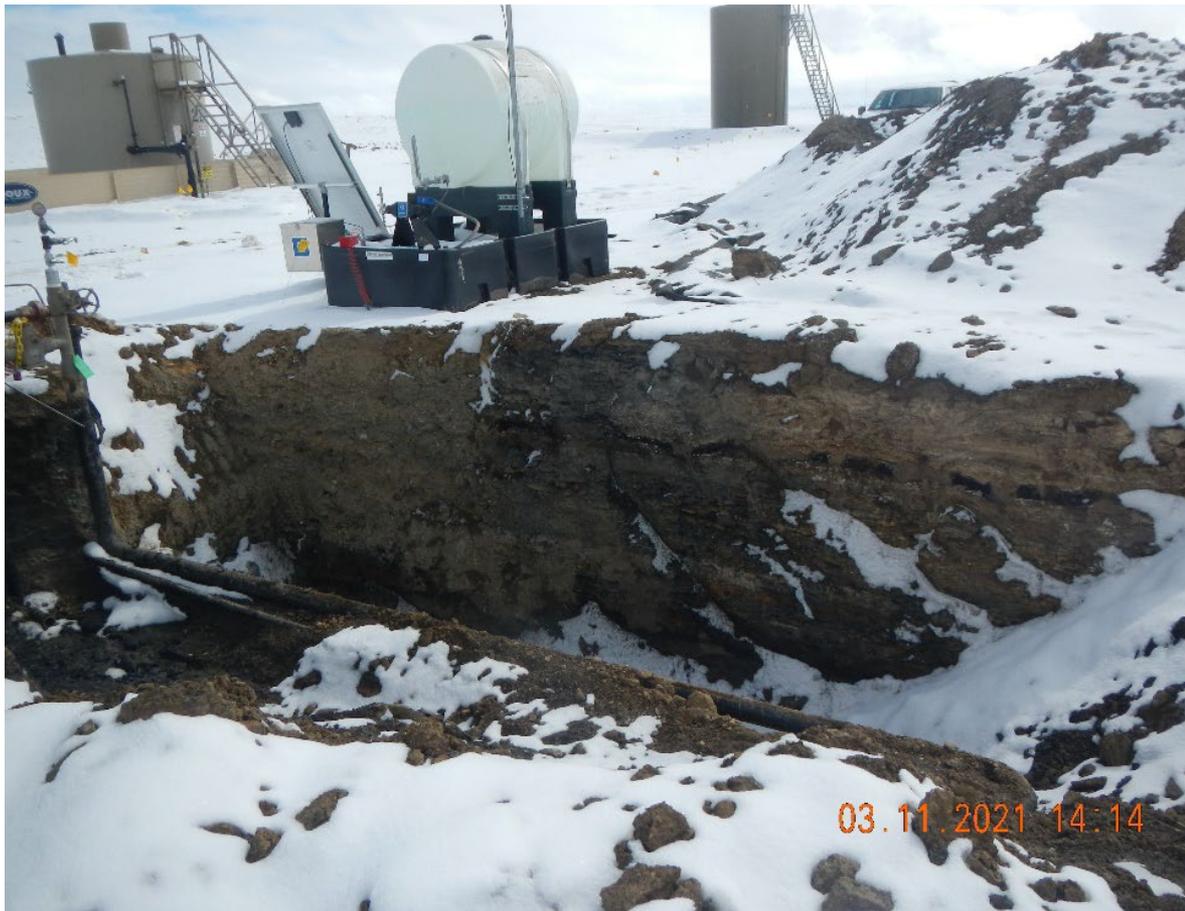
Photo #9 looking south
