Inspection Photos

Location Name: CAERUS PICEANCE LLC KNOX-68S96W /14SENW

Location ID: 334083

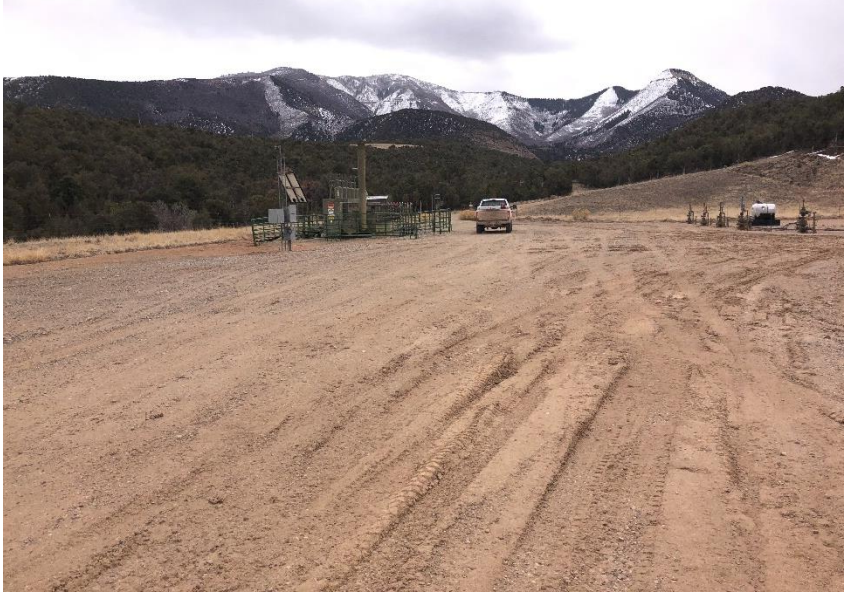
Photo #3276 from entrance to location.

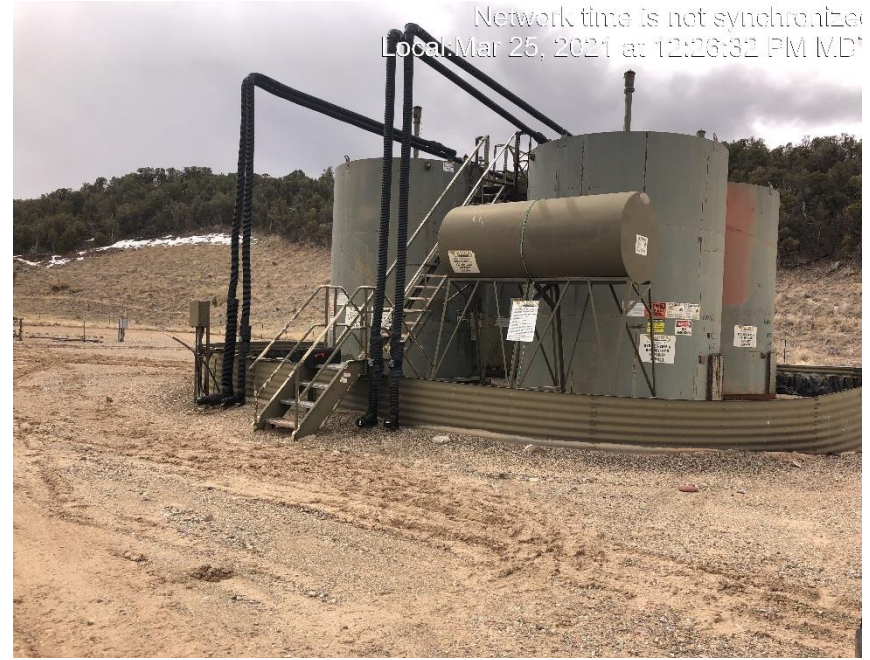
Photo #3277 from entrance to location

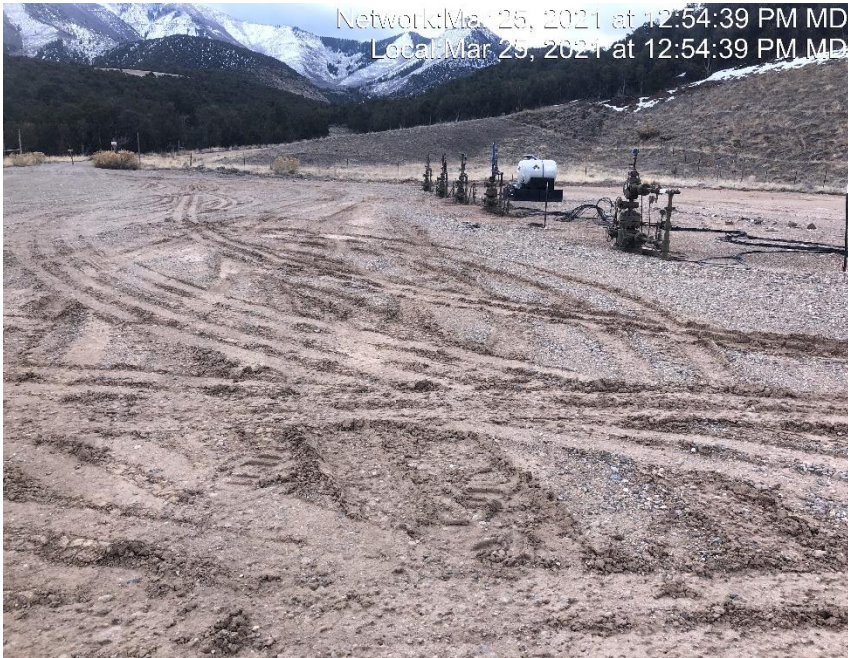
Photo #3278 Location lacks stabilization.

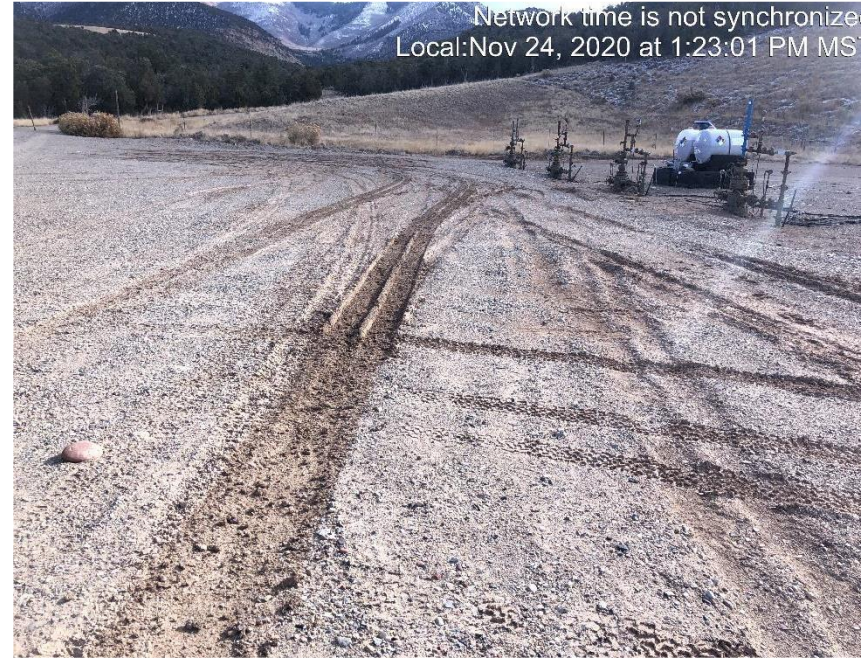
Photo #2326 from inspection #699802158 conducted on 11/24/20.

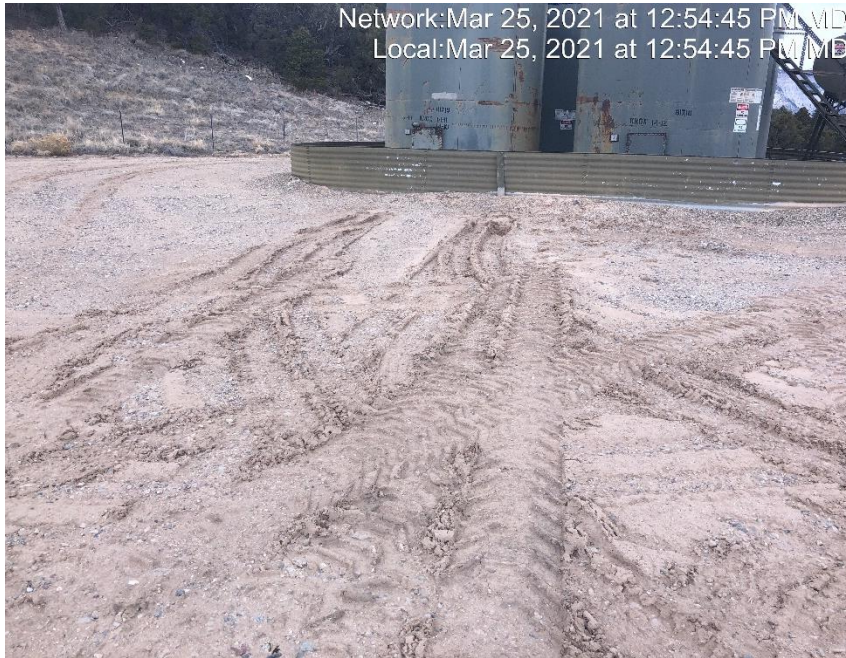
Photo #3279 Location lacks stabilization.

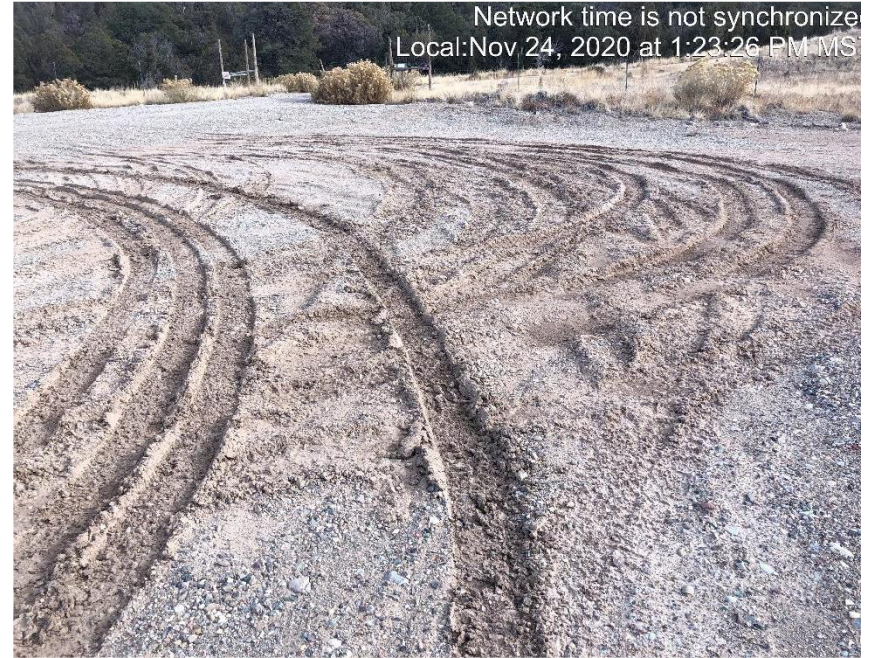
Photo #2327 from inspection #699802158 conducted on 11/24/20.

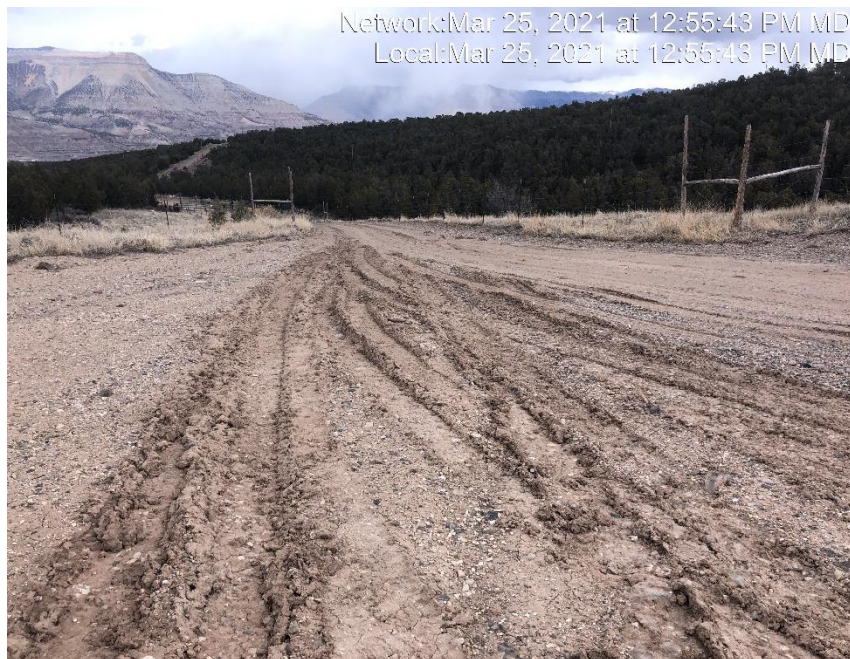
Photo #3280 No form of tracking control at entrance to location

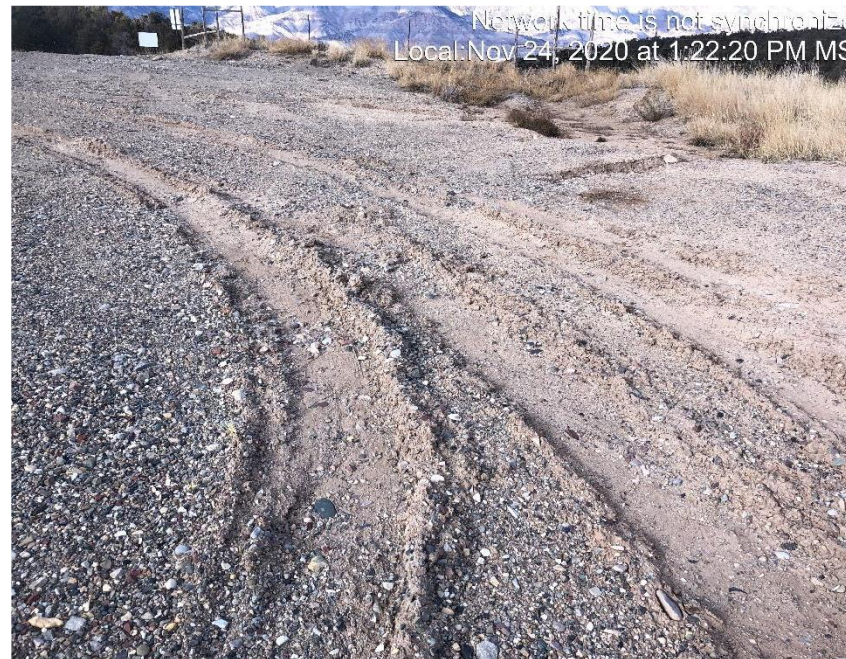
Photo #2325 from inspection #699802158 conducted on 11/24/20.
