Inspection Photos

Location Name: CAERUS PICEANCE LLC M. DUTTON 68S95W /7SWSW

Location ID: 334127

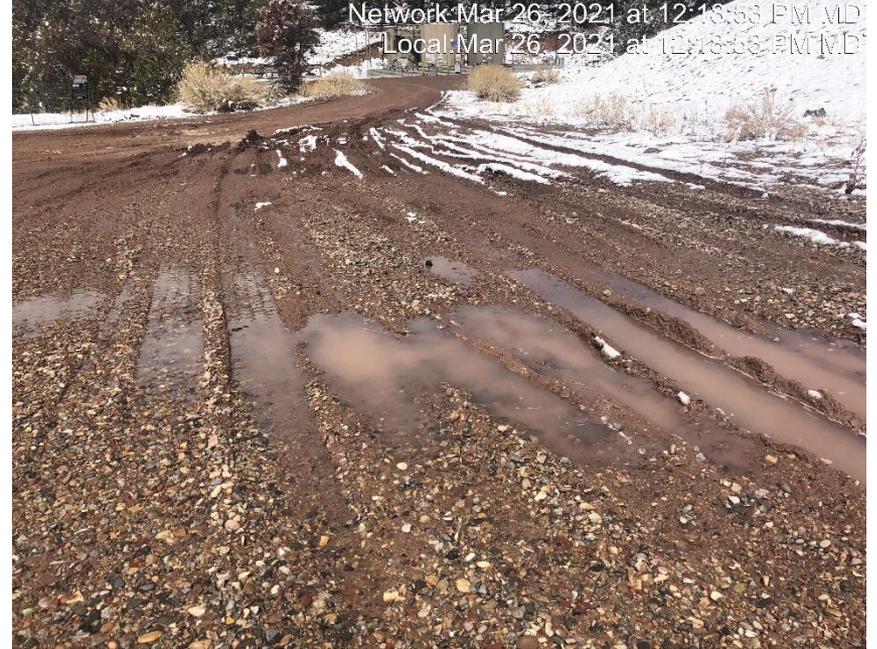
Photo #3307 Location lacks stabilization.

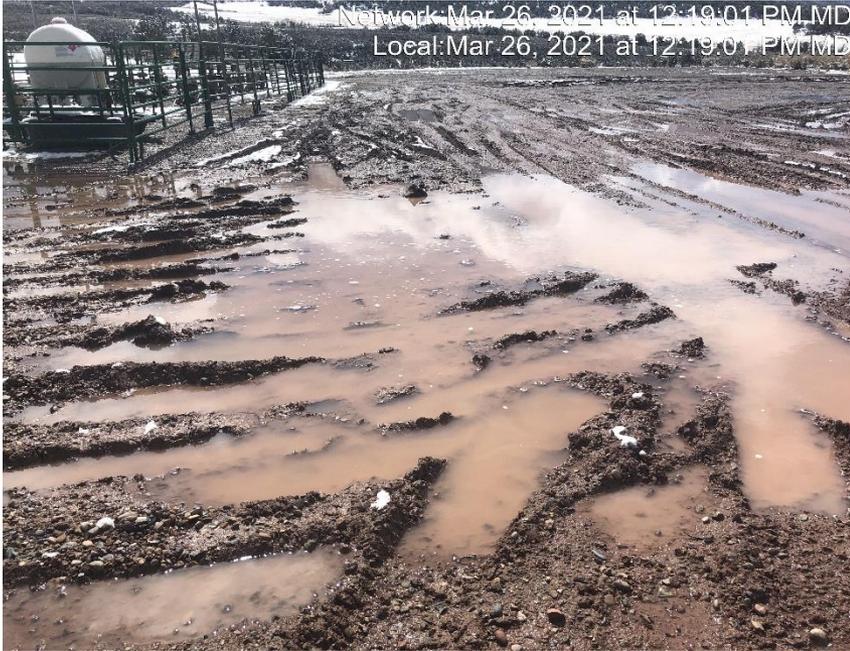
Photo #3308 Location lacks stabilization.

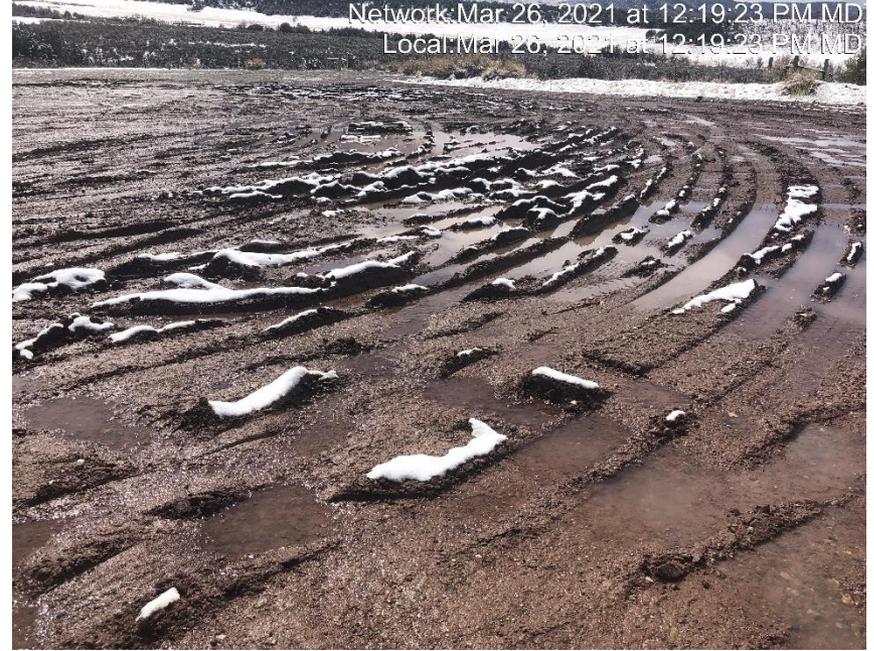
Photo #3309 Location lacks stabilization.

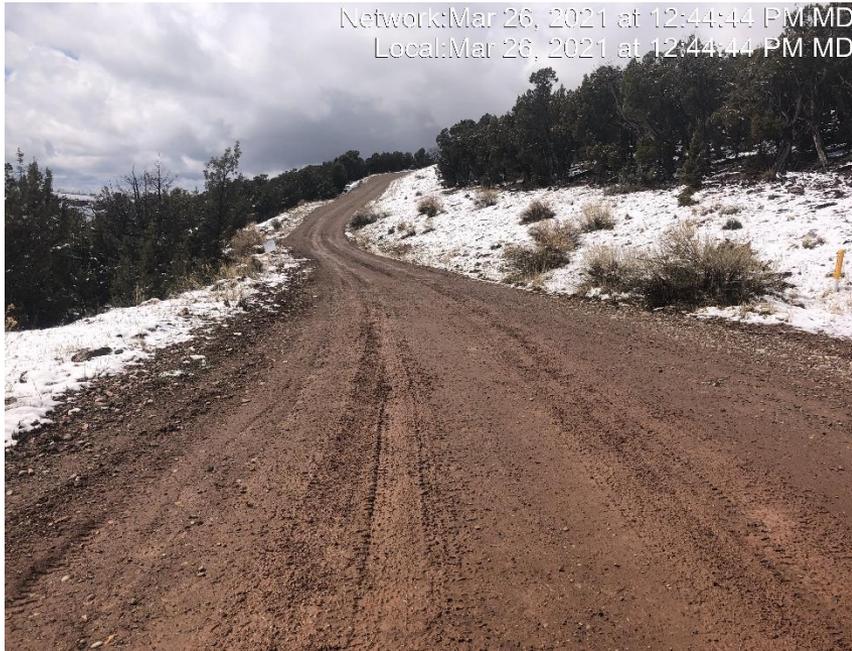
Photo #3310 No form of tracking control at entrance to location.
