# Inspection Photos

3/25/2021

Operator: TEP ROCKY MOUNTAIN LLC - 96850

Location ID: 475753

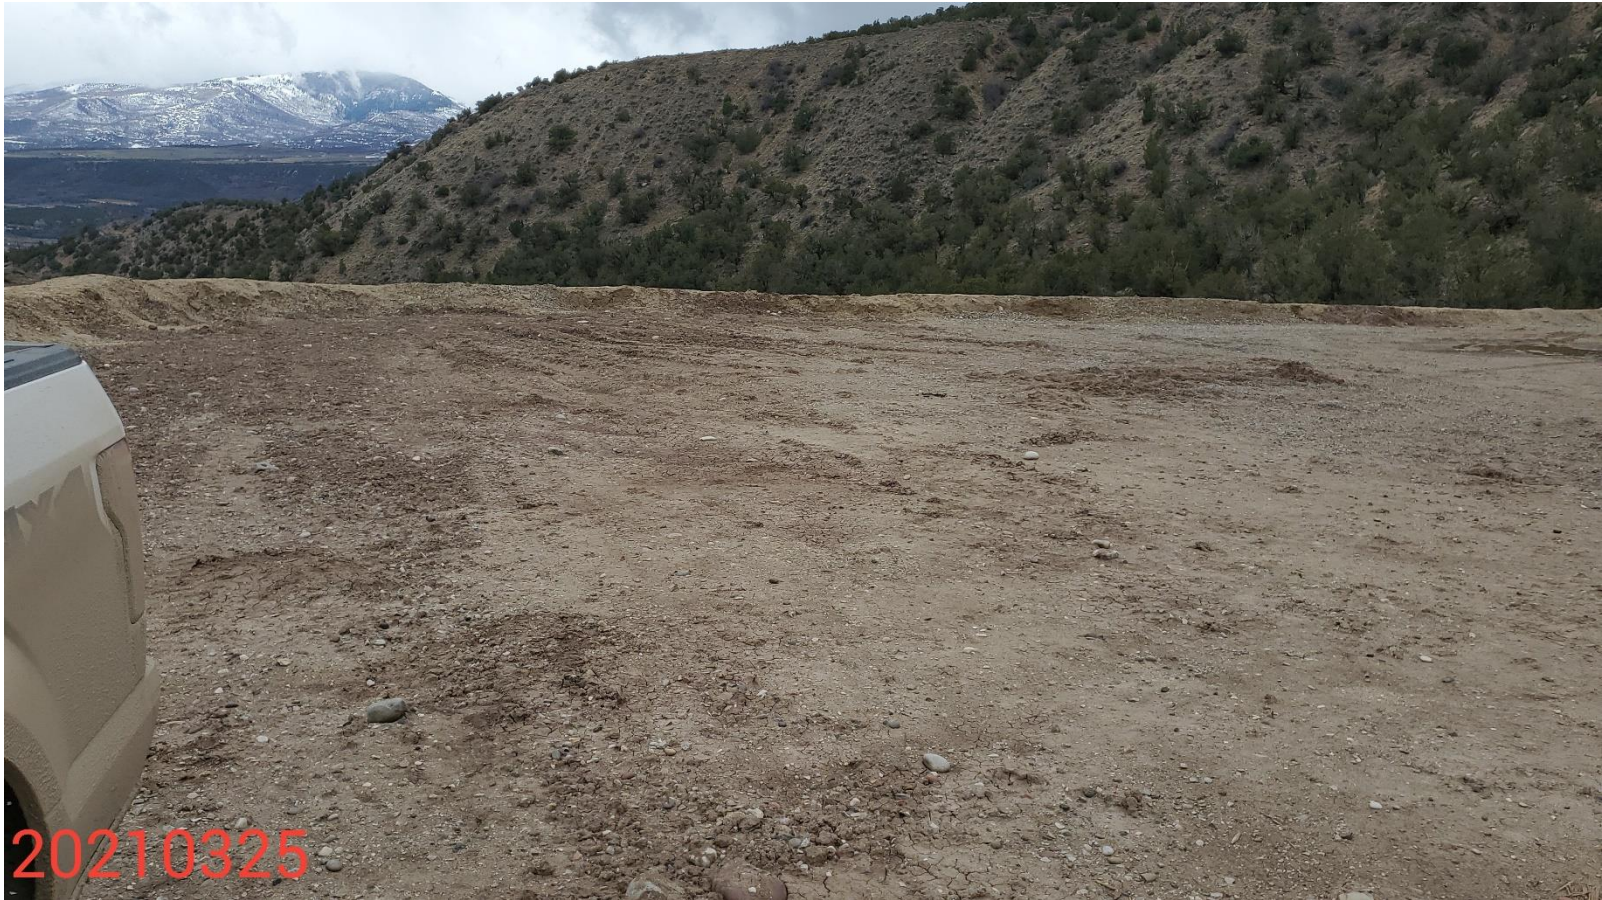
**Photo 1:** Photo taken from the eastern end of the Location, facing south. Photos 1-4 provide an overview of the Location from south, southwest, northwest to north.

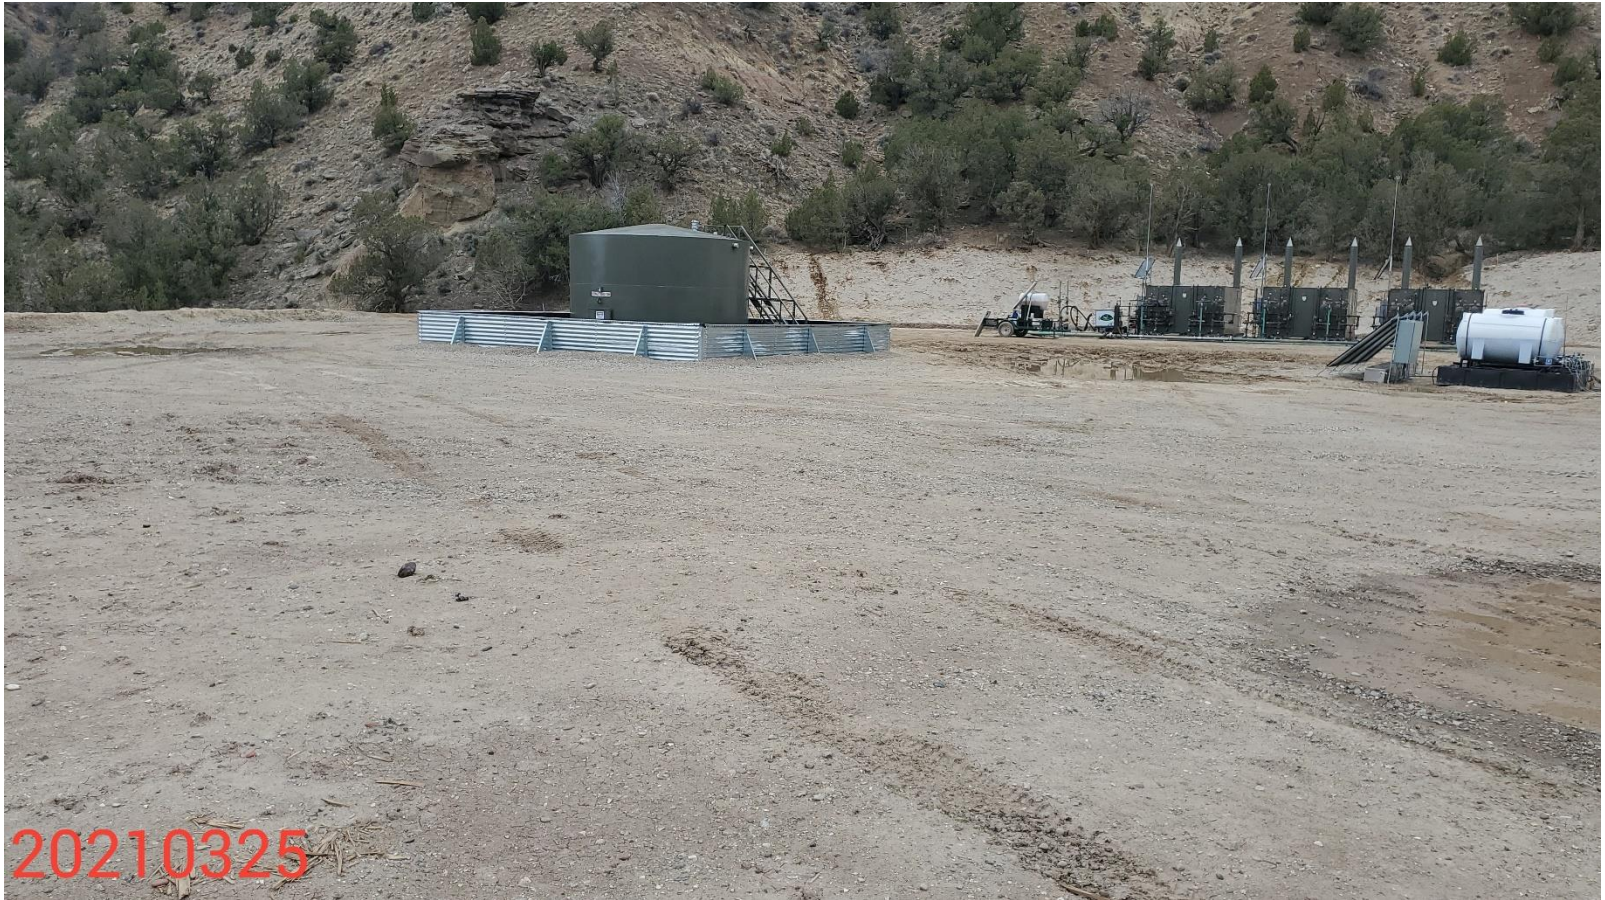
**Photo 2:** See comments under photo 1.

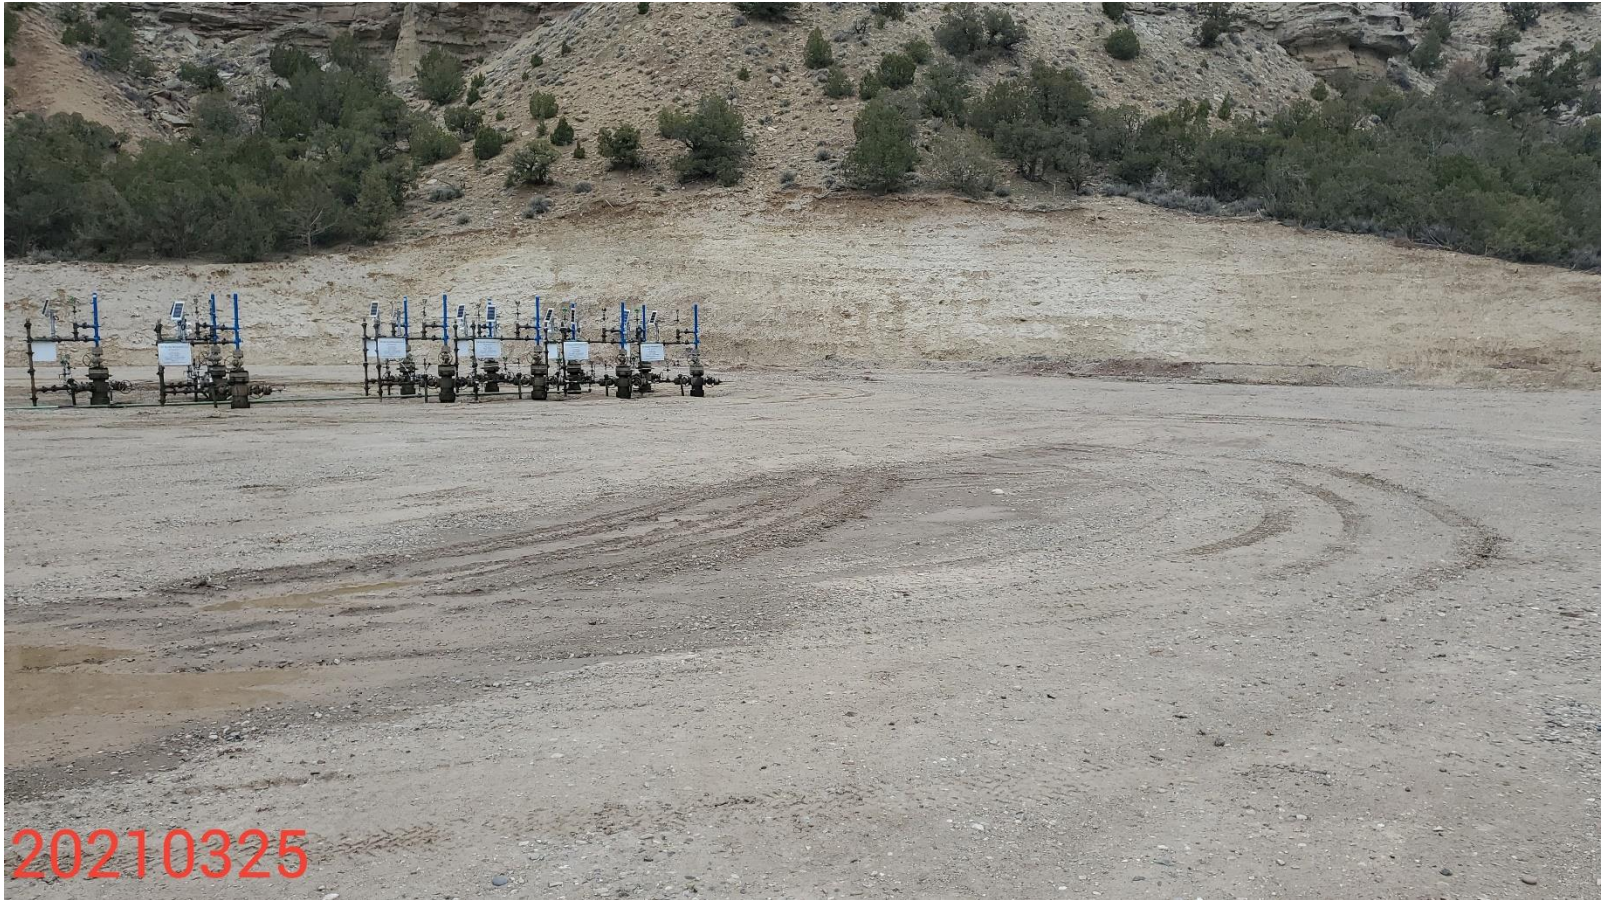
**Photo 3:** See comments under photo 1.

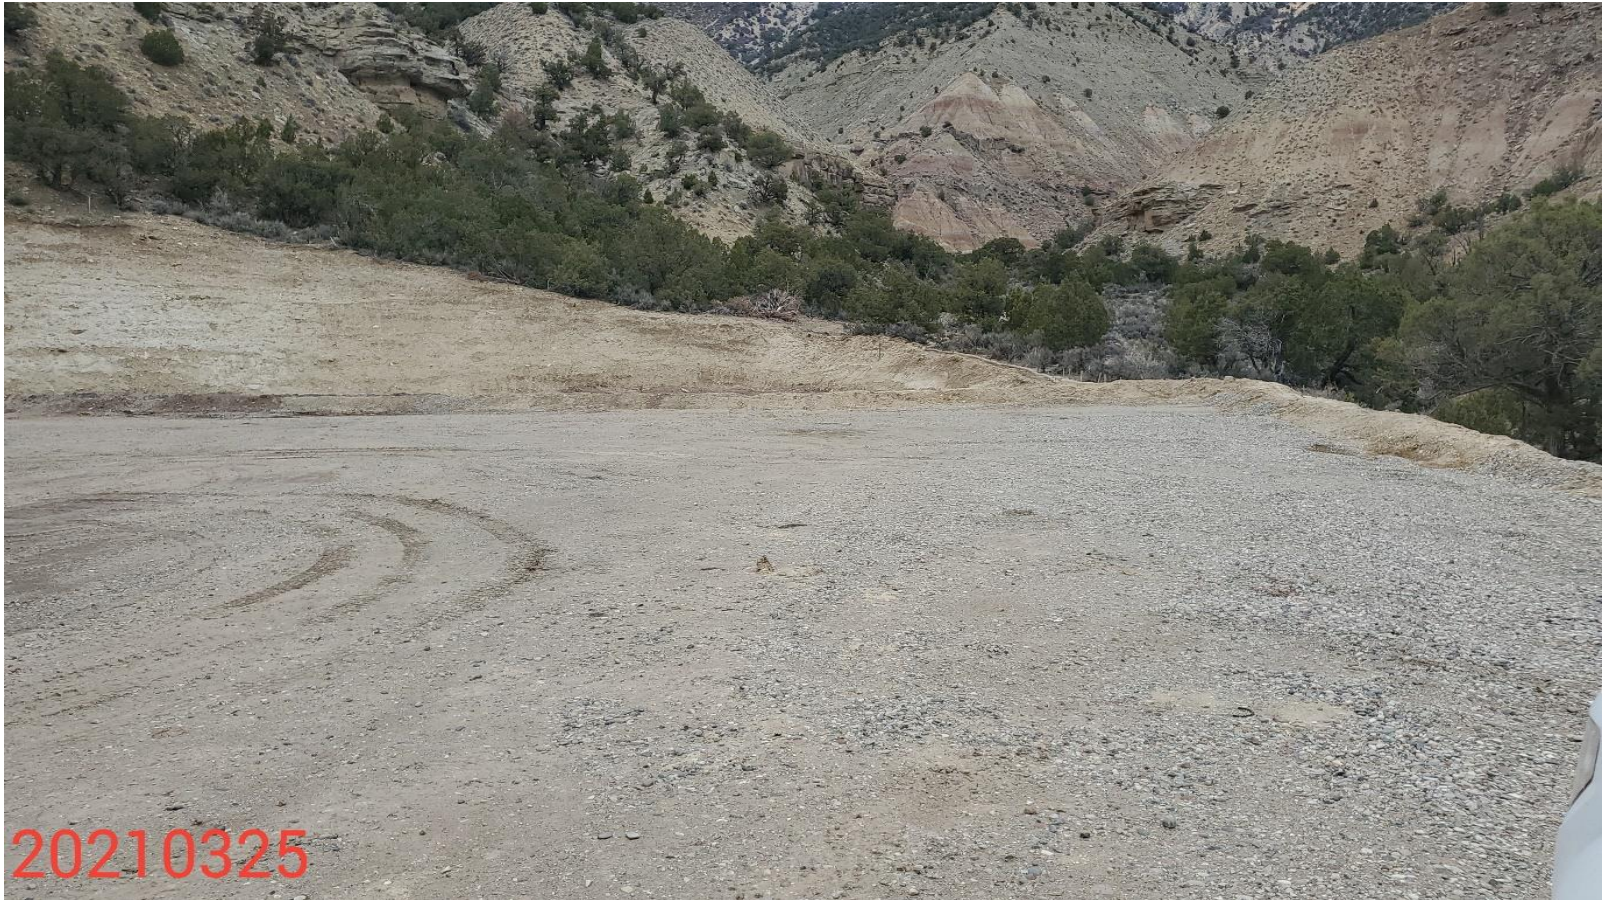
**Photo 4:** See comments under photo 1.

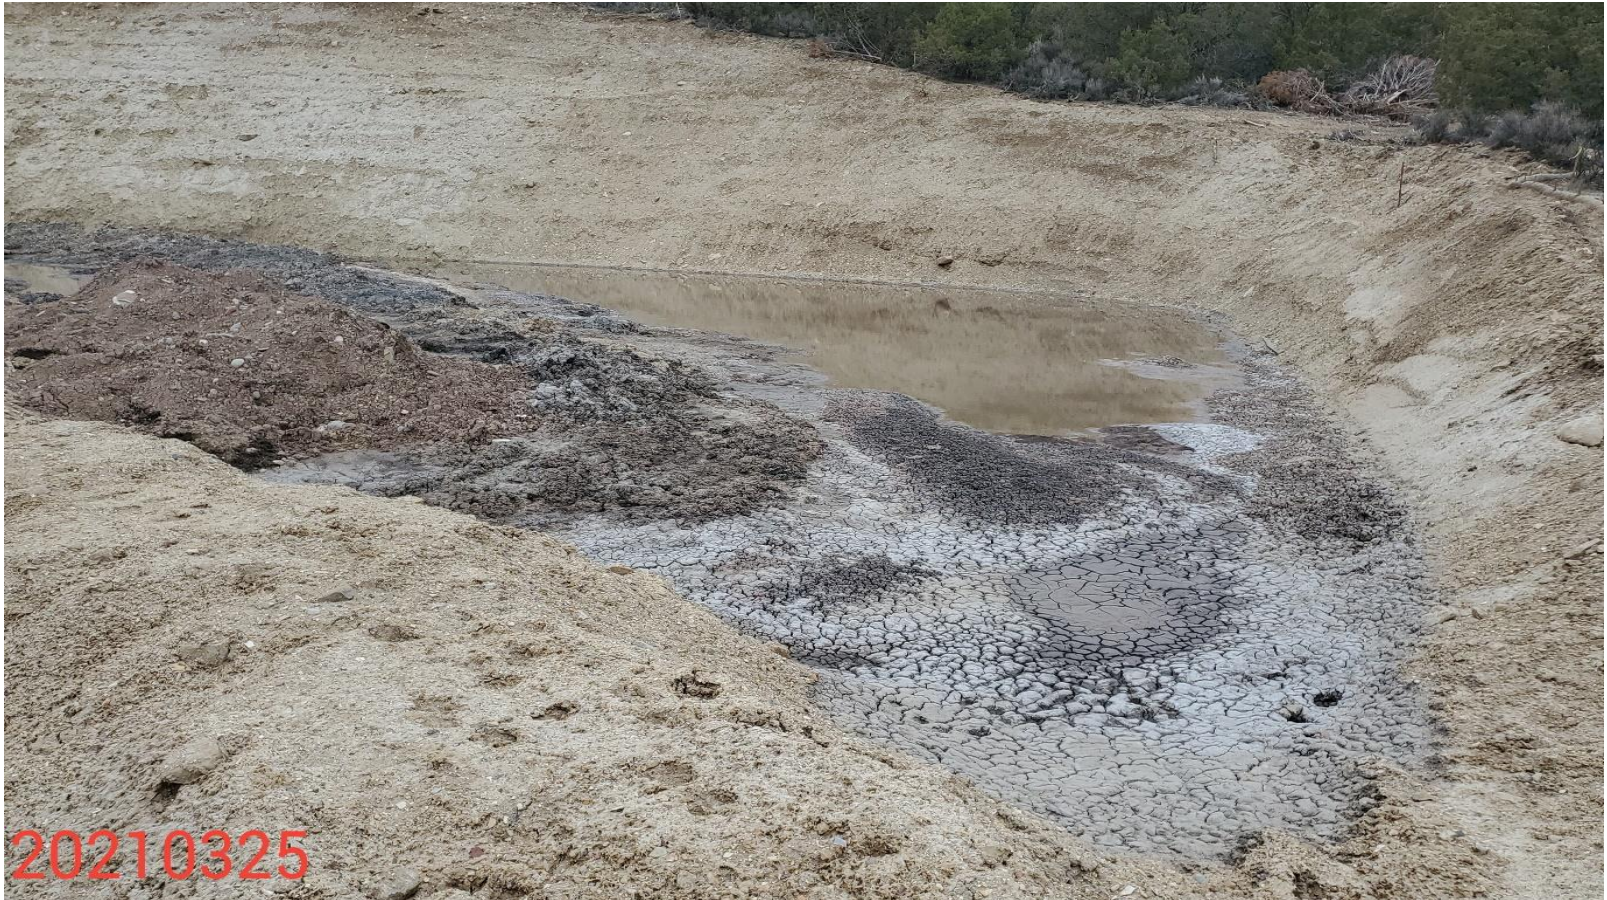
**Photo 5:** Photo taken from the northeast end of the Location, facing north. Photo shows drill pit. Interim reclamation of the Location due; pit will require closure in accordance with 900 series rules.

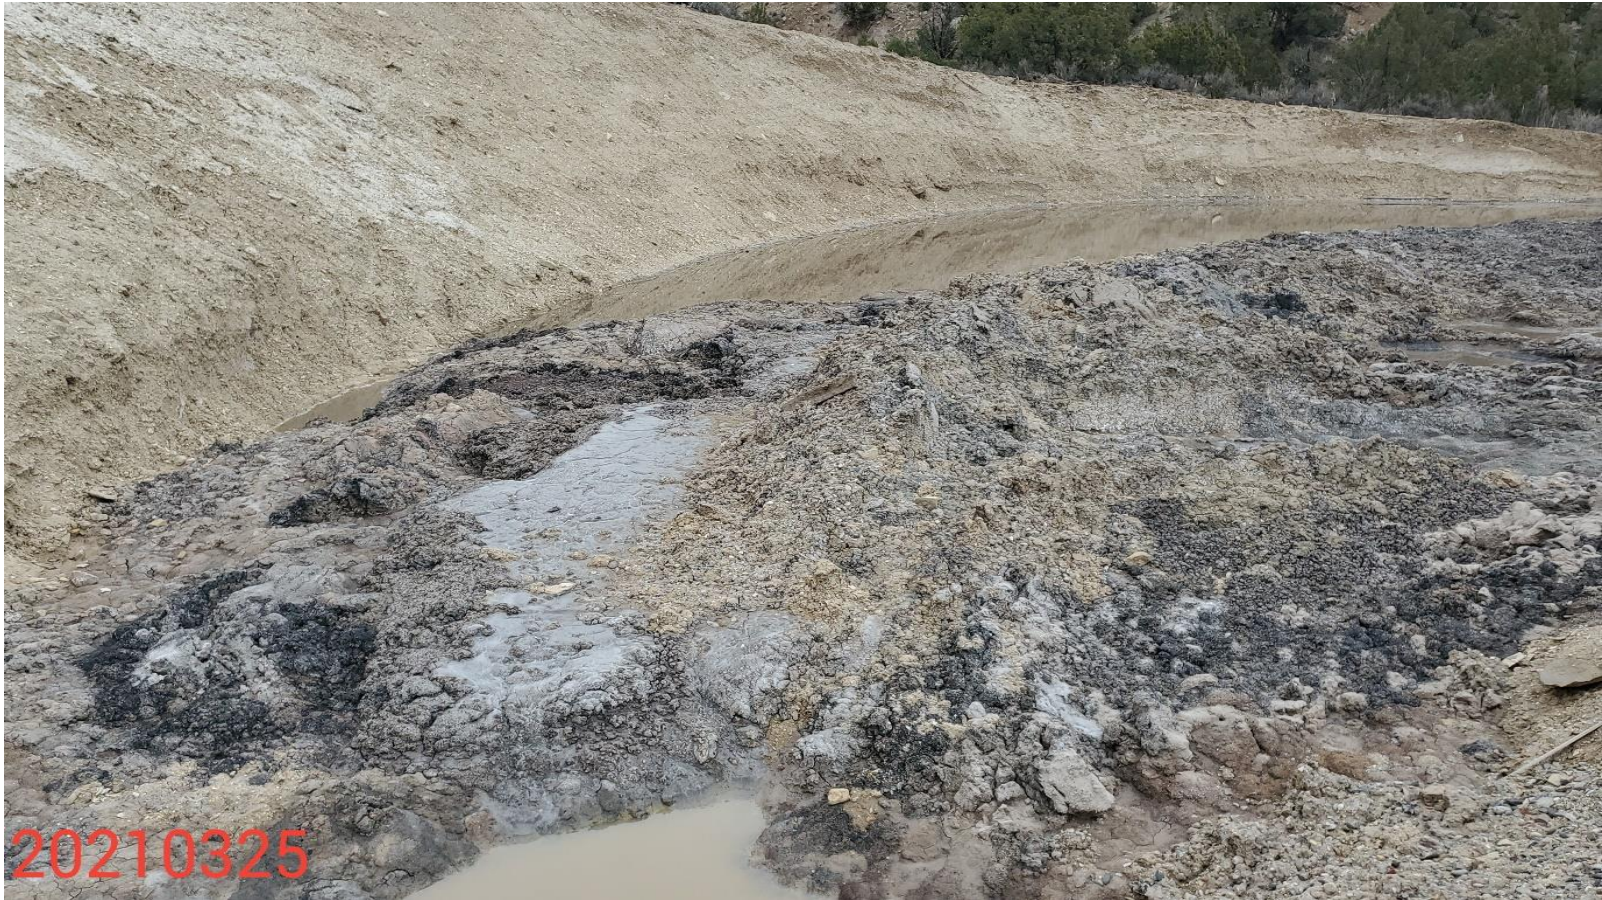
**Photo 6:** Photo taken from the northwest end of the Location, facing northeast. Photo shows drill pit. Interim reclamation of the Location due; pit will require closure in accordance with 900 series rules.

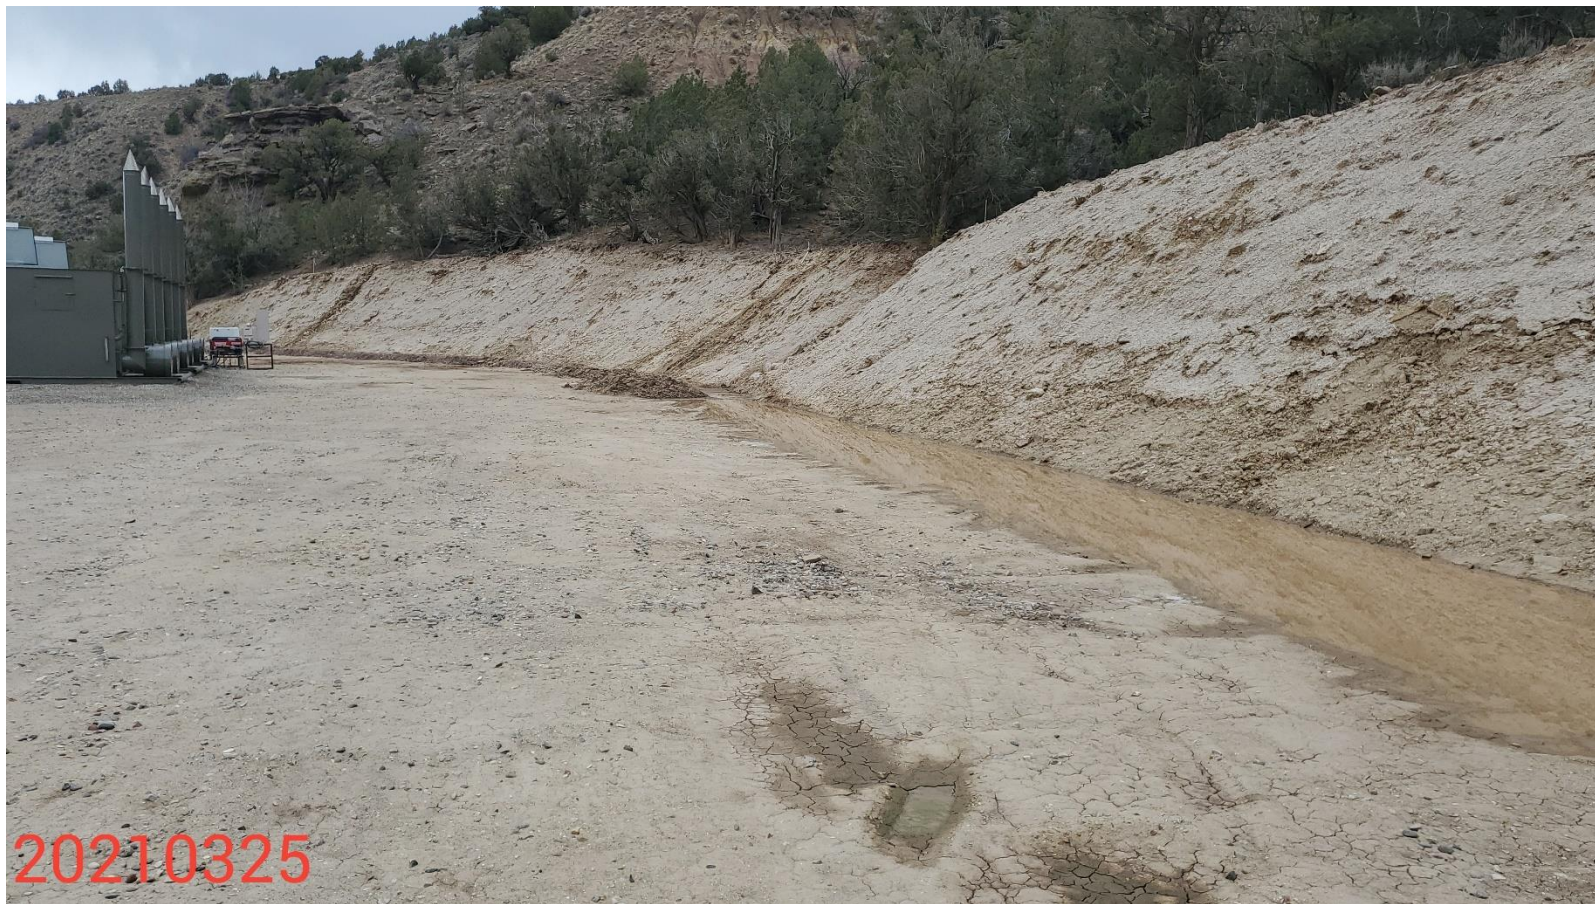
**Photo 7:** Photo taken from the northwest end of the Location, facing south. Photo shows stormwater ditch on the west end of the pad has filled with sediment, and is no longer in proper functioning condition. Photo also shows that a berm has been installed along a portion of the ditch.

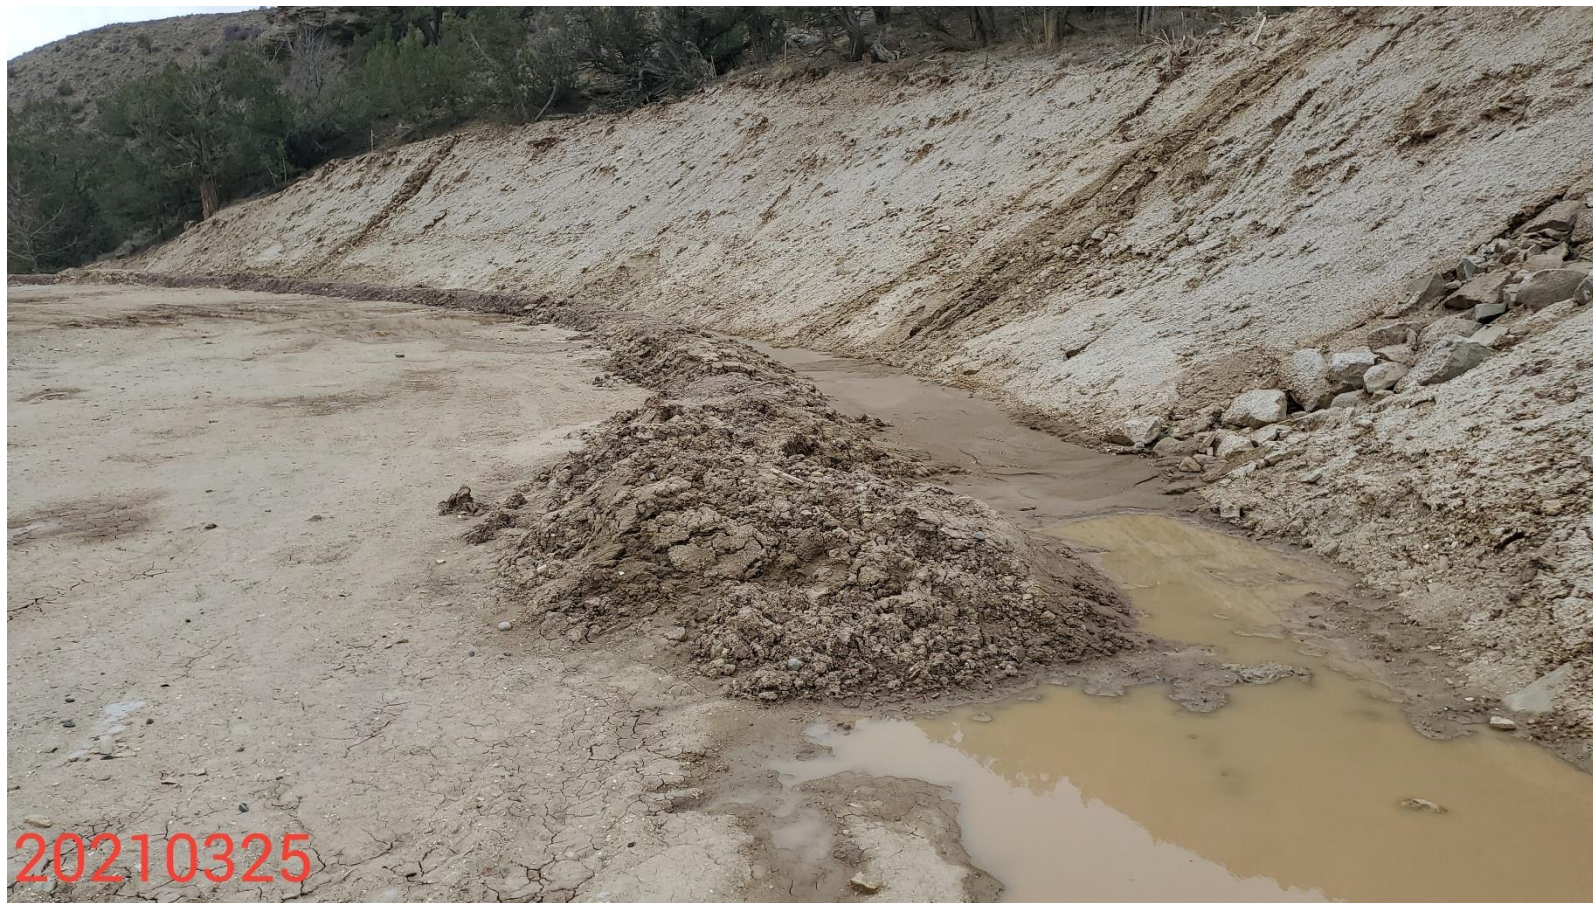
**Photo 8:** Photo taken from the west end of the Location, facing south. Photo shows stormwater ditch on the west end of the pad has filled with sediment, and is no longer in proper functioning condition. Photo also shows that a berm has been installed along a portion of the ditch; berm has not been installed in accordance with good engineering practices; berm has not been properly compacted.

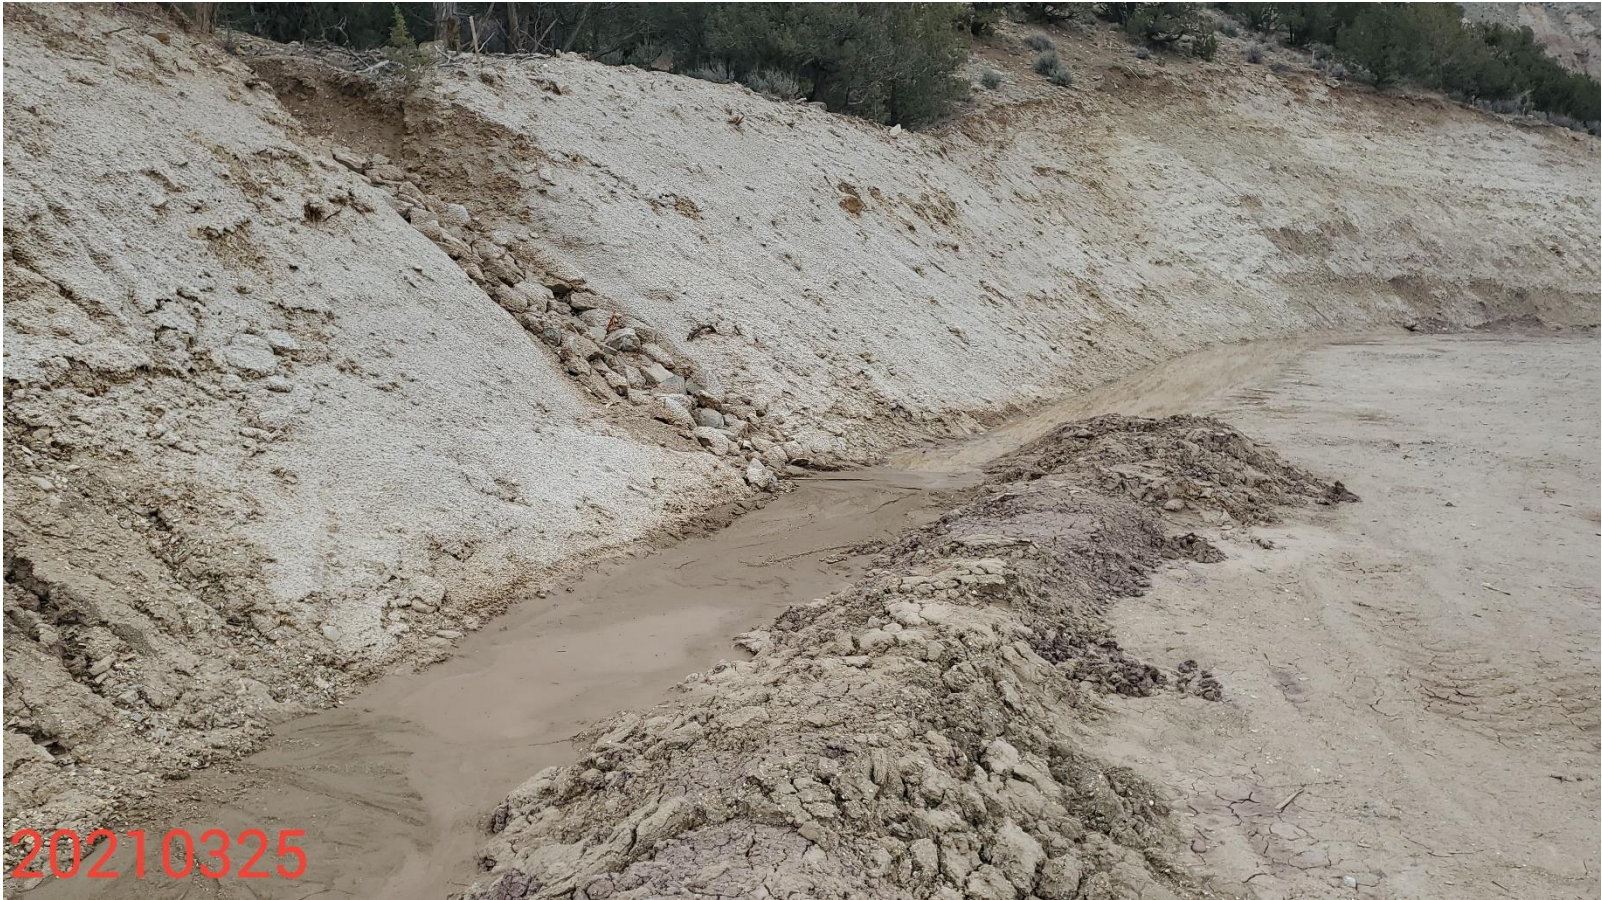
**Photo 9:** See comments under photo 8 regarding ditch and berm. Photo also shows that control measures to properly manage run-on, and to stabilize protect the slopes of the Location remain missing, insufficient or inadequate.

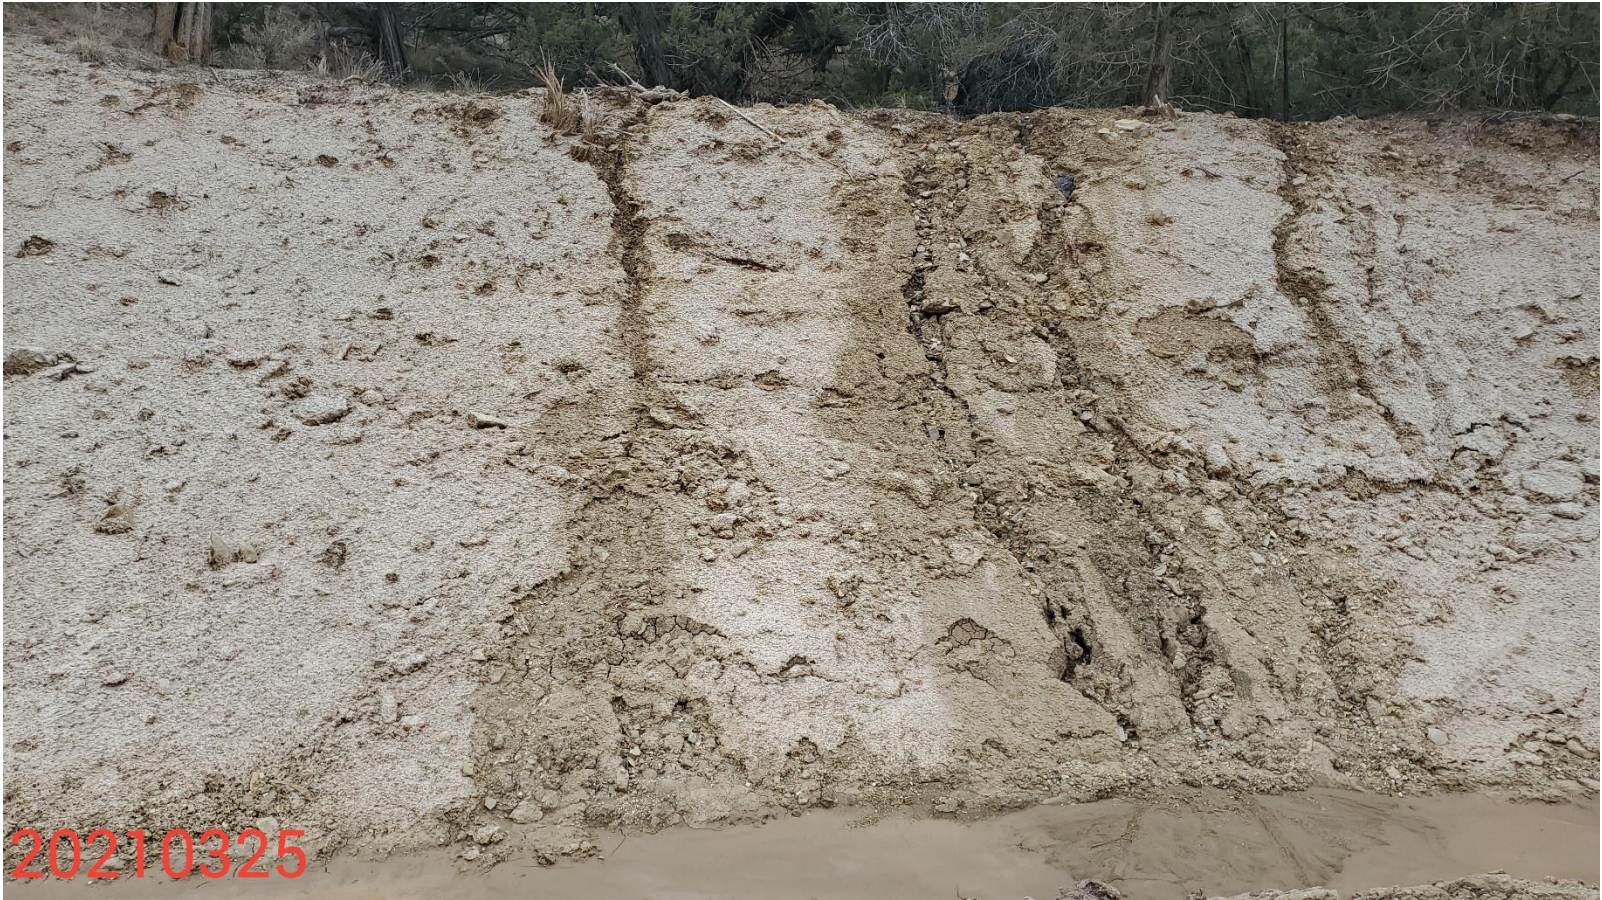
**Photo 10:** Photo taken from the cut slopes on the west end of the Location. Photo shows that control measures to properly manage run-on, and to stabilize protect the slopes of the Location remain missing, insufficient or inadequate. Sediment has filled the ditch.

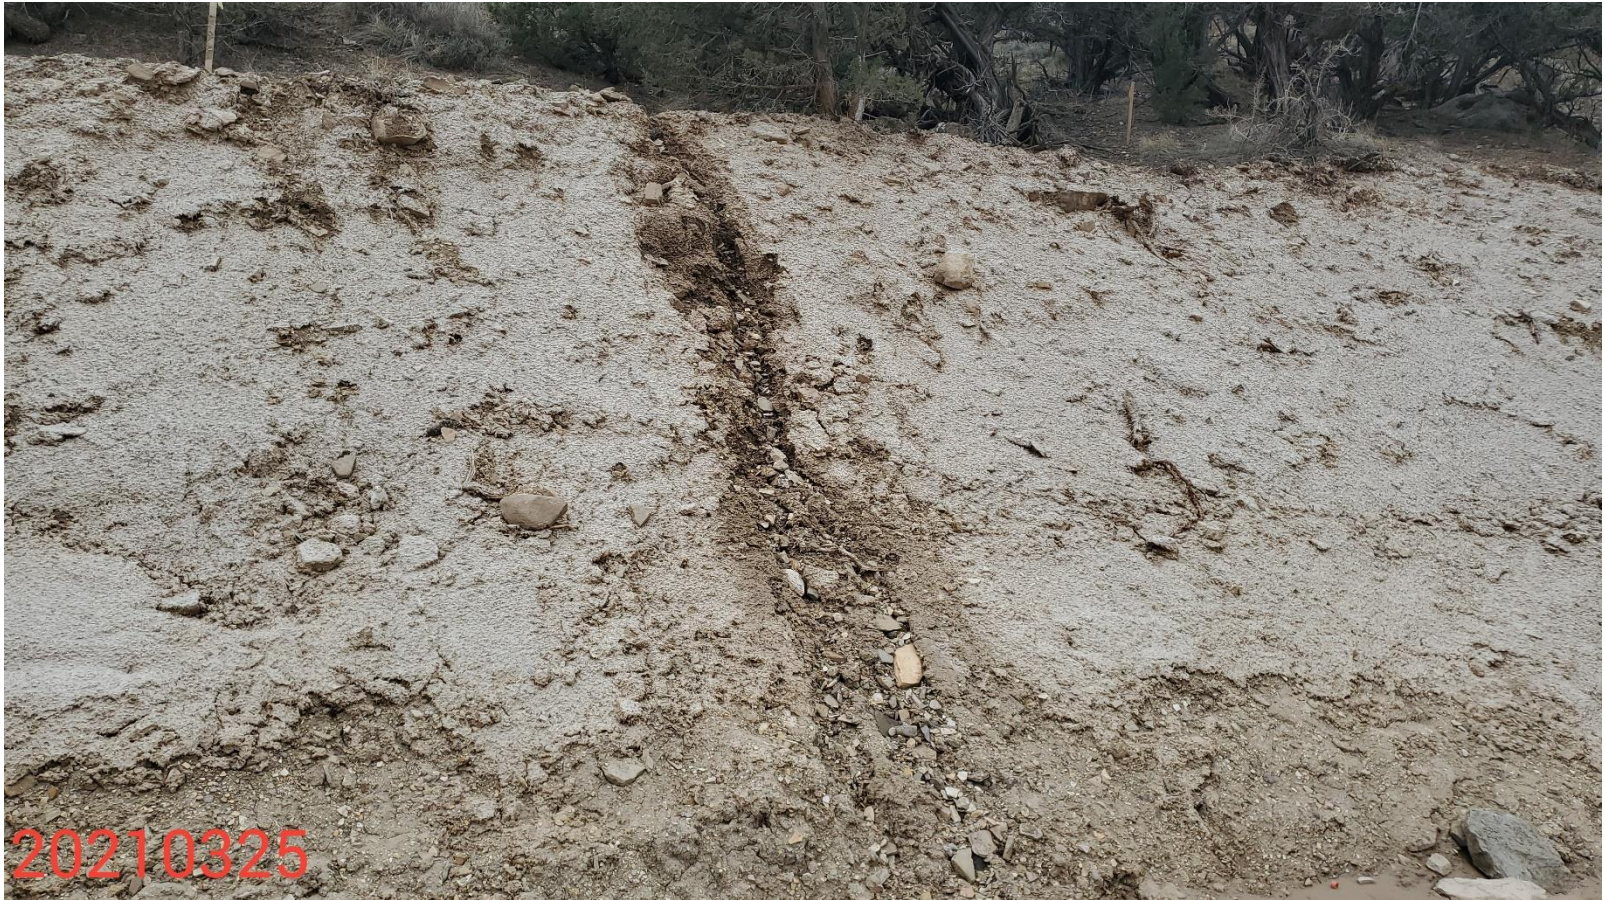
**Photo 11:** Photo taken from the cut slopes on the west end of the Location. Photo shows that control measures to properly manage run-on, and to stabilize protect the slopes of the Location remain missing, insufficient or inadequate.

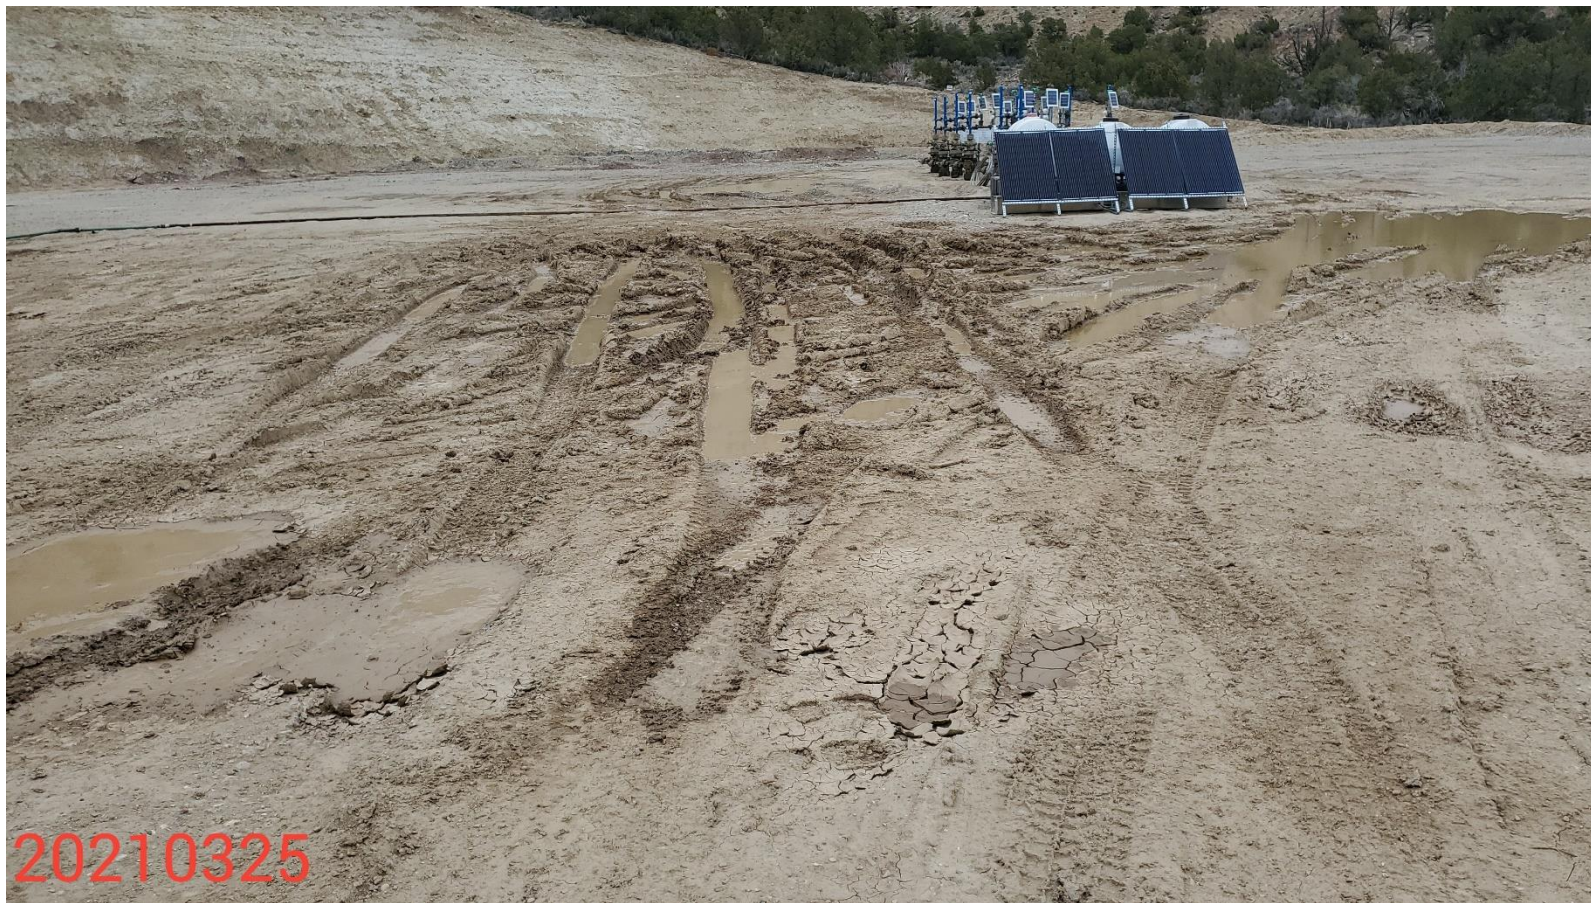
**Photo 12:** Photo taken from the Location, facing north. Photo shows control measures to stabilize/protect unpaved areas of the Location are missing or insufficient

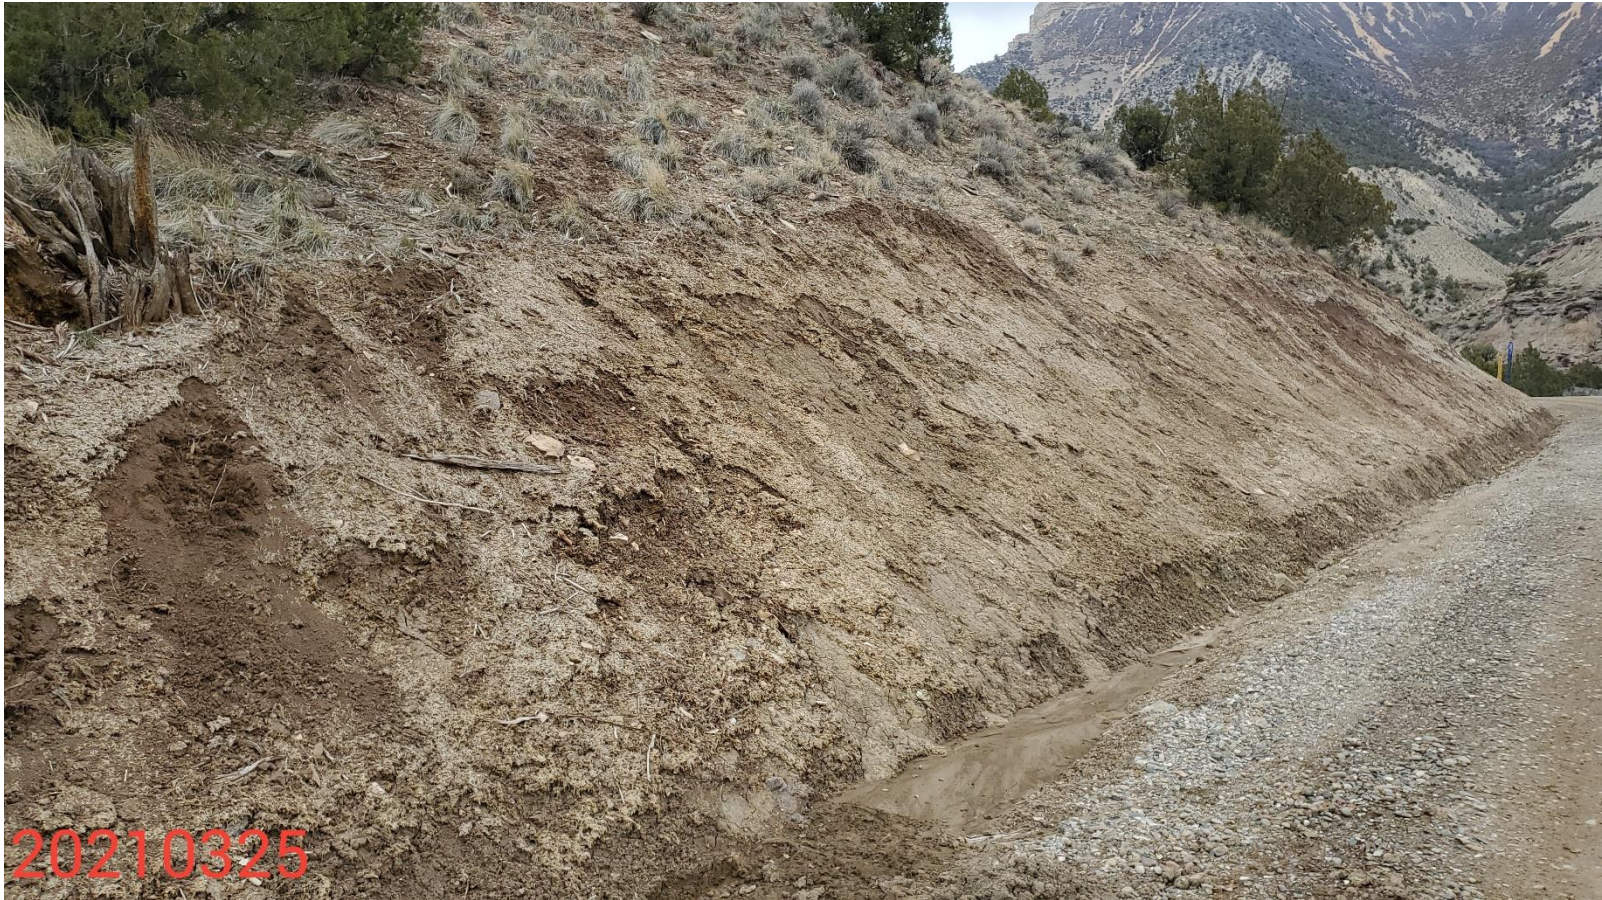
**Photo 13:** Photo taken from the access road south of the Location, facing north. Photo shows that the hydromulch applied to the slopes are degrading, and are no longer in proper functioning condition. Degradation evident. BMP alone insufficient to manage run-on and stabilize/protect slopes.

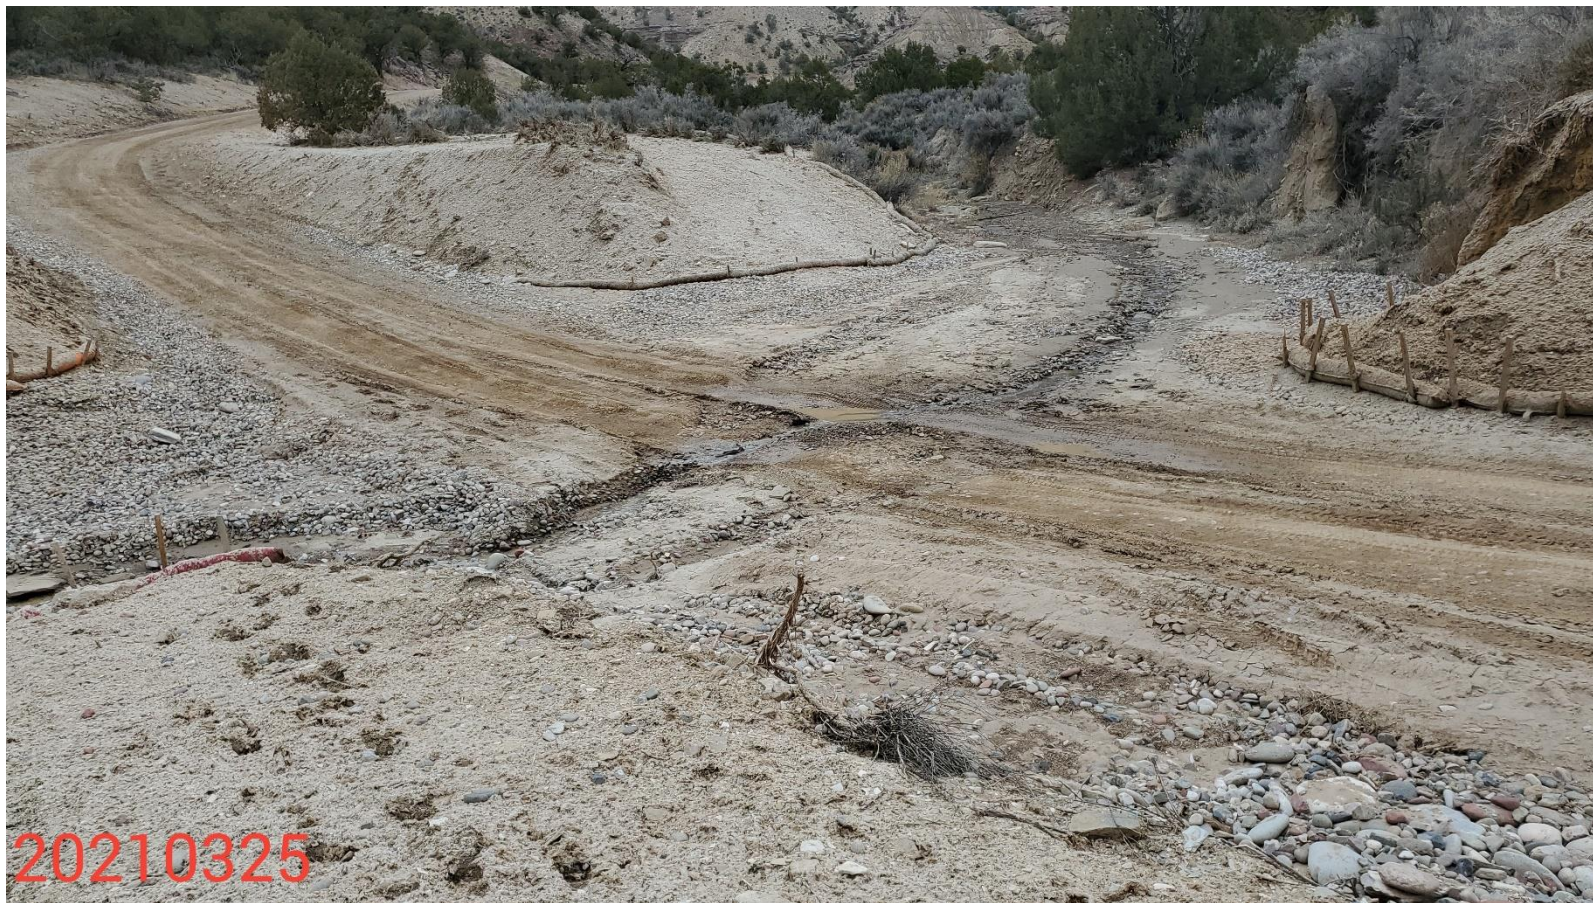
**Photo 14:** Photo taken from the access road at the stream crossing, facing north. Photo shows proper BMPs per good engineering practices remain missing, or insufficient to stabilize access road at stream crossing, and protect stream/waters of the state; Head cutting and sediment laden discharge observed.

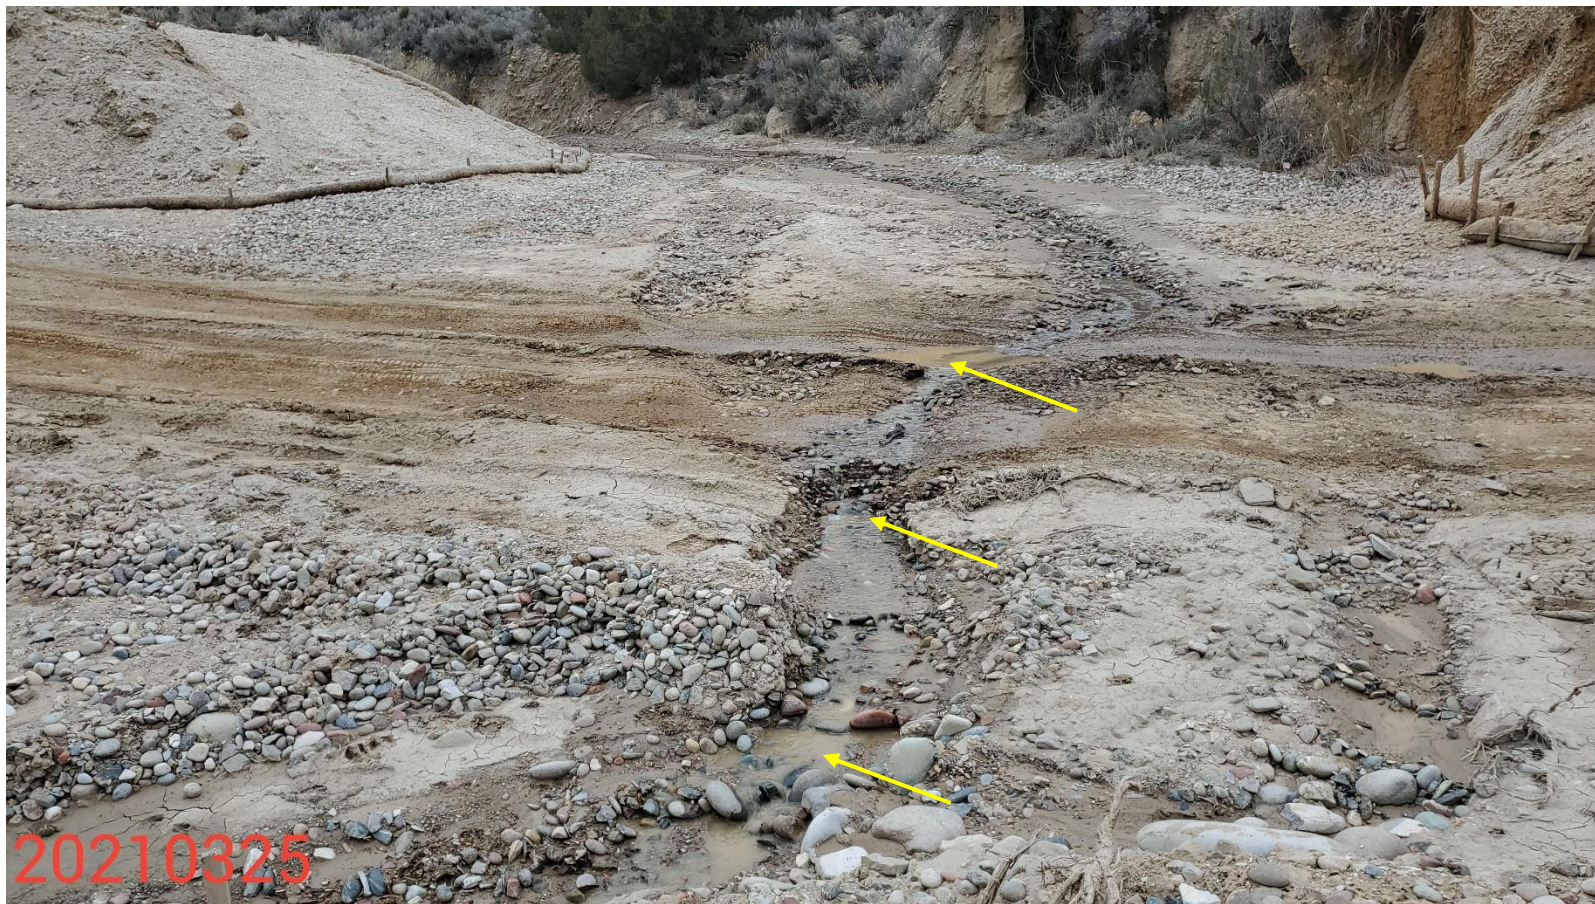
**Photo 15:** Continued from photo 14. Photo shows headcutting/degradation evident within the stream crossing. Photo also shows sediment discharge into the stream/waters of the state occurring at the stream crossing.
