# Inspection Photos

3/25/2021

Operator: TEP ROCKY MOUNTAIN LLC - 96850

Location ID: 475753

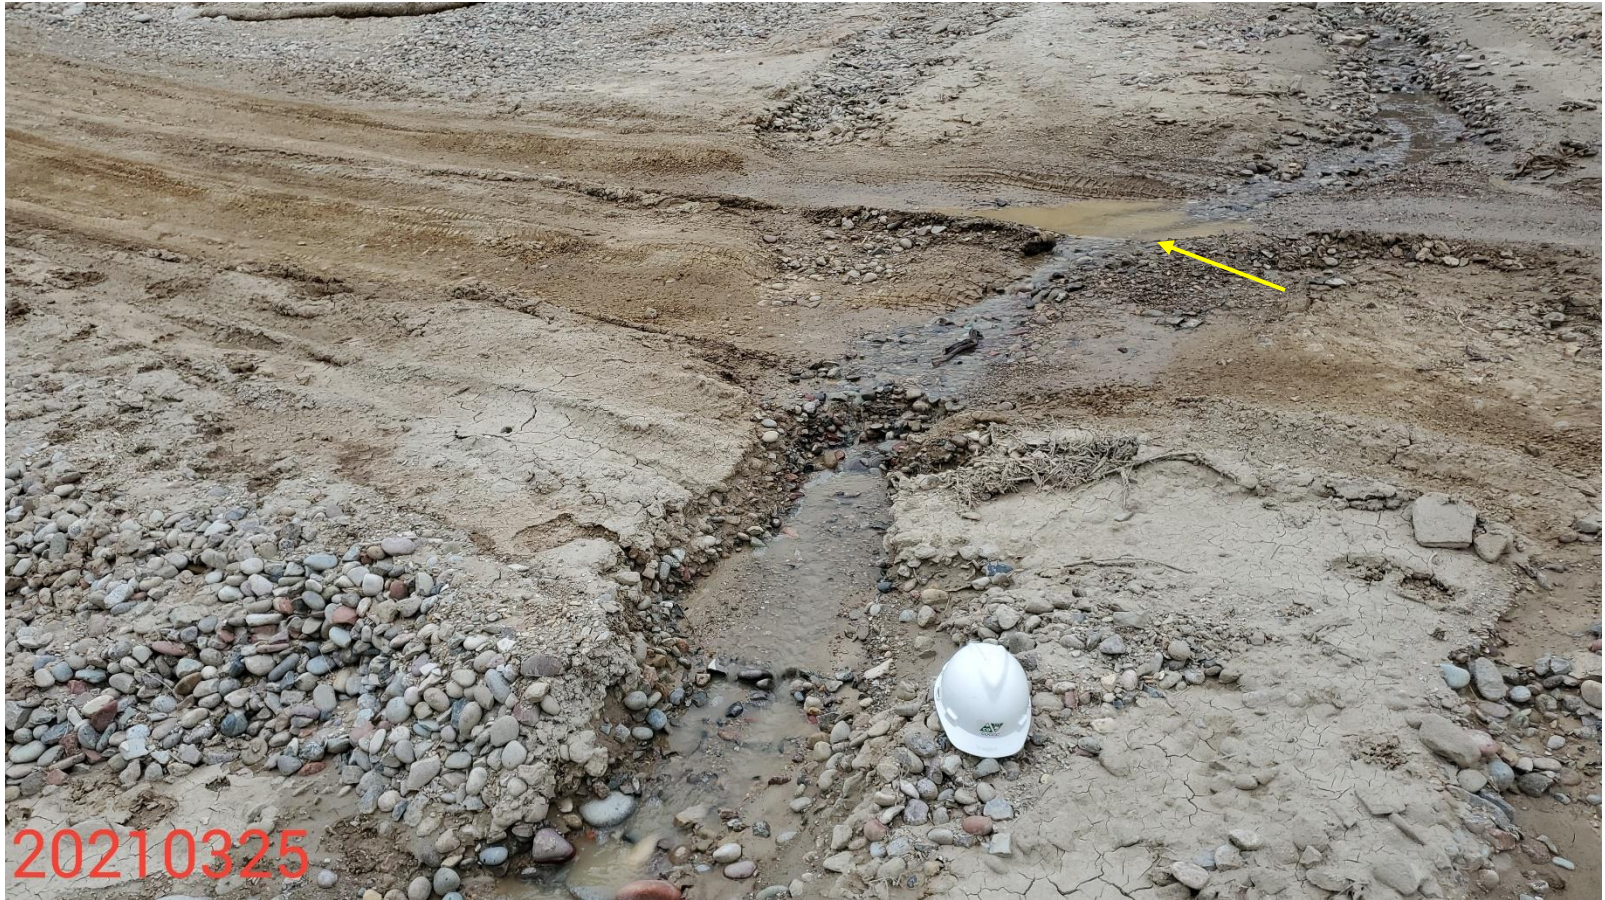
**Photo 15:** Continued from photo 14. Photo shows headcutting/degradation evident within the stream crossing. Photo also shows sediment discharge into the stream/waters of the state occurring at the stream crossing.

**Photo 16:** See comments under photo 15. Safety helmet used for reference.

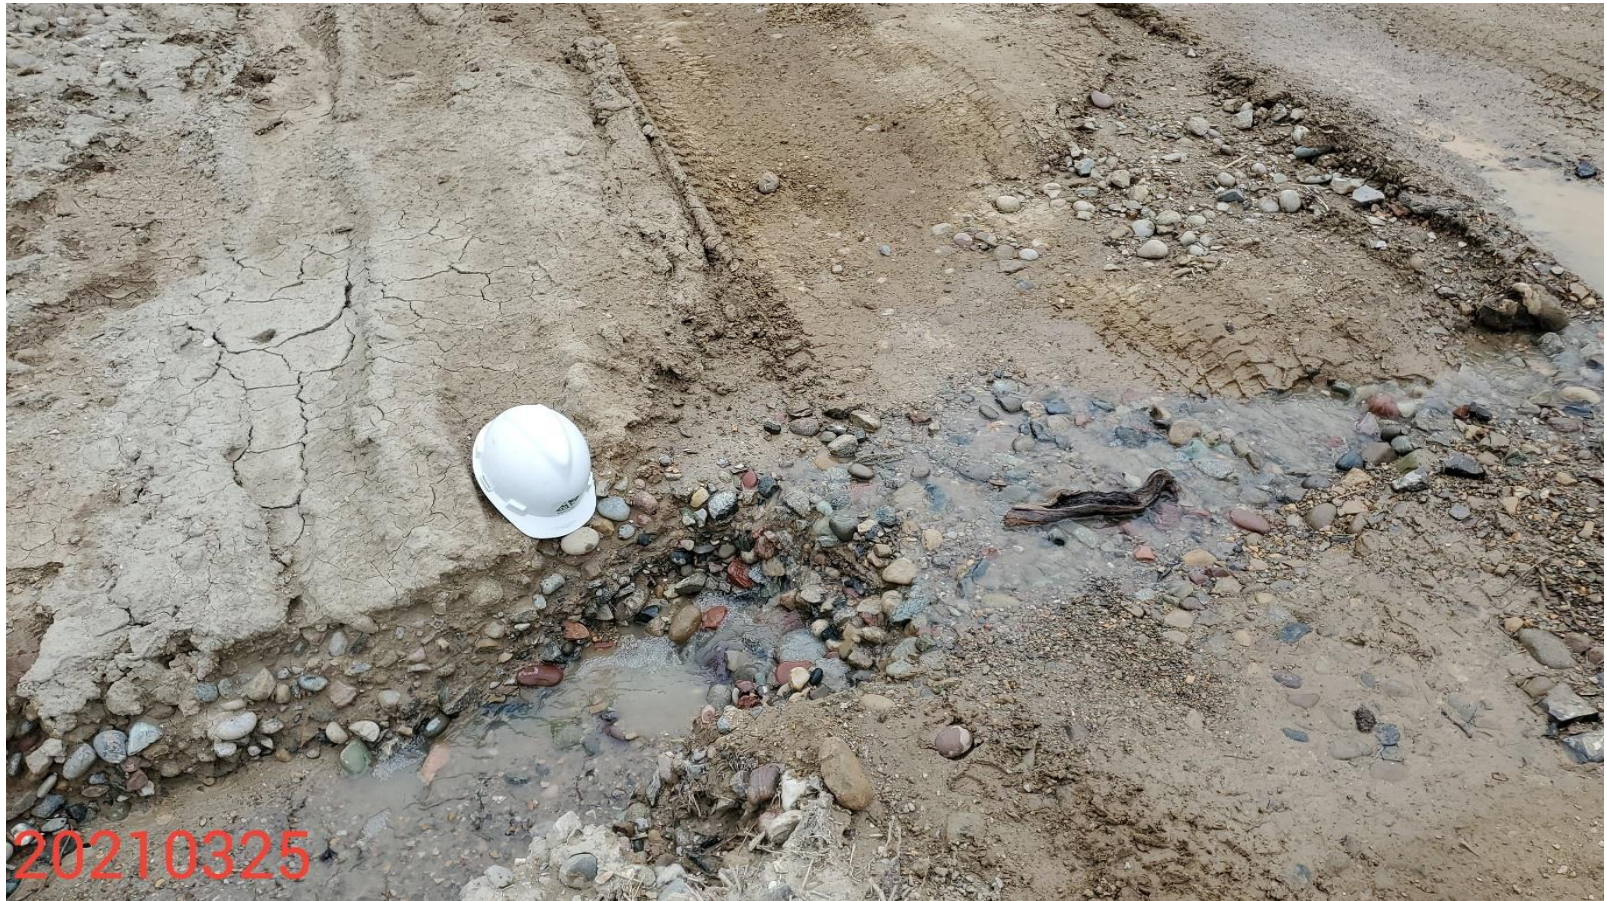
**Photo 17:** See comments under photo 15. Safety helmet used for reference.

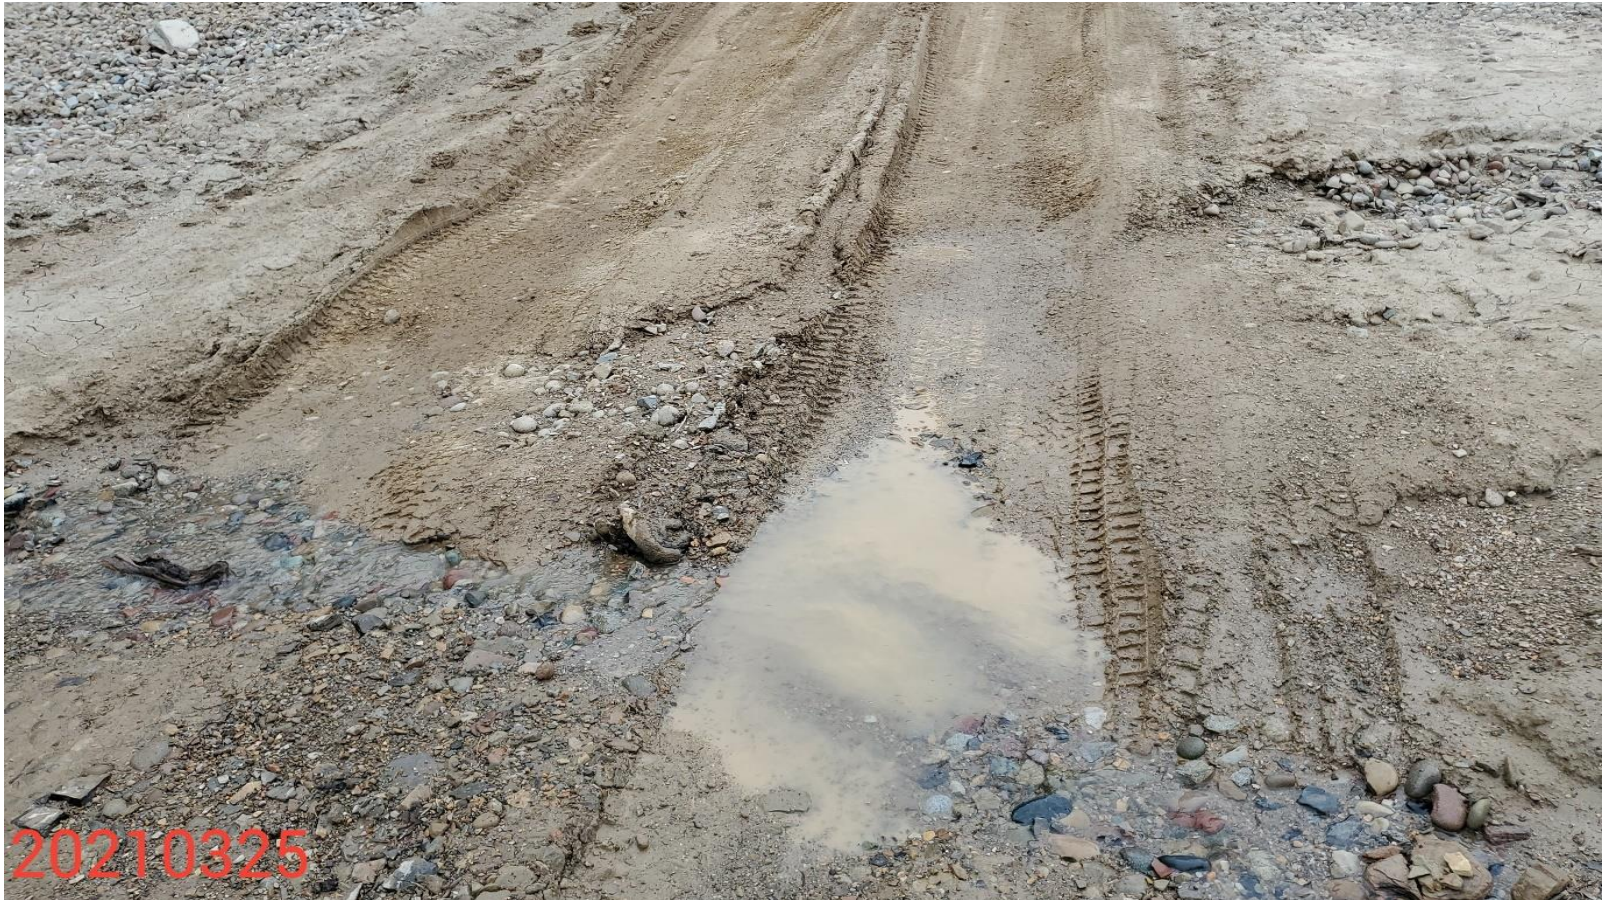
**Photo 18:** Photo shows headcutting/degradation evident within the stream crossing. Photo also shows sediment discharge into the stream/waters of the state occurring at the stream crossing.

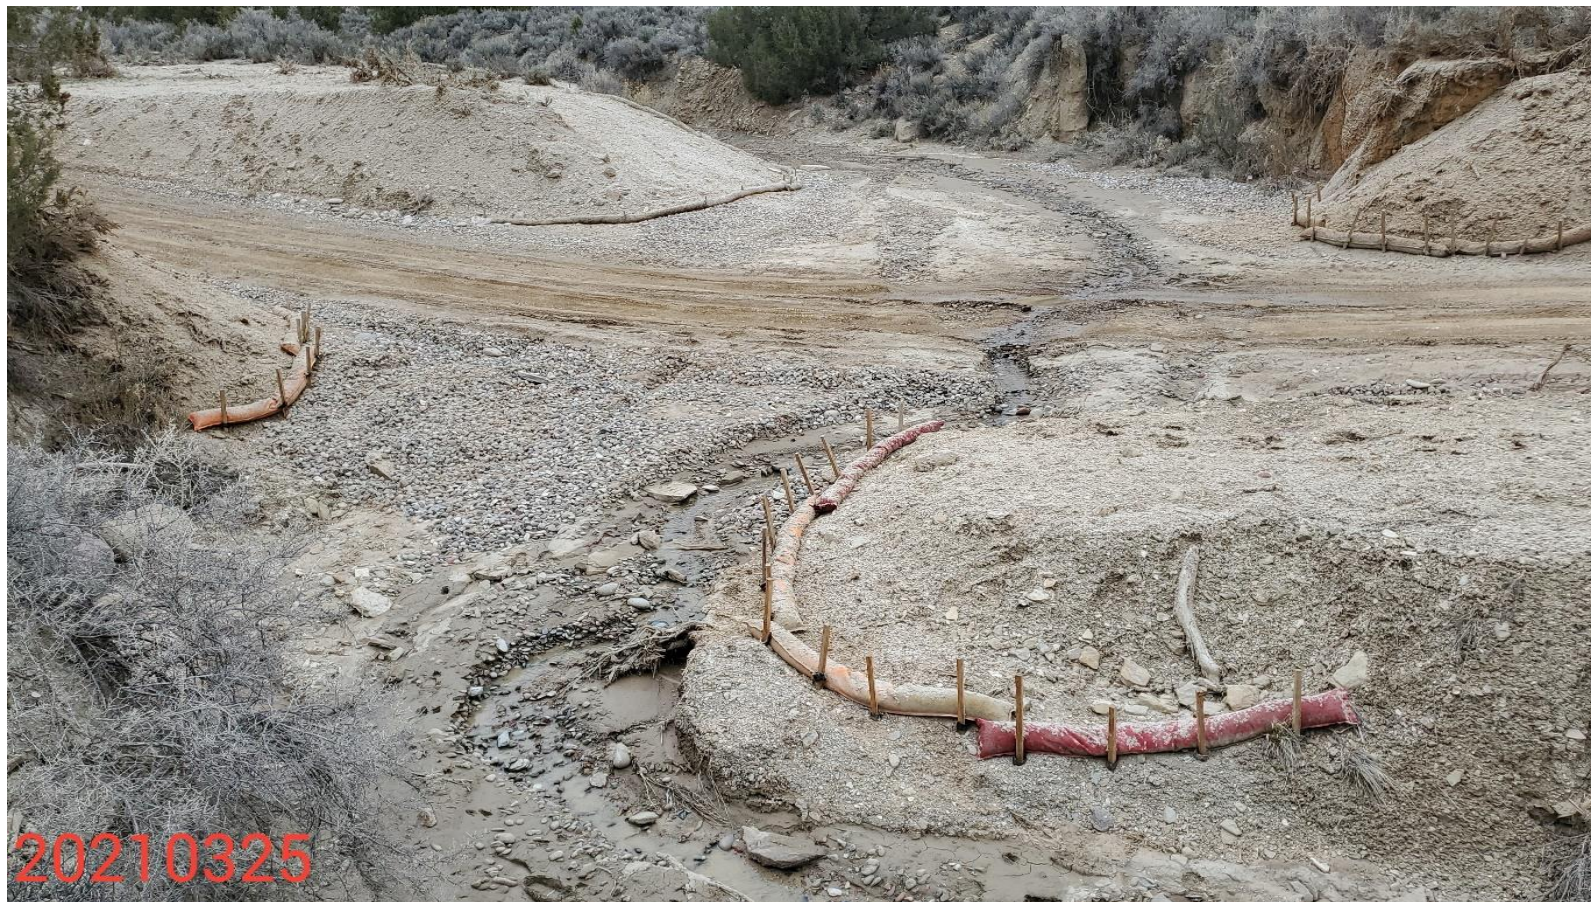
**Photo 19:** Photo taken from below the stream crossing, facing upstream. Photo shows headcutting/degradation evident within the stream crossing. Photo also shows sediment discharge into the stream/waters of the state occurring at the stream crossing.

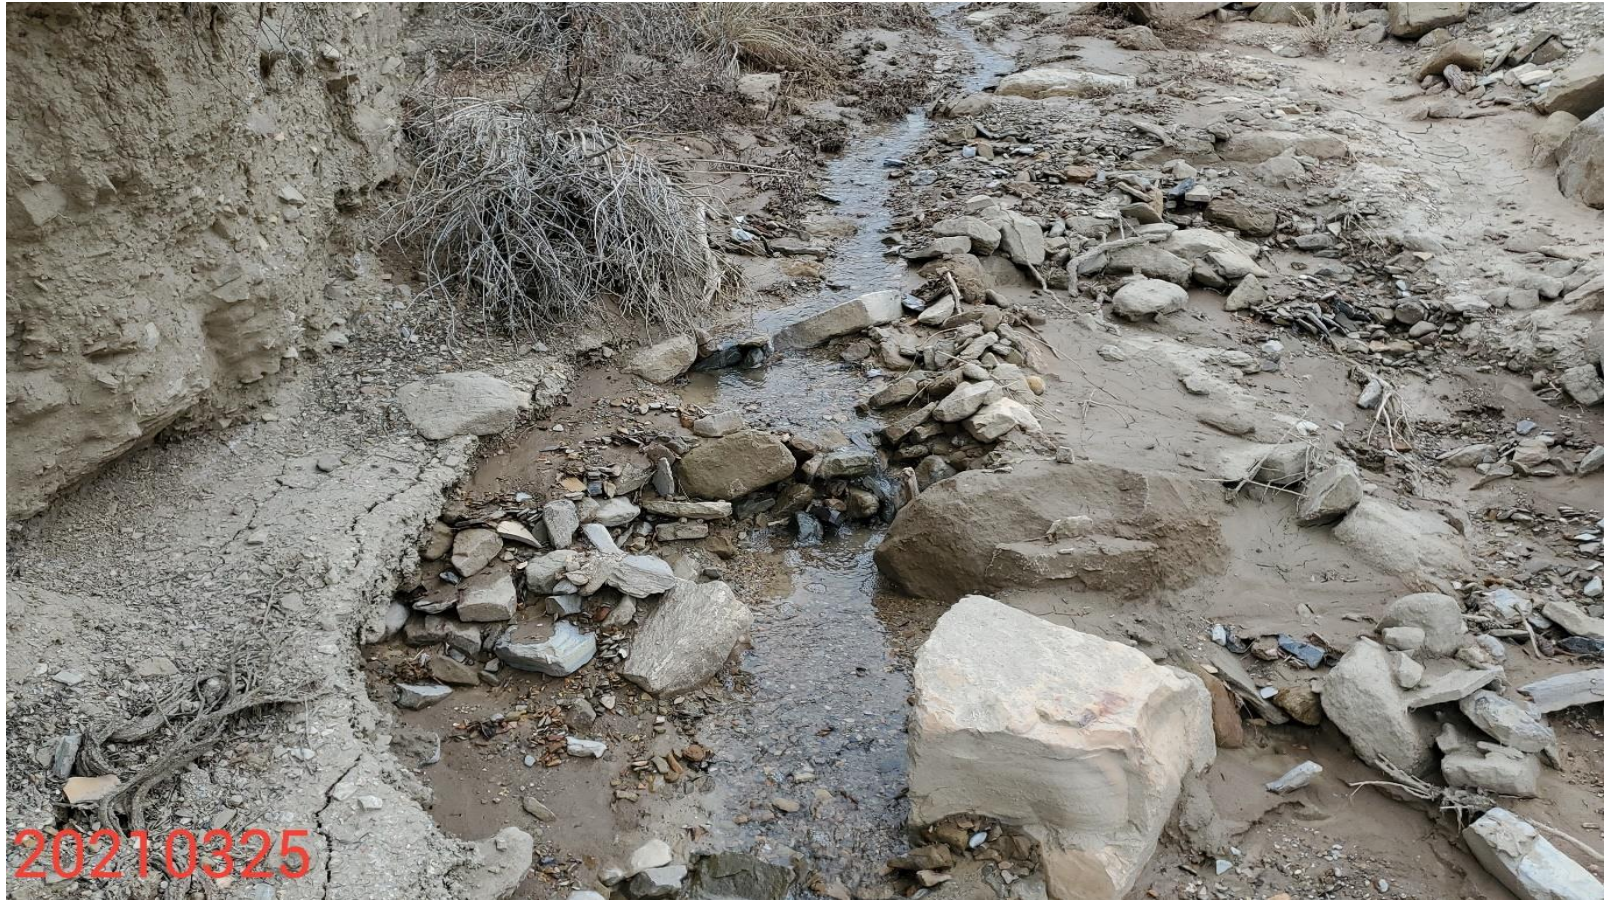
**Photo 20:** Photo taken upstream from the access road/stream crossing. Photo shows waters are clear and not laden with sediment.

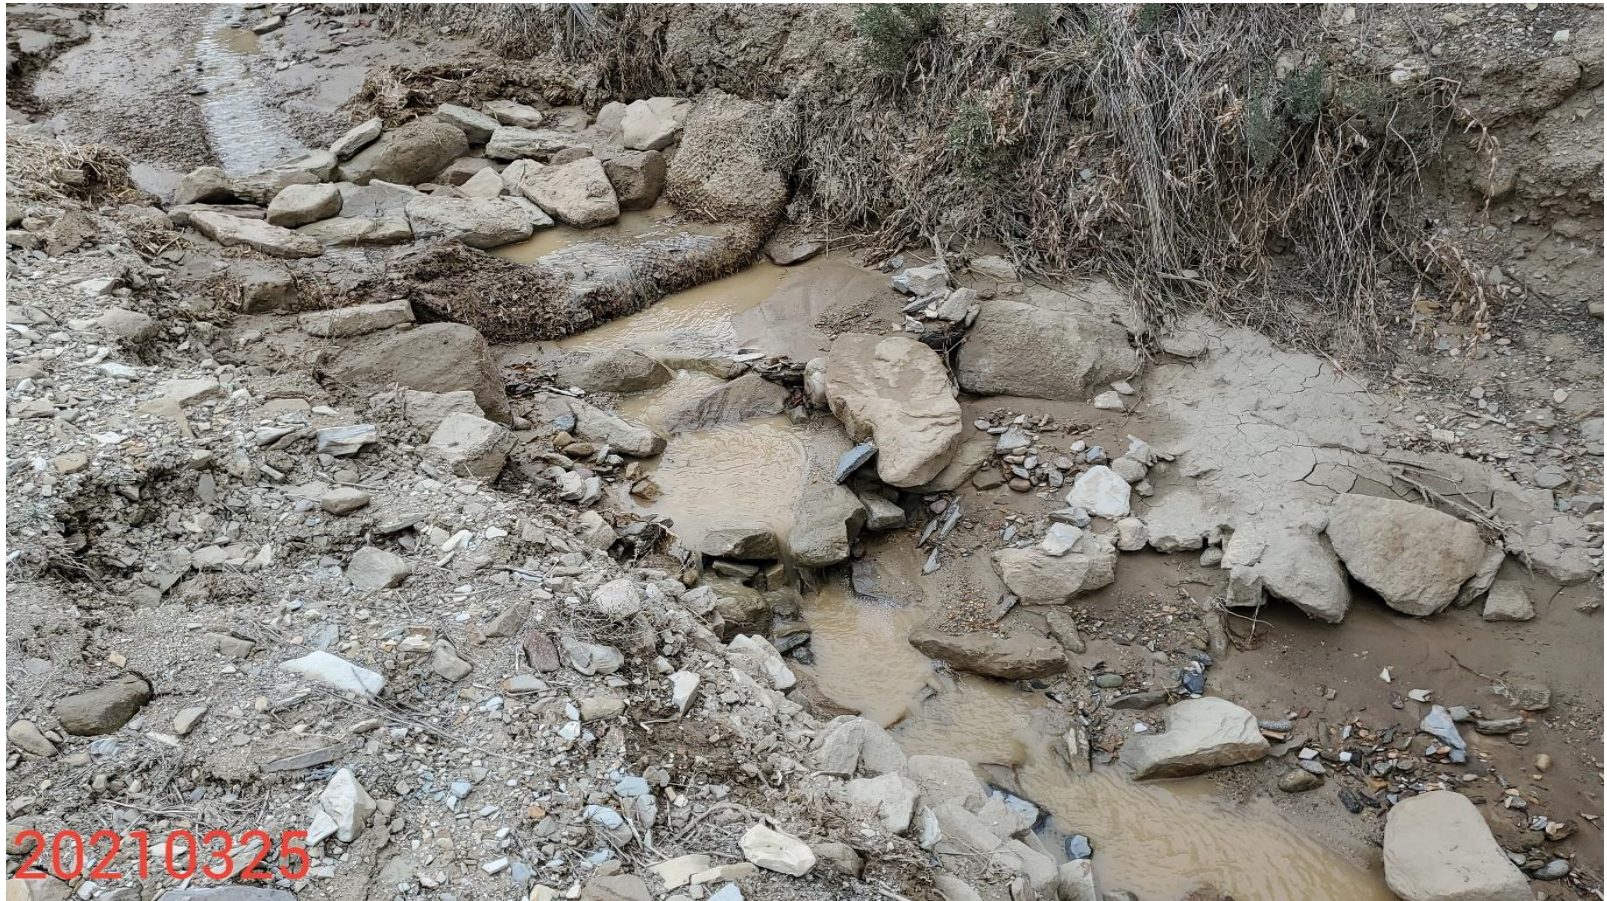
**Photo 21:** Photo taken from the below the access road/stream crossing. Photo shows waters are not clear and are laden with sediment. Impacts to waters of the state observed.

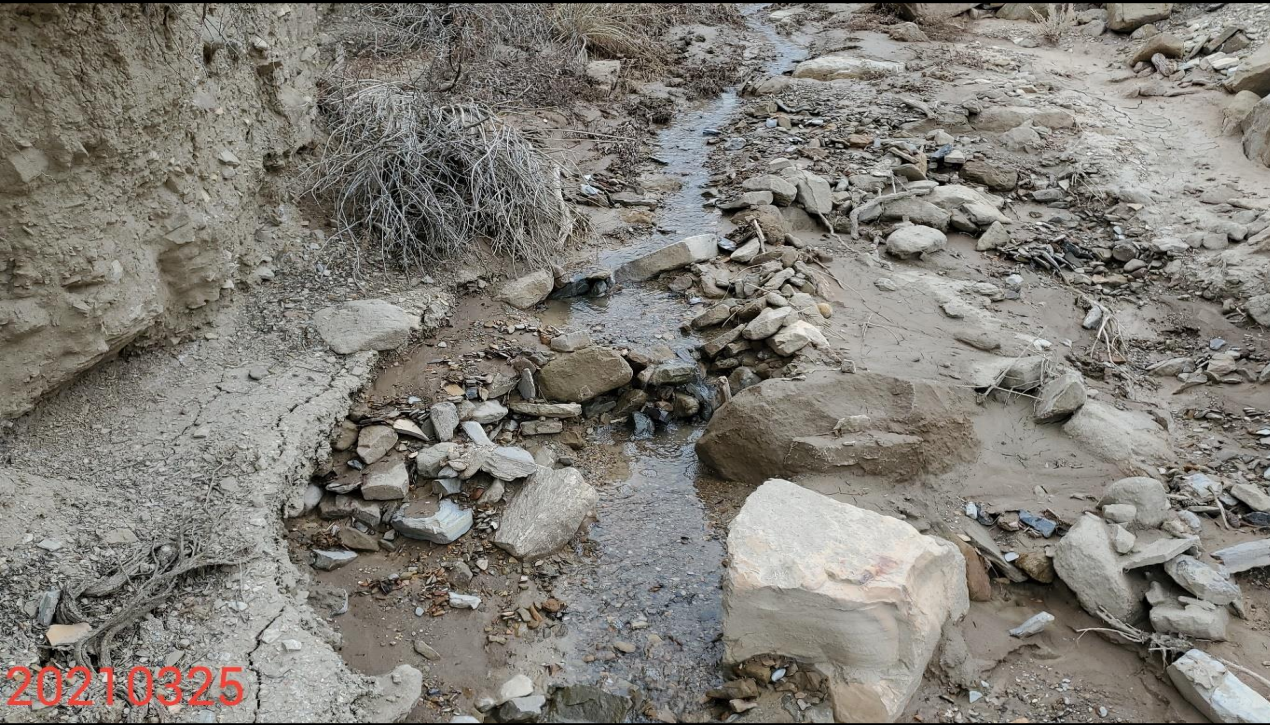
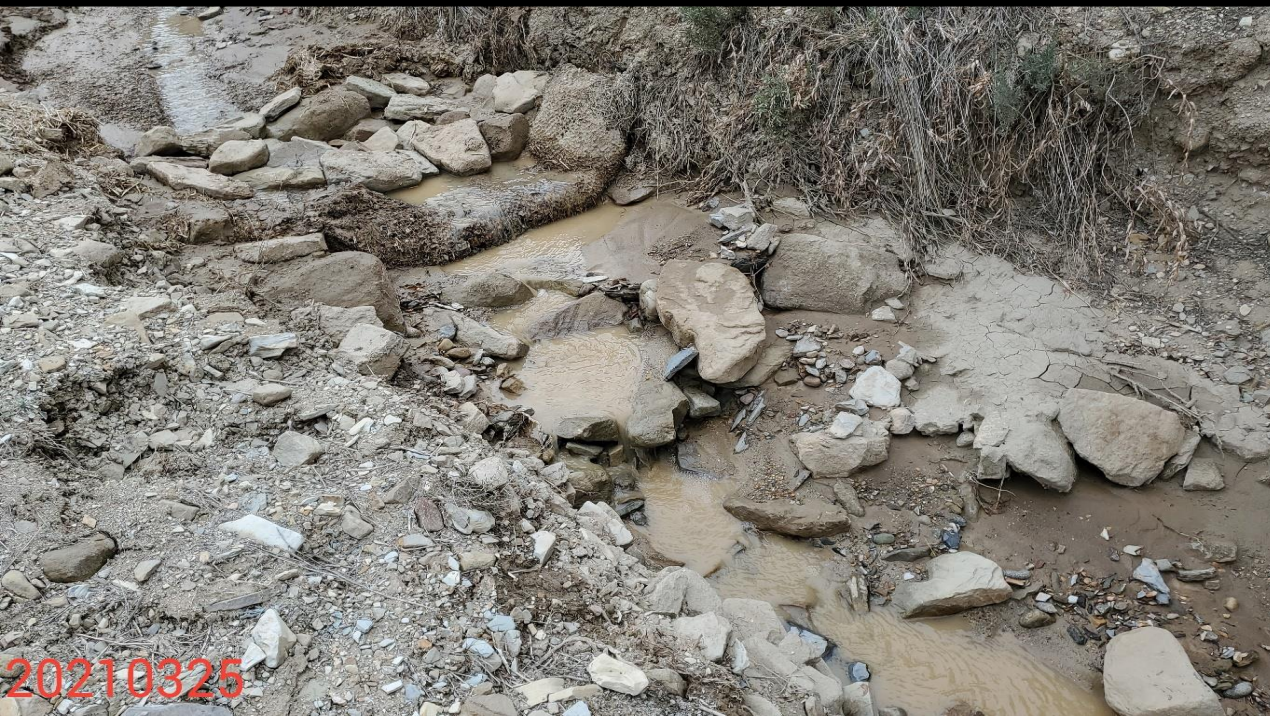
Side by side comparison of photo 20 (top, upstream) and photo 21 (bottom, downstream). Photos shows that the stream/waters of the state above the stream crossing remain clear, and that the stream/waters of the state below the stream crossing have become laden with sediment; impacts to waters of the state observed.
