Inspection Photos

API: 073-06449

Operator: WIEPKING-FULLERTON ENERGY

Inspection Date: 3/25/2021

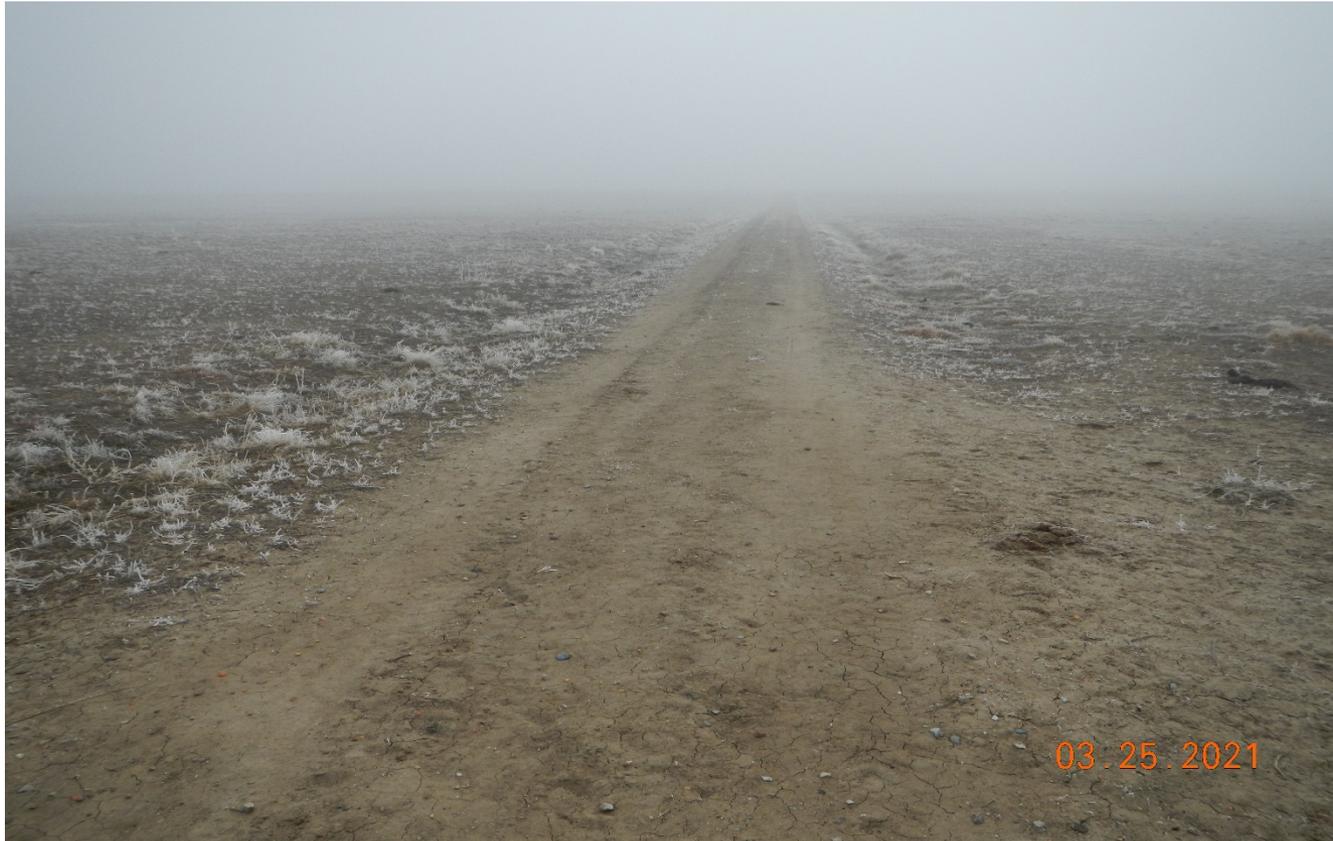
Photo 1. Facing east toward the access road near the Bubba State 4 location. A portion of the access road was not regraded and reclaimed.

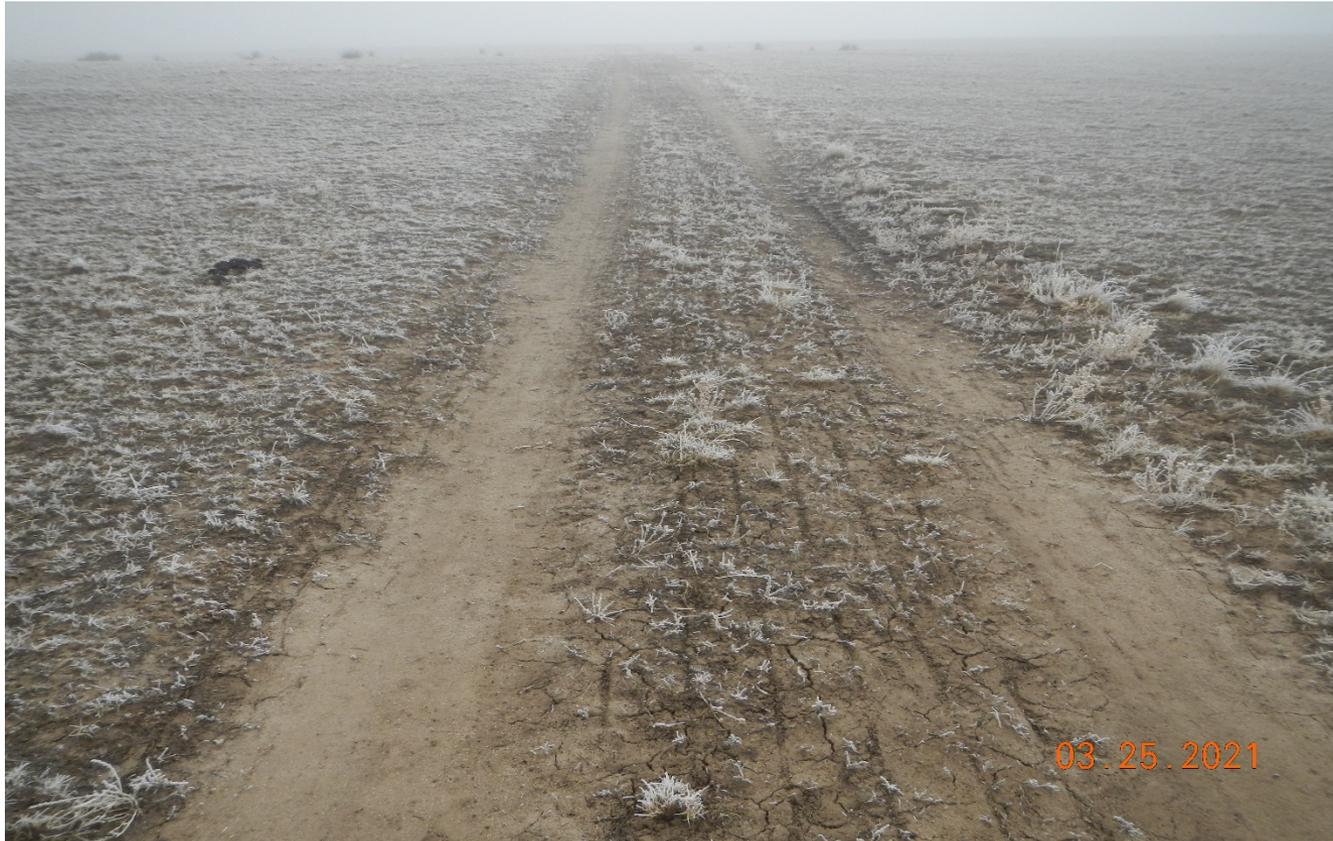
Photo 2. Facing east along the access road. It appears the a portion of the road was recently seeded however, the road is compacted. The road needs to be decompacted and reseeded.

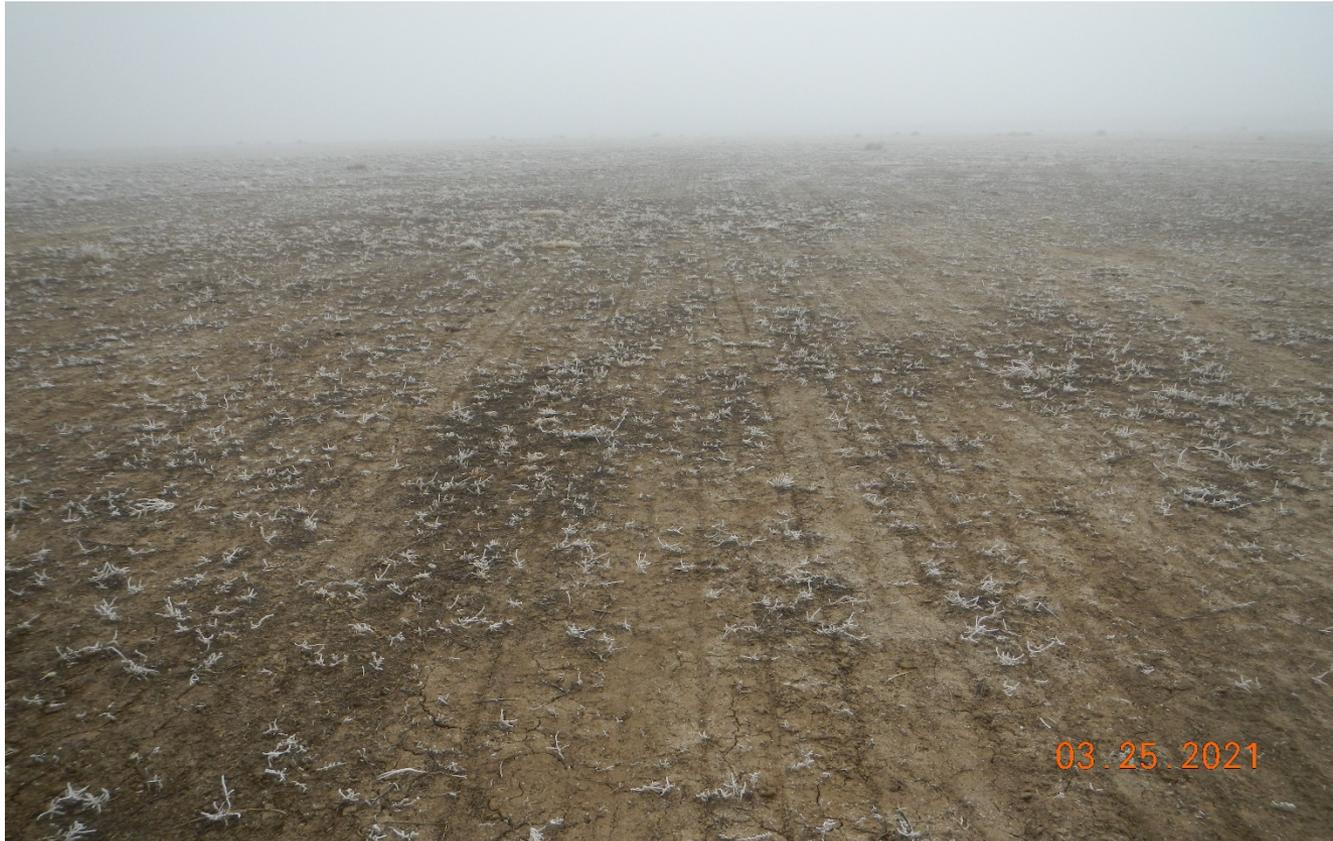
Photo 3. Facing east toward the location. It appears the location have been recently drill seeded.
