# Inspection Photos

API: 073-06513

Operator: WIEPKING-FULLERTON ENERGY

Inspection Date: 3/25/2021

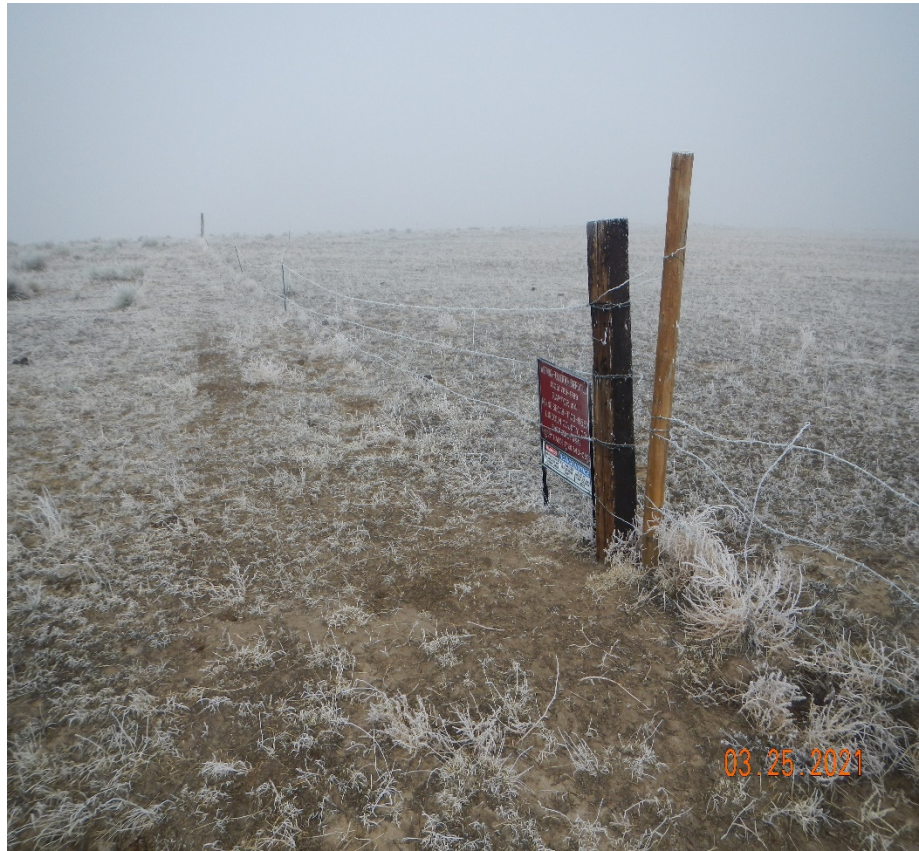
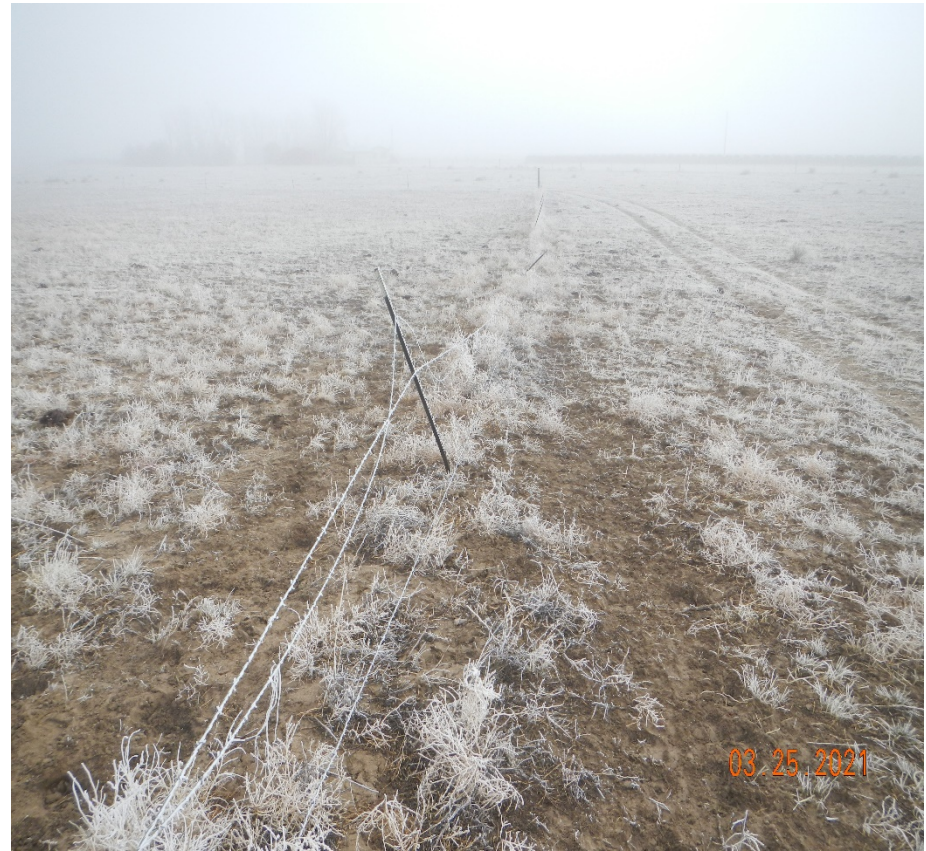
**Photo 1.** Facing at the fenced location. The fence is not maintained.

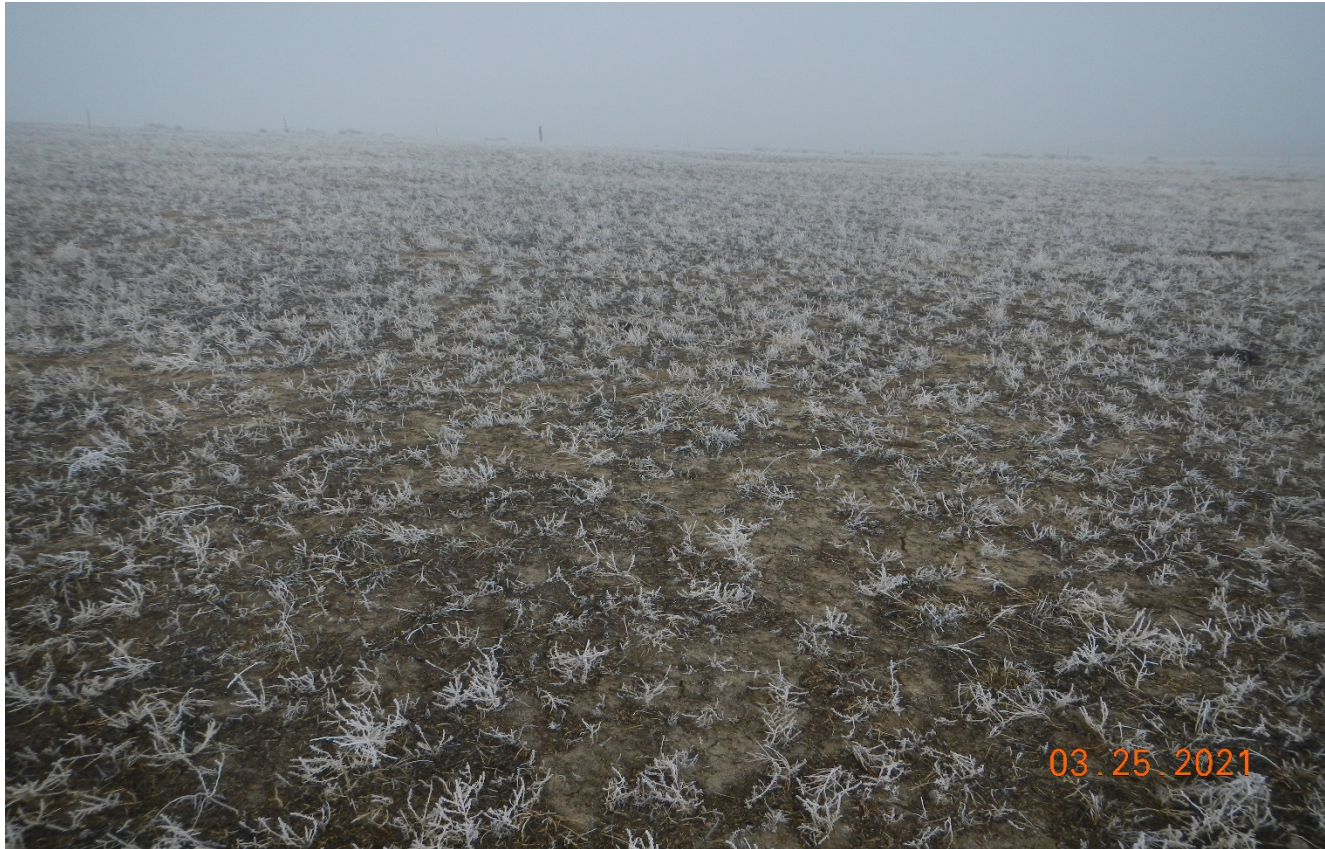
**Photo 2.** Center of the location facing north.

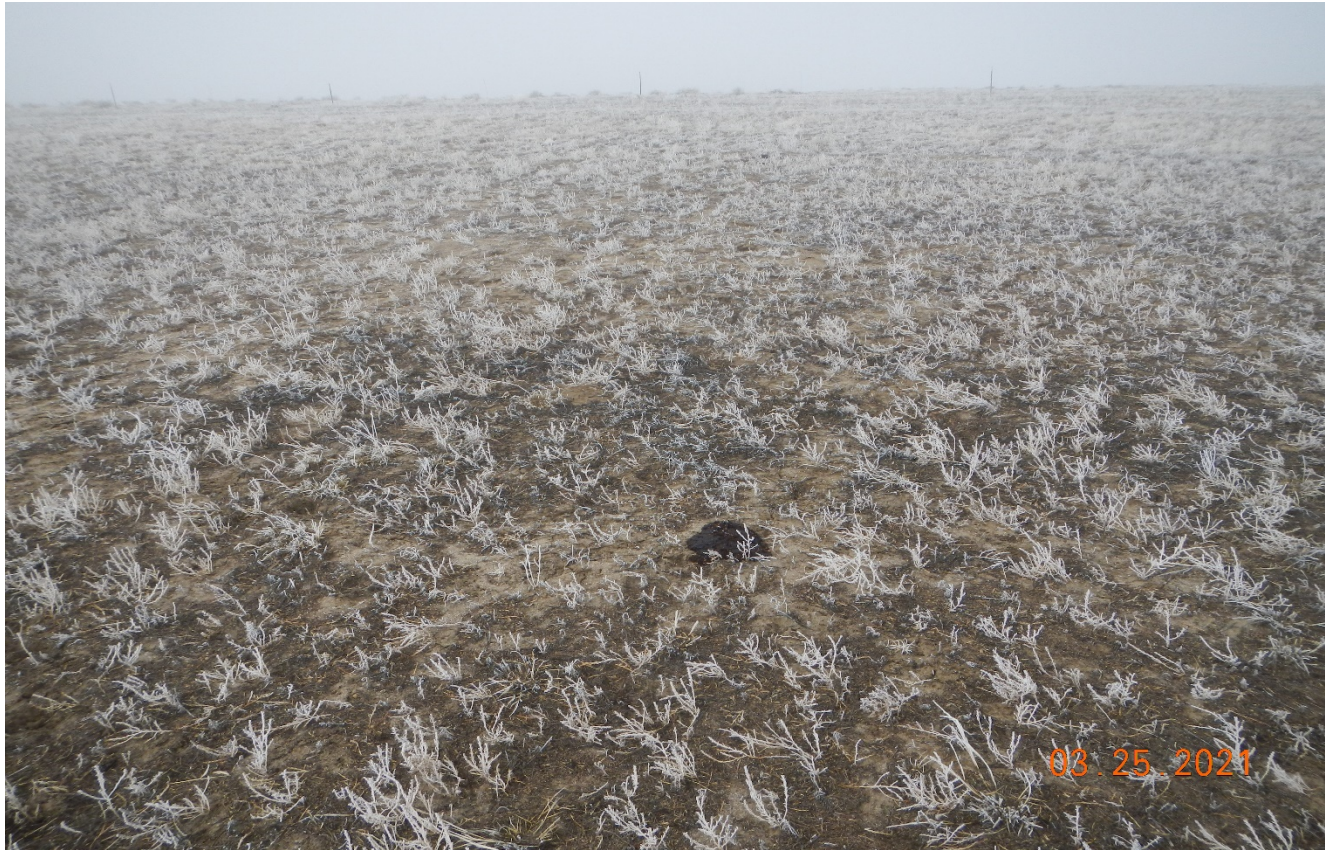
**Photo 3.** Center of the location facing west. Areas at the western portion of the location do not appear to be establishing desirable vegetation.

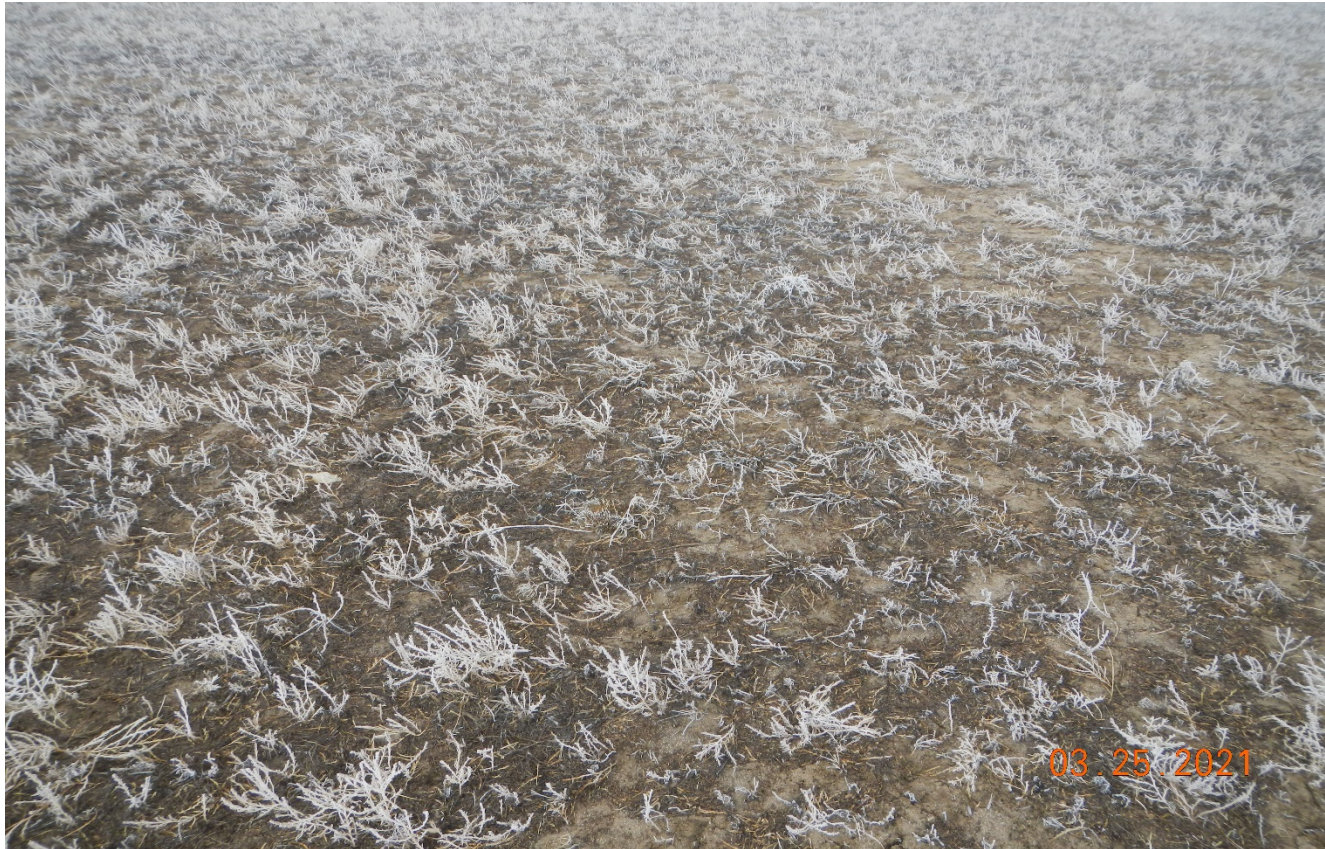
**Photo 4.** View of groundcover at the western side of the location shows mostly undesirable weeds (Kochia).

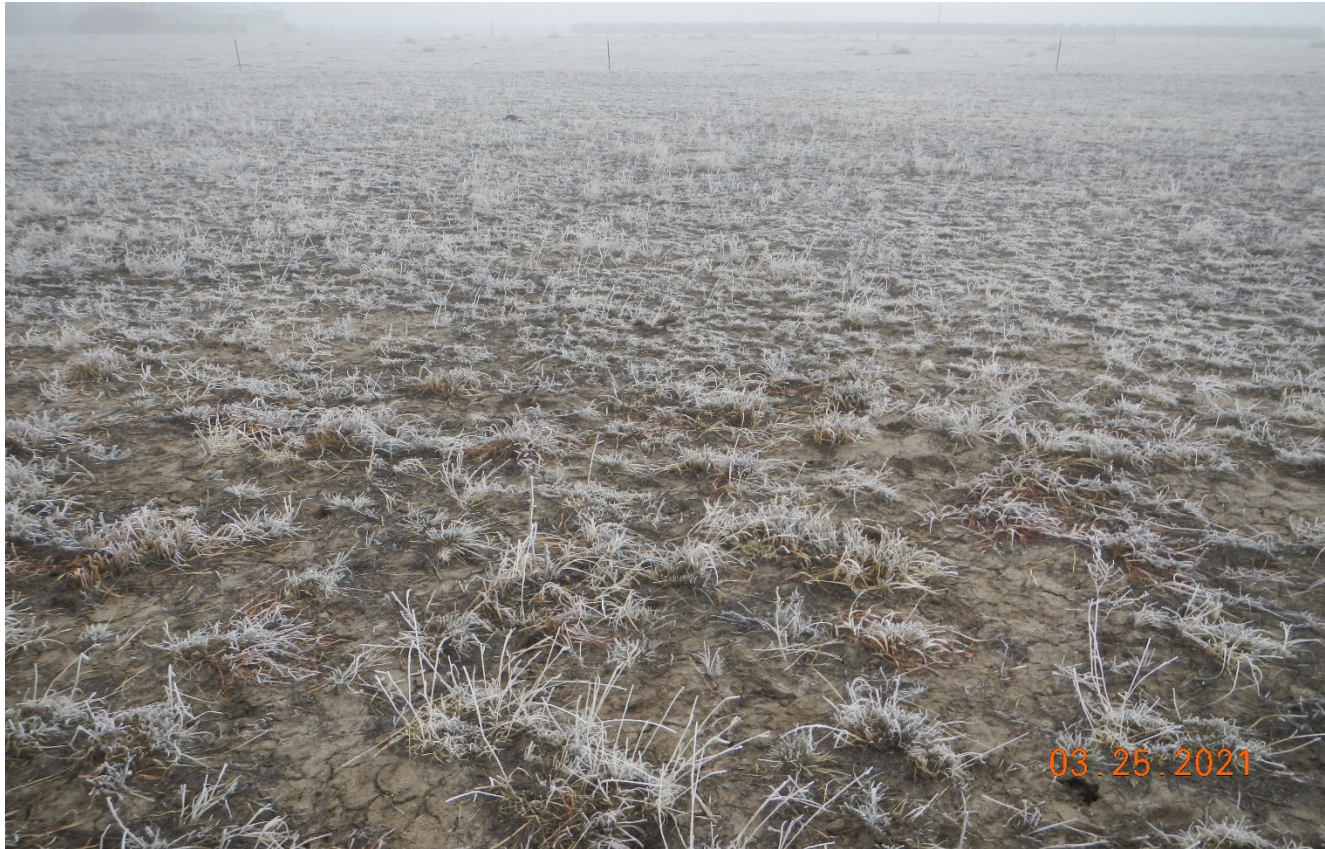
**Photo 5.** Facing east at the location. The eastern side of the location consists of desirable vegetation cover which appears to be establishing.
