Inspection Photos
Operator: Simcoe
Facility: 067-07558
Date: 3/29/2021

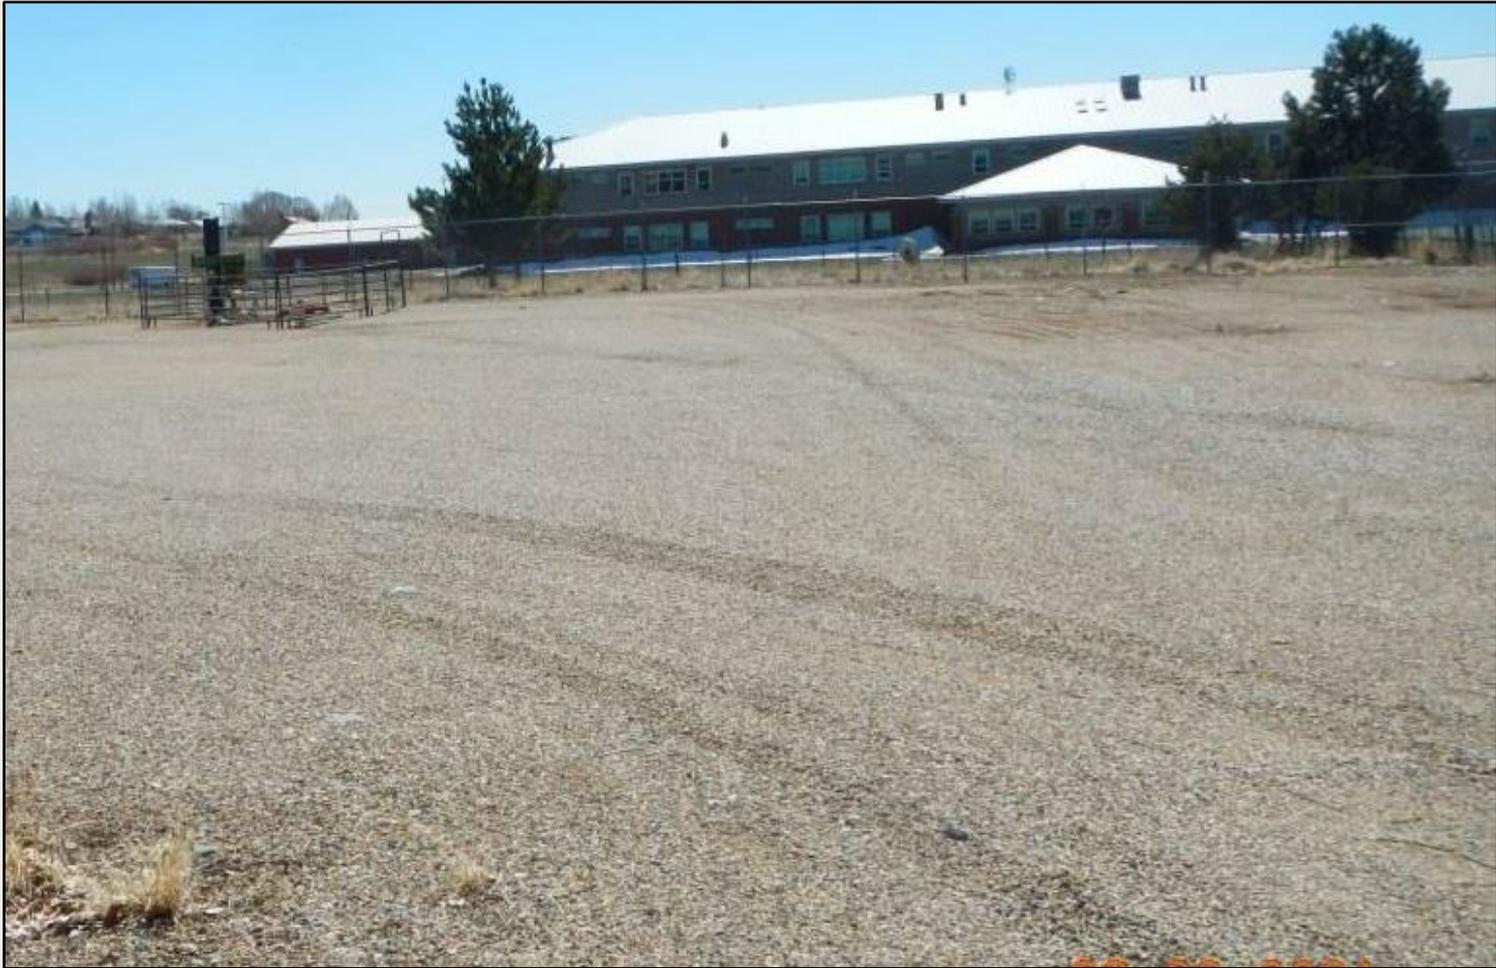
Photo 1. View of the project area from the well pad entrance facing center.

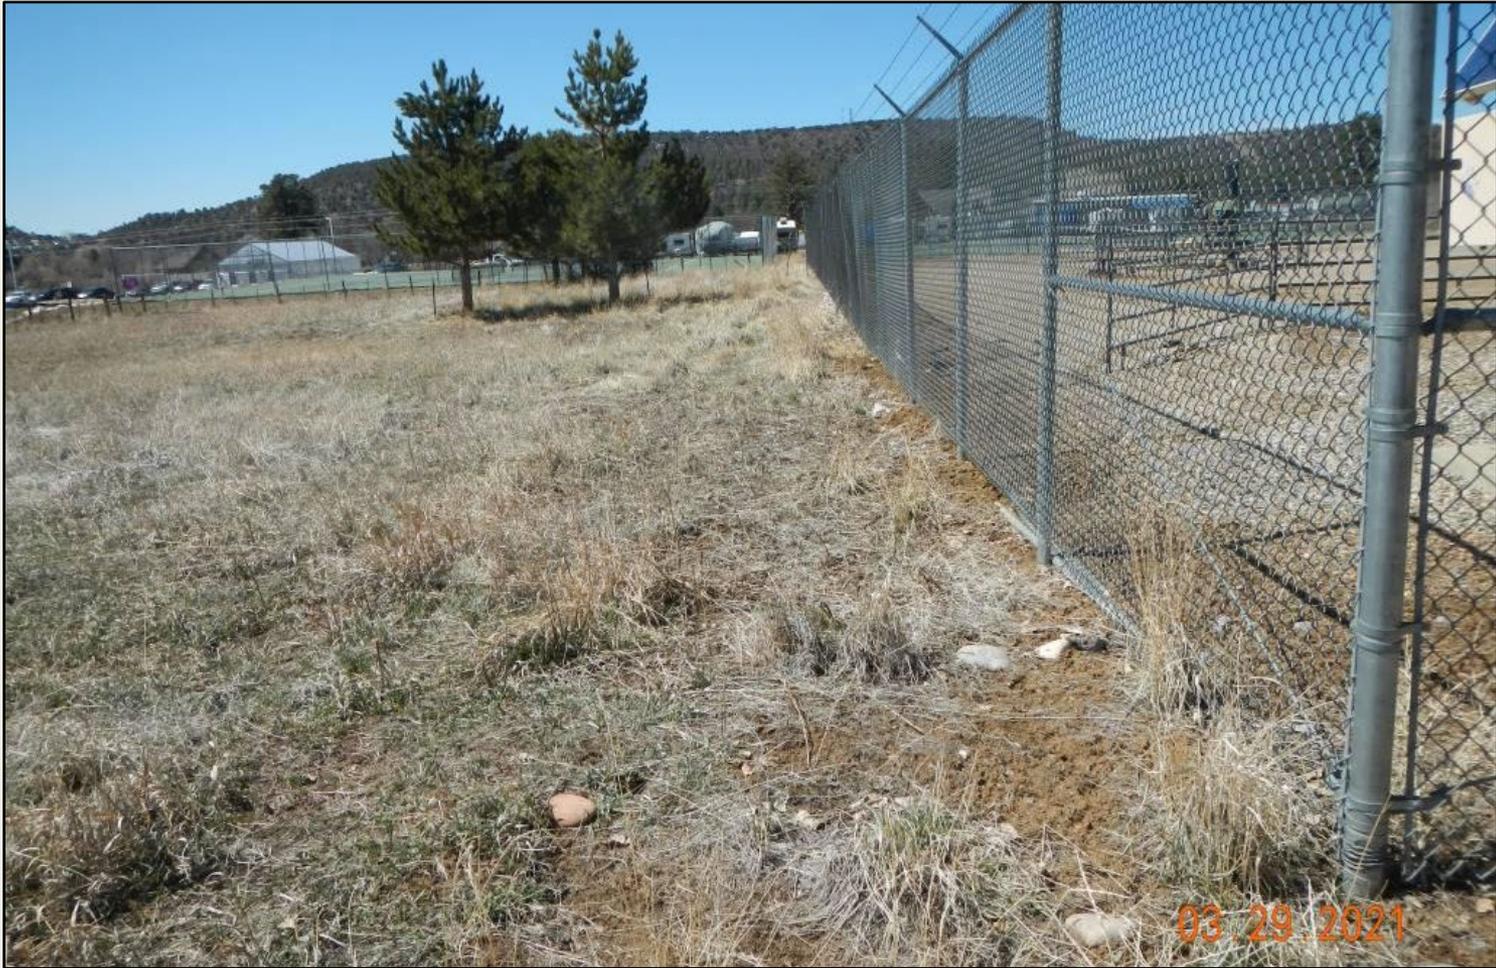
Photo 2. View of the southern project area from the southeastern corner facing westward. Revegetation is progressing, largely with smooth brome and mixed wheatgrasses.

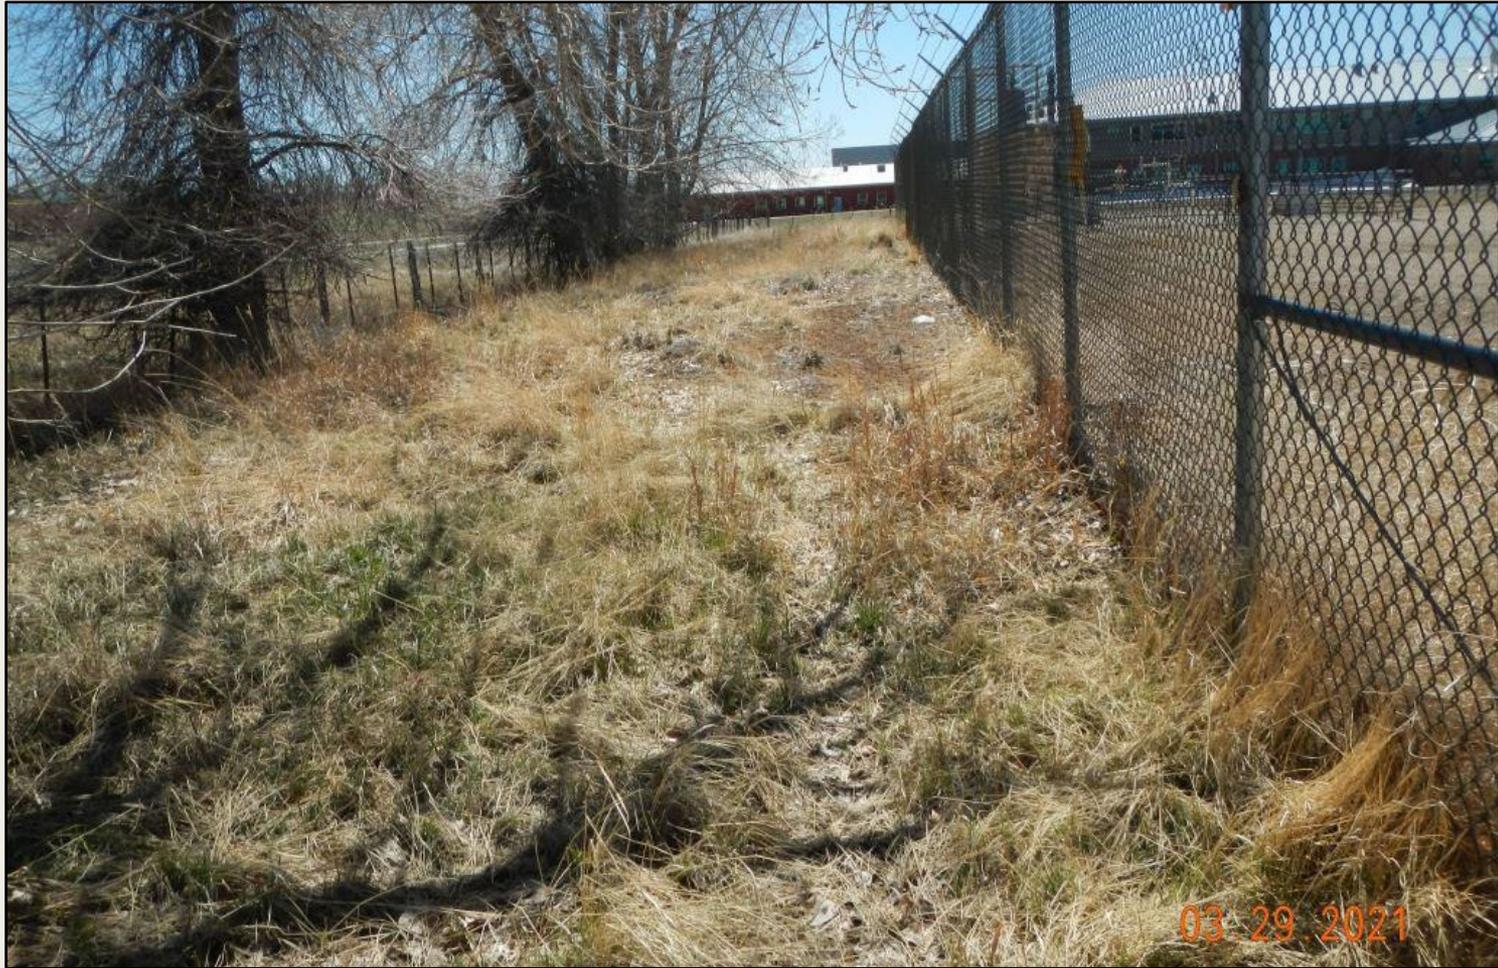
Photo 3. View of the eastern project area from the northeastern corner facing southward.

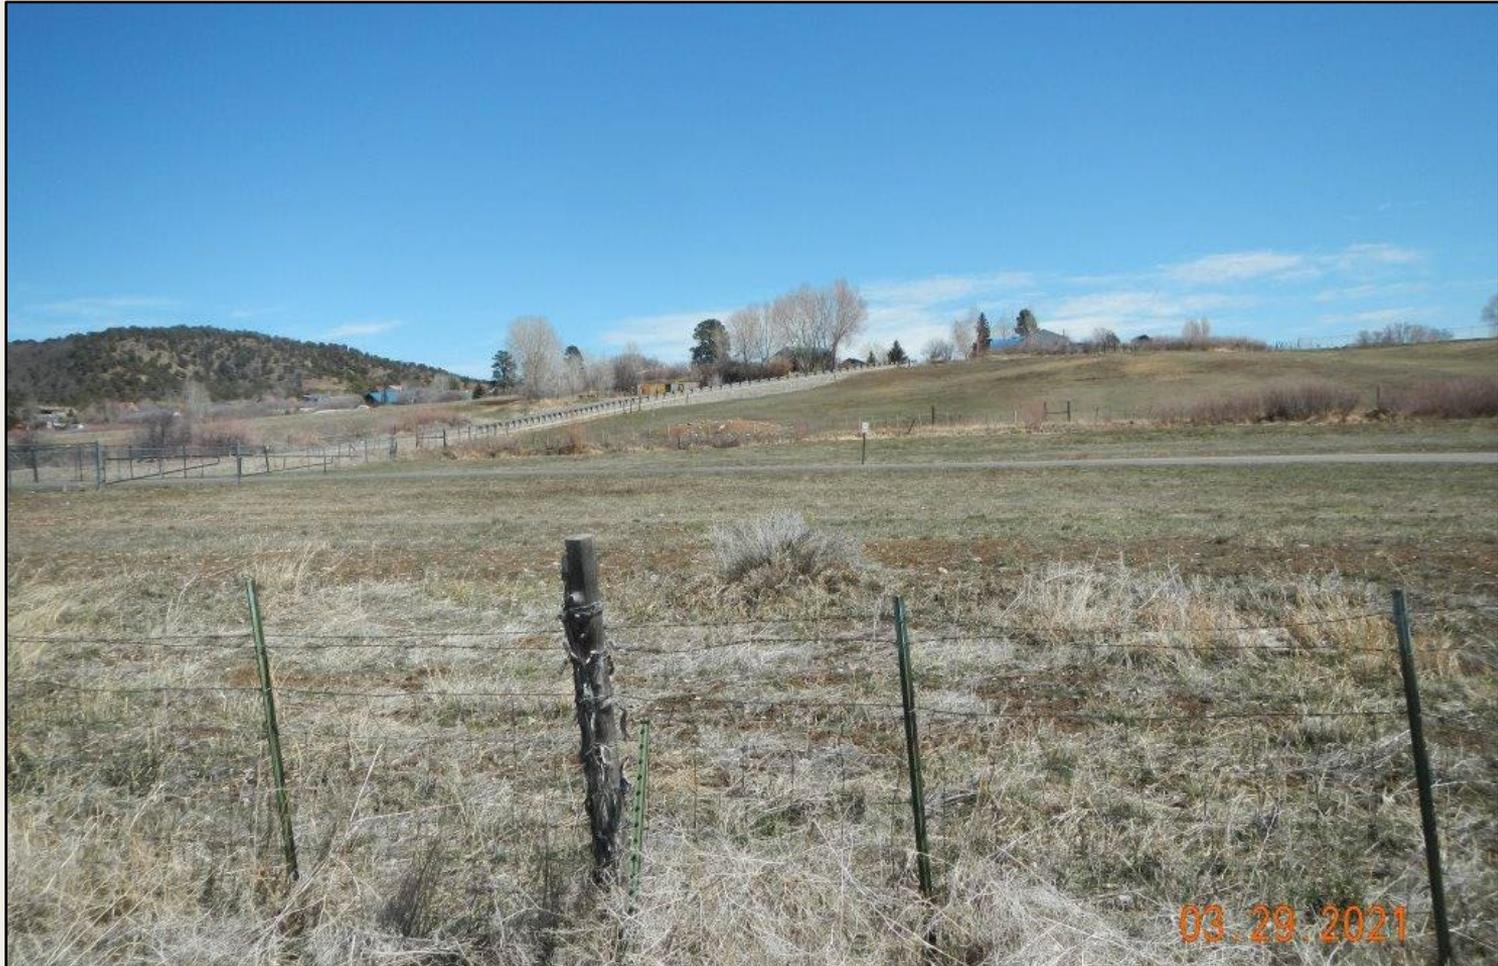
Photo 4. View of the reference area comprised of irrigated grass field comprised largely of smooth brome and mowed grasses not identifiable at this time.
