## Inspection Photos

Location Name: CAERUS PICEANCE LLC KEINATH FEDERAL-68S96W /18SWNE

Location ID: 334316

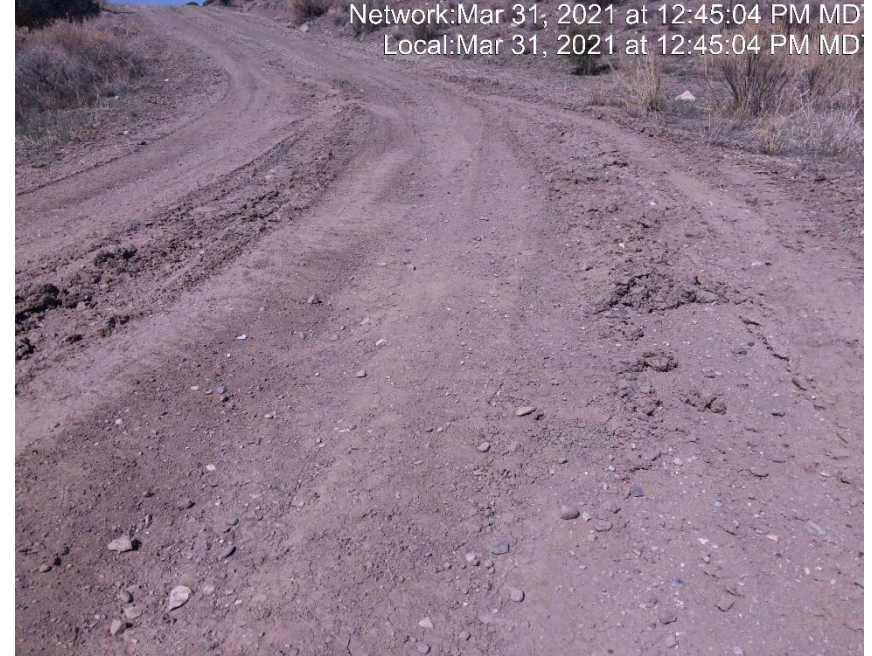
**Photo #3357 Access road lacks stabilization.**

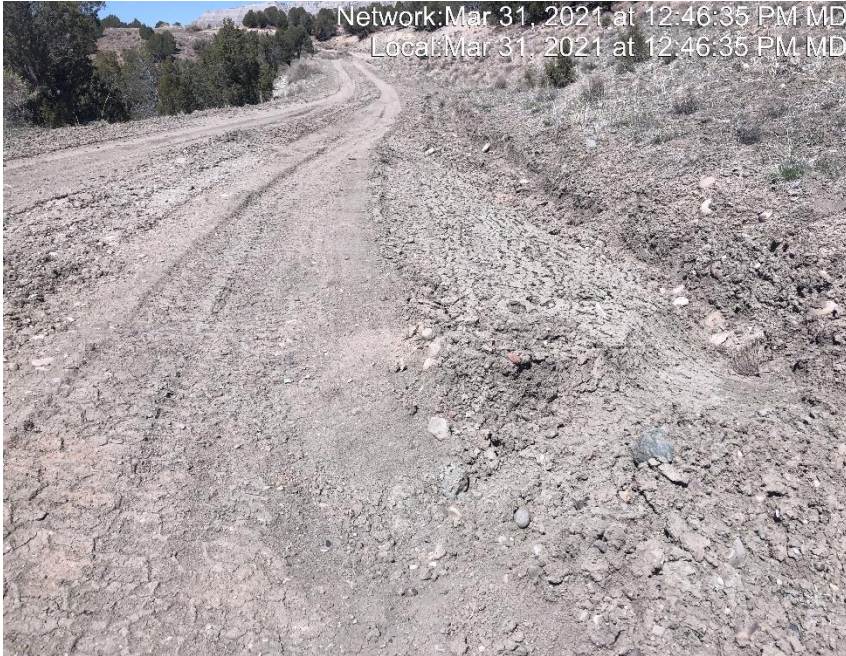
**Photo #3358 Access road lacks stabilization.**

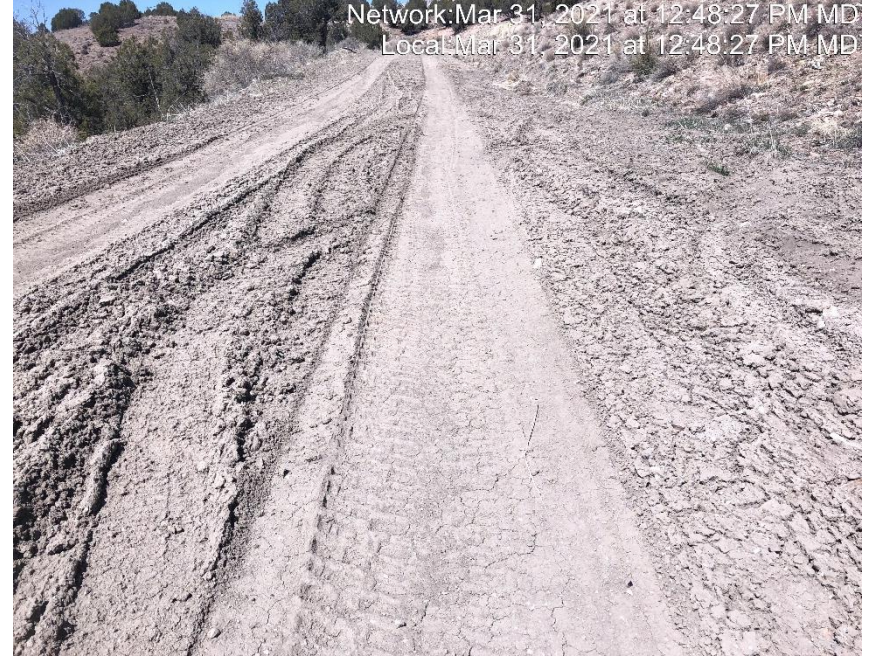
**Photo #3360 Access road lacks stabilization.**

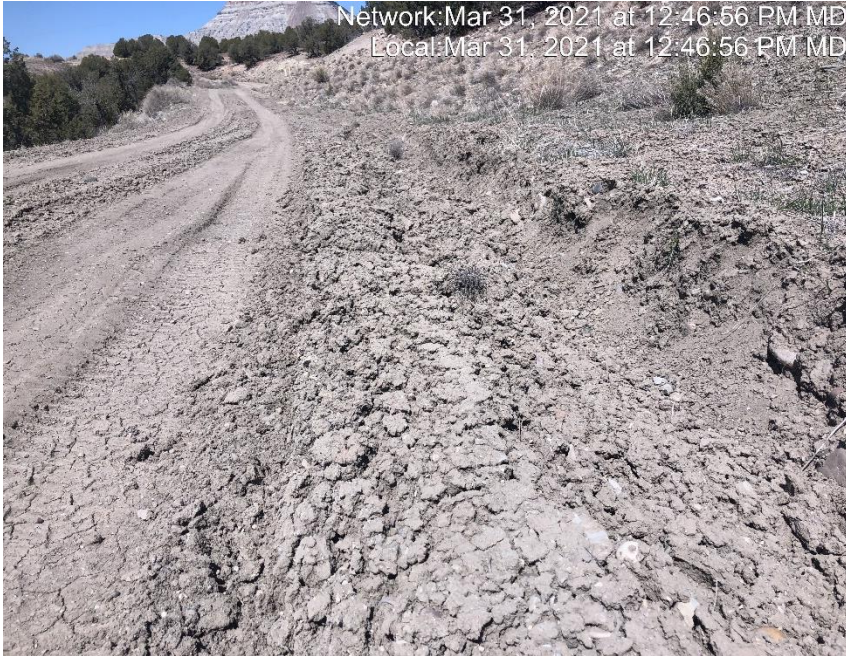
**Photo #3359 Sediment has migrated into ditch**

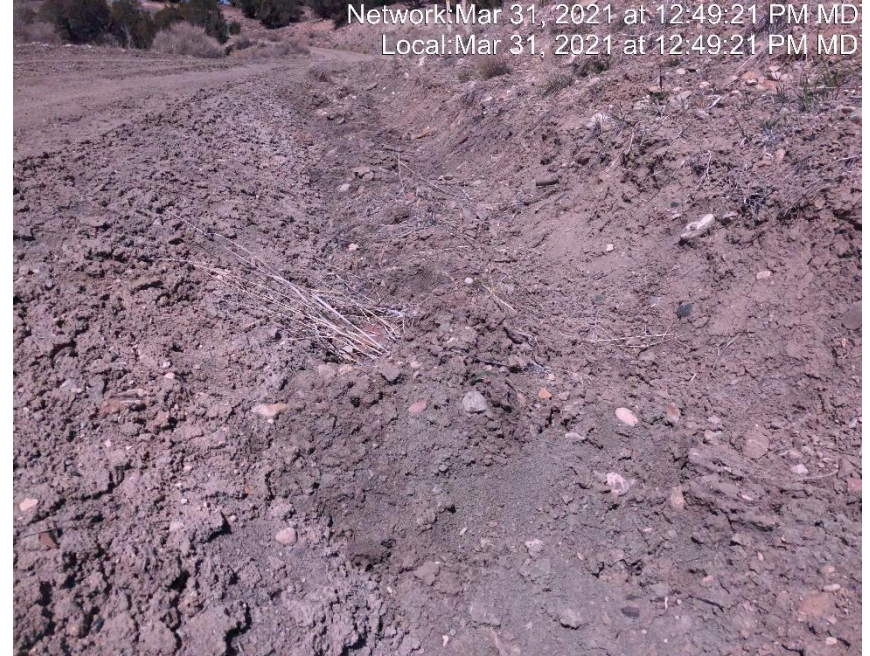
**Photo #3361 Sediment has migrated into ditch**

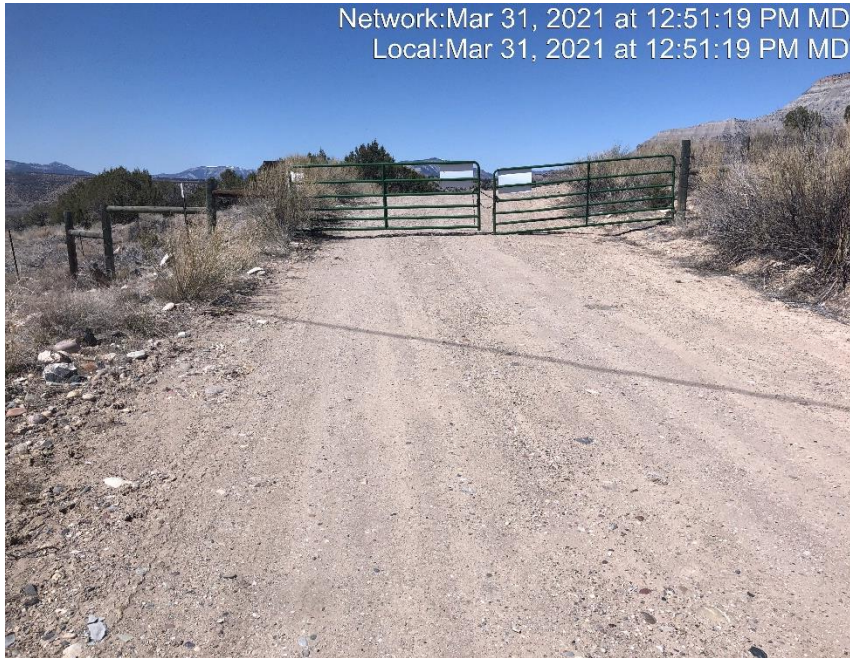
**Photo #3362** No form of tracking control at entrance to access road.

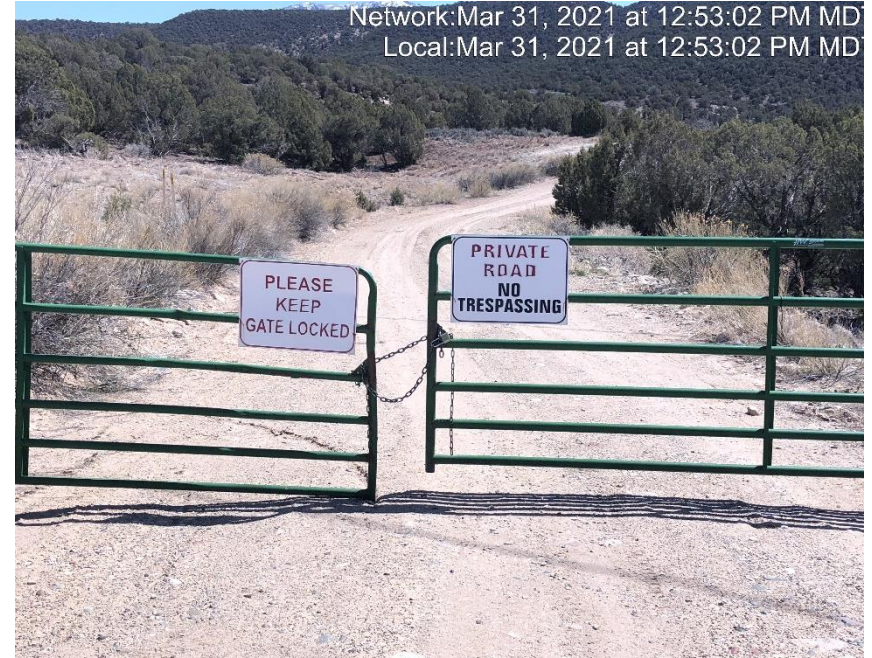
**Photo #3363** Access road is used to access location and does not have any public access.
