Inspection Photos

3/31/2021

Operator: SG INTERESTS I LTD # 77330

Location ID: 422990

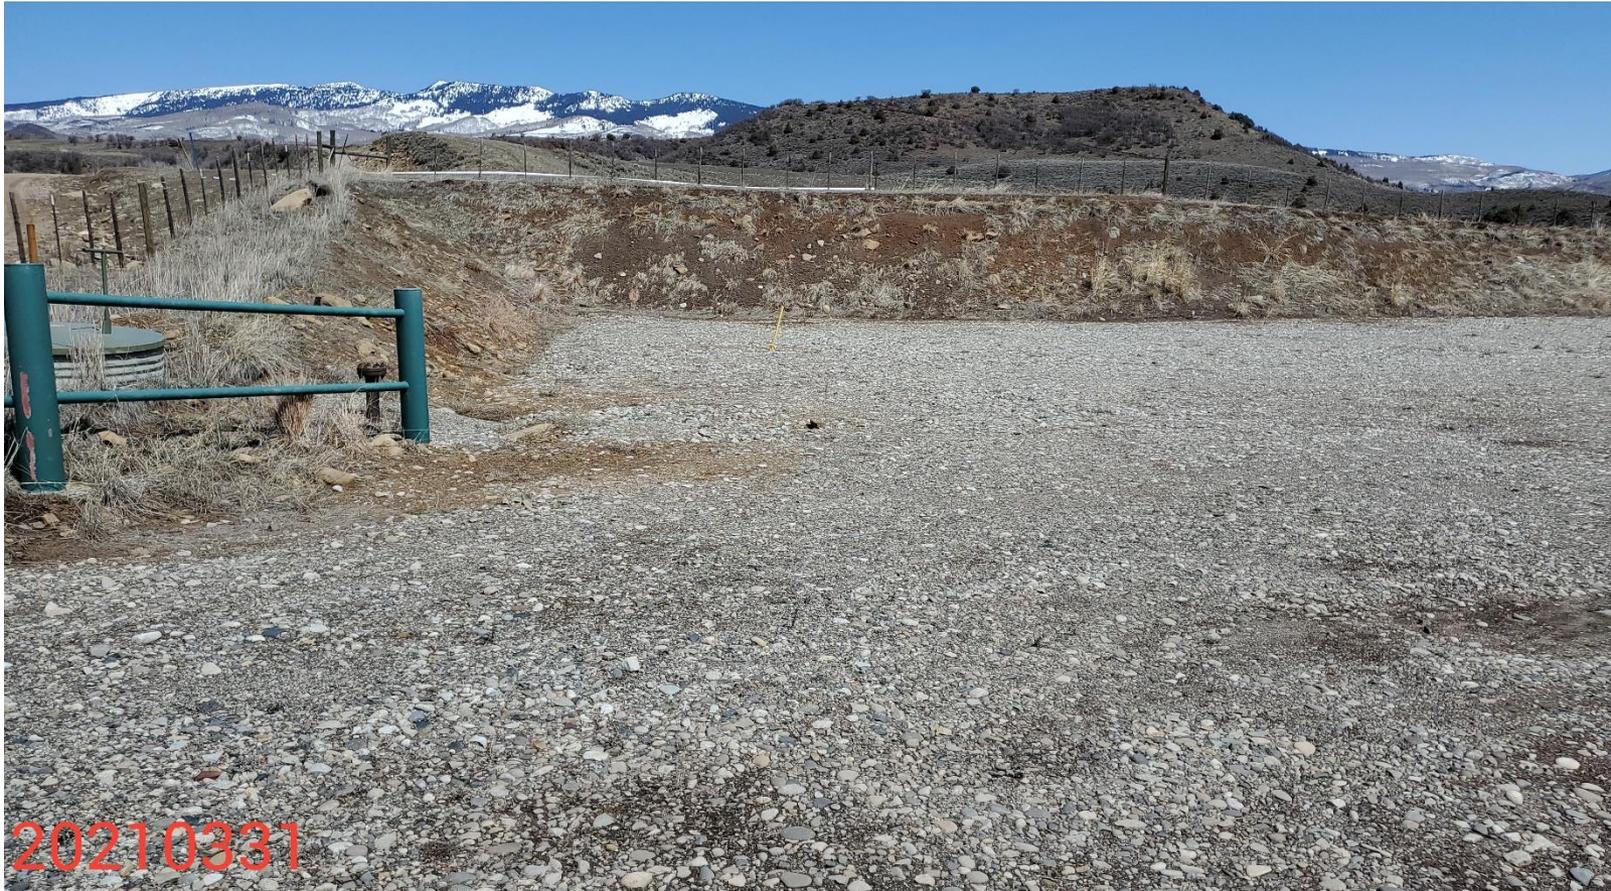
Photo 1: Photo taken from the West end of the Location, facing north. Photos 1-3 provide an overview of the Location from west, east to south.

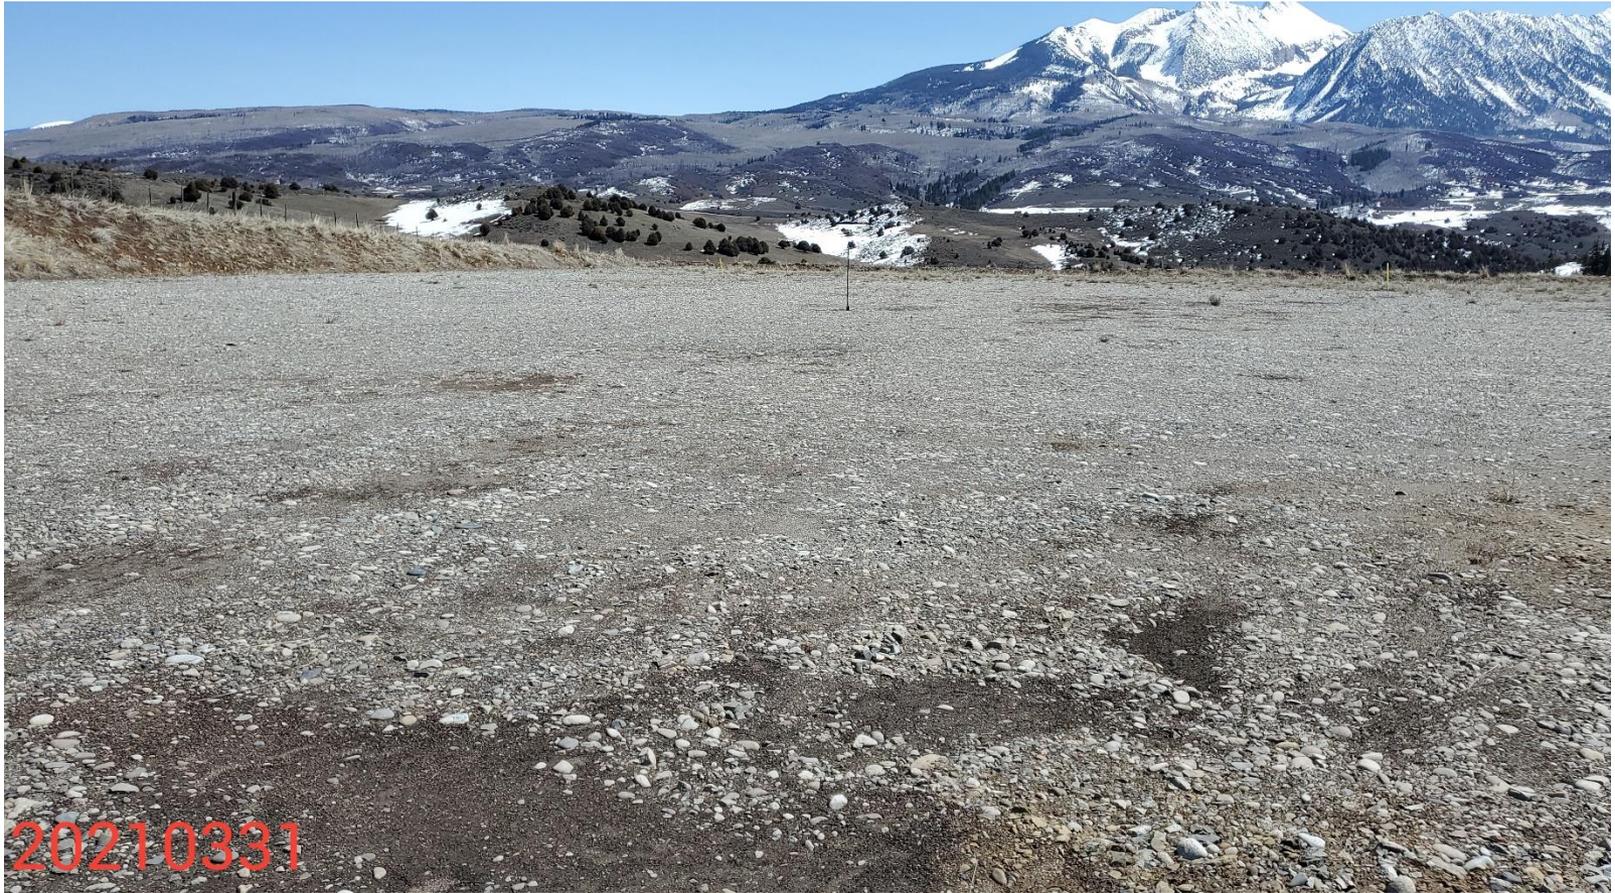
Photo 2: See comments under photo 1.

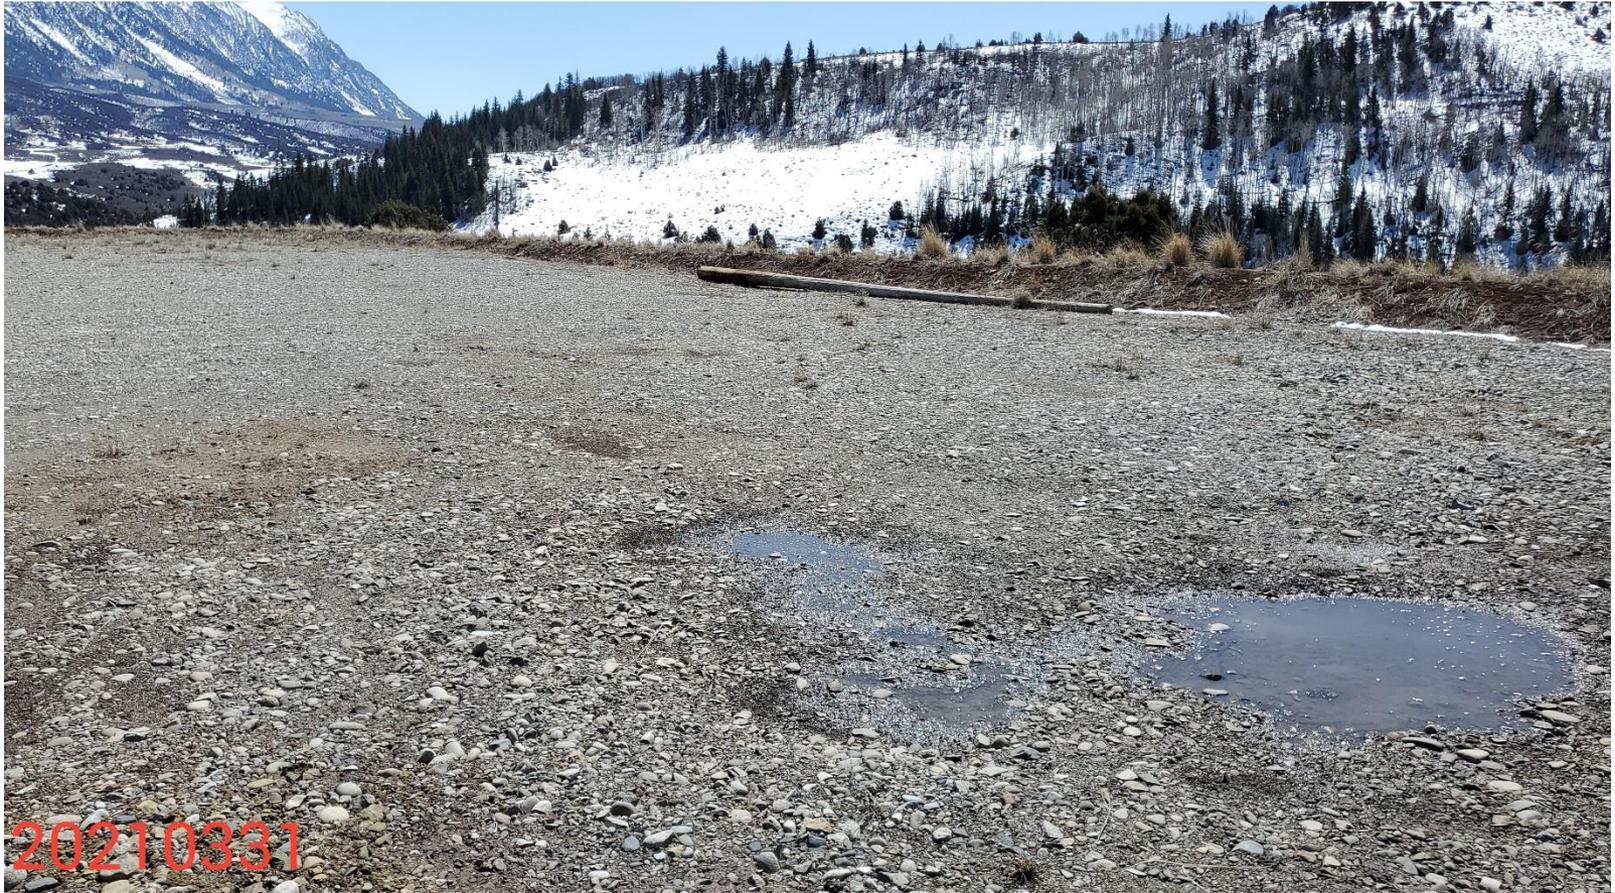
Photo 3: See comments under photo 1.

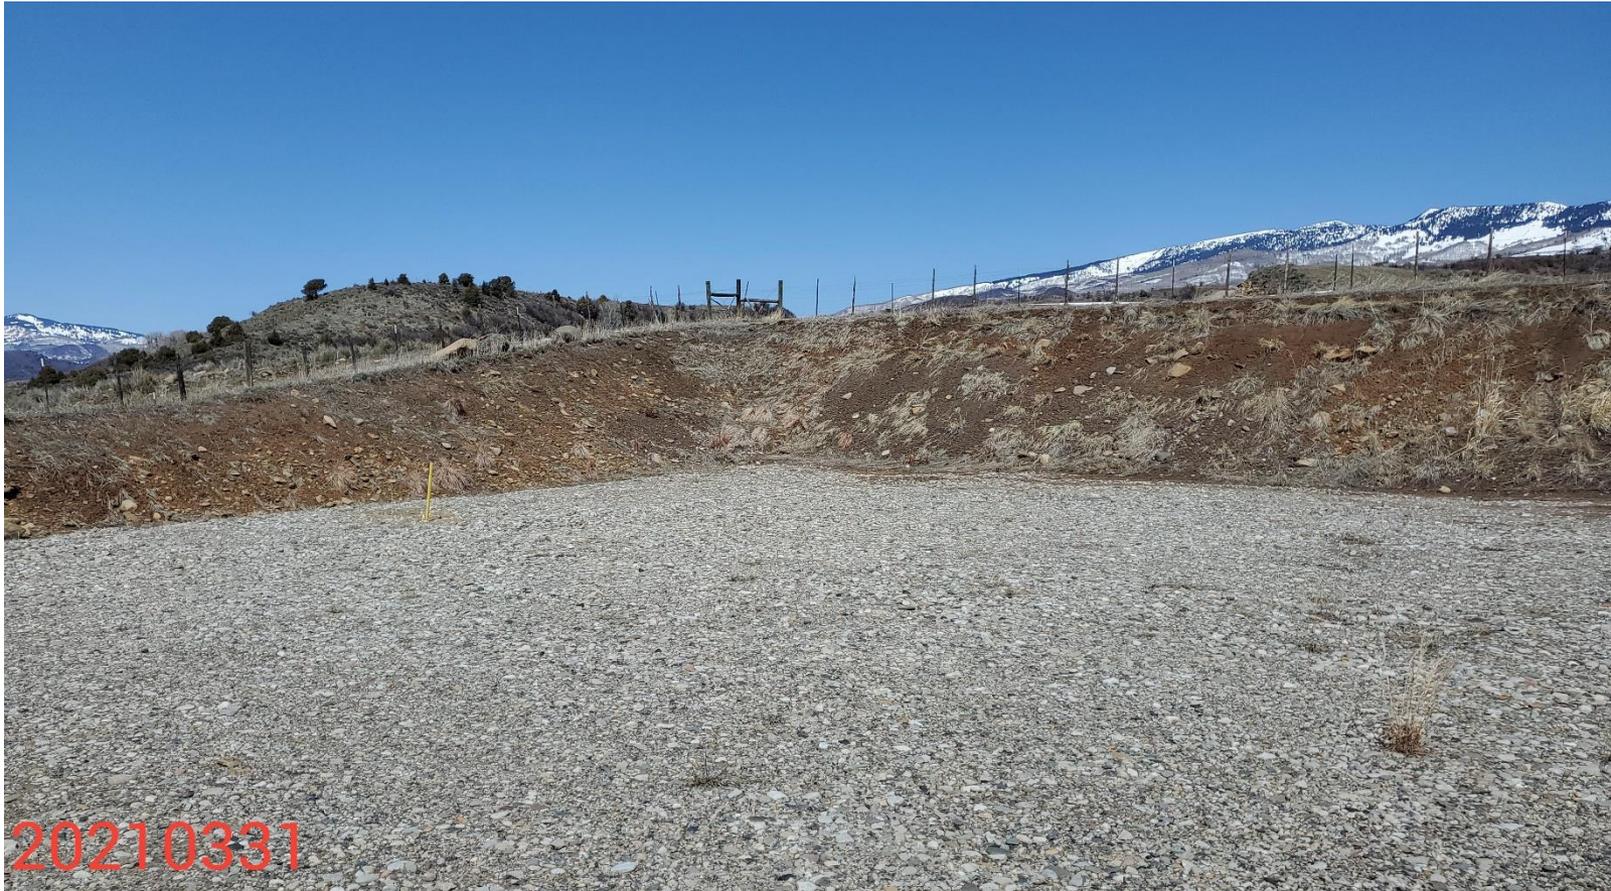
Photo 4: Photo taken from the Location, facing northwest. Photo shows cut slopes of the Location. Previous inspection required Operator to implement control measures to stabilize/protect slopes of the Location; BMPs remain missing or insufficient to stabilize/protect slopes of the Location in accordance with Rule 1002.f.(2)C.

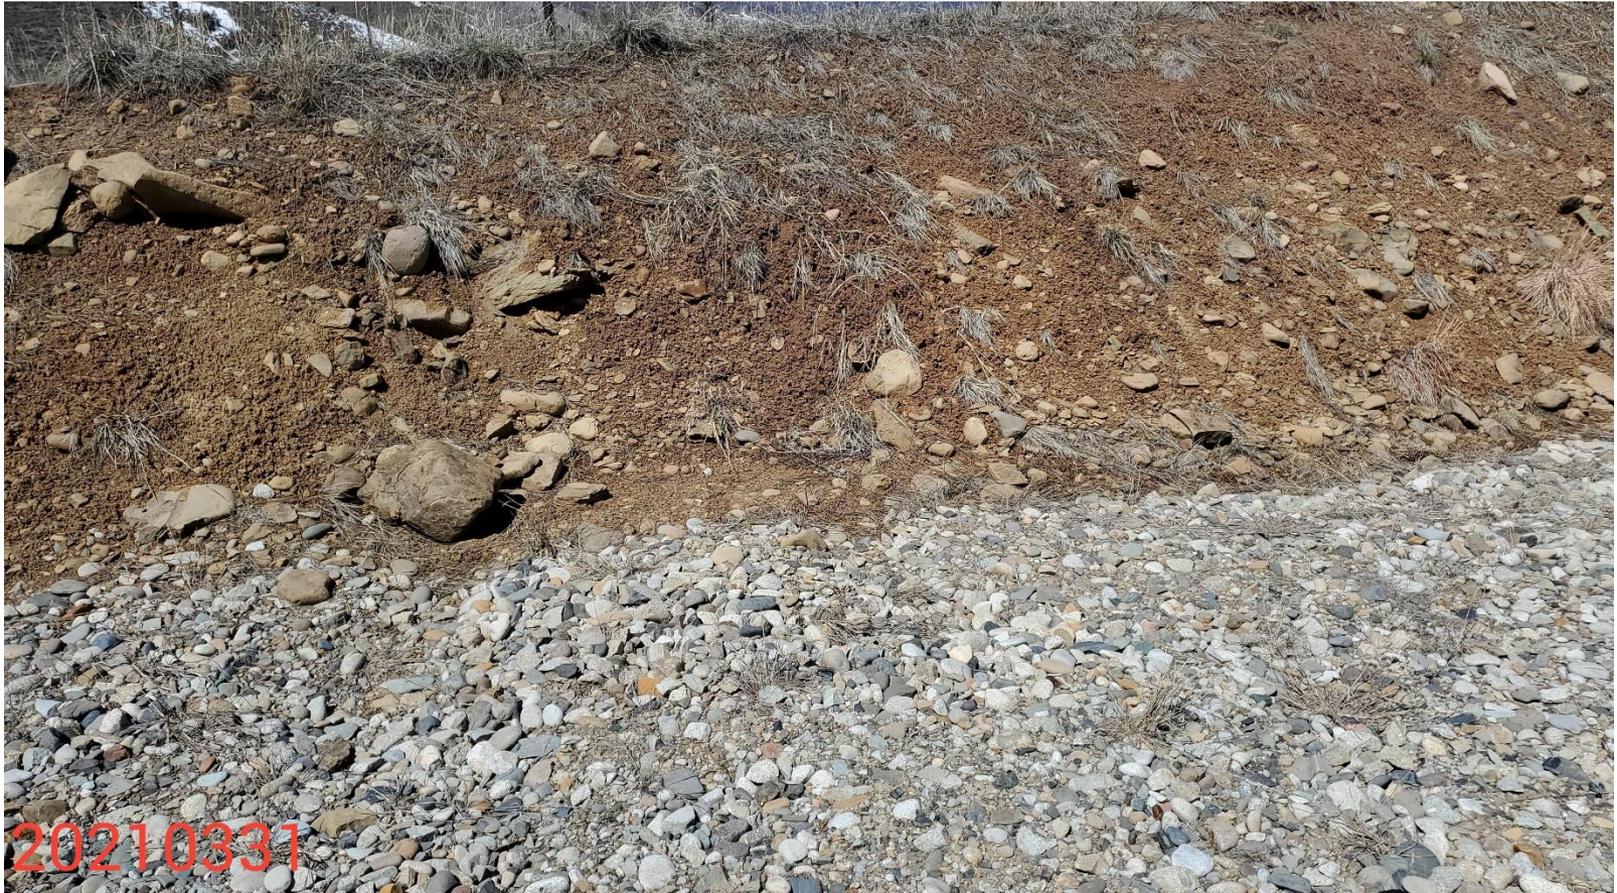
Photo 5: Photo taken from the cut slopes of the Location. Photo shows control measures to stabilize/protect slopes on the Location remain missing or insufficient in accordance with Rule 1002.f.(2)C.

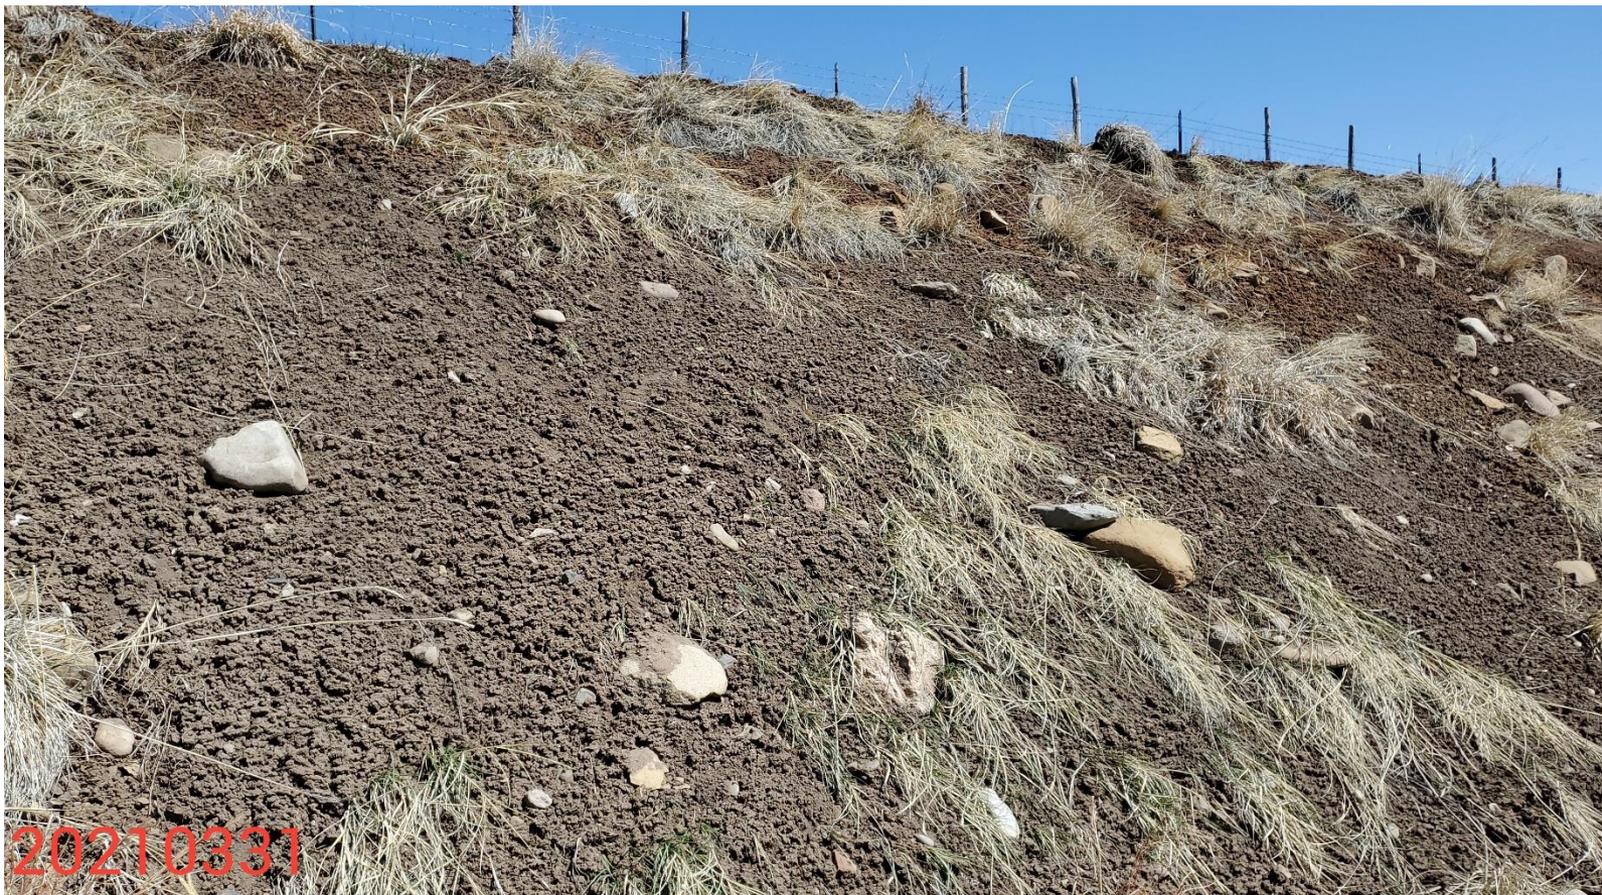
Photo 6: Photo taken from the cut slopes of the Location. Photo shows control measures to stabilize/protect slopes on the Location remain missing or insufficient in accordance with Rule 1002.f.(2)C.

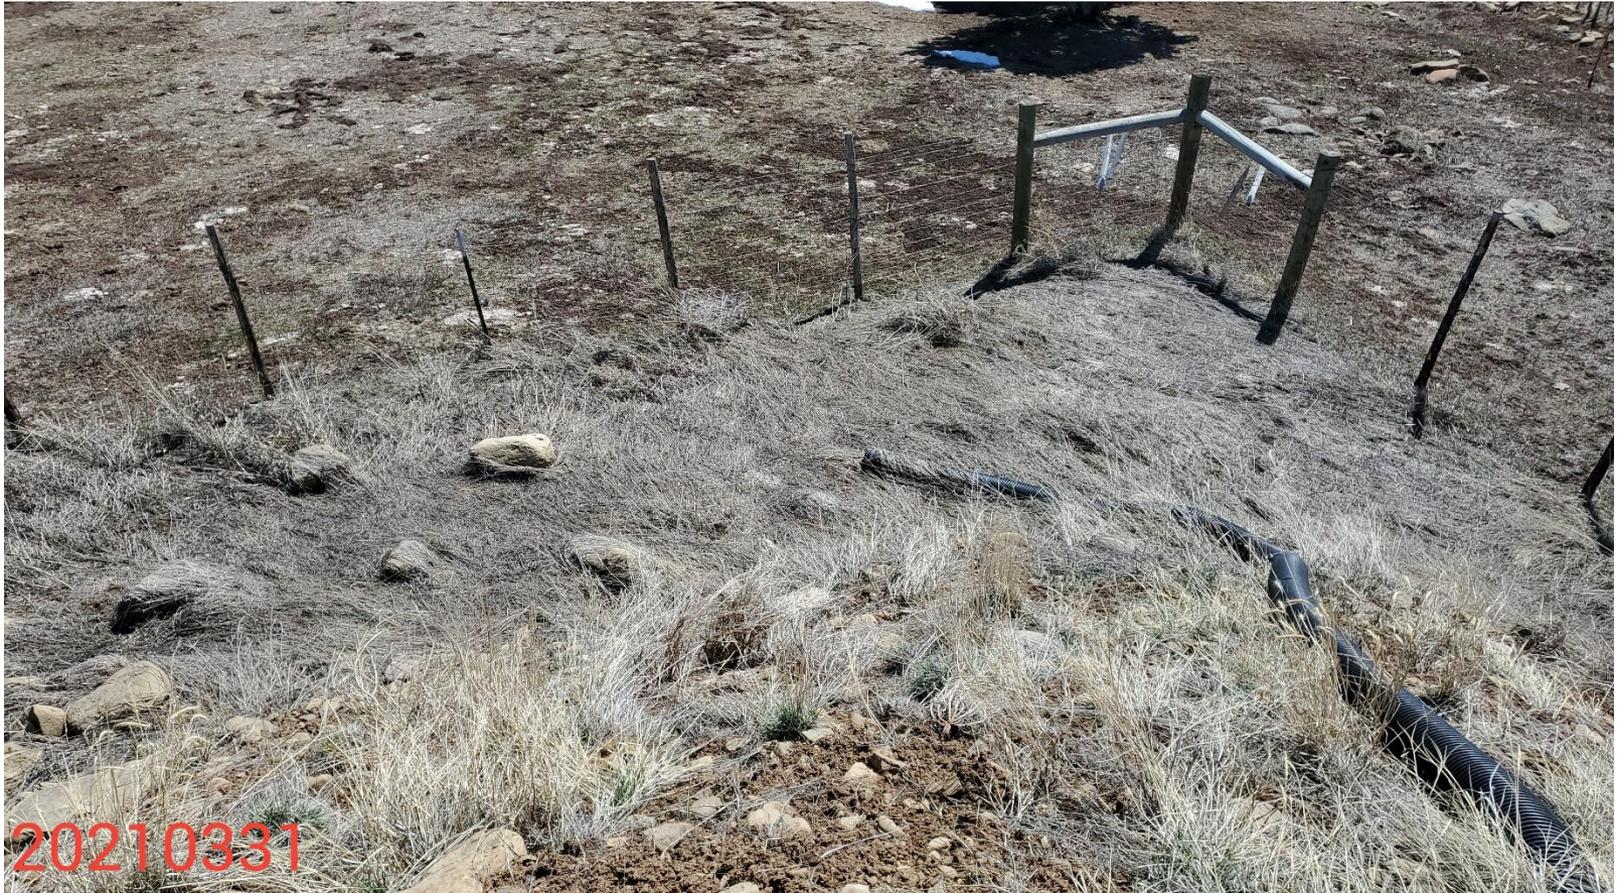
Photo 7: Photo taken from the southeast corner of the Location. Photo shows example of slope drain that has not been constructed with an appropriate outlet in accordance with good engineering practices.

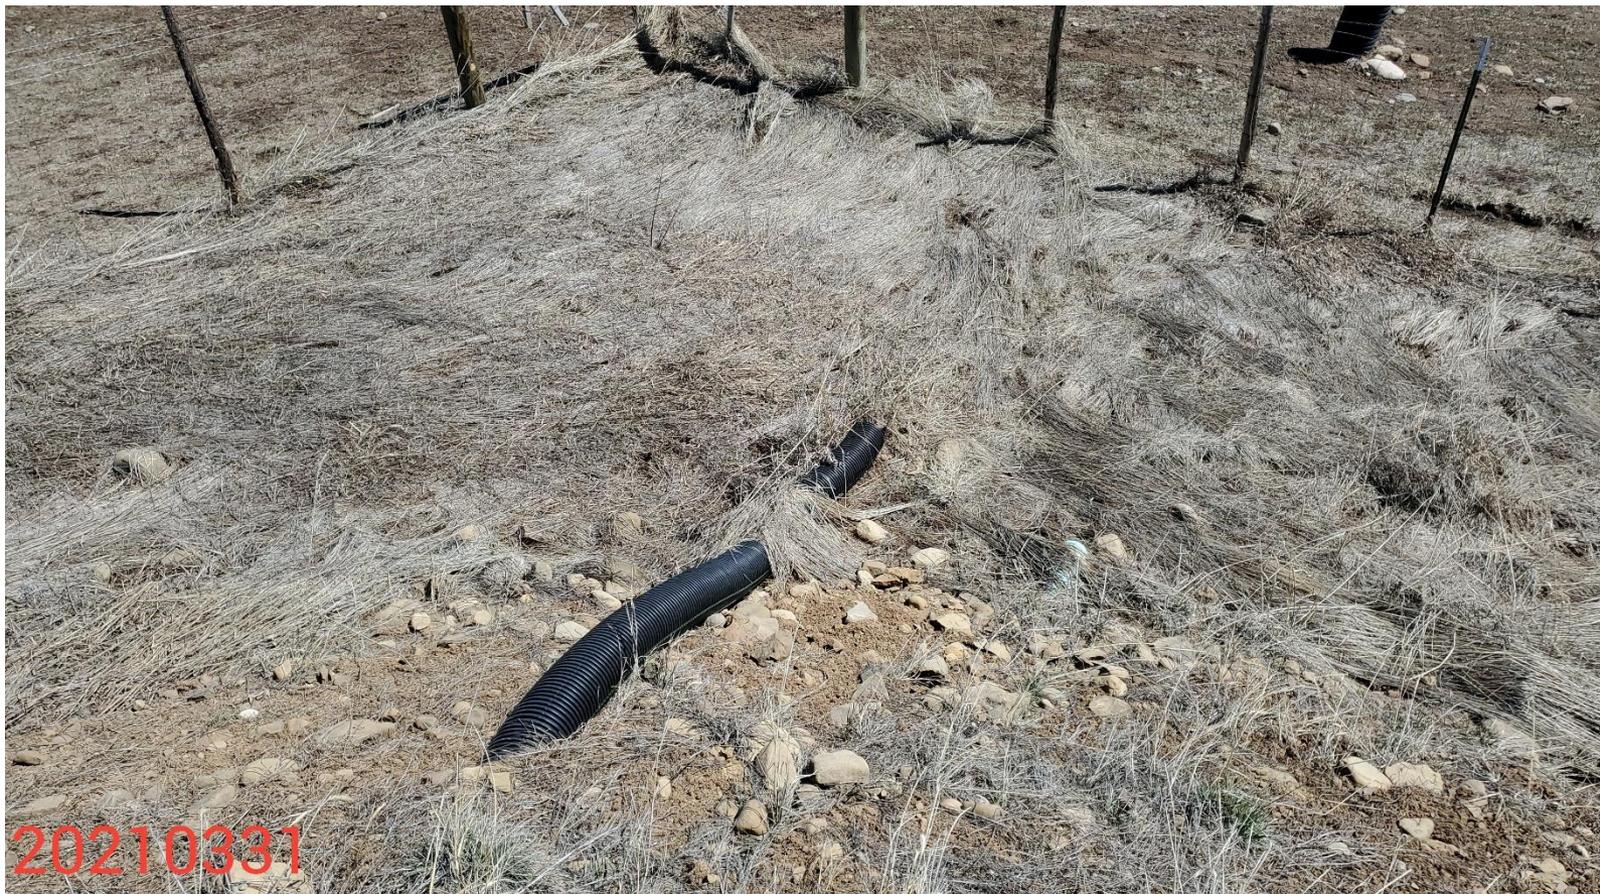
Photo 8: Photo taken from the northeast corner of the Location. Photo shows example of slope drain that has not been constructed with an appropriate outlet in accordance with good engineering practices.
