Inspection Photos

3/31/2021

Operator: SG INTERESTS I LTD # 77330

Location ID: 414132

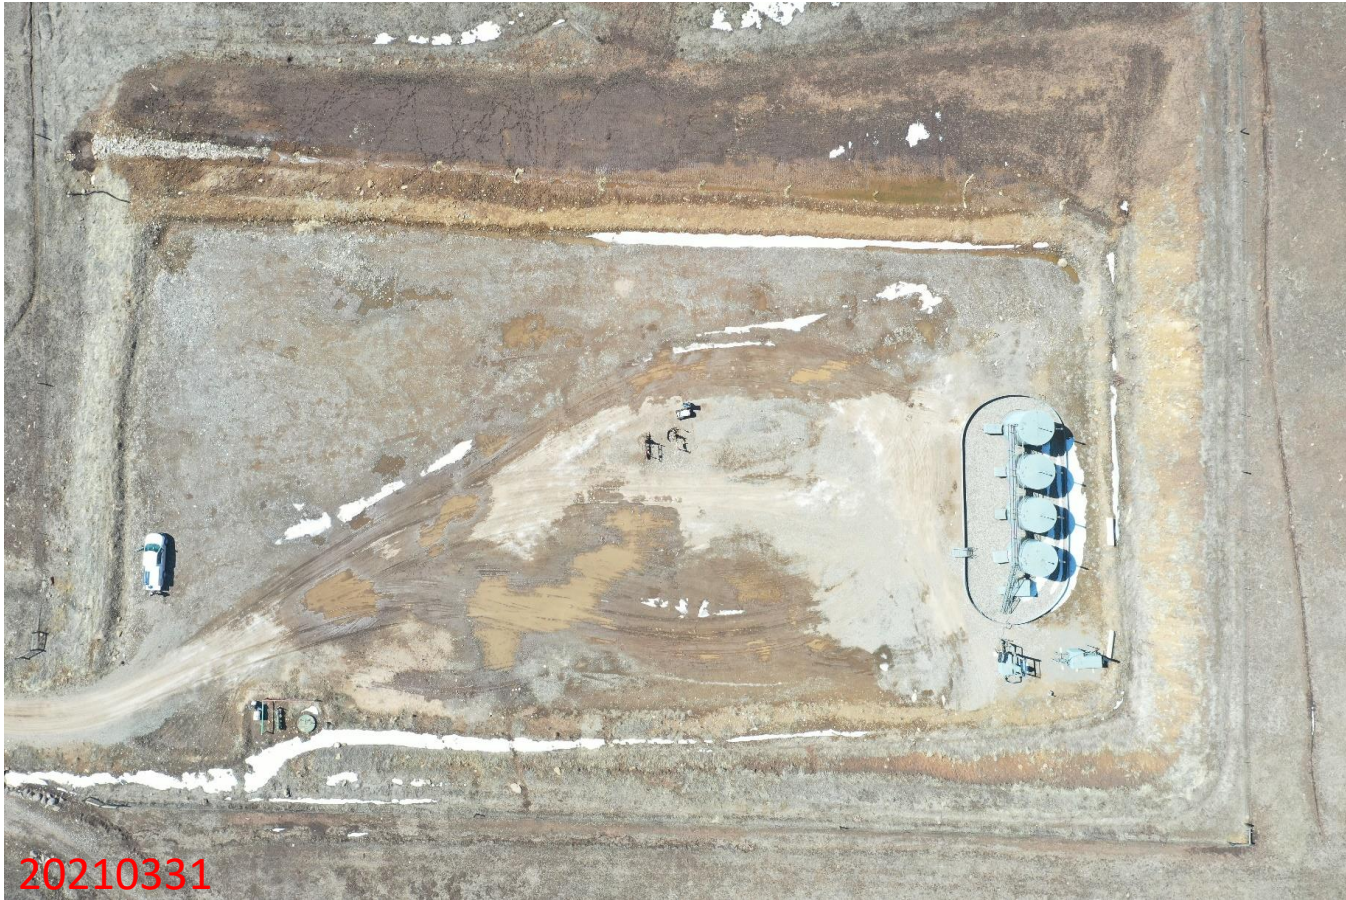
Photo 1: Photo taken with a small unmanned aerial system. Photo shows aerial image/overview of the Location. Previous inspection required Operator to conduct interim reclamation on areas not needed for production. Photo shows reclamation of areas not needed for production on the Location has not been conducted pursuant to 1003 requirements.

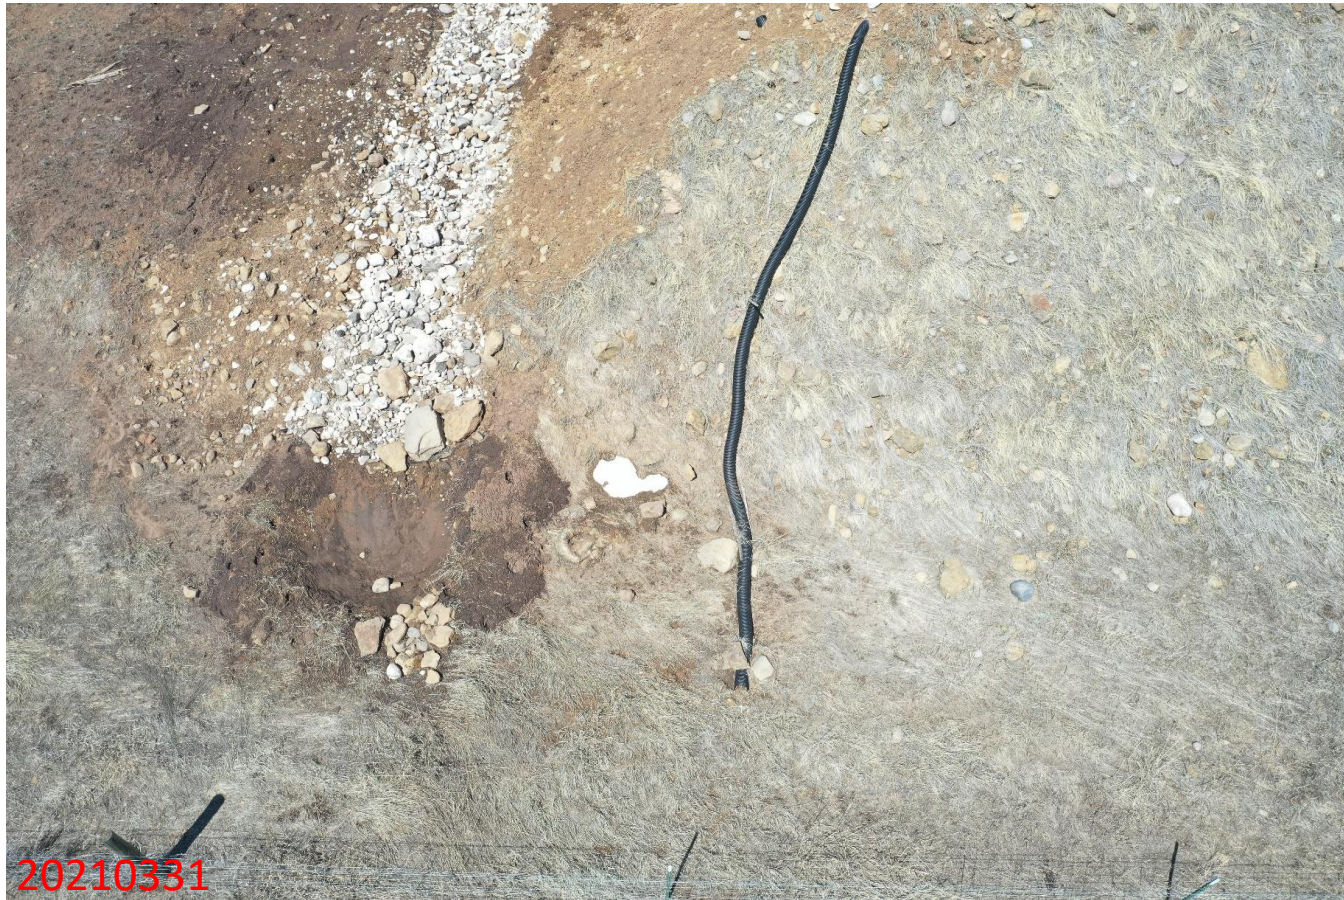
Photo 2: Aerial image showing sediment trap, ditch and slope drain on the southwestern end of the Location; Slope drain has not been constructed with an appropriate outlet per good engineering practices.

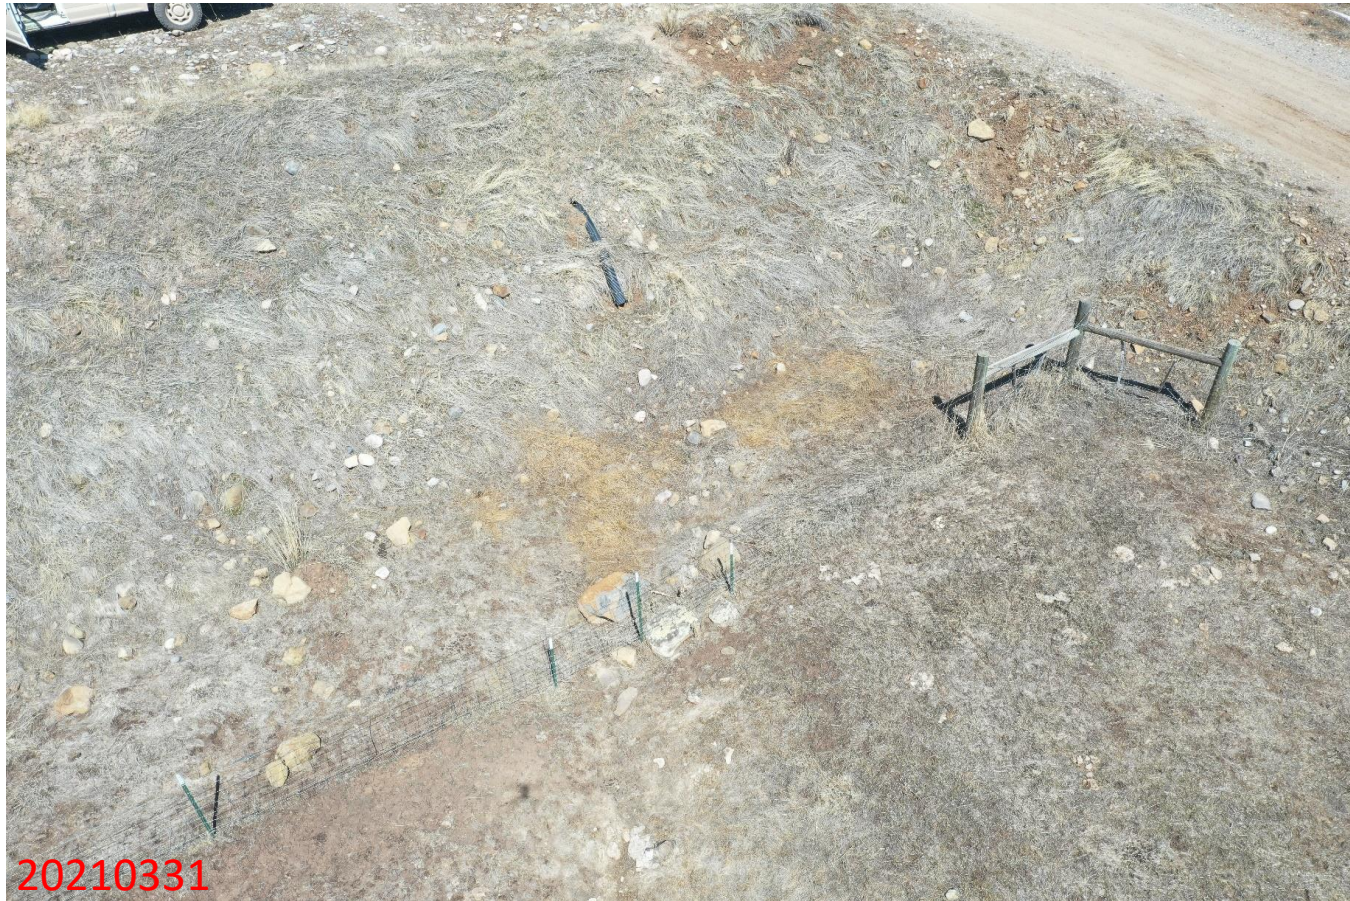
Photo 3: Aerial image showing slope drain on the southeastern end of the Location;
Slope drain has not been constructed with an appropriate outlet per good engineering
practices

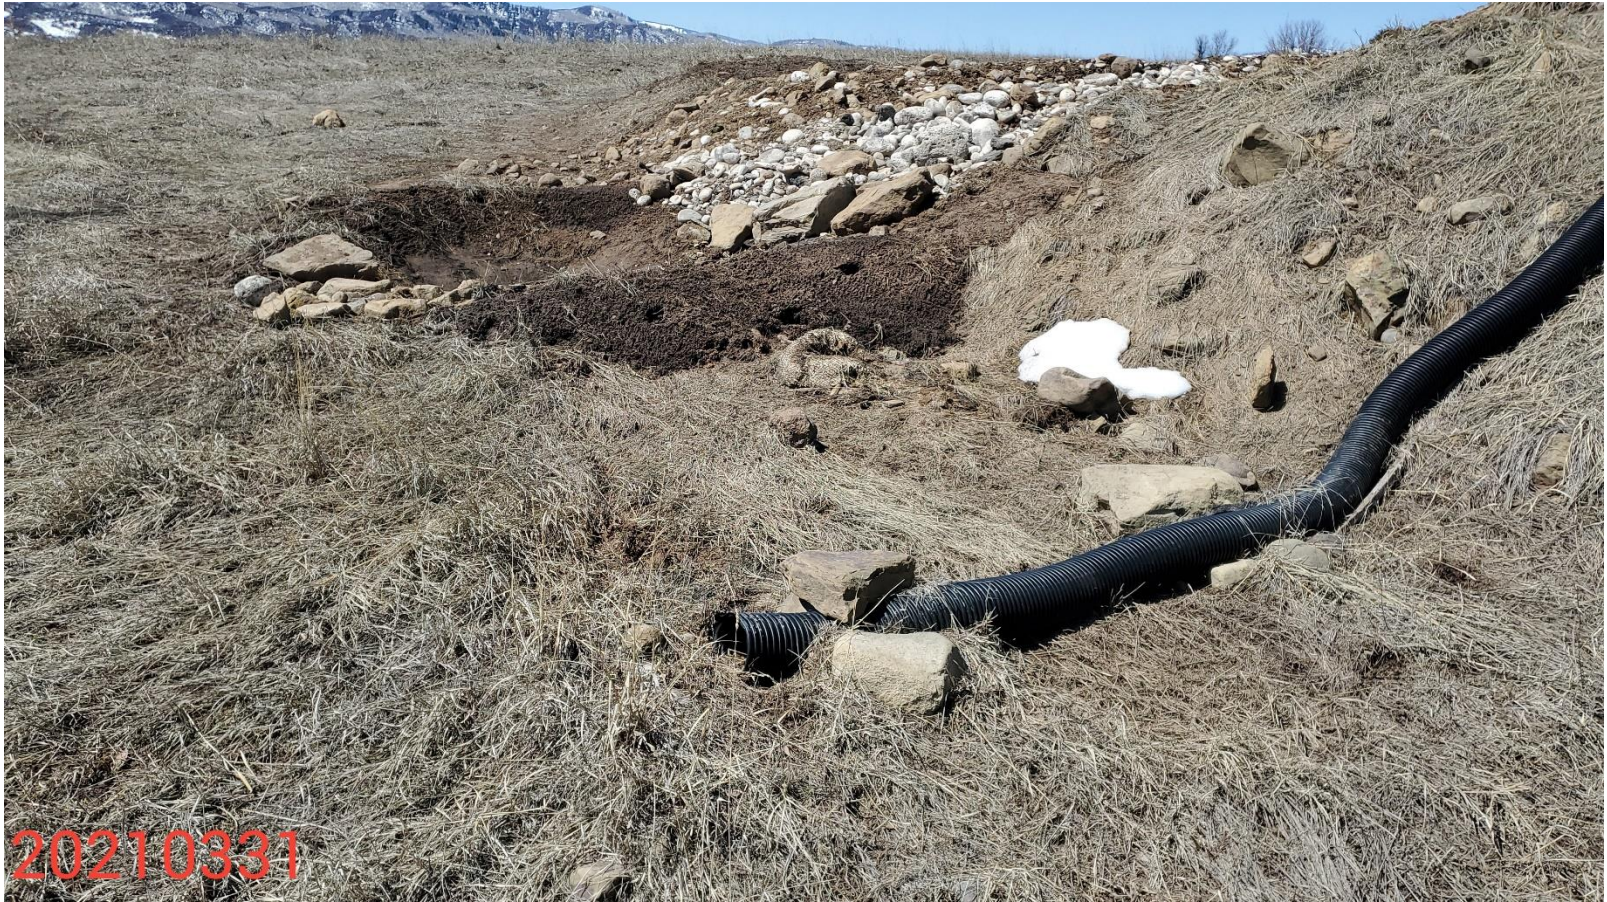
Photo 4: Photo taken from the southwest end of the Location. Photo shows slope drain outlet, sediment trap and ditch; BMPs have not been installed in accordance with good engineering practices.

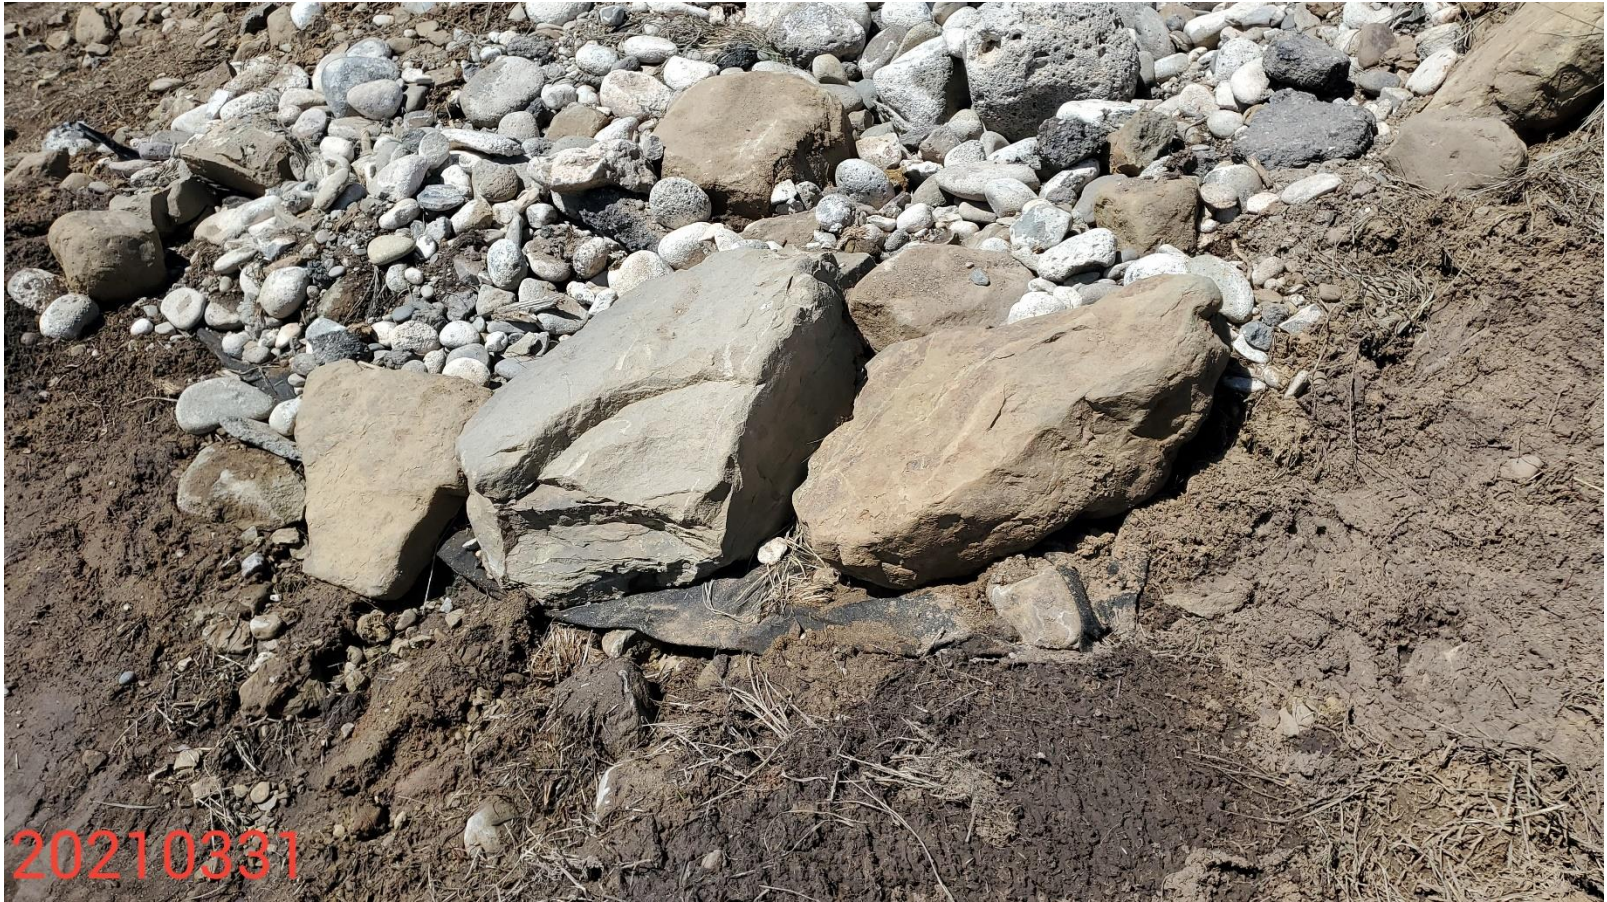
Photo 5: Photo shows stormwater ditch; inlet to sediment trap has been lined and armored with various sized aggregate, however, rounded river stone appears to have been utilized in the ditch, and is not considered a good engineering practice.

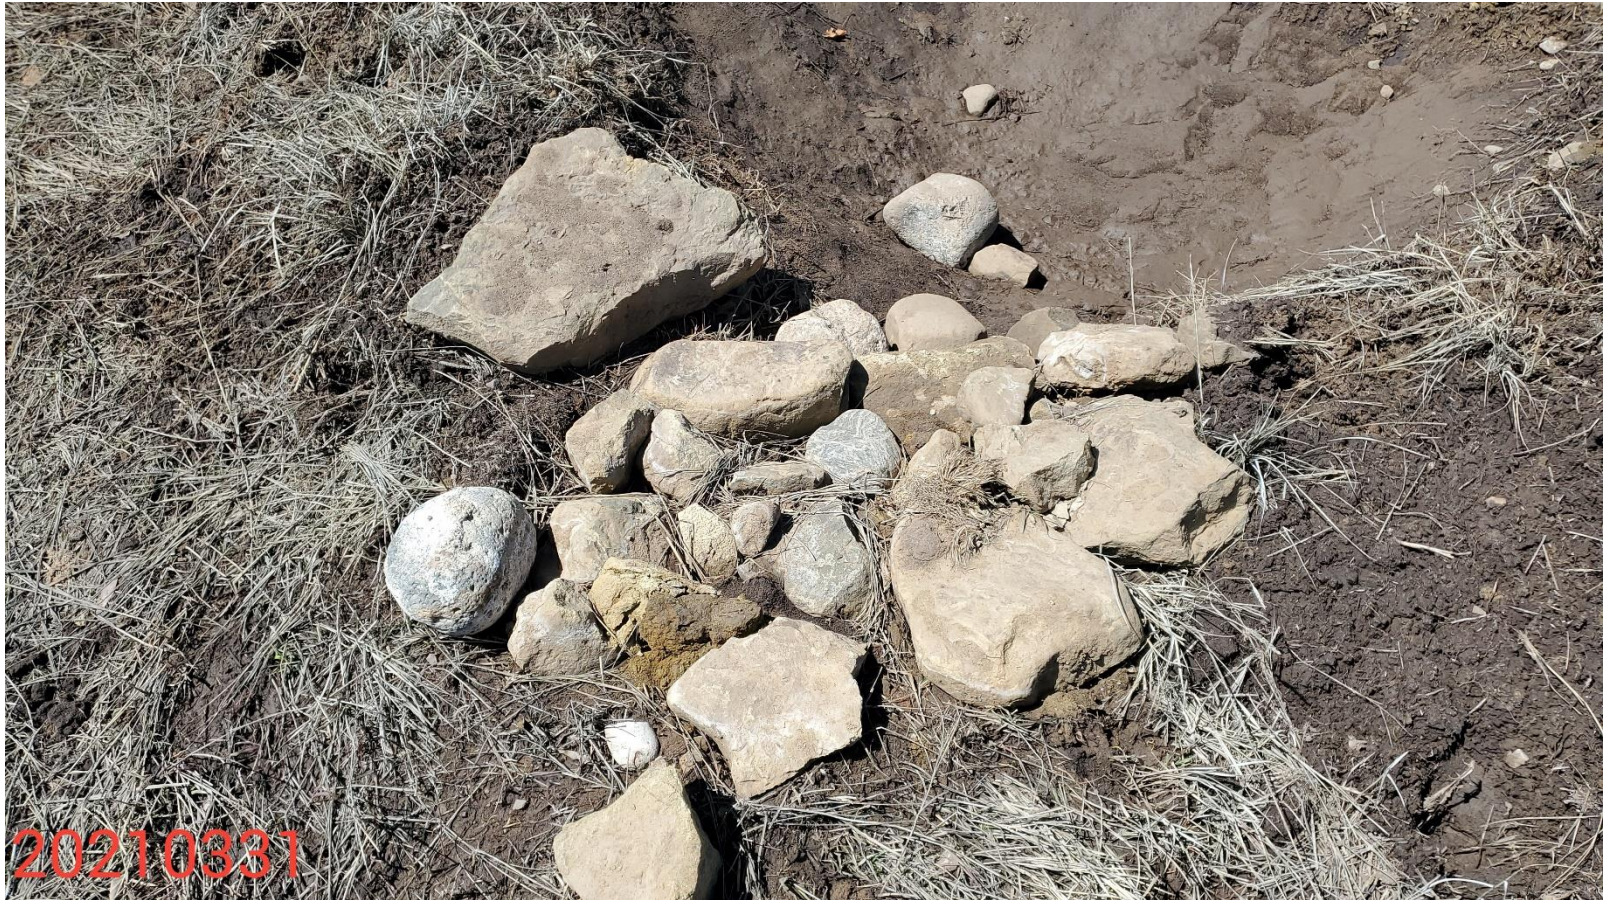
Photo 6: Photo taken from the northeast corner of the Location. Photo shows outlet at sediment trap; BMP has not been constructed in accordance with good engineering practices.

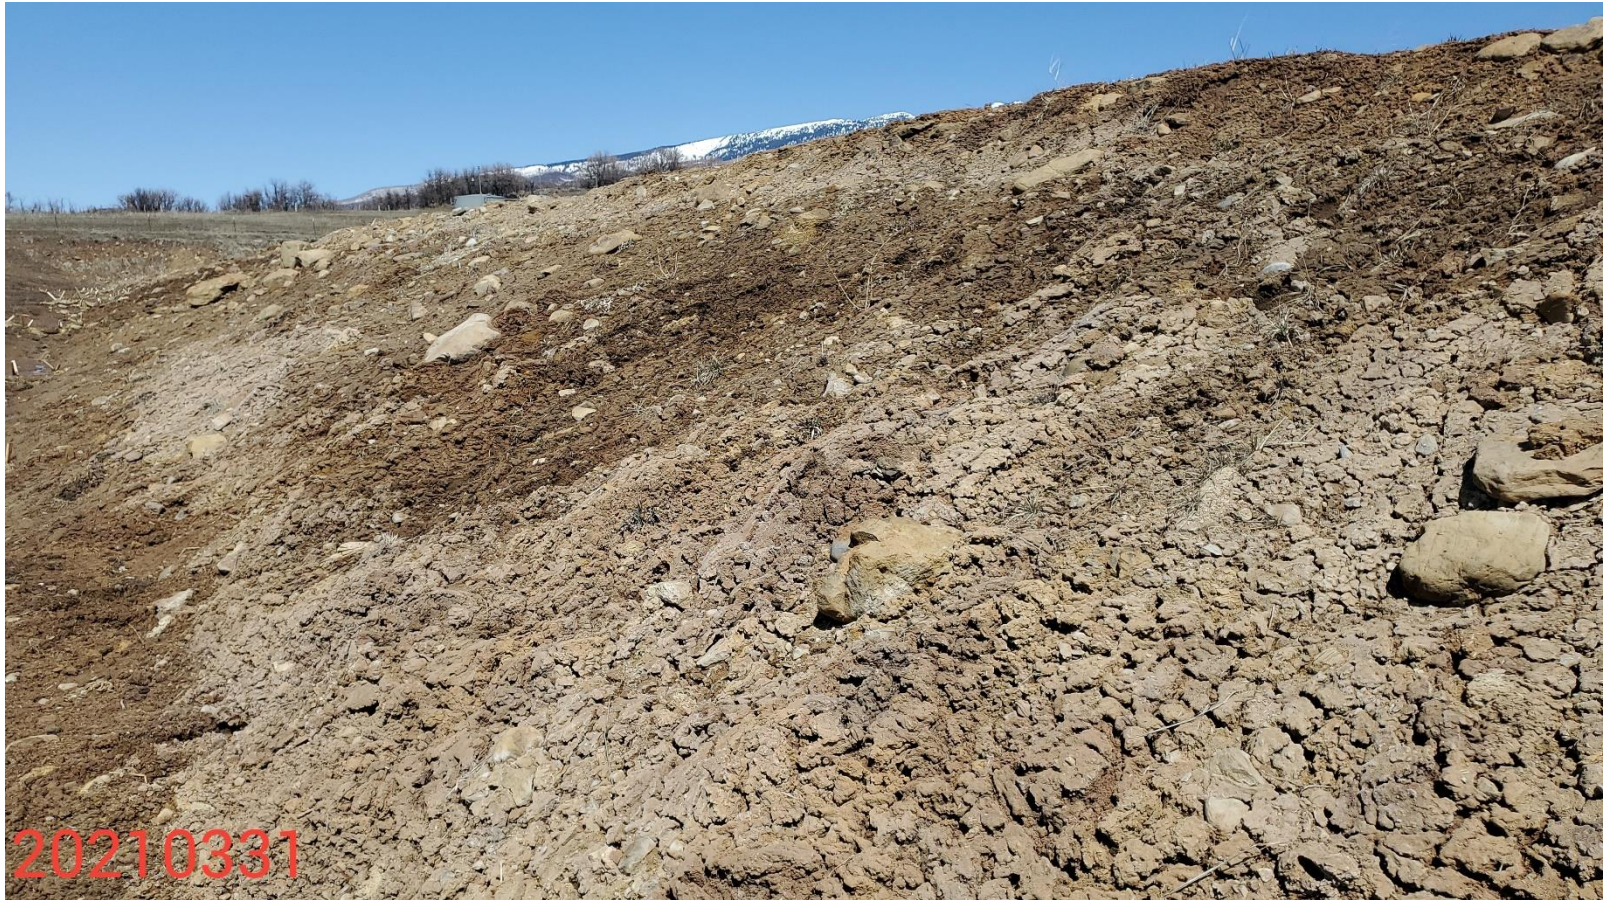
Photo 7: Photo taken from the slopes on the west end of the Location, facing north. Photo shows control measures to stabilize and protect slopes on the Location remain missing or insufficient.

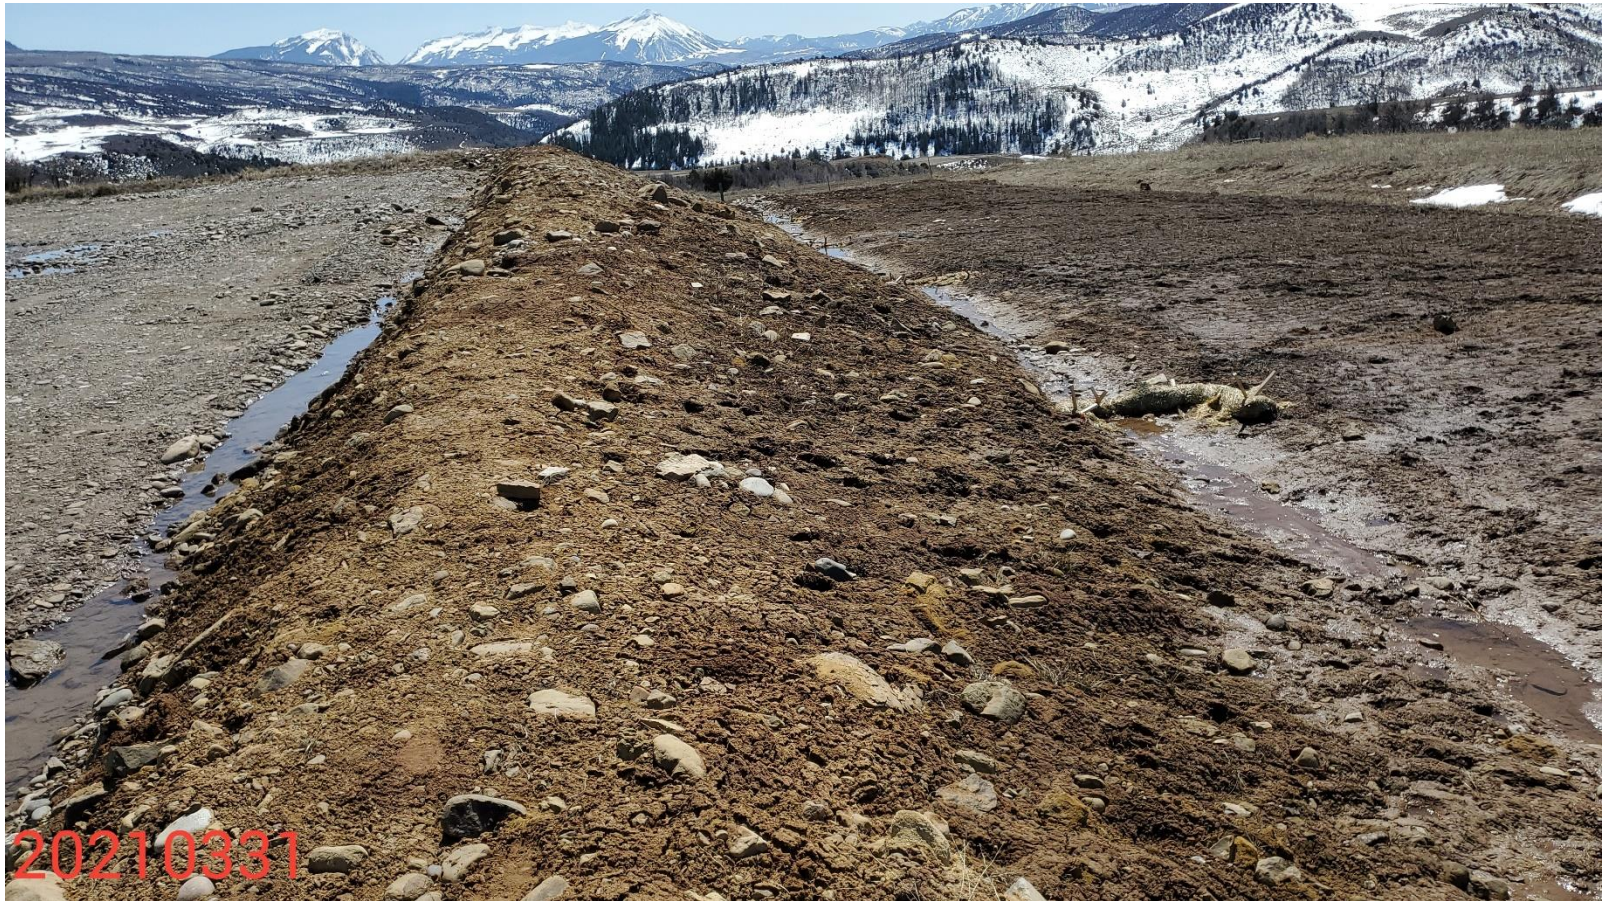
Photo 8: Photo taken from the slopes on the west end of the Location, facing south. Photo shows control measures to stabilize and protect slopes on the Location remain missing or insufficient.

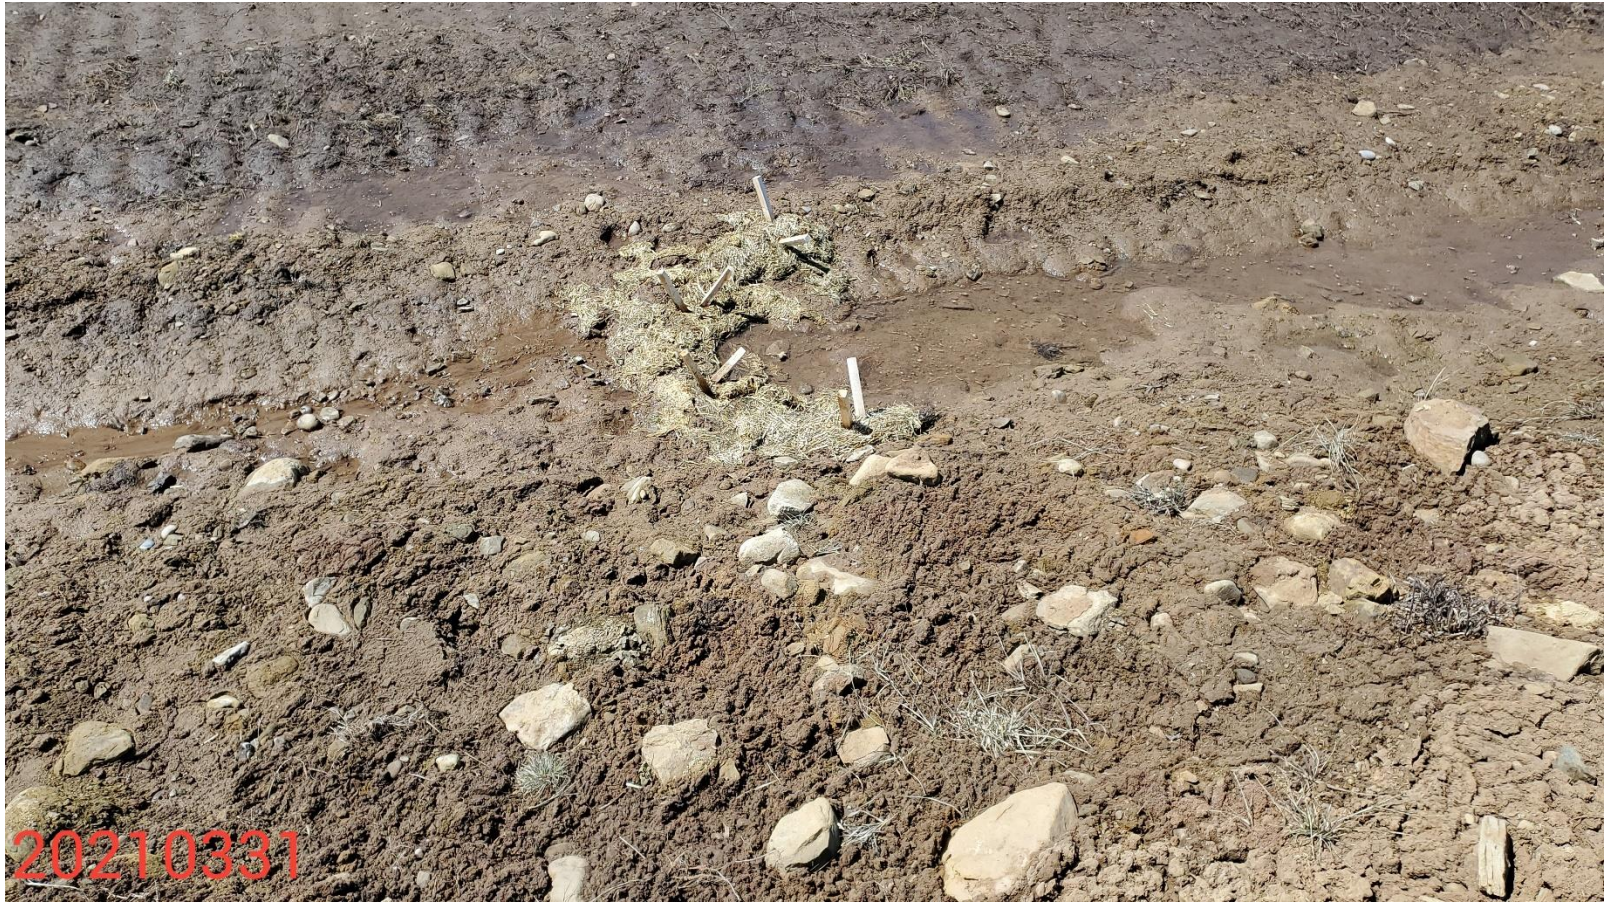
Photo 9: Photo taken from the west end of the Location. Photo shows example of wattle control measures implemented as velocity checks that have not been maintained in a proper functioning condition.

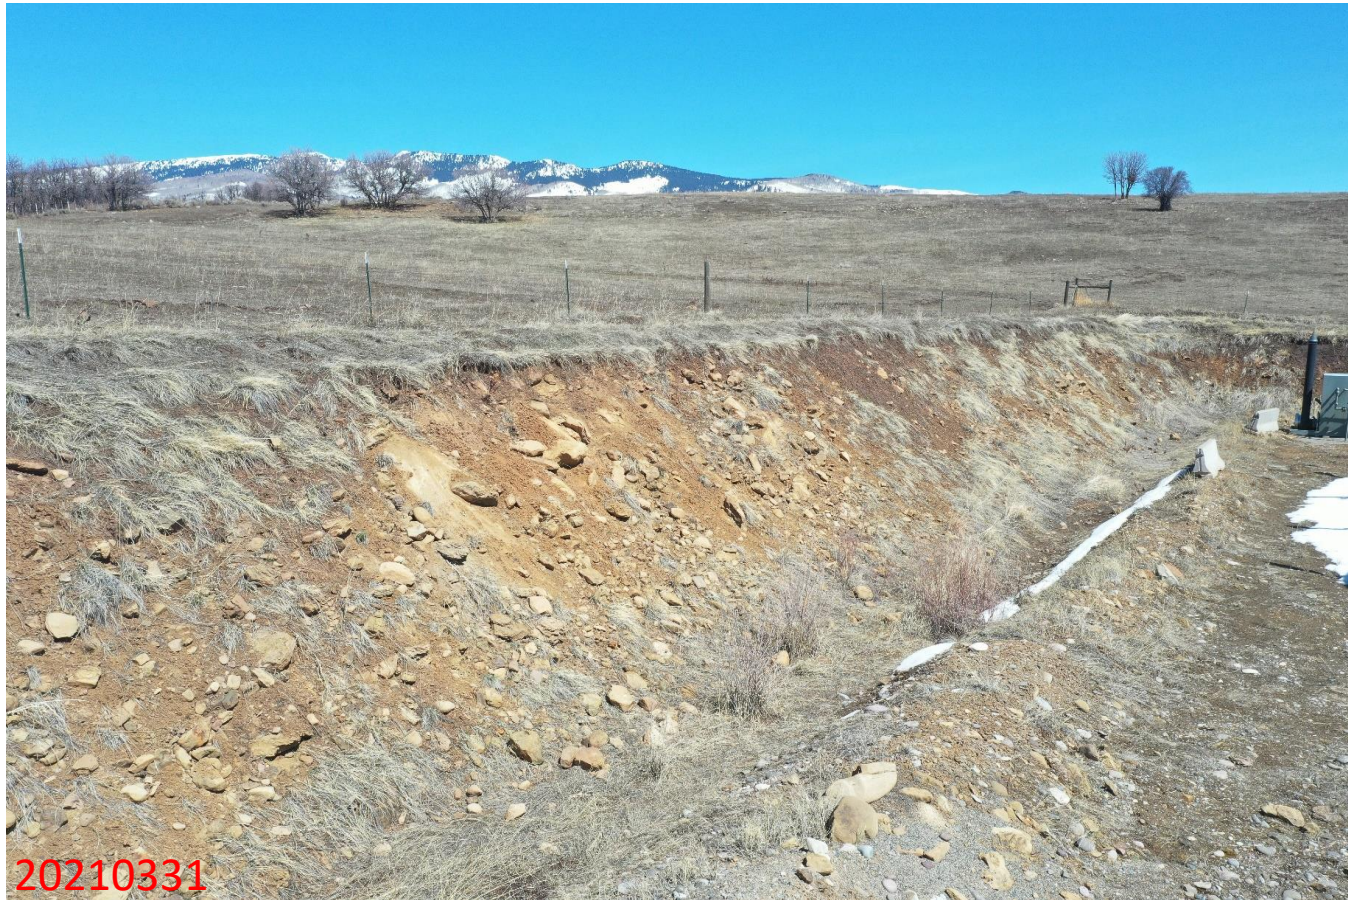
Photo 10: Photo taken from the cut slopes on the north end of the Location. Photo shows control measures to stabilize and protect slopes on the Location remain missing or insufficient.

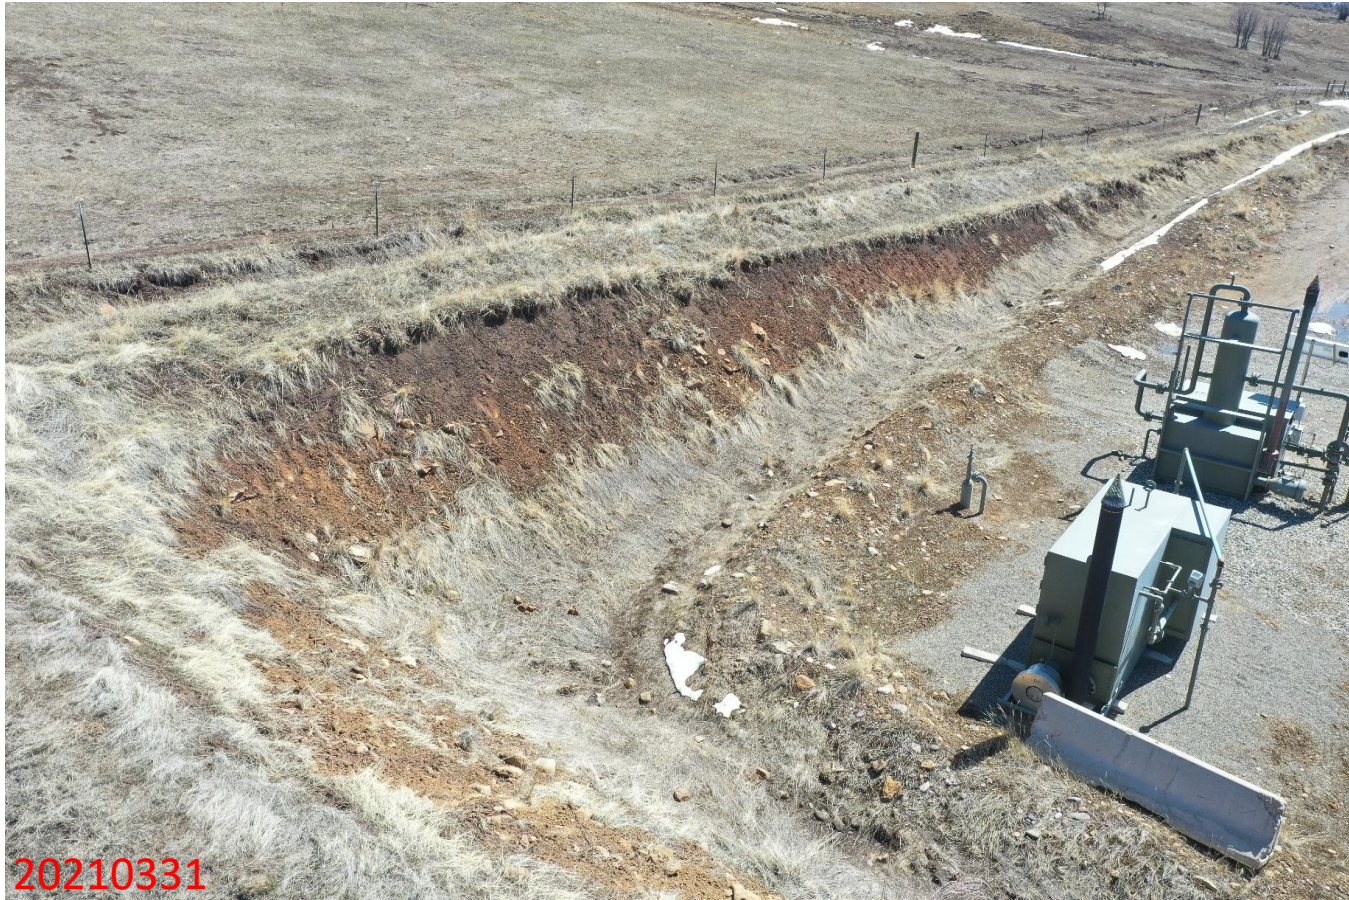
Photo 11: Photo taken from the cut slopes on the northeast end of the Location. Photo shows control measures to stabilize and protect slopes on the Location remain missing or insufficient.

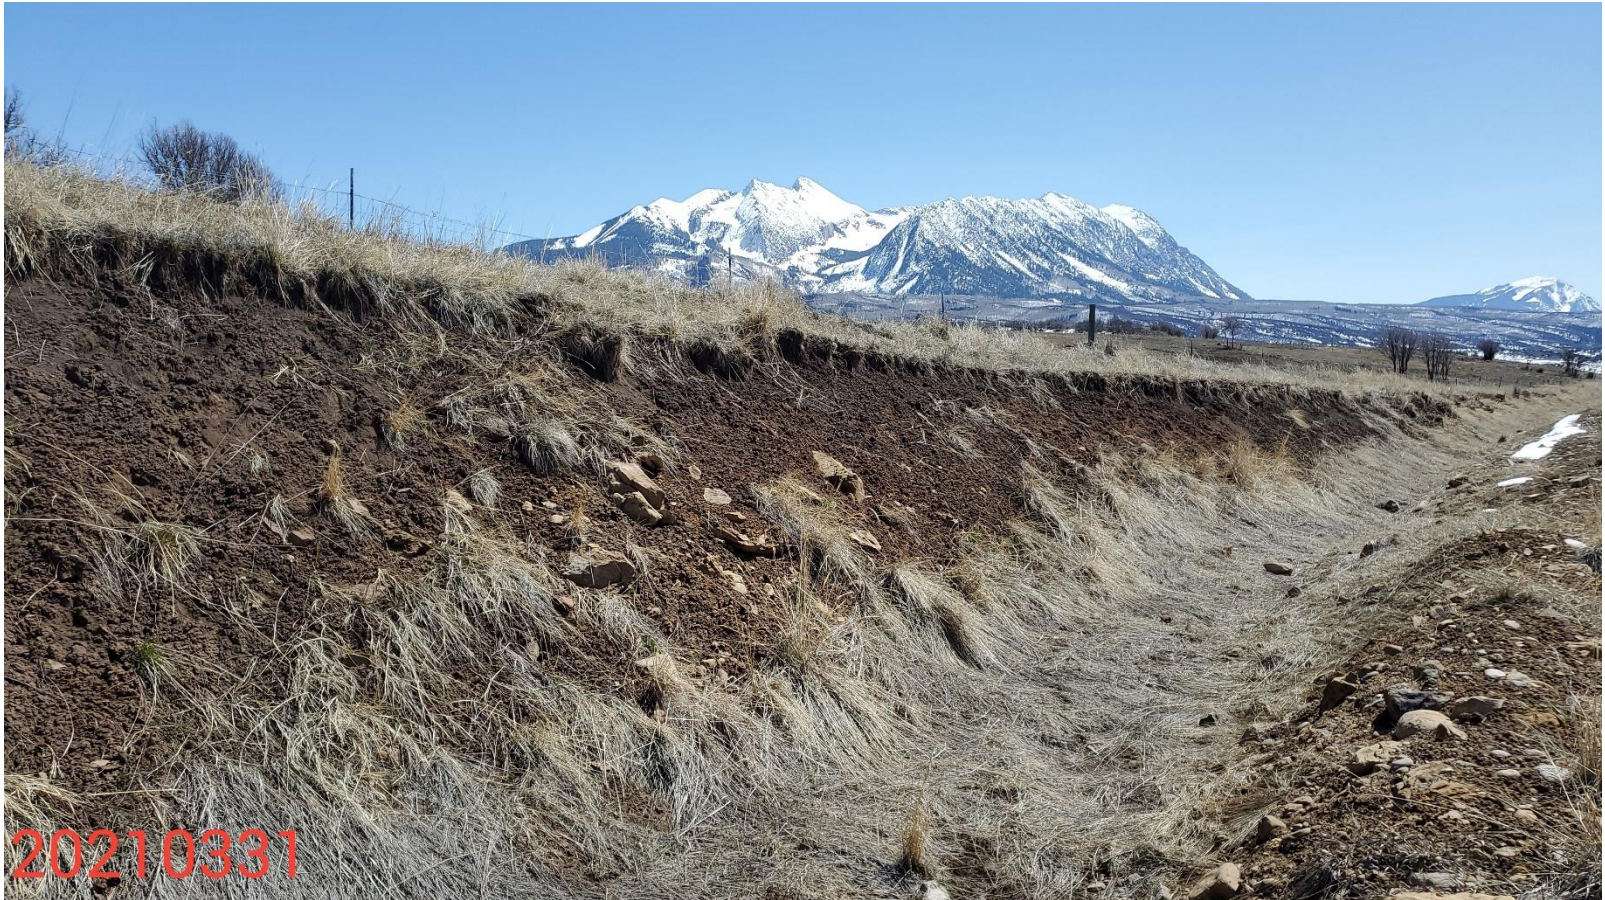
Photo 12: Photo taken from the cut slopes on the northeast end of the Location. Photo shows control measures to stabilize and protect slopes on the Location remain missing or insufficient.

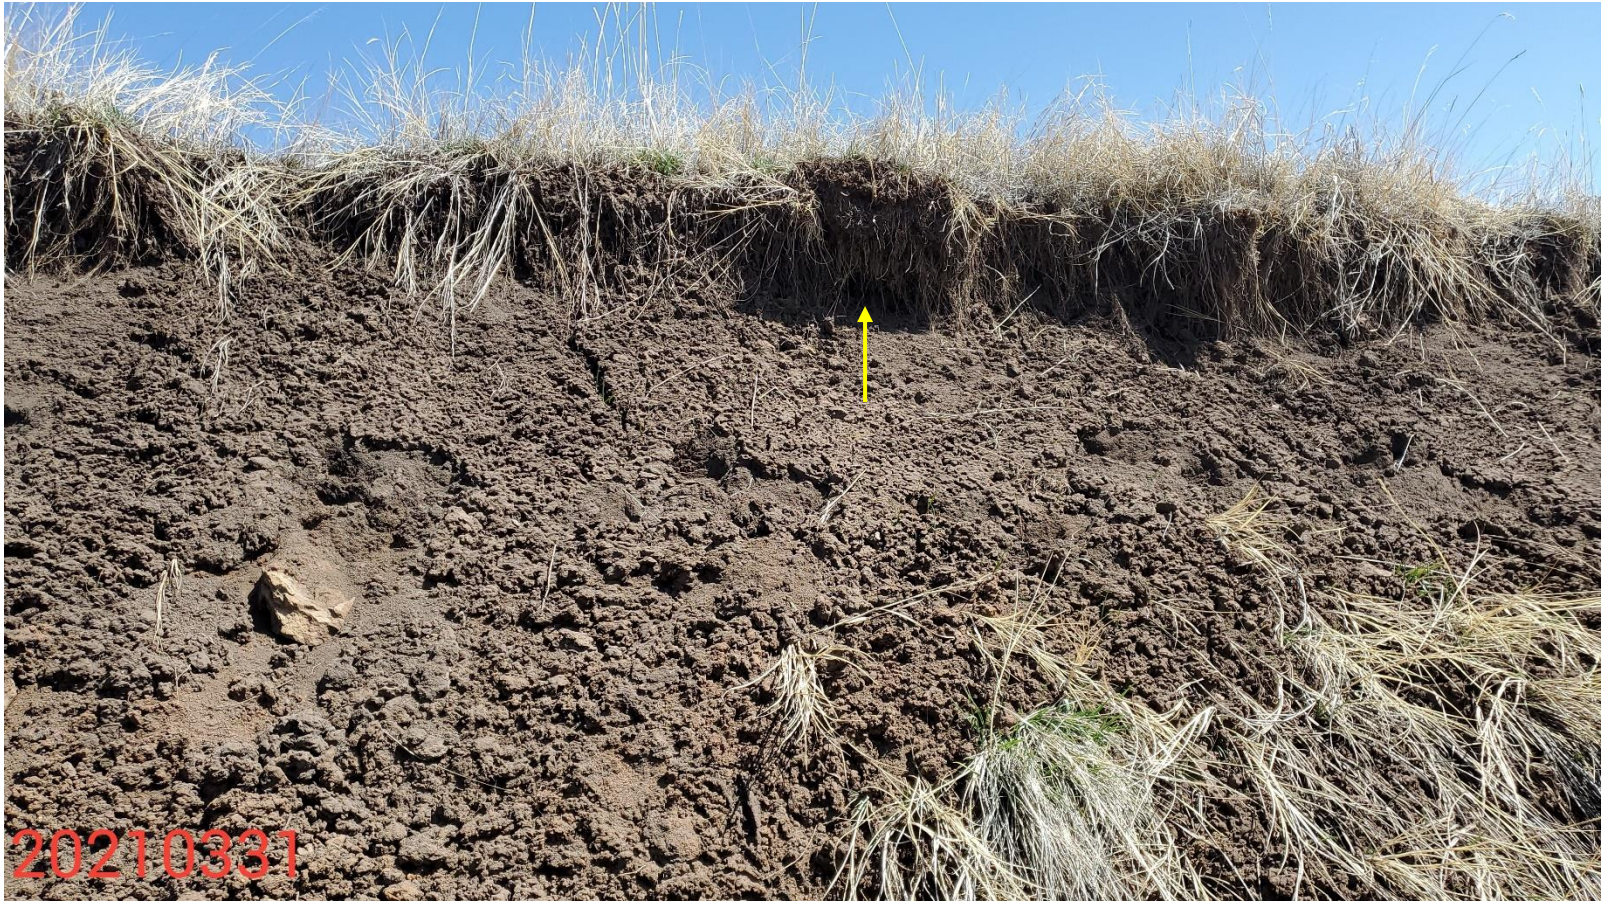
Photo 13: Photo taken from the cut slopes on the northeast end of the Location. Photo shows control measures to stabilize and protect slopes on the Location remain missing or insufficient. Photo also shows example of erosion that has cut beneath vegetation and plant roots, compromising stability.
