Inspection Photos

API: 071-09582

Operator: OGRIS OPERATING LLC

Inspection Date: 4/1/2021

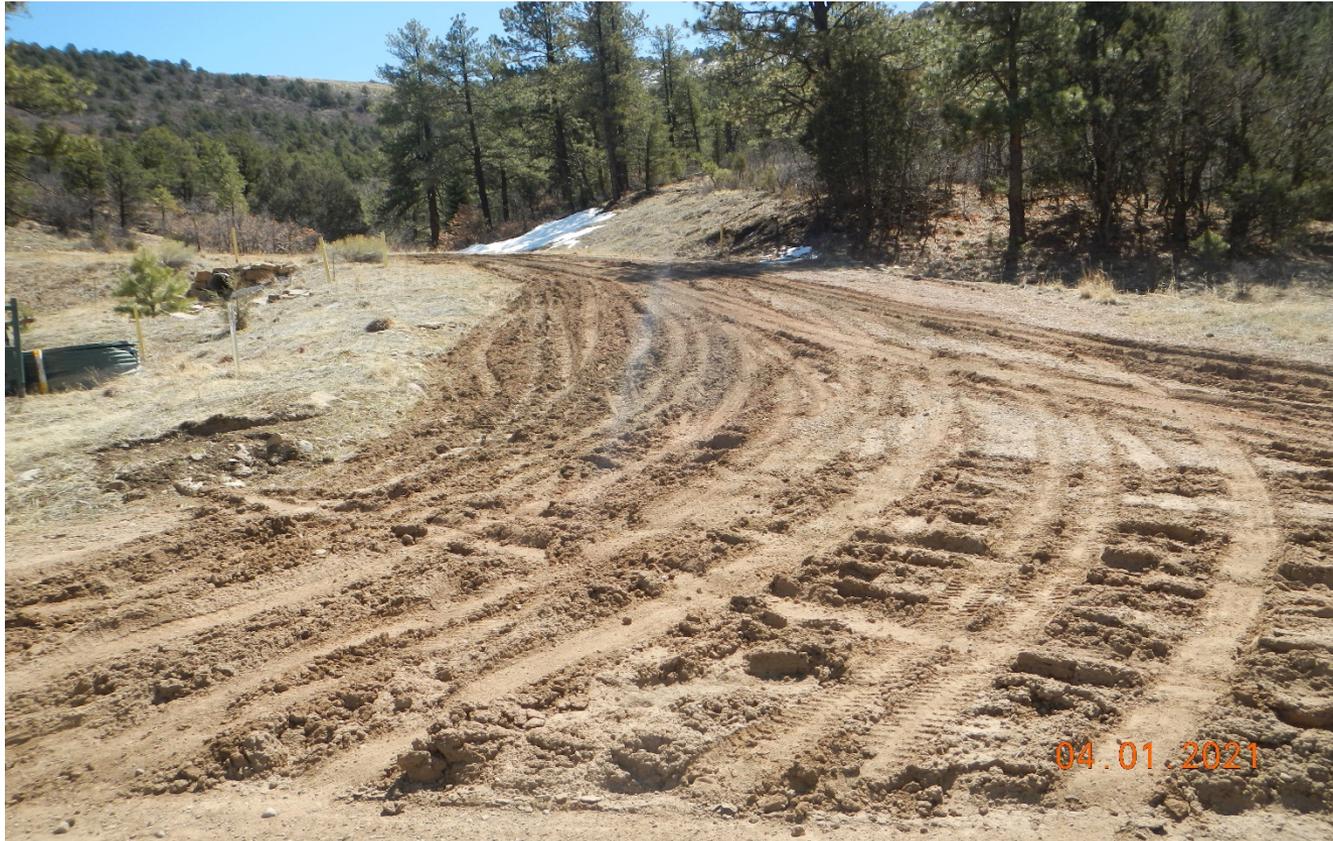
Photo 1. Facing toward the access road. The access road is rutted and not stabilized and maintained.

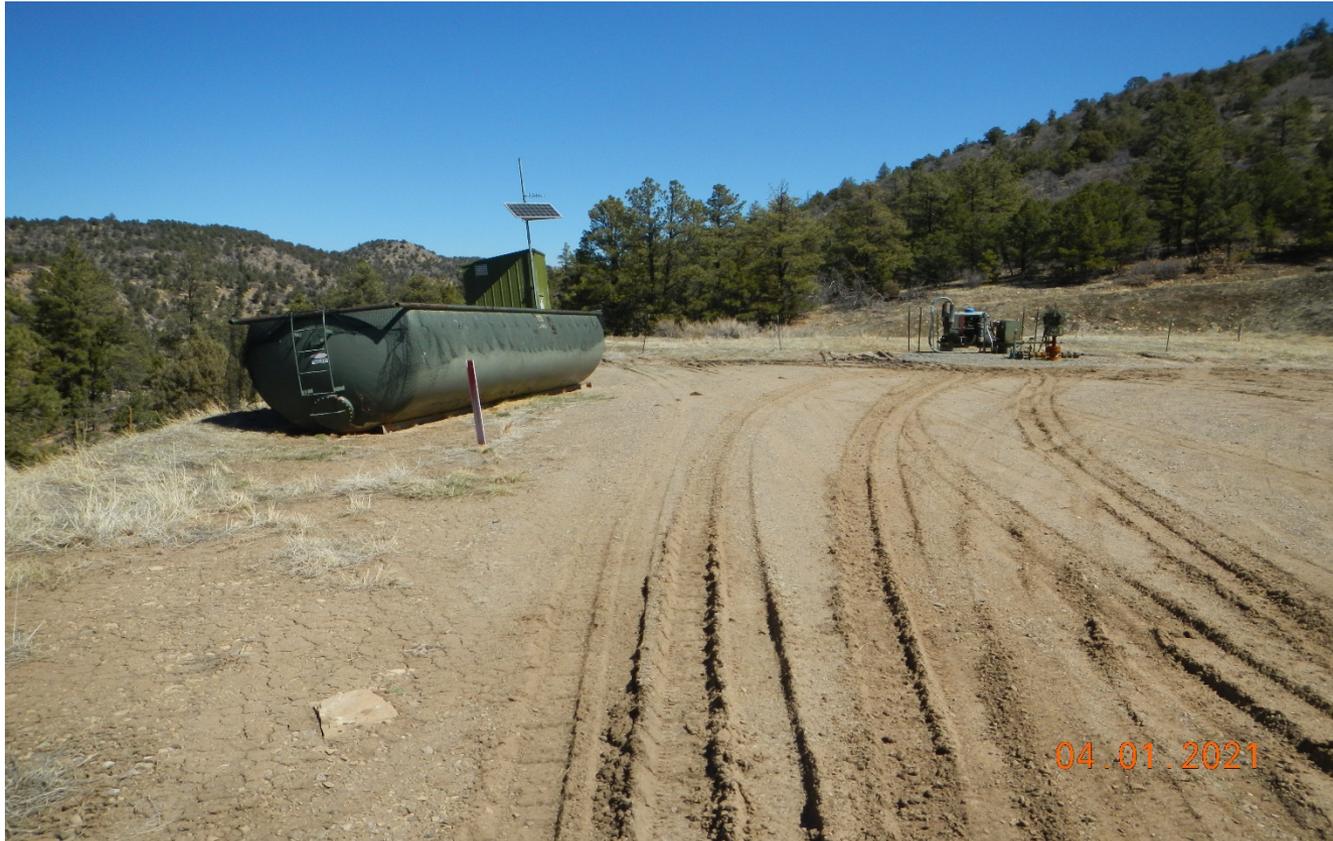
Photo 2. Facing toward the location. There is no secondary containment around the PW tank.

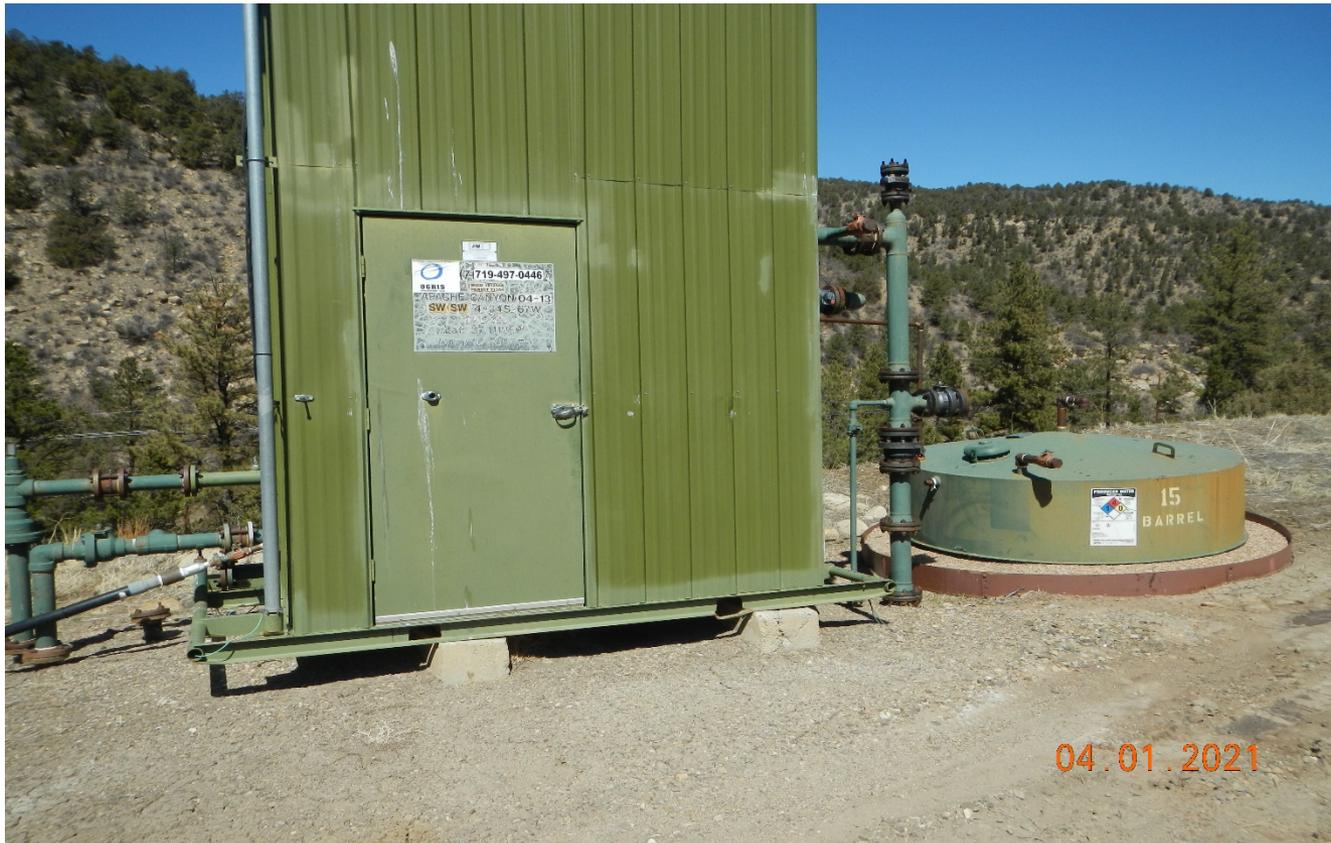
Photo 3. The well sign is faded and not legible.

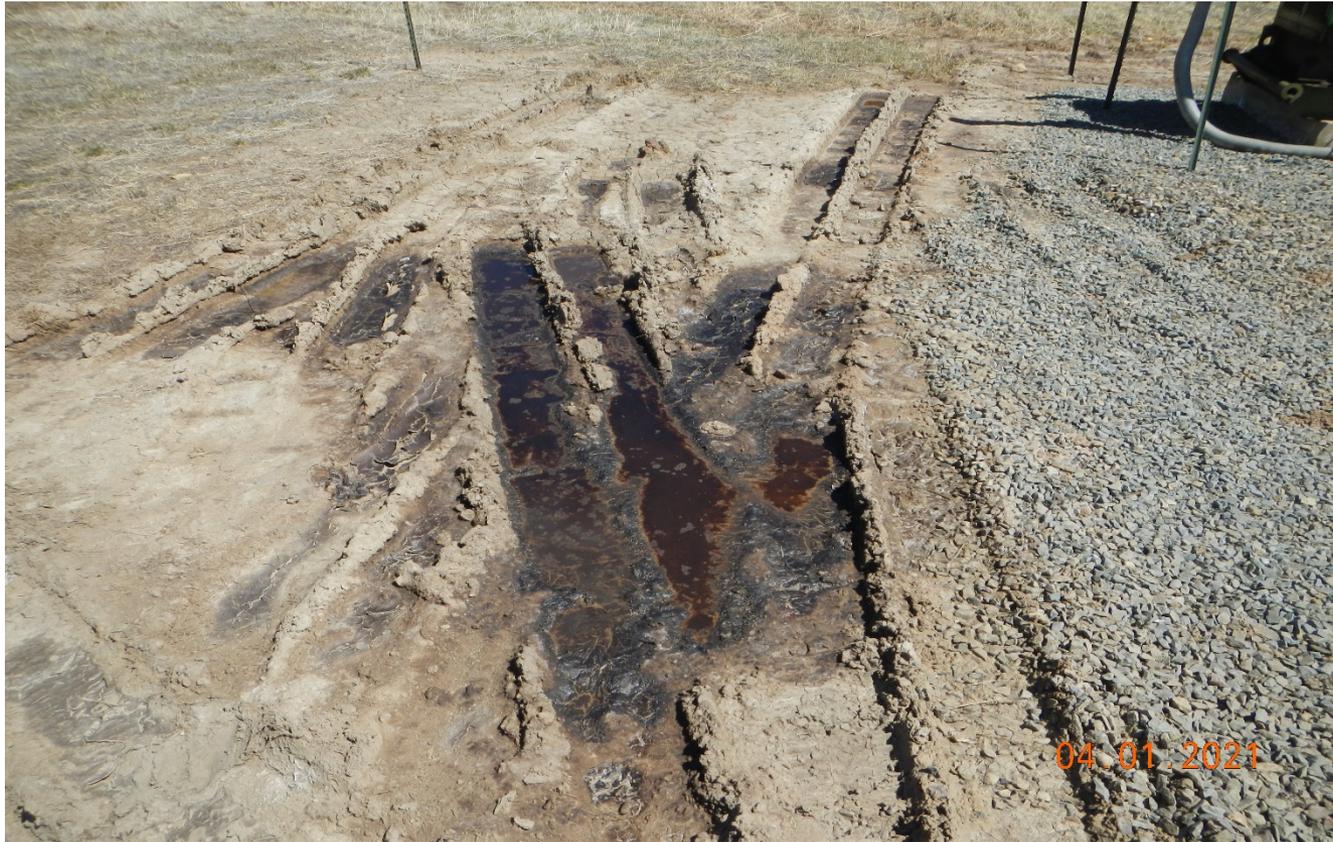
Photo 4. There appears to be oil stained soil near the well.
