Inspection Photos
Suckla-Brown Unit 17 Header
Spill ID 478370 (AC)

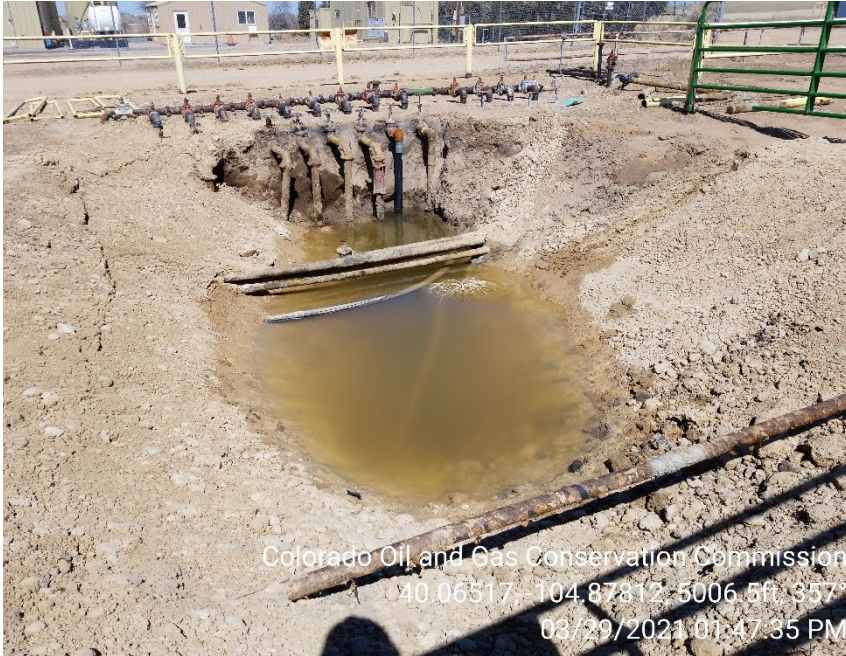
Photo 1 – Open spill excavation; impacted soils appear to still be in place in excavation wall adjacent to header. Hydrocarbon sheen visible on groundwater in excavation.

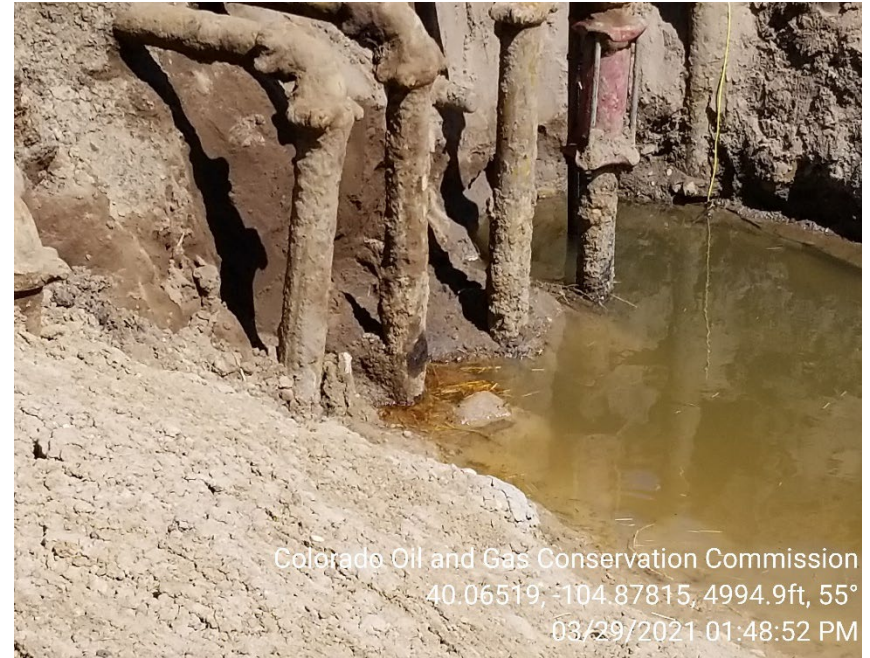
Photo 2 – Impacted soils appear to still be in place in excavation wall adjacent to header. Hydrocarbon sheen visible on groundwater in excavation.

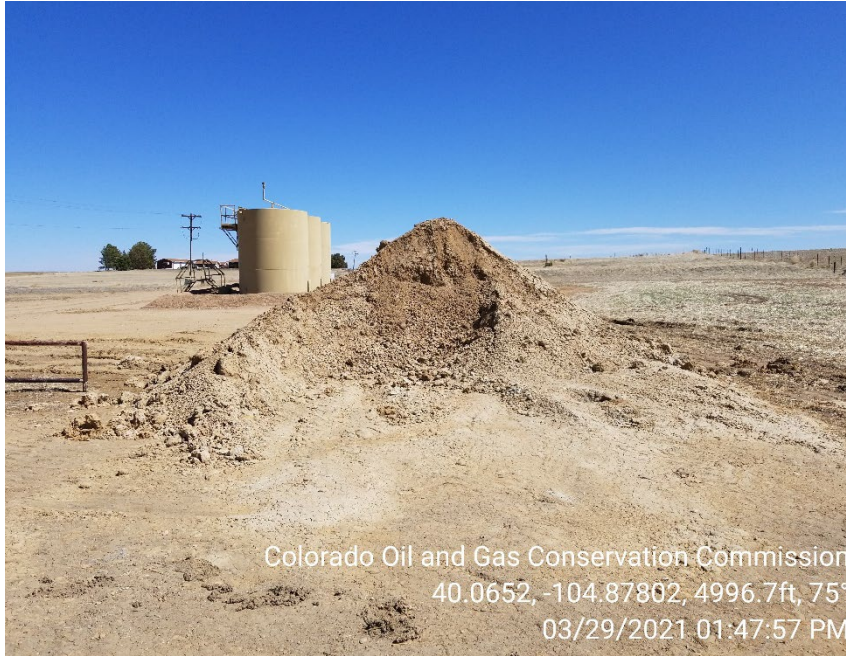
Photo 3 – Soil stockpiled on site with no BMPs

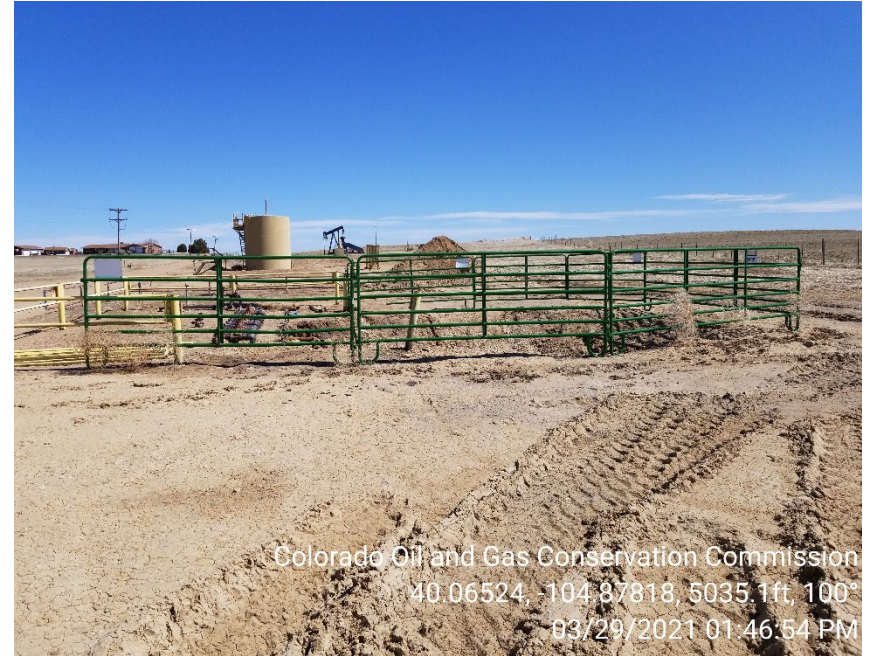
Photo 4 – Fencing around open excavation
