Inspection Photos

API: 071-09475

Operator: OGRIS OPERATING LLC

Inspection Date: 4/1/2021

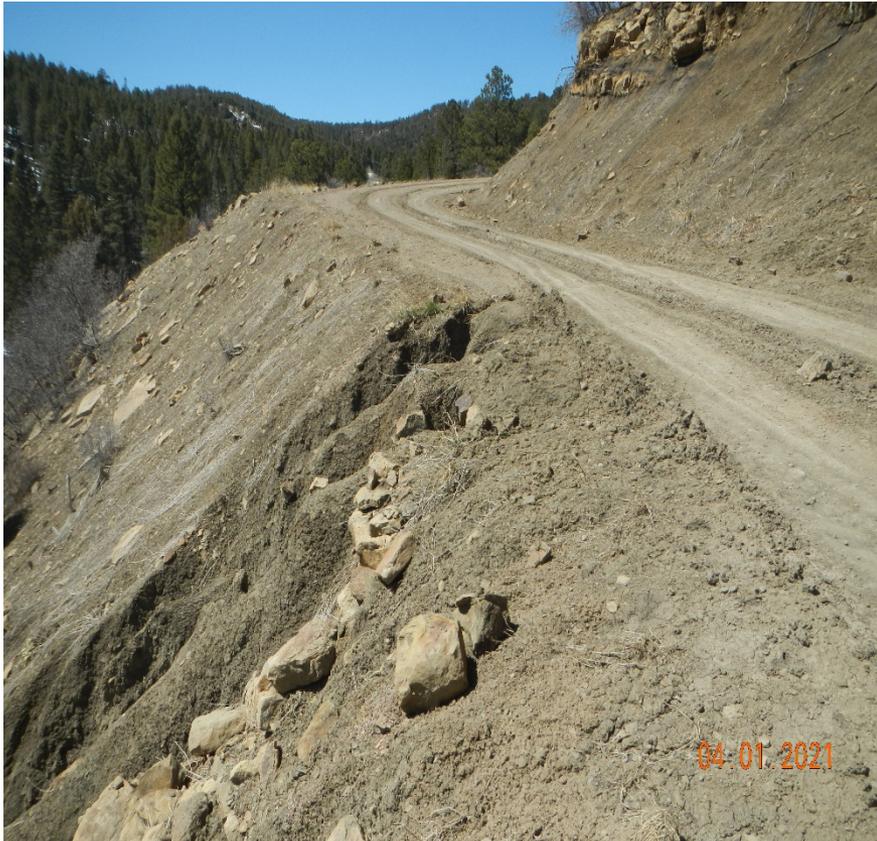
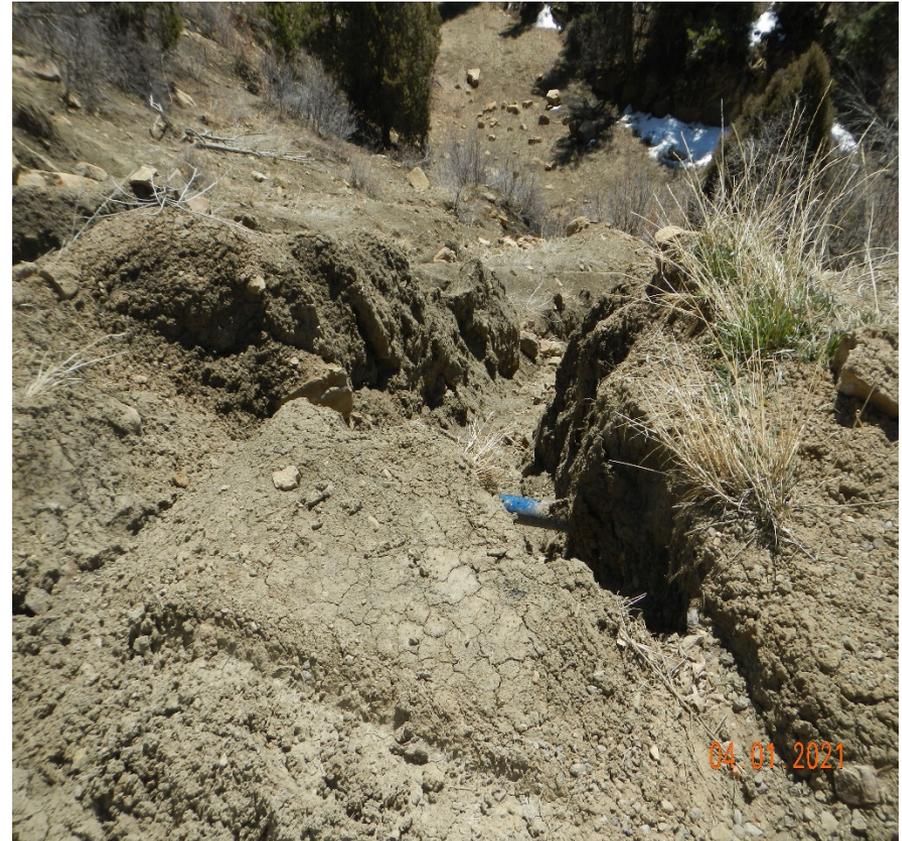
Photo 1. Facing west along the main road at Lat/Long:37.1099,-104.94878. Erosion has occurred along the fill slope of the road. This area needs to be repaired and stabilized.

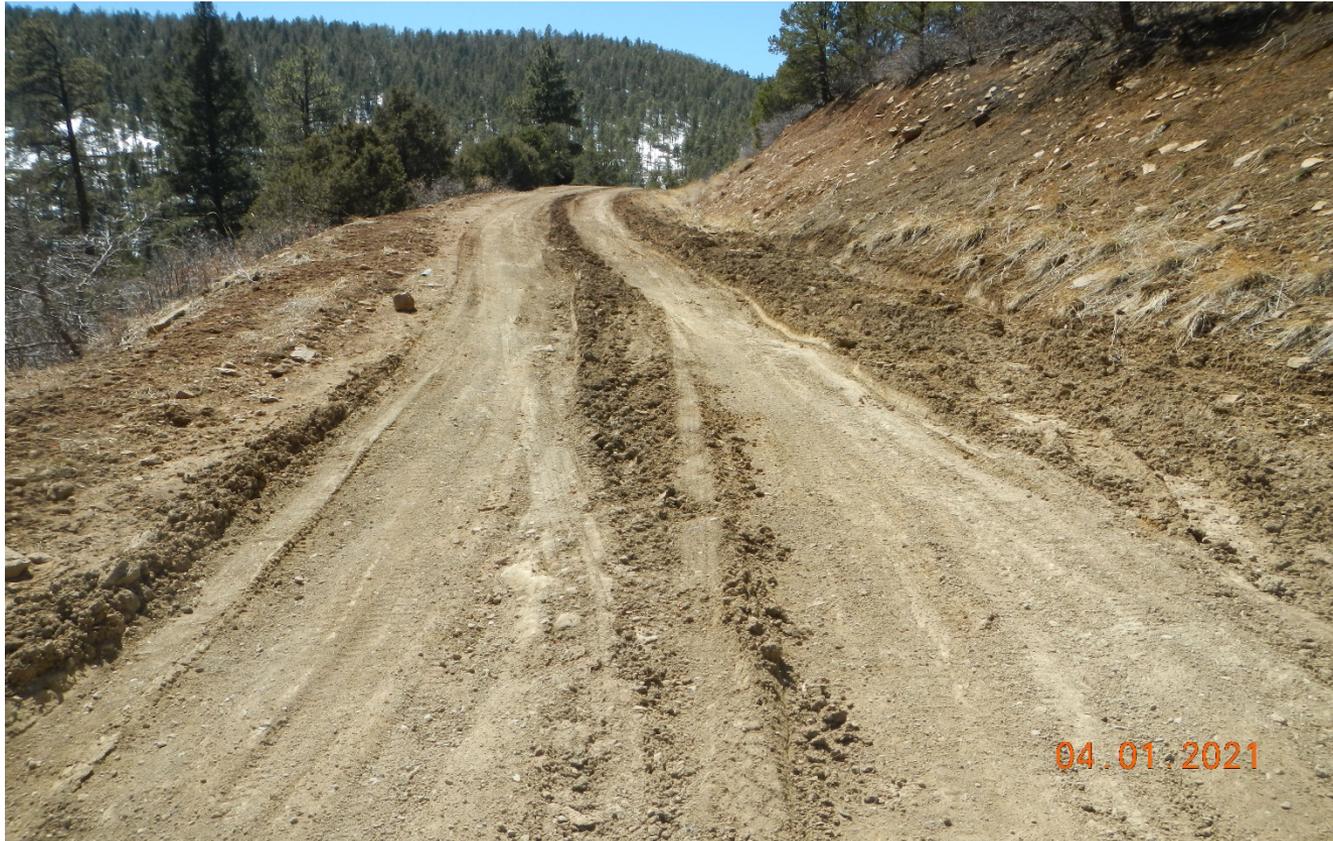
Photo 2. Facing along the main road. It appears vehicles slipped off the road causing rutting. The road needs to be repaired and stabilized.

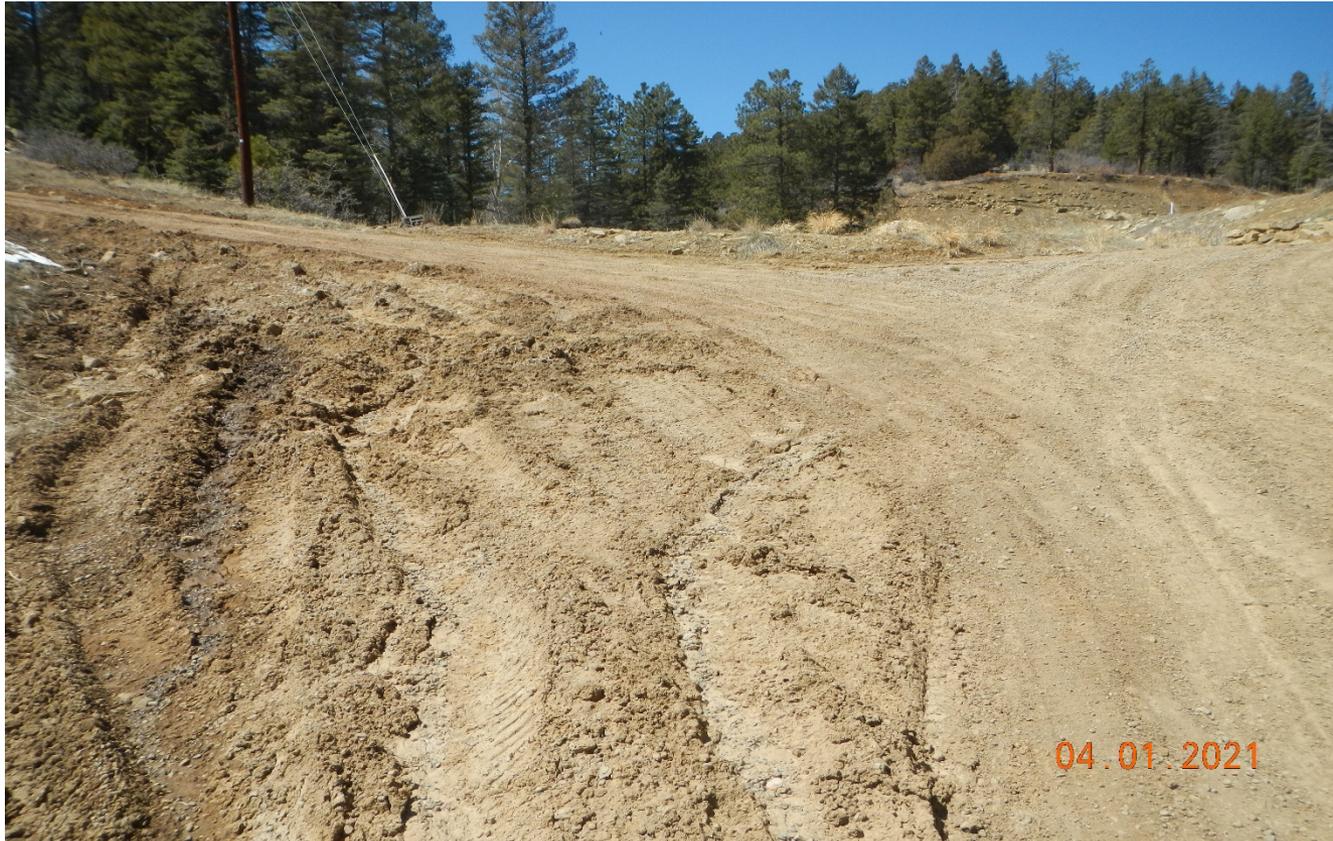
Photo 3. Facing toward the access road at right side of photo. There is rutting along the main road ascending the hill which needs to be repaired and stabilized.

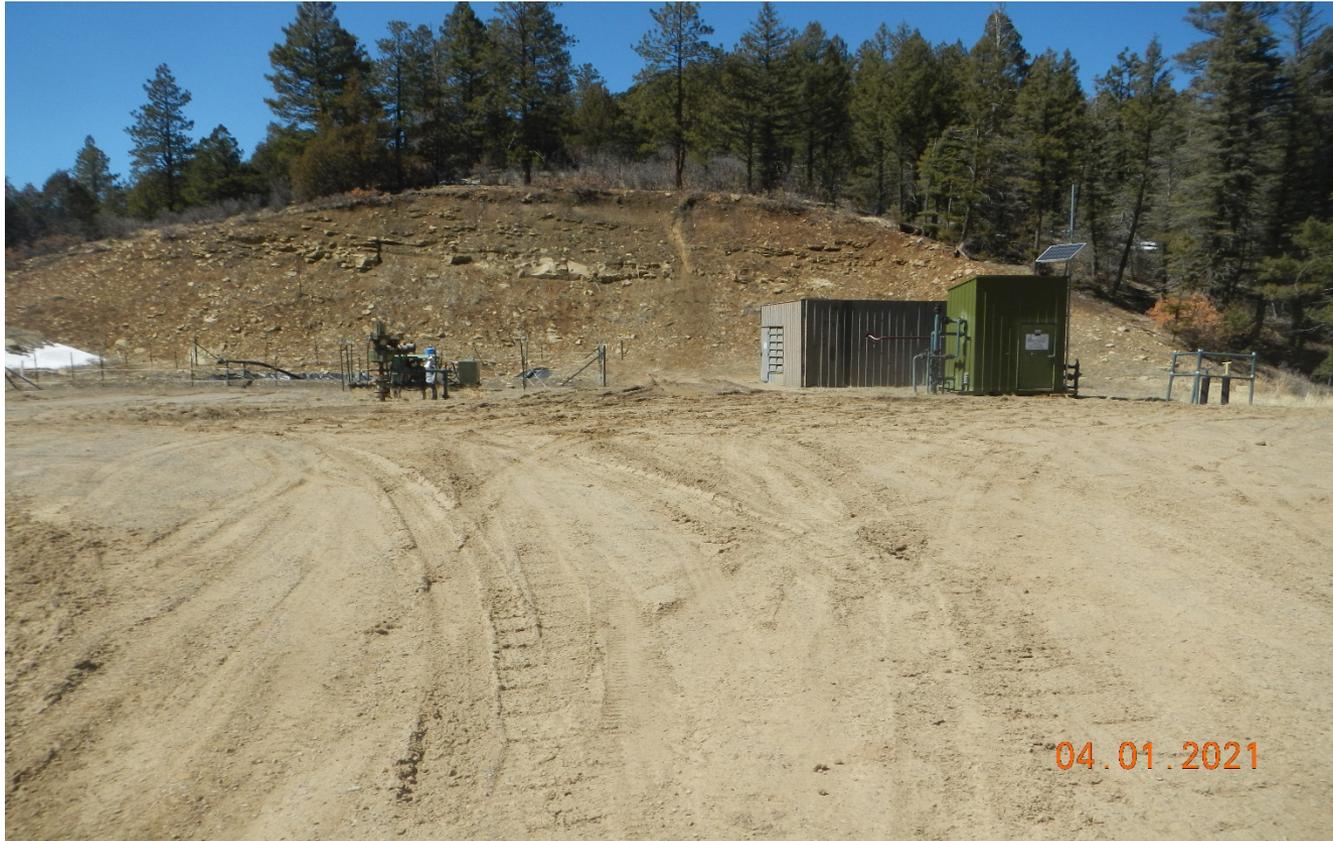
Photo 4. Facing toward the location.

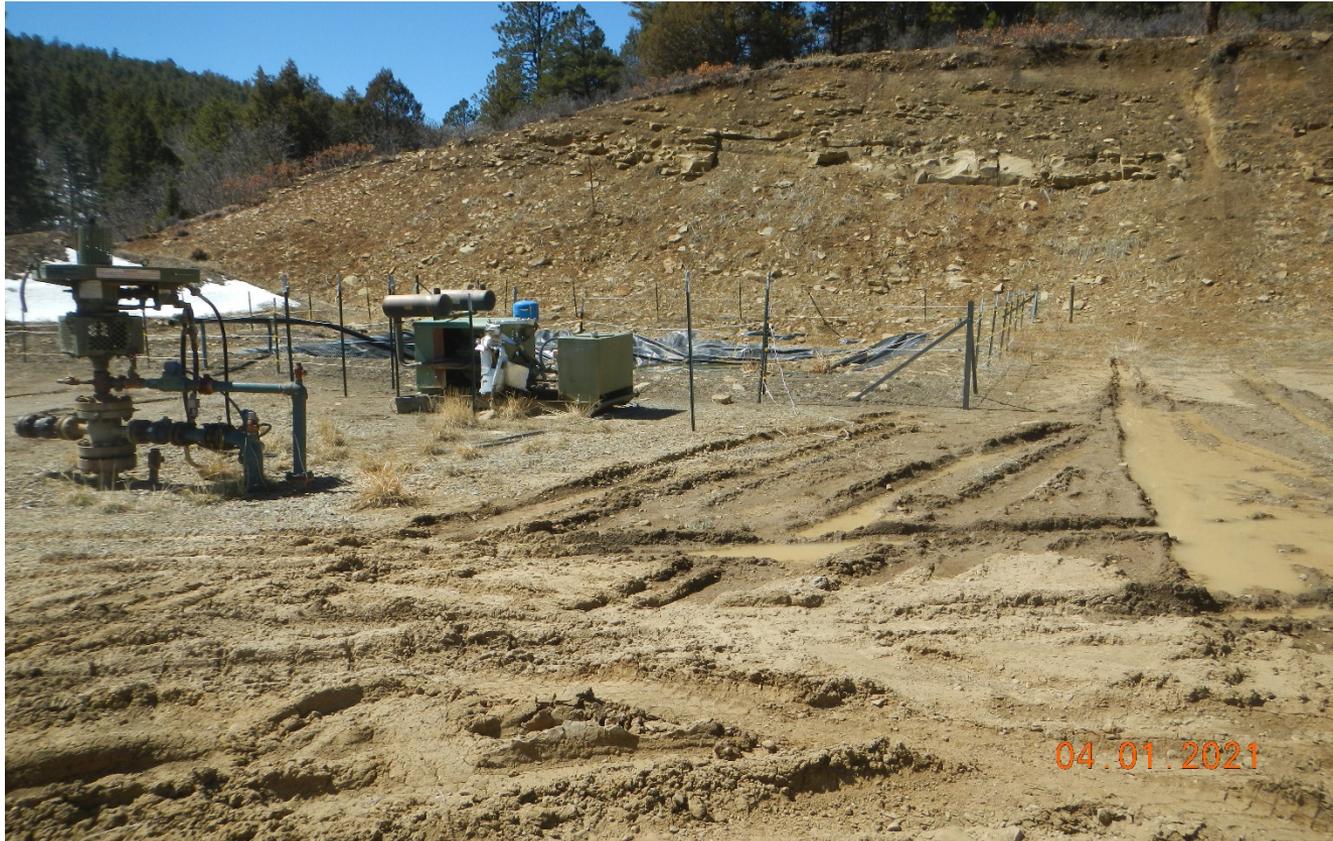
Photo 5. There is vehicle rutting on the location. The fence around the pit needs to be repaired to prevent wildlife entry.
