Inspection Photos

API: 071-07944

Operator: OGRIS OPERATING LLC

Inspection Date: 4/1/2021

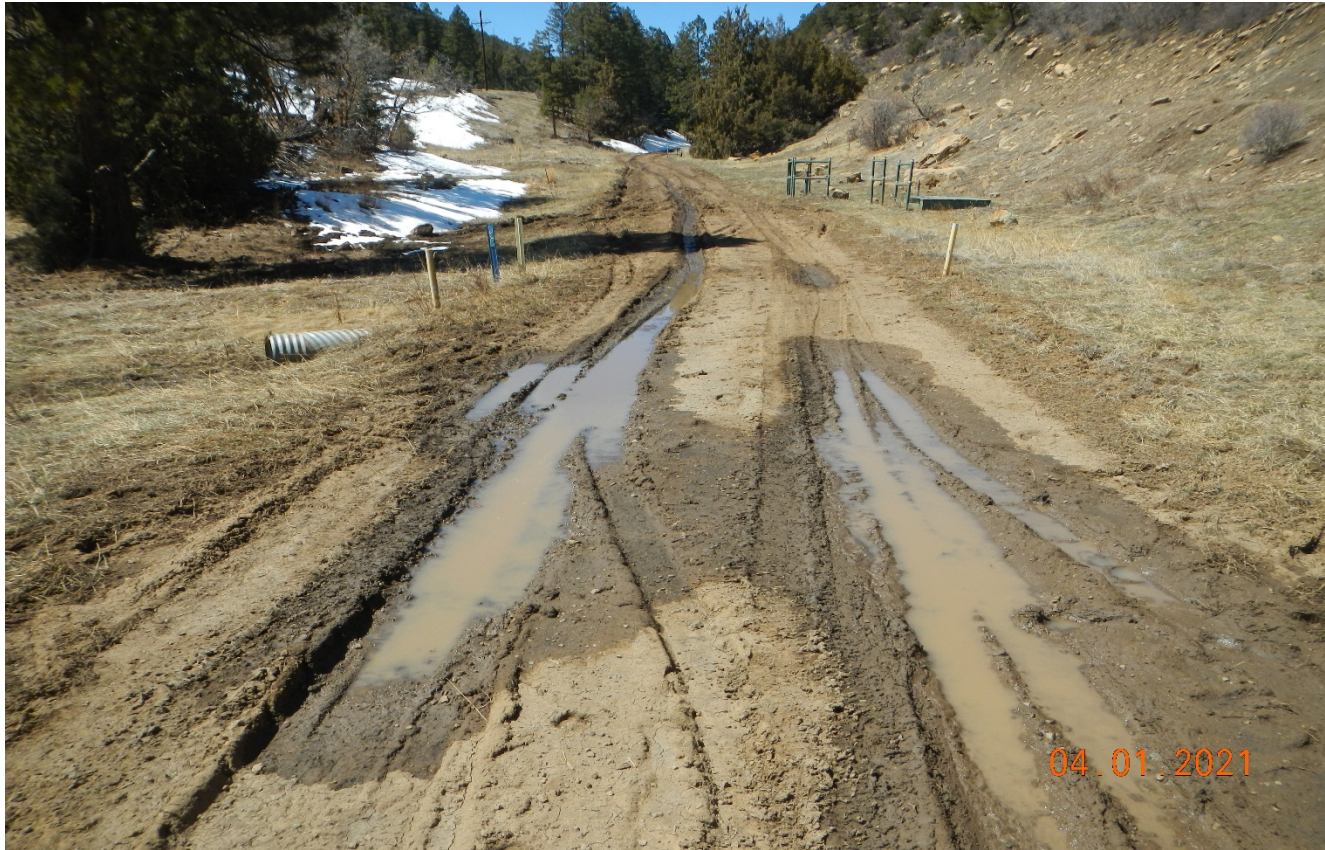
Photo 1. Facing west toward the access road at the canyon bottom near AC 1-16. The road in the canyon bottom is rutting and not maintained or stabilized.

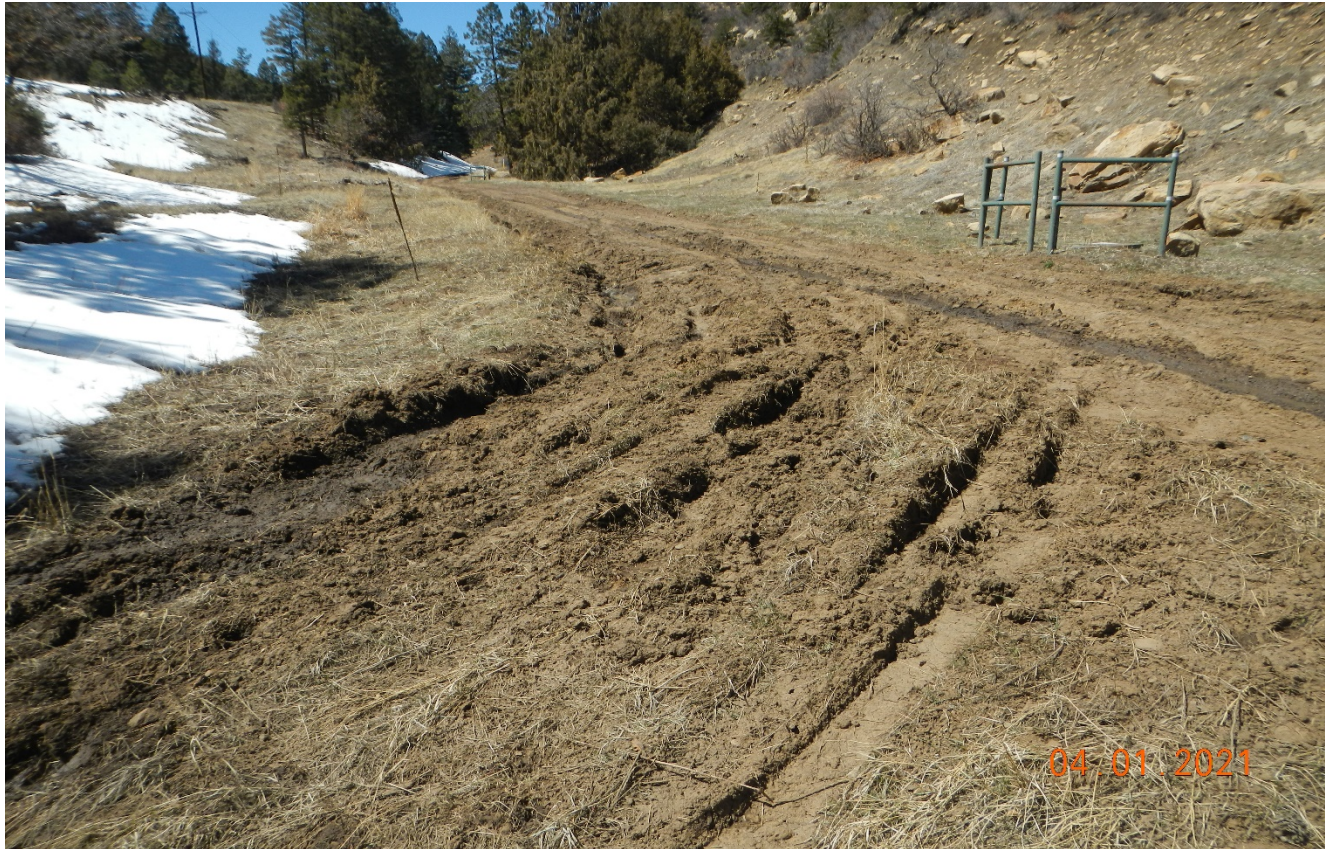
Photo 2. It appears a vehicle slid off the road and got stuck which has caused ruts off the road.

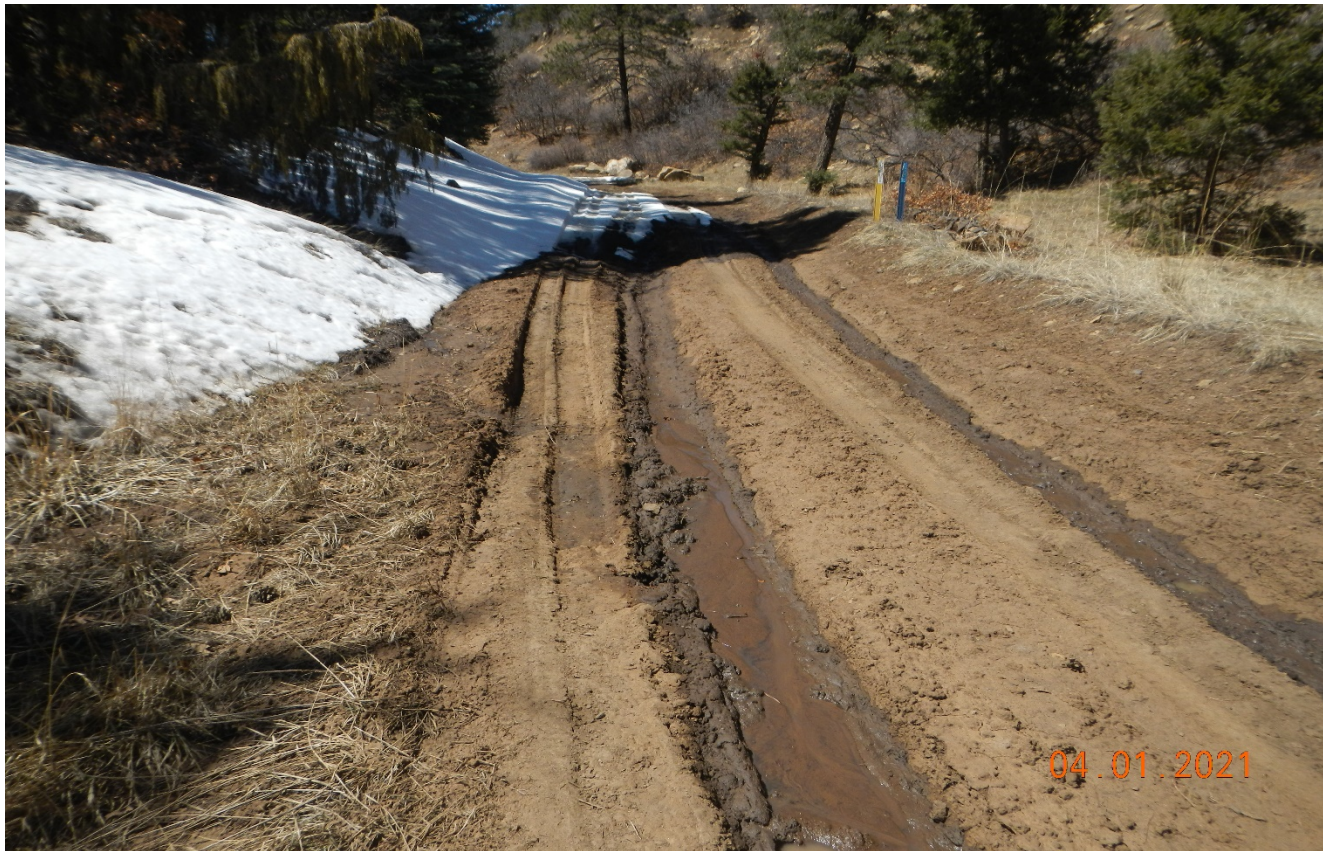
Photo 3. The road along the canyon bottom is not stabilized and maintained.

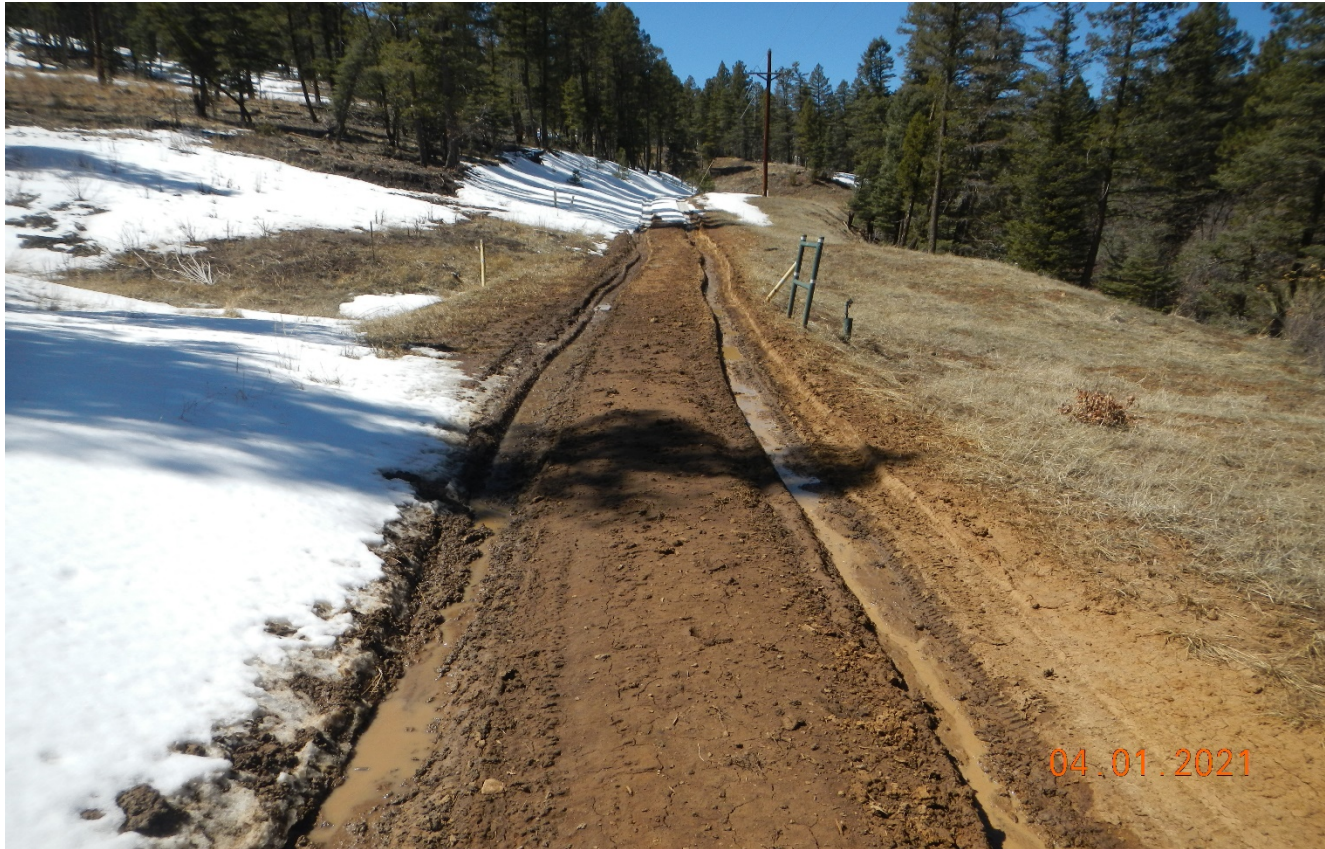
Photo 4. The road along the canyon bottom is not stabilized and maintained.

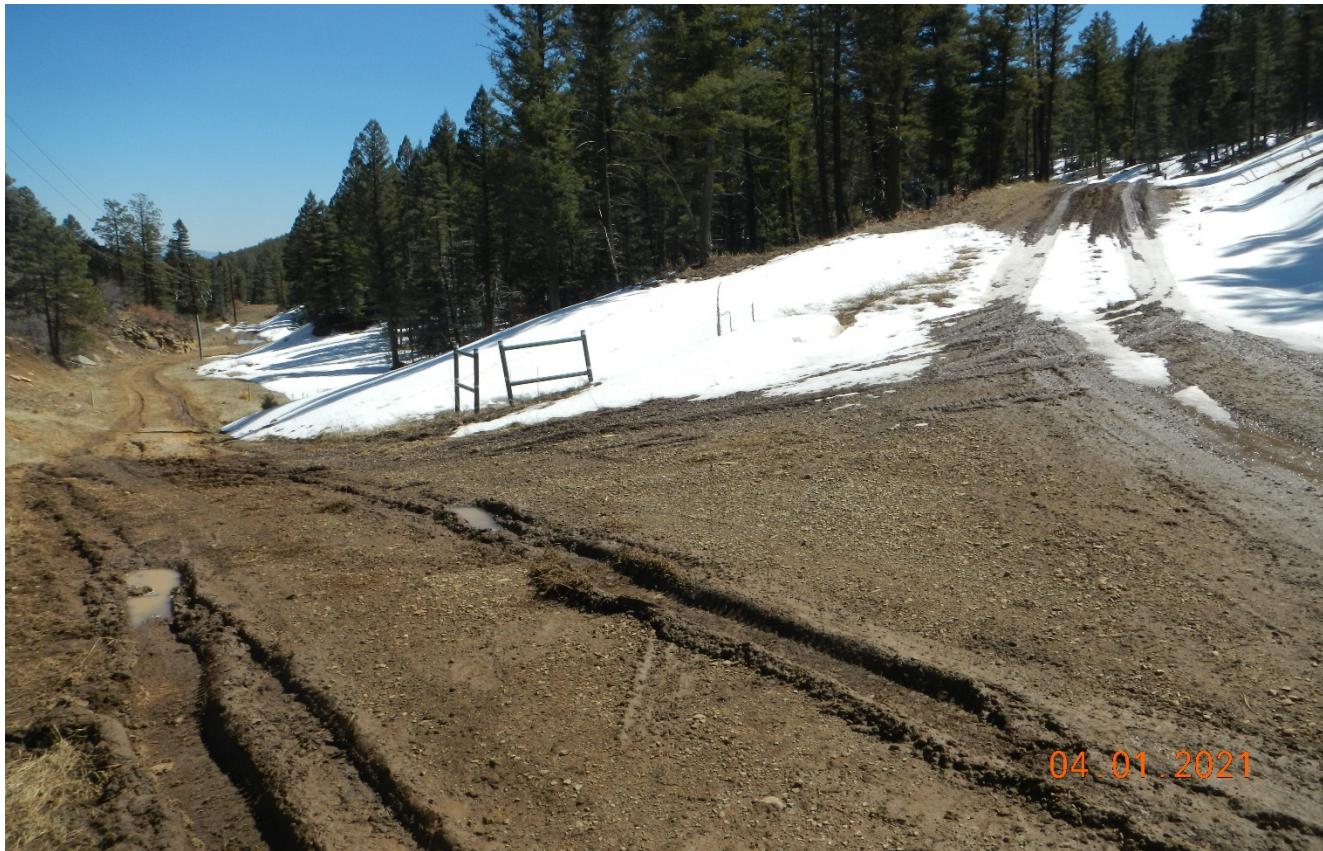
Photo 5. Facing toward the access road to the right which leads to the location.

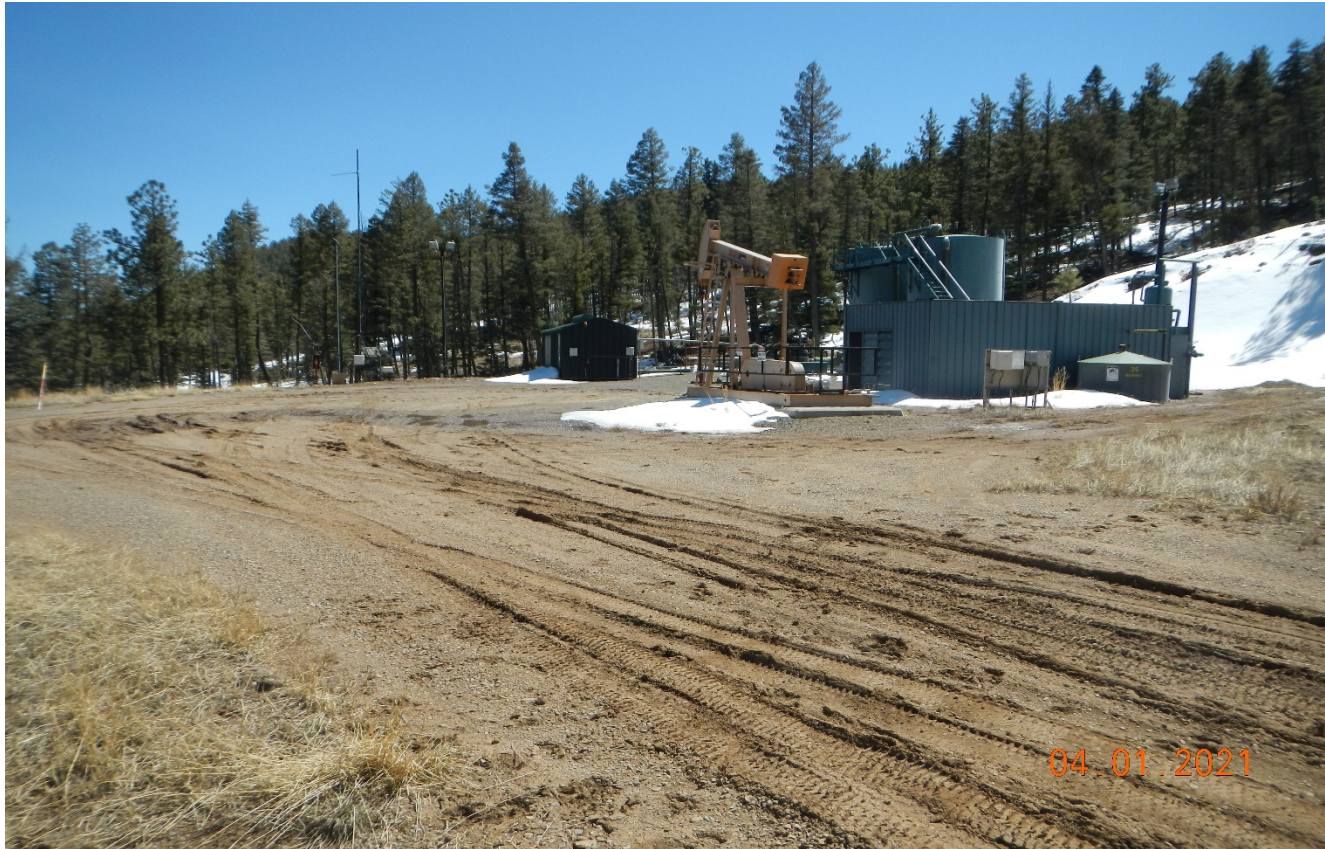
Photo 6. Facing toward the location.
