## Stormwater Inspection Report

<b>Operator:</b>	Laramie Energy, LLC
<b>Project:</b>	Cascade Creek
<b>Location:</b>	Cascade Creek 629-23-43 Pad
<b>Date:</b>	Thursday, March 18, 2021
<b>Weather:</b>	Partly Cloudy, Light Wind, 50°, Lo 27°

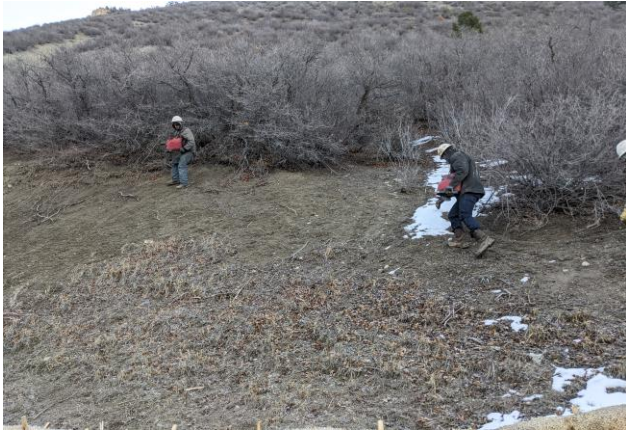
**Photo 1**

*Broadcast Seeding the CC 629-23-42 Cut-Slope*

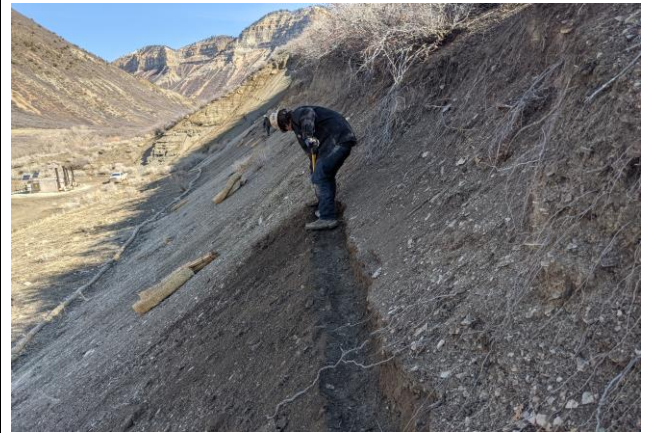
**Photo 2**

*Hand Digging Trench for Wattle Installation*

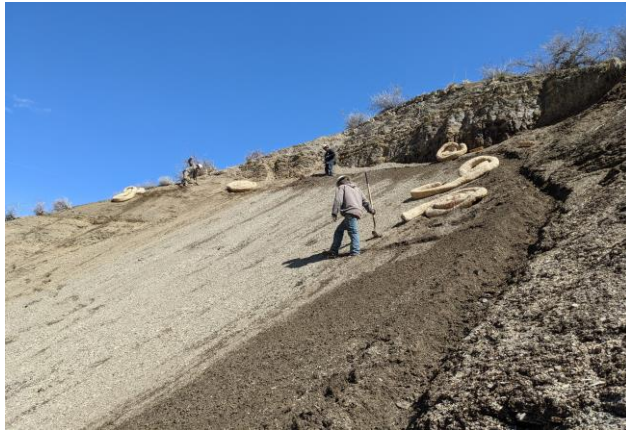
**Photo 3**

*Installing Wattle above Loose Shale Material*

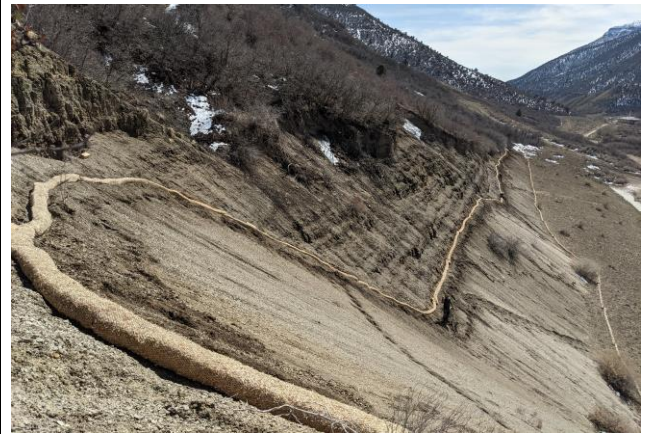
**Photo 4**

*Wattle Laid Out in Preparation for Staking*

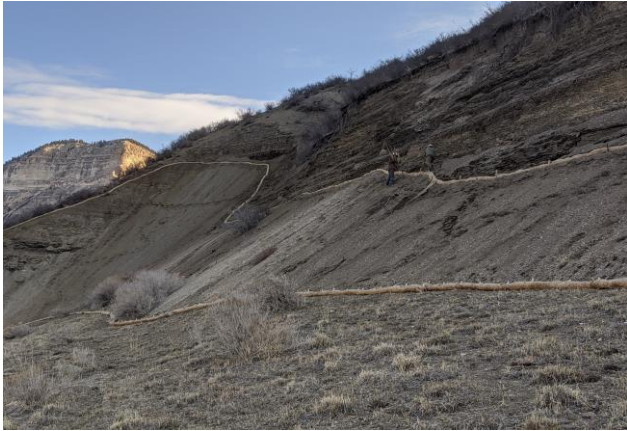
**Photo 1**

*Wattle Installed on the CC 629-23-42 Pad*

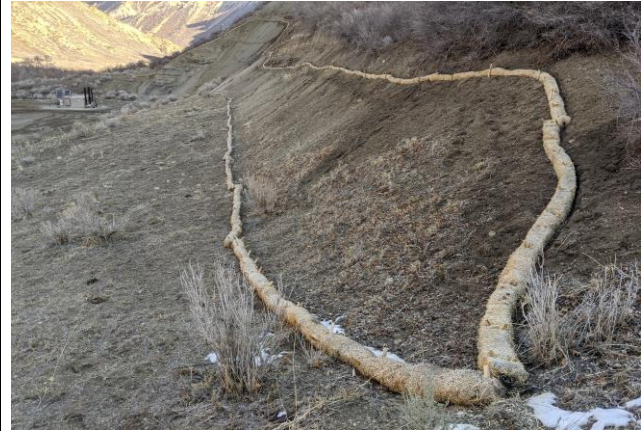
**Photo 2**

*Wattle Installed on the CC 629-23-42 Pad*

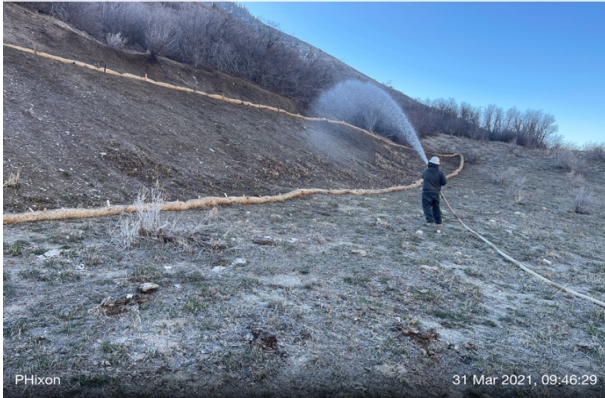
**Photo 1**

*The contractor prepping the area for hydroseeding*

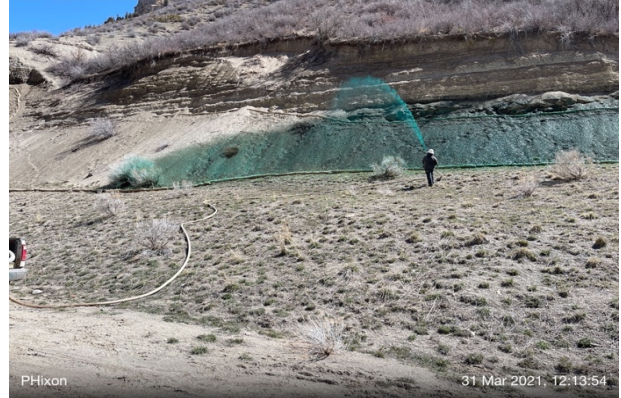
**Photo 2**

*Broadcasting the hydroseed mix*

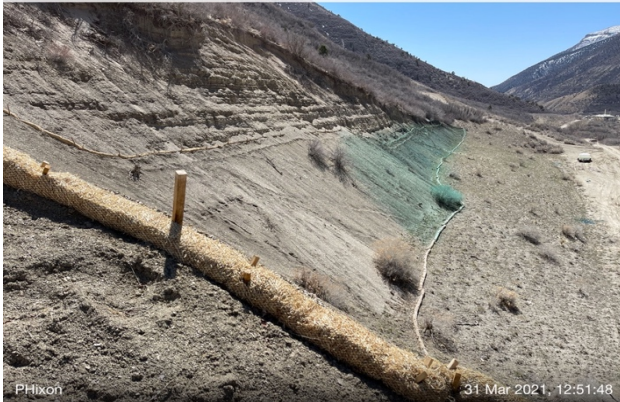
**Photo 3**

*The extent of the hydroseeding*

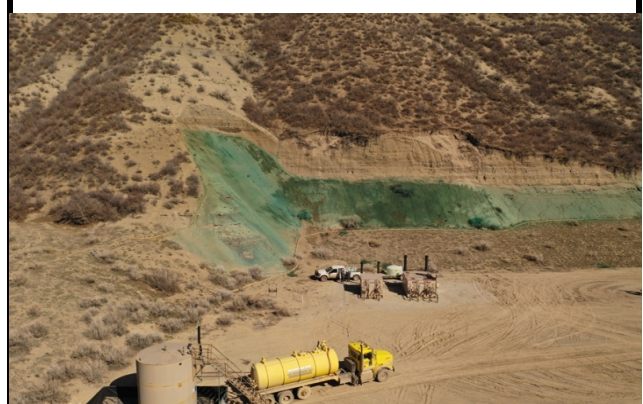
**Photo 4**

*Ariel view showing the application of the hydro seeding.*
