Inspection Photos
Location Name: RSU-Anschutz Federal 4-62-2_1 SWNW
Location ID: 436165

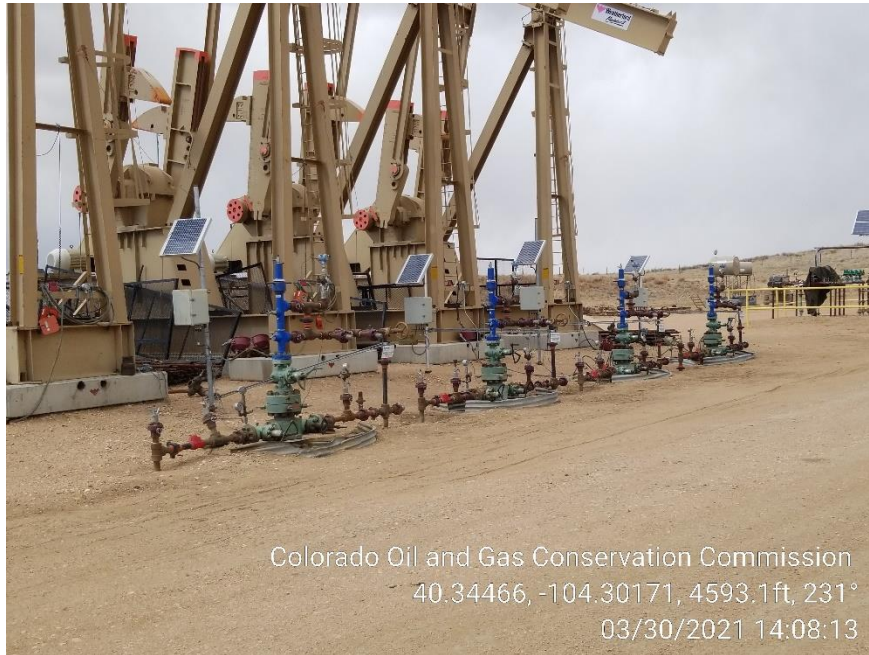
Photo 1 – Wellheads and Pumping Units

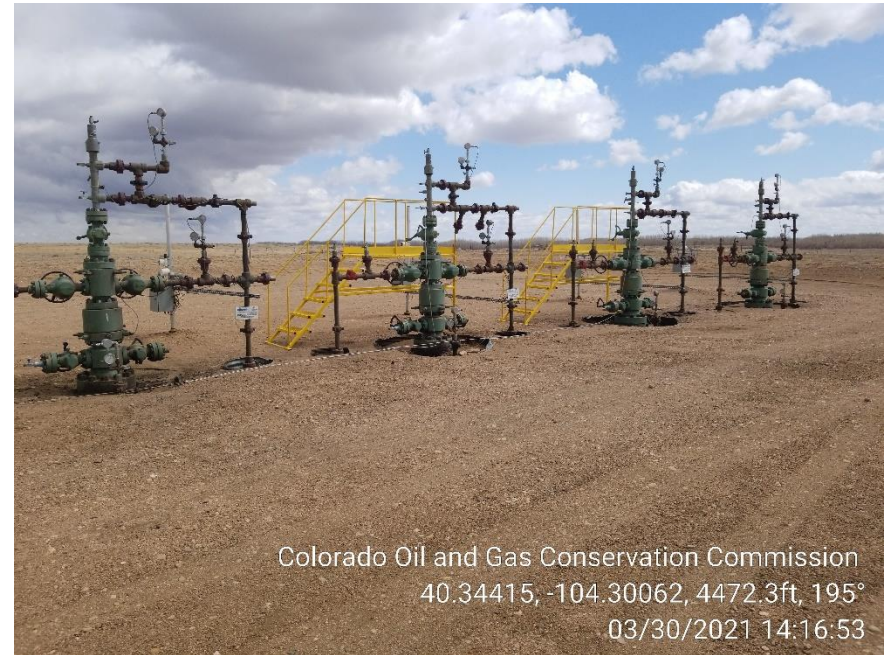
Photo 2 – Wellheads

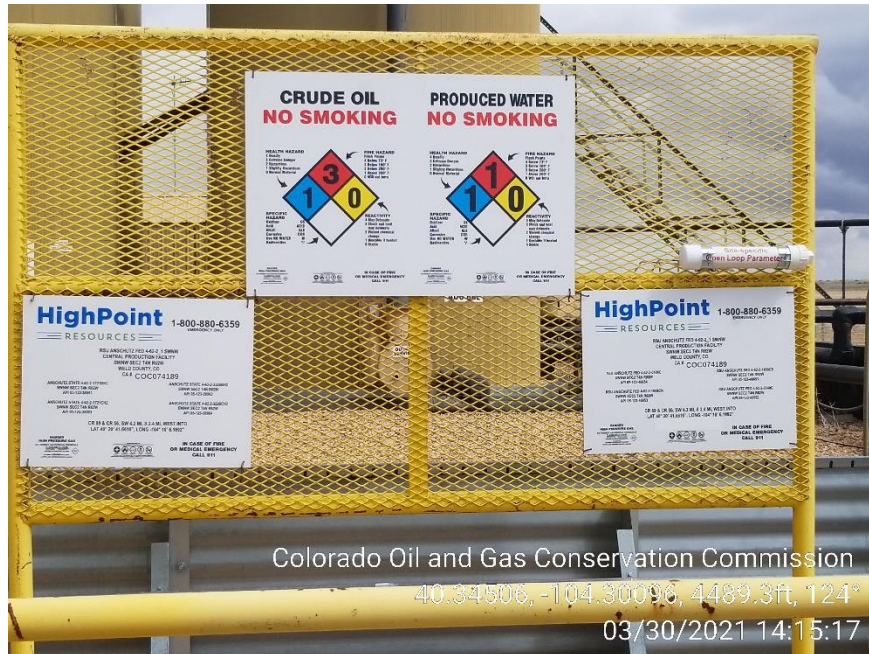
Photo 3 – Tank Battery Signs

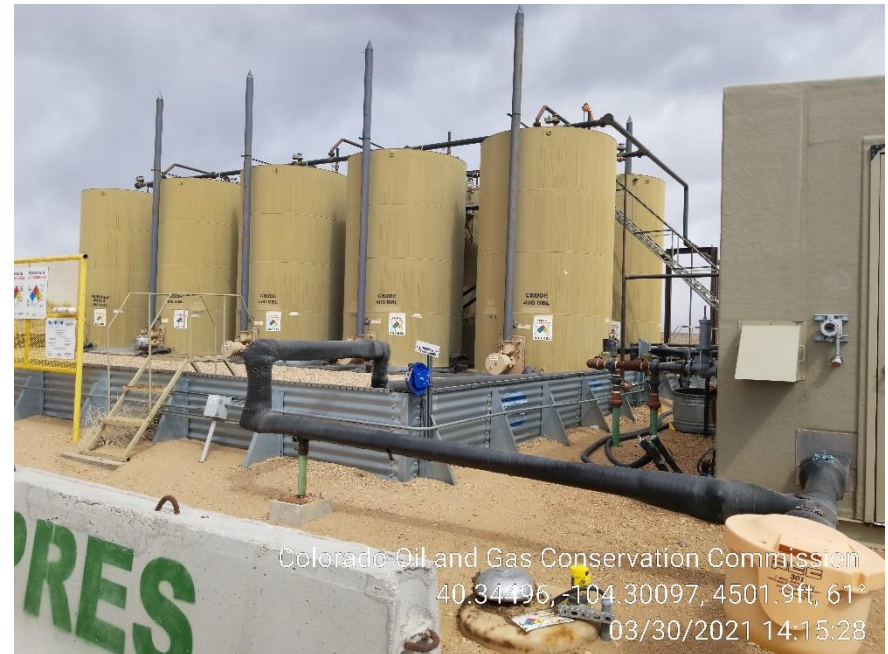
Photo 4 – Tank Battery

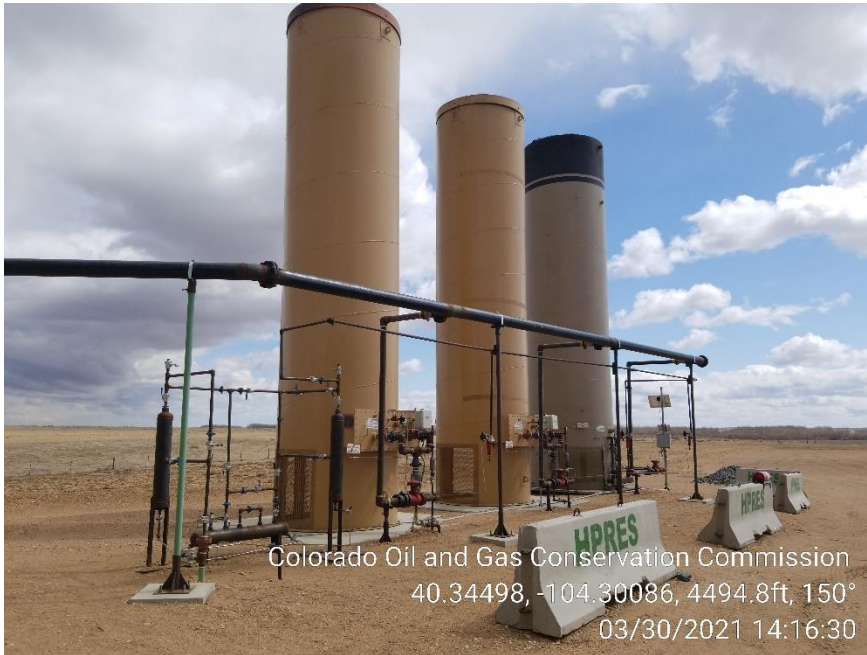
Photo 5 - ECDs

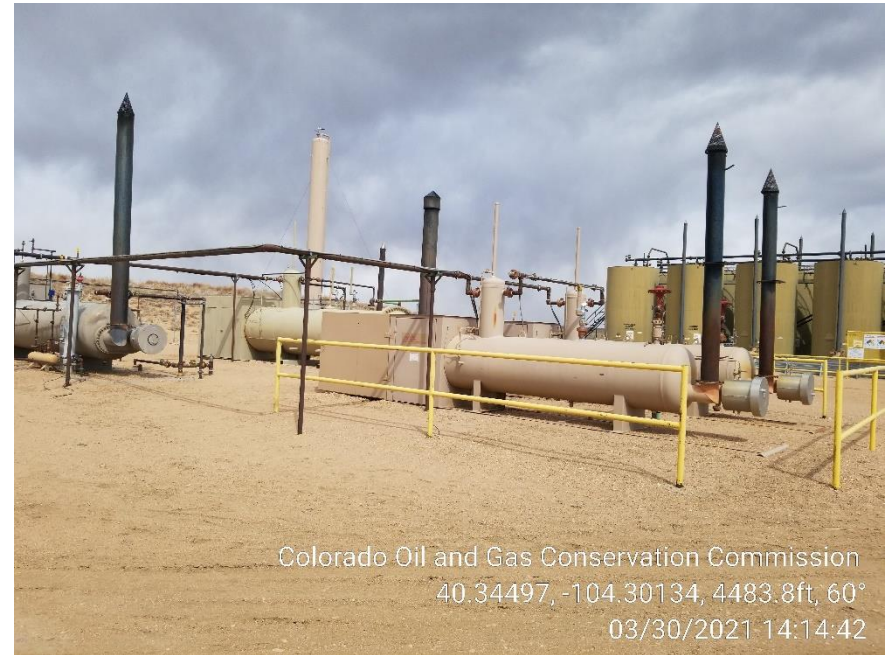
Photo 6 – Separators

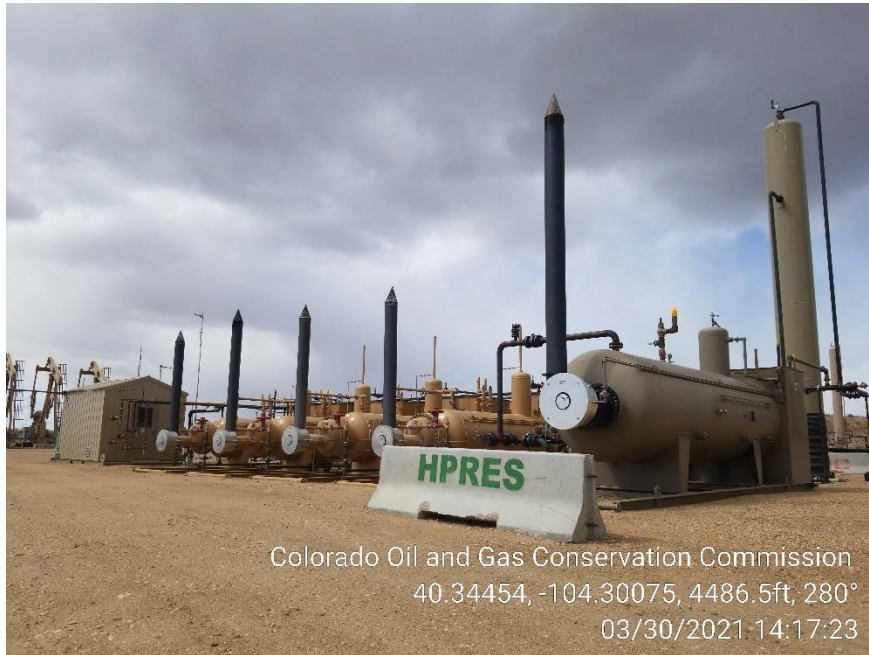
Photo 7 – Separators

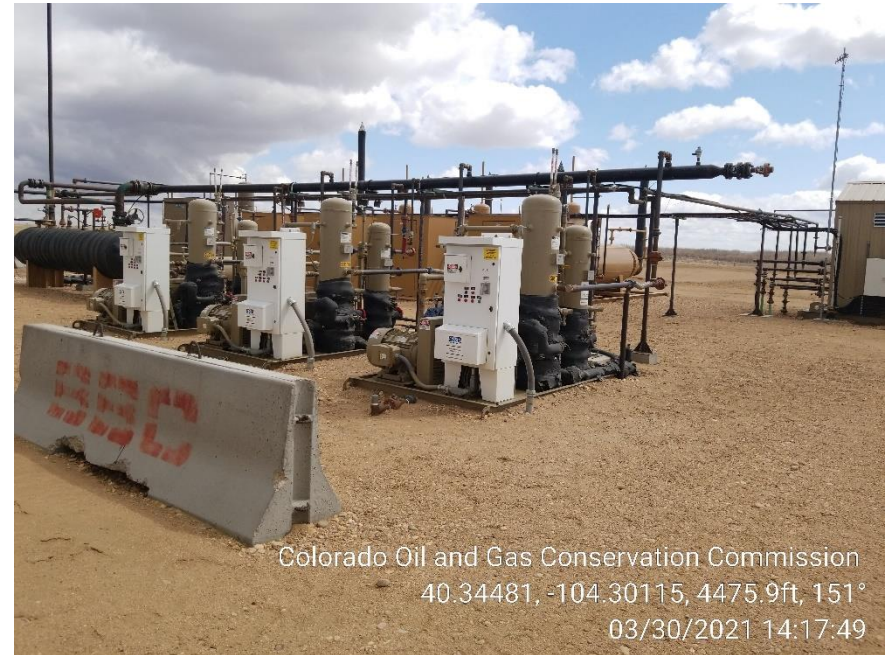
Photo 8 – VRUs

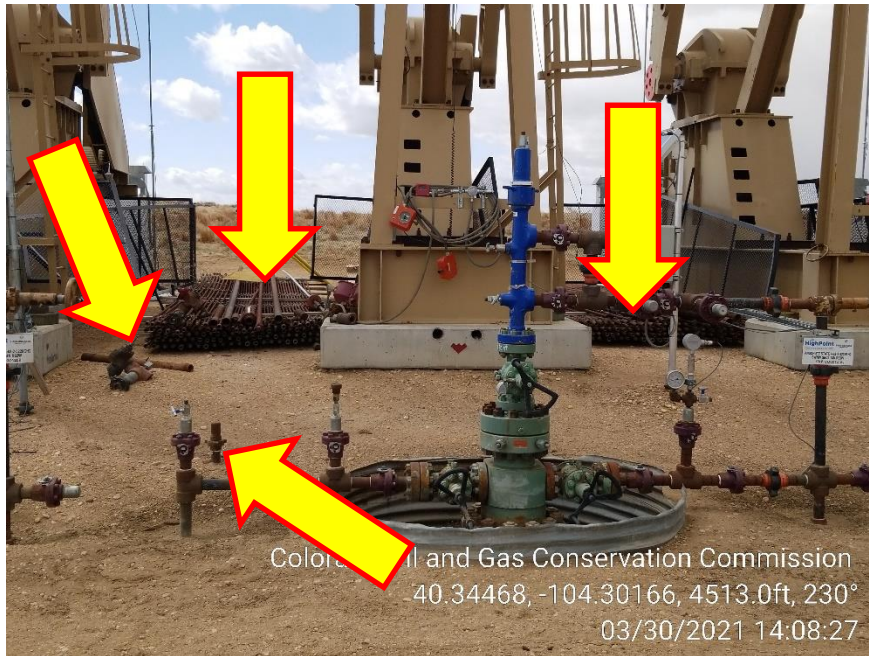
Photo 9 – Unmarked Riser and Unused Rods and Wellhead Parts

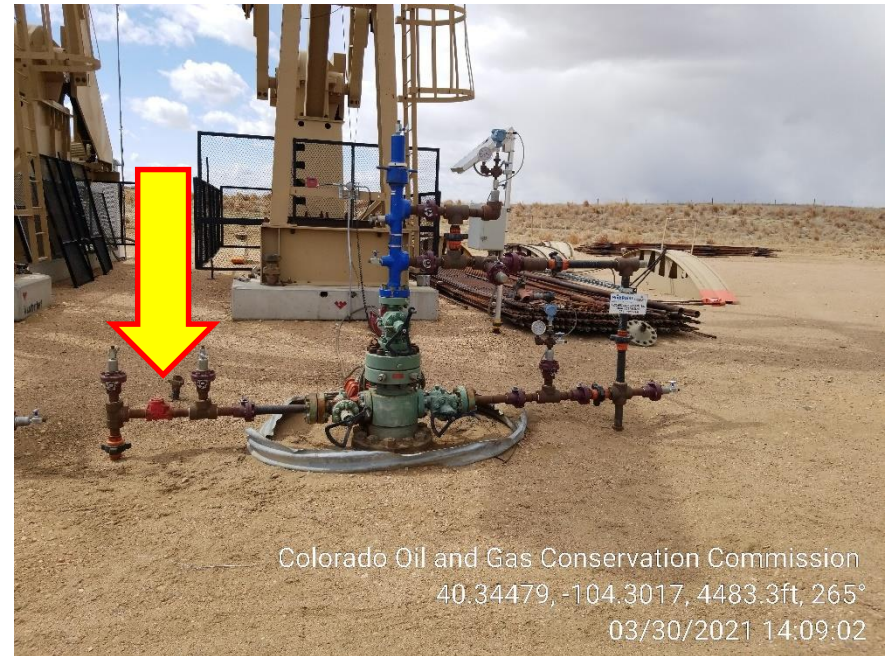
Photo 10 – Unmarked Riser and Unused Rods and Wellhead Parts

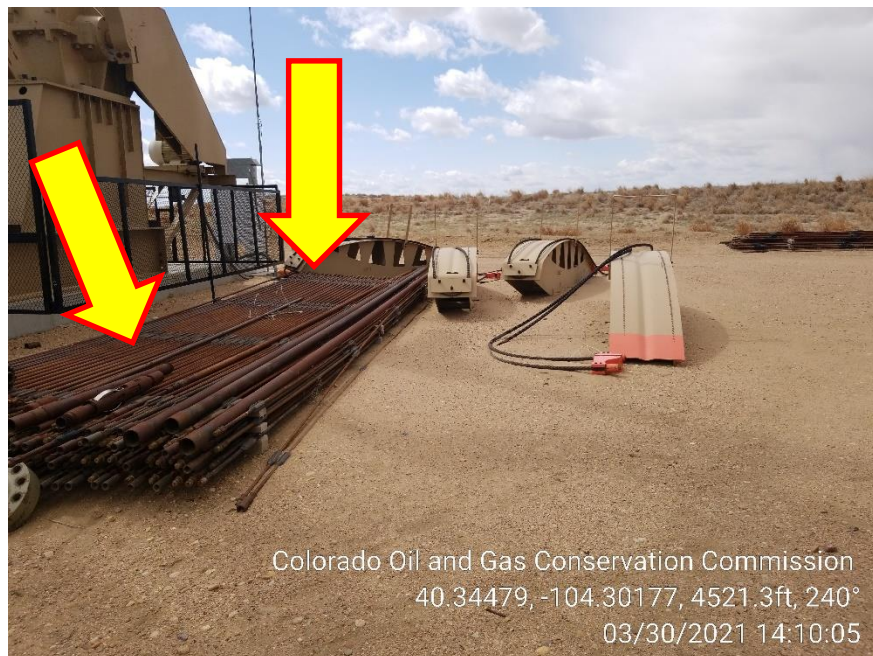
Photo 11 – Unused Rods

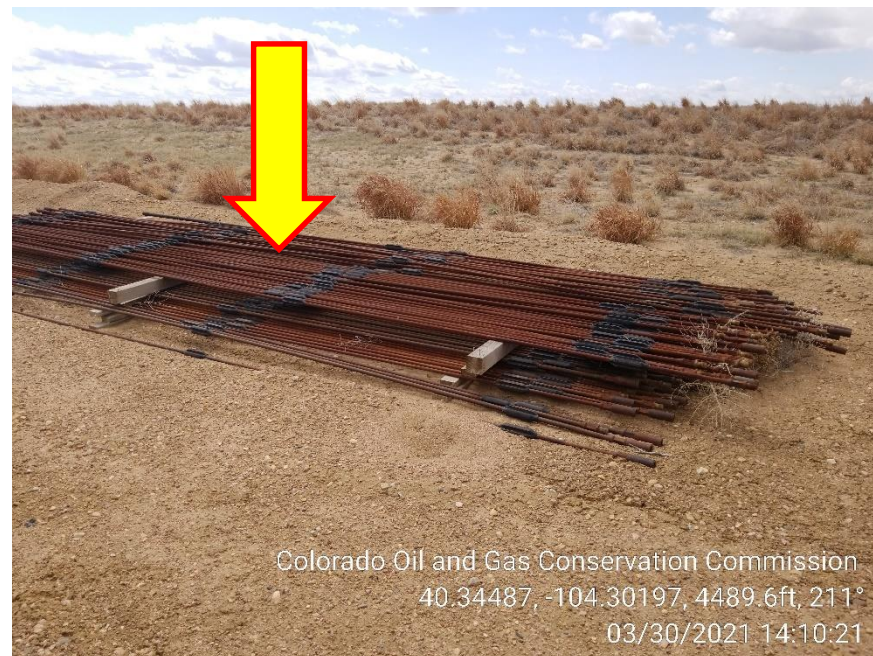
Photo 12 – Unused Rods

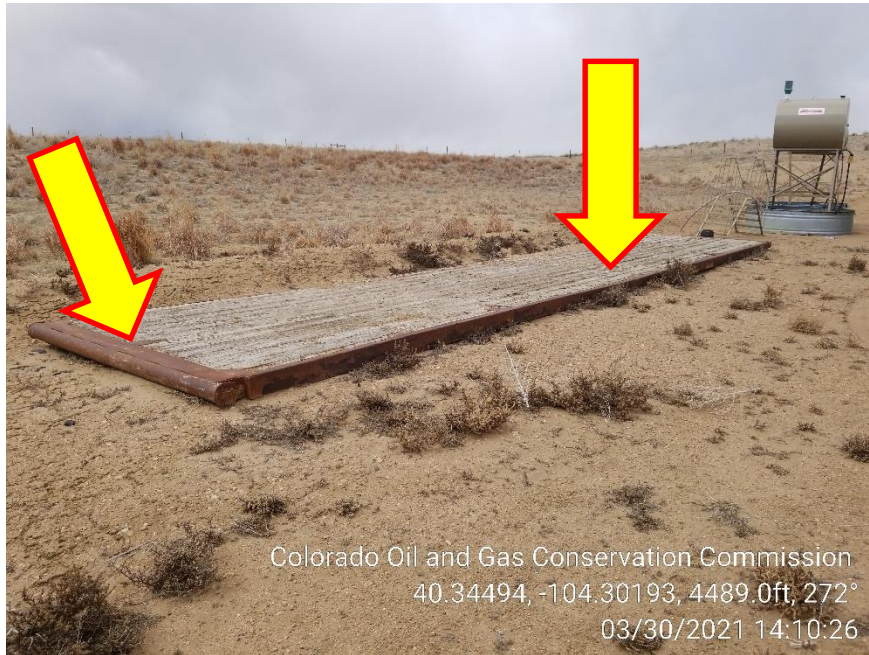
Photo 13 – Unused Rig Equipment

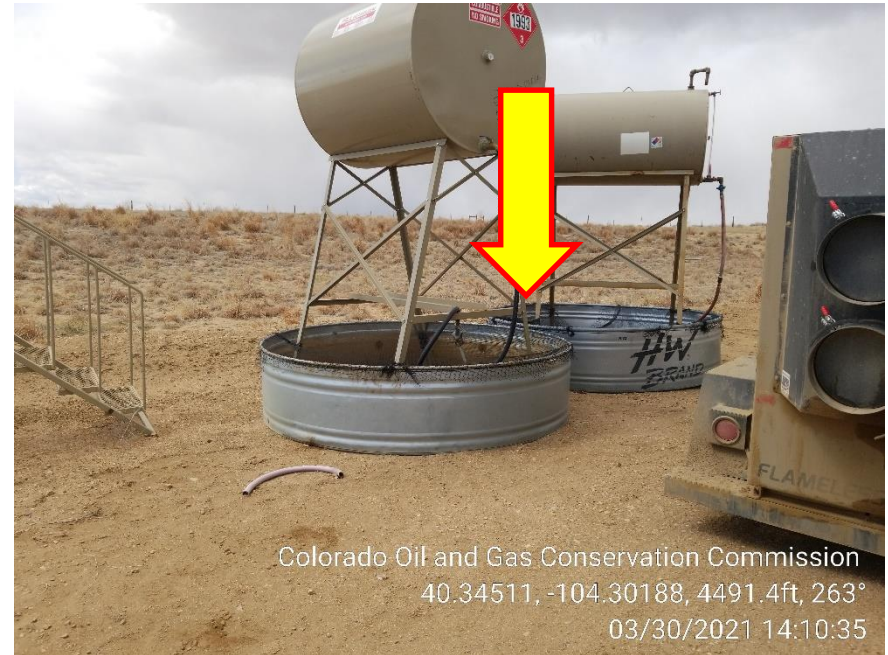
Photo 14 – Day Tanks now have Wildlife Netting

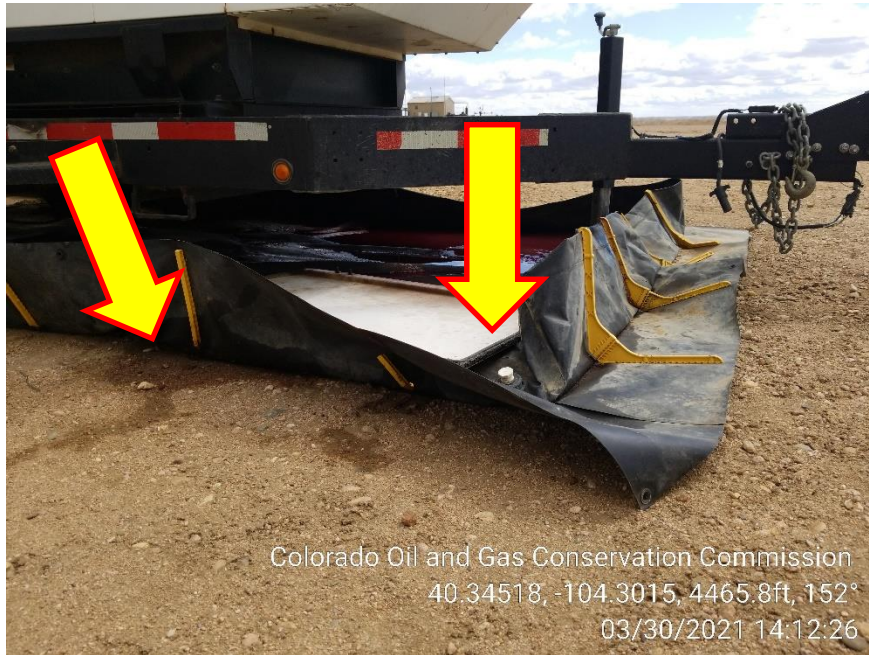
Photo 15 – Secondary Containment is compromised and Stained Soil

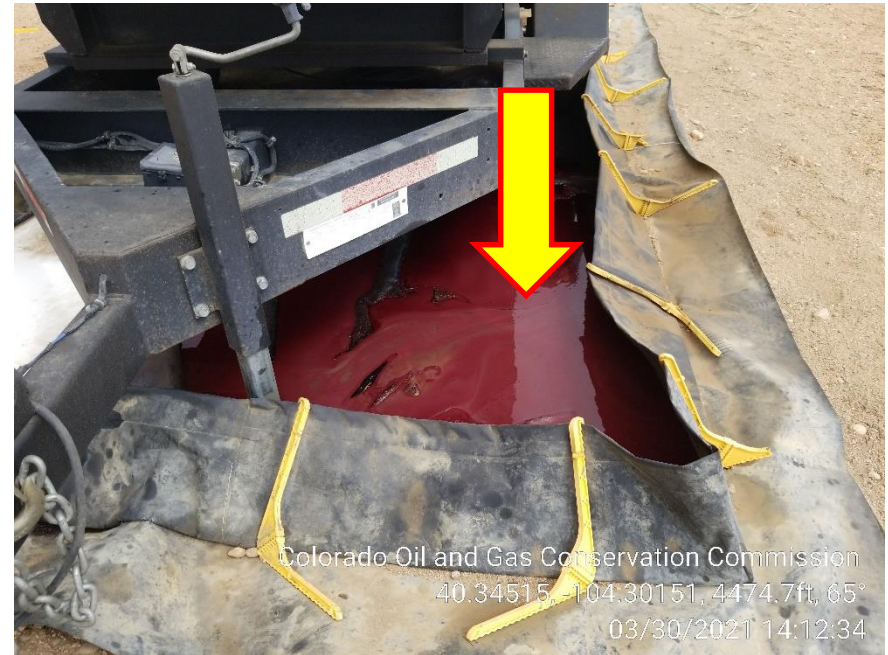
Photo 16 – Standing Oil in Containment

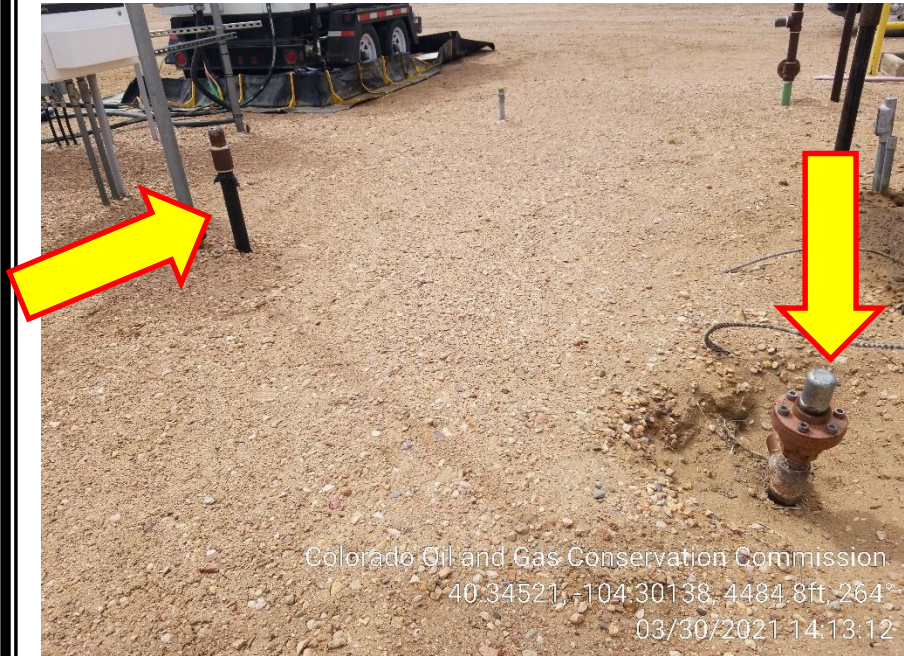
Photo 17 – Unmarked Risers

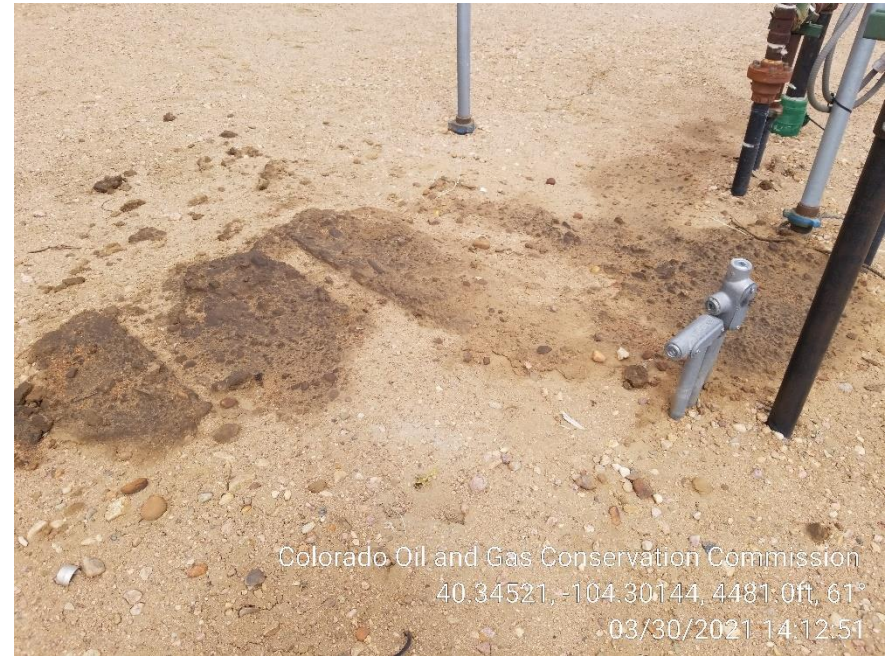
Photo 18 – Stained Soil

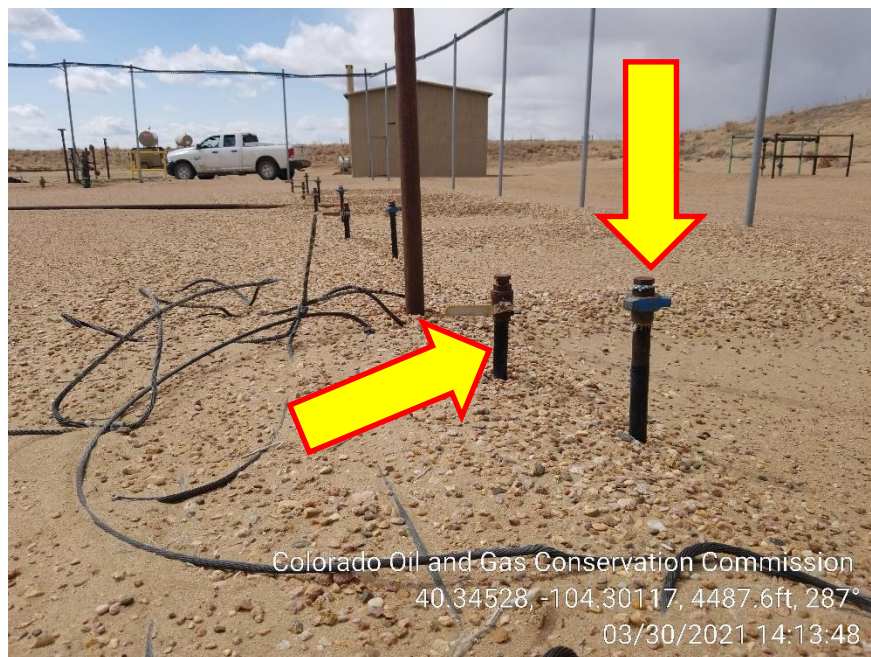
Photo 19 – Unmarked Risers and Debris (Cables)

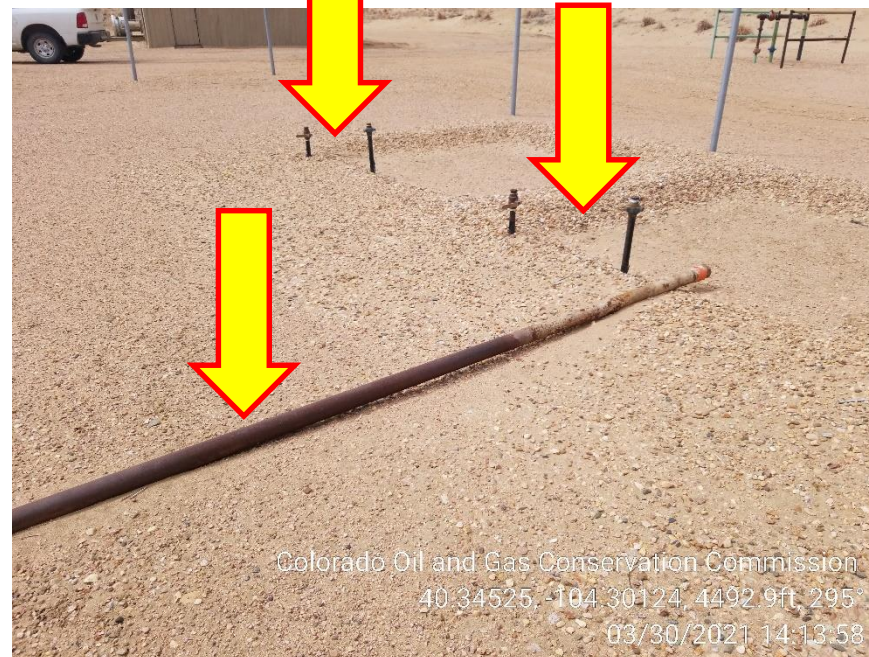
Photo 20 – Unmarked Risers and Unused Pipe

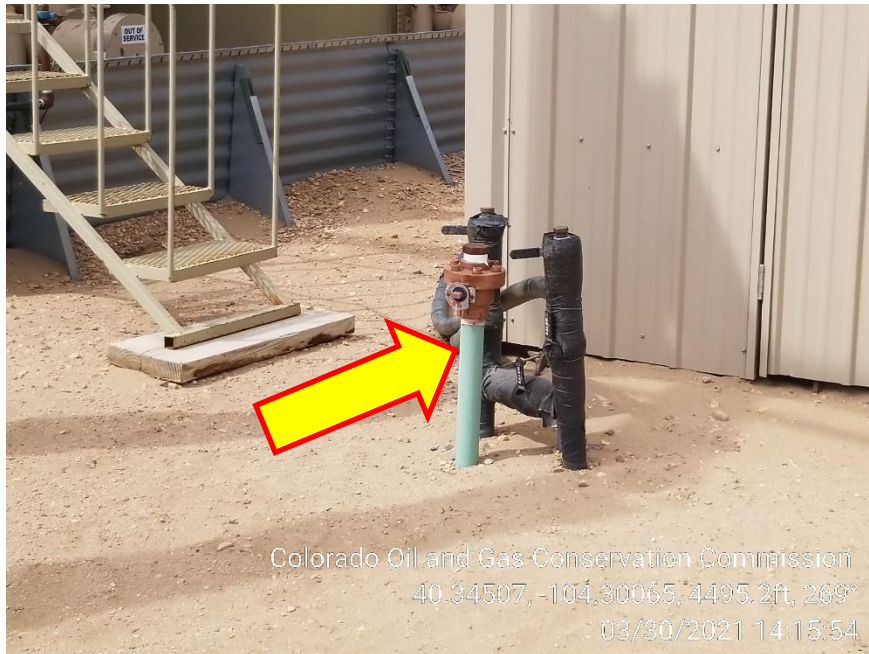
Photo 21 – Unmarked Riser at LACT

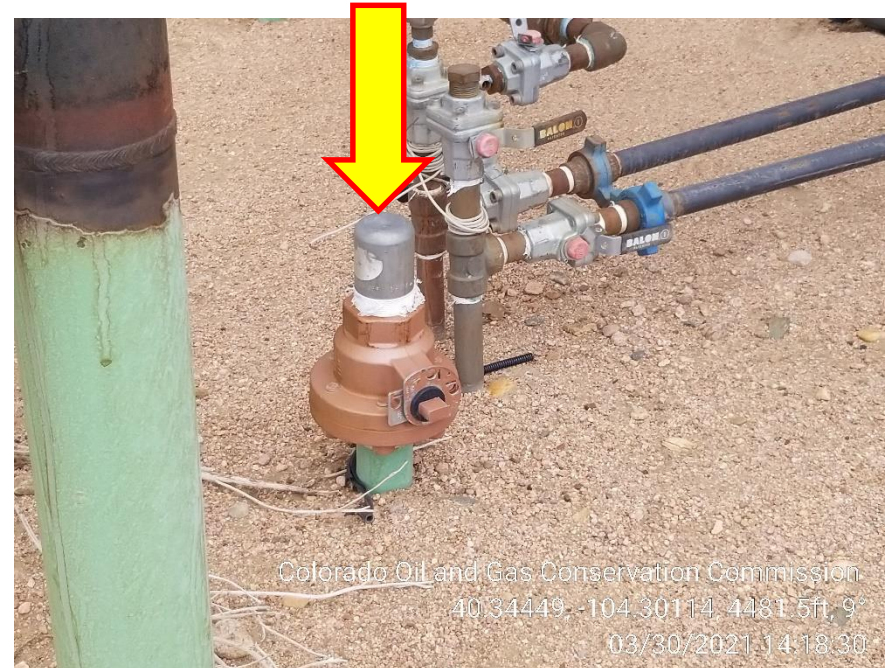
Photo 22 – Unmarked Riser at Line Heater on Southside of Location
