Inspection Photos

Location Name: CAERUS PICEANCE LLC NOCKS-68S96W /2NENE

Location ID: 334078

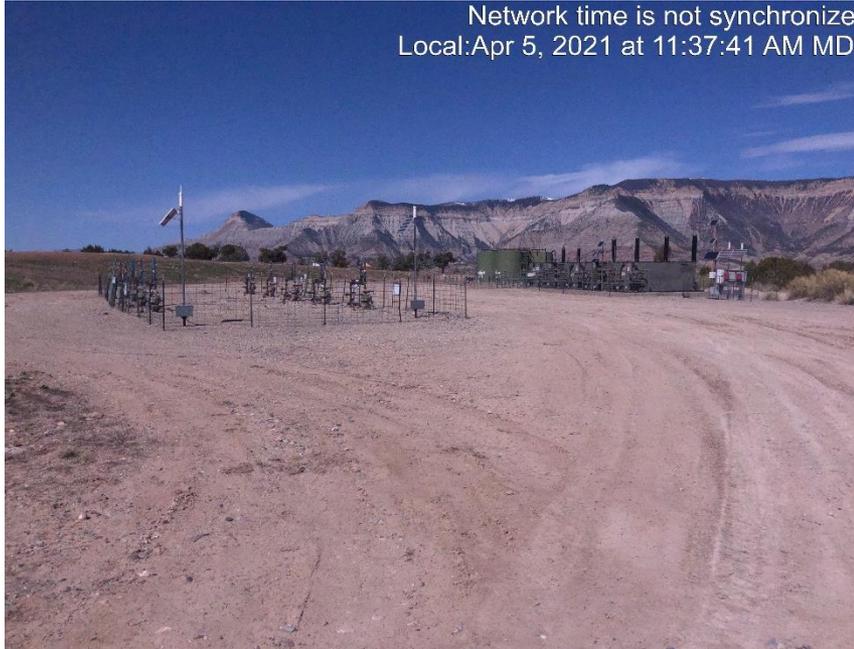
Photo #3370 from entrance to location.

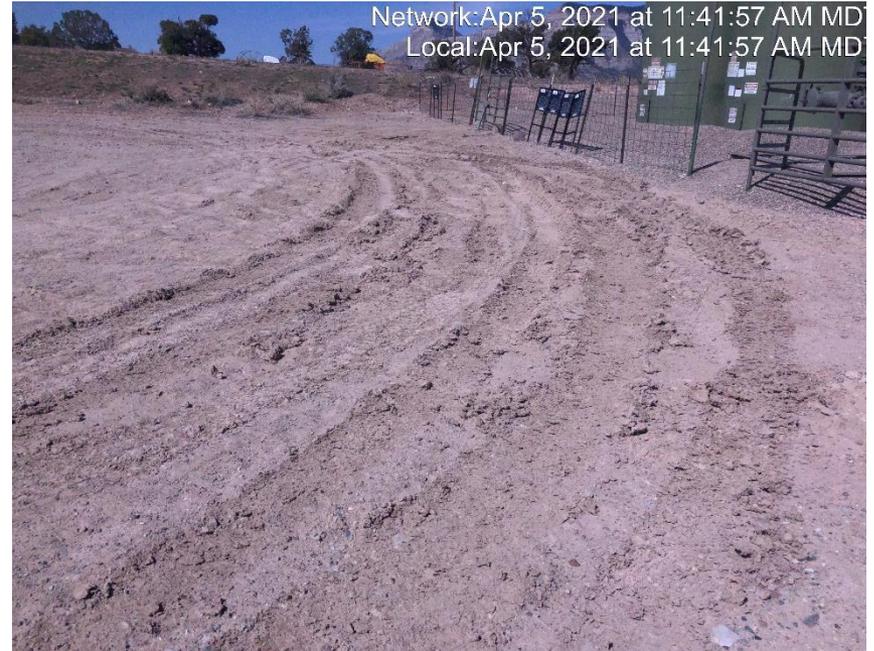
Photo #3371 Location lacks stabilization.

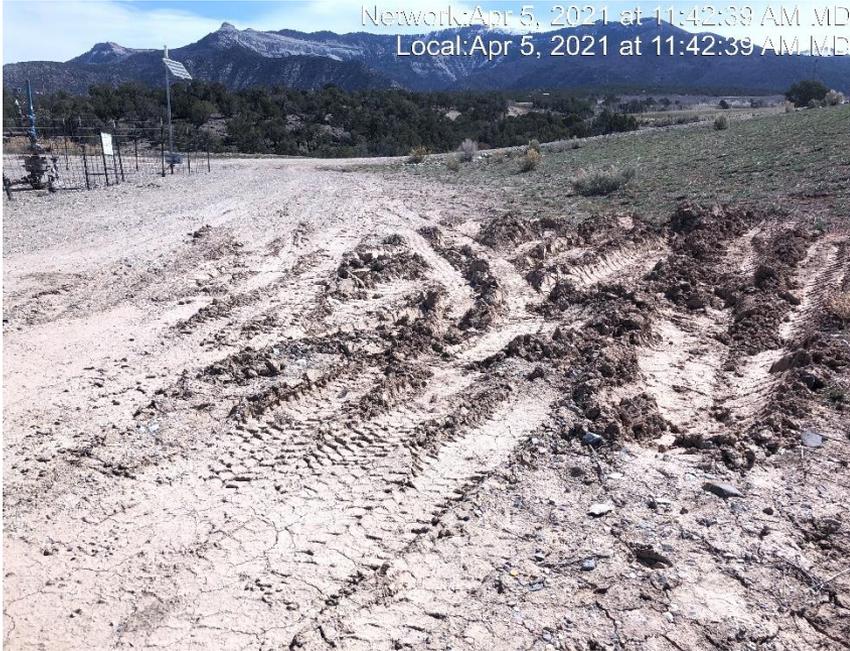
Photo #3372 Location lacks stabilization.

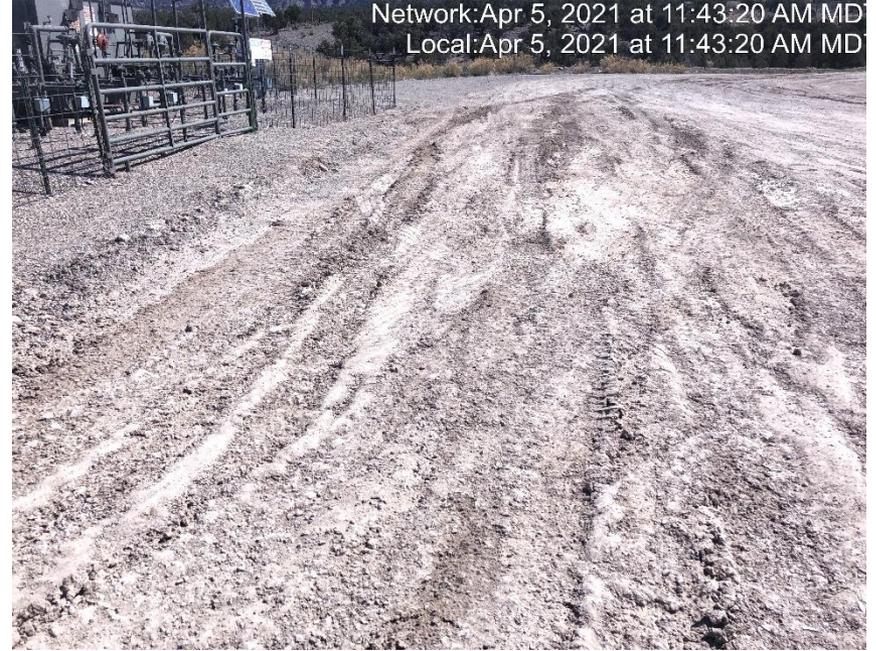
Photo #3373 Location lacks stabilization.

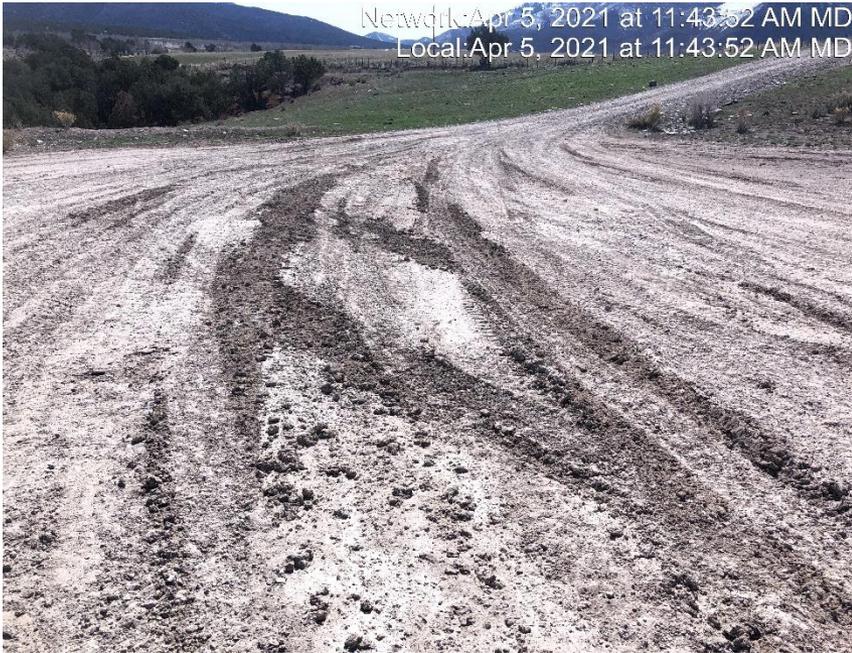
Photo #3374 No form of tracking control at entrance to location
