Inspection Photos
Well 081-06242
Inspection Date: 4/6/2021
All Photos taken by Kris Neidel

COLORADO
Oil & Gas Conservation
Commission
Department of Natural Resources

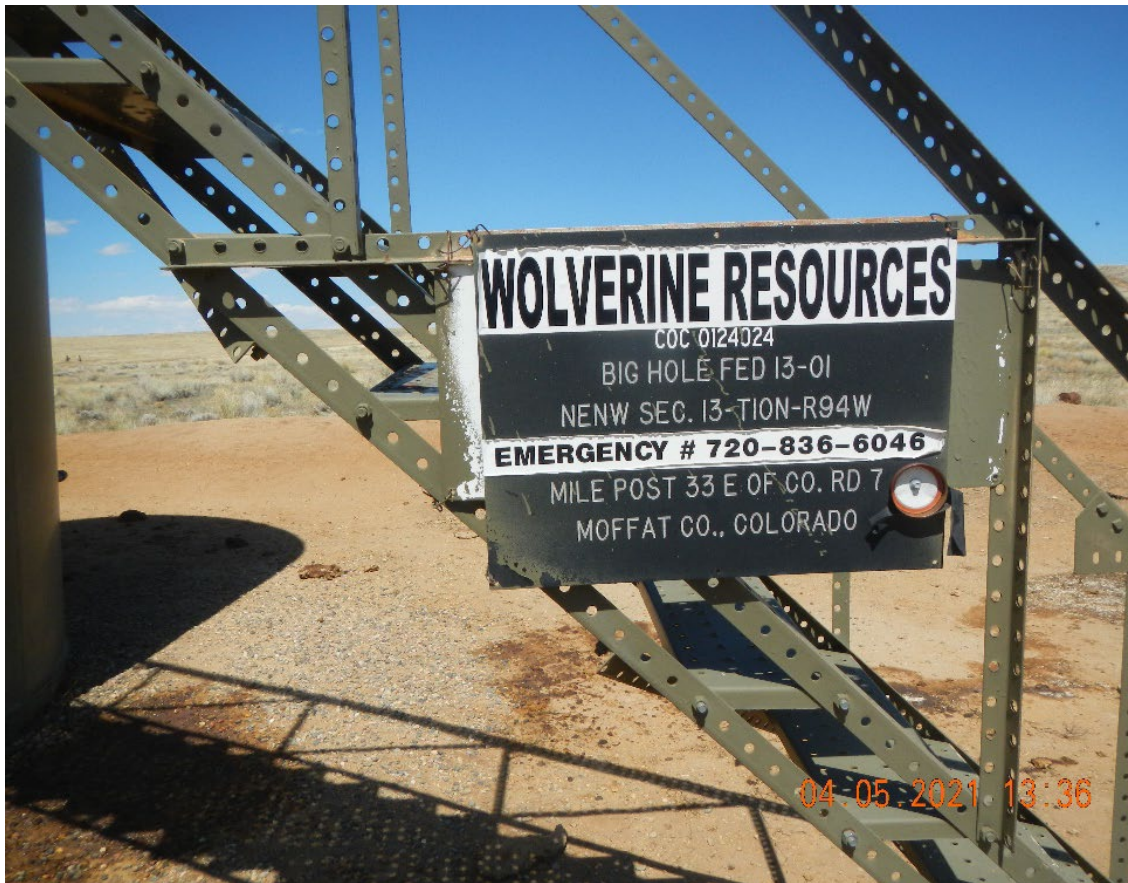
Photo #1 Sign at tank battery.

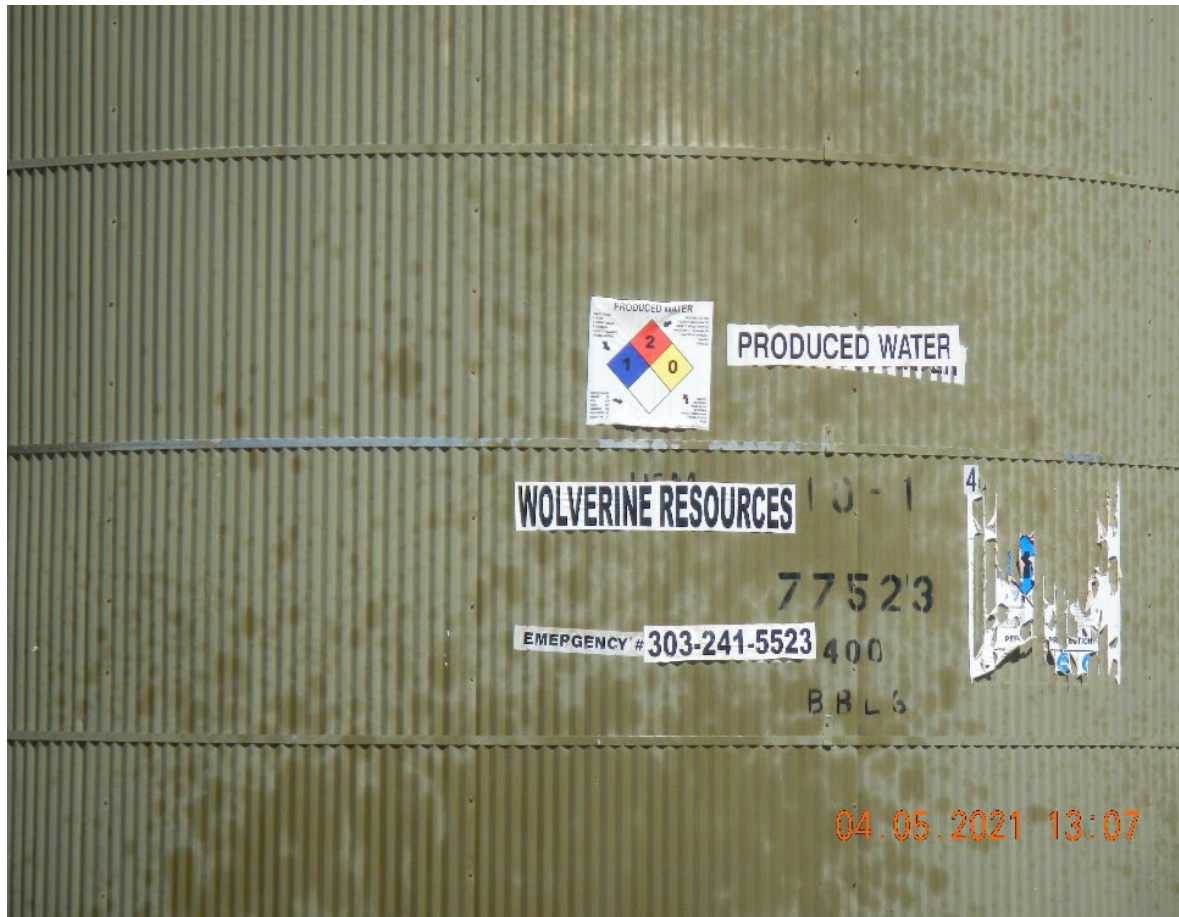
Photo #2 Tank Labels

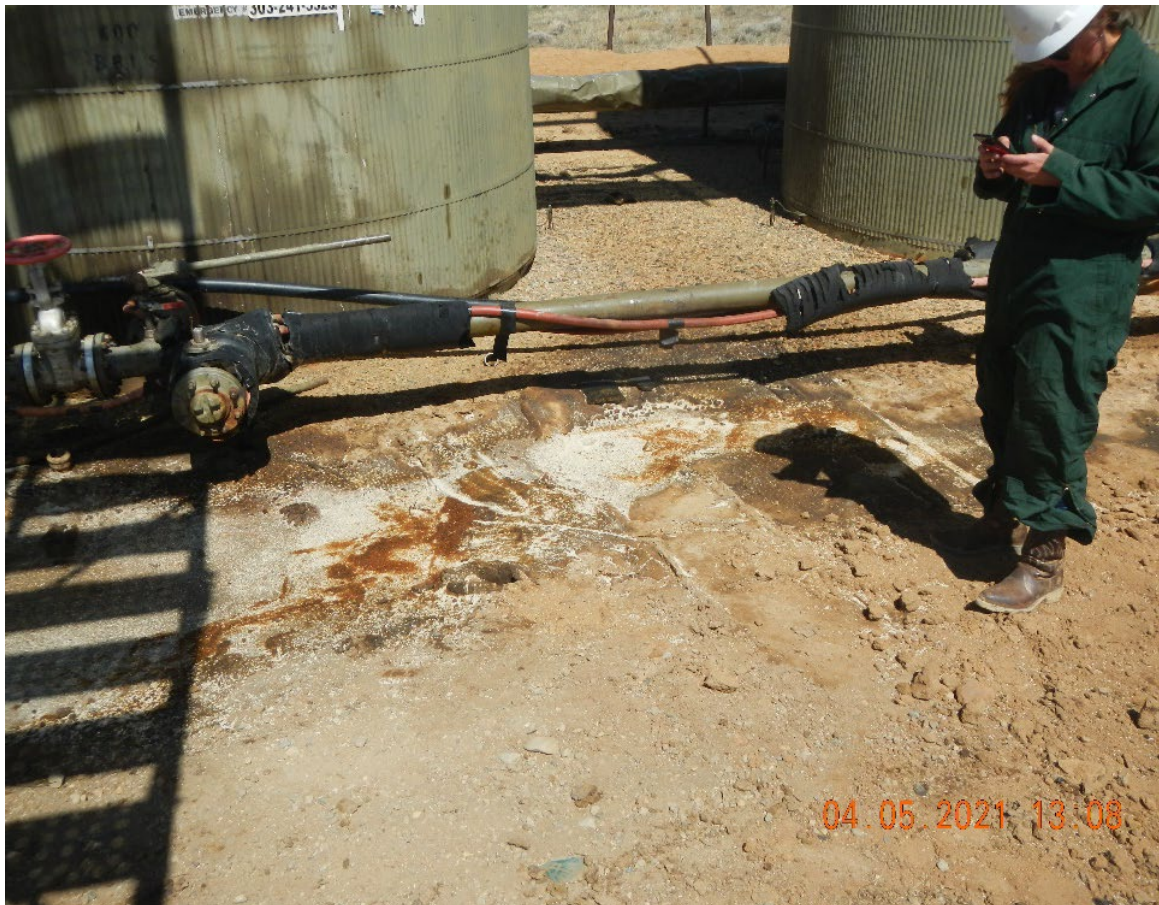
Photo #3 Area of Pipe with no insulation is area of Release. See Photos 31-36 for detail of failure point.

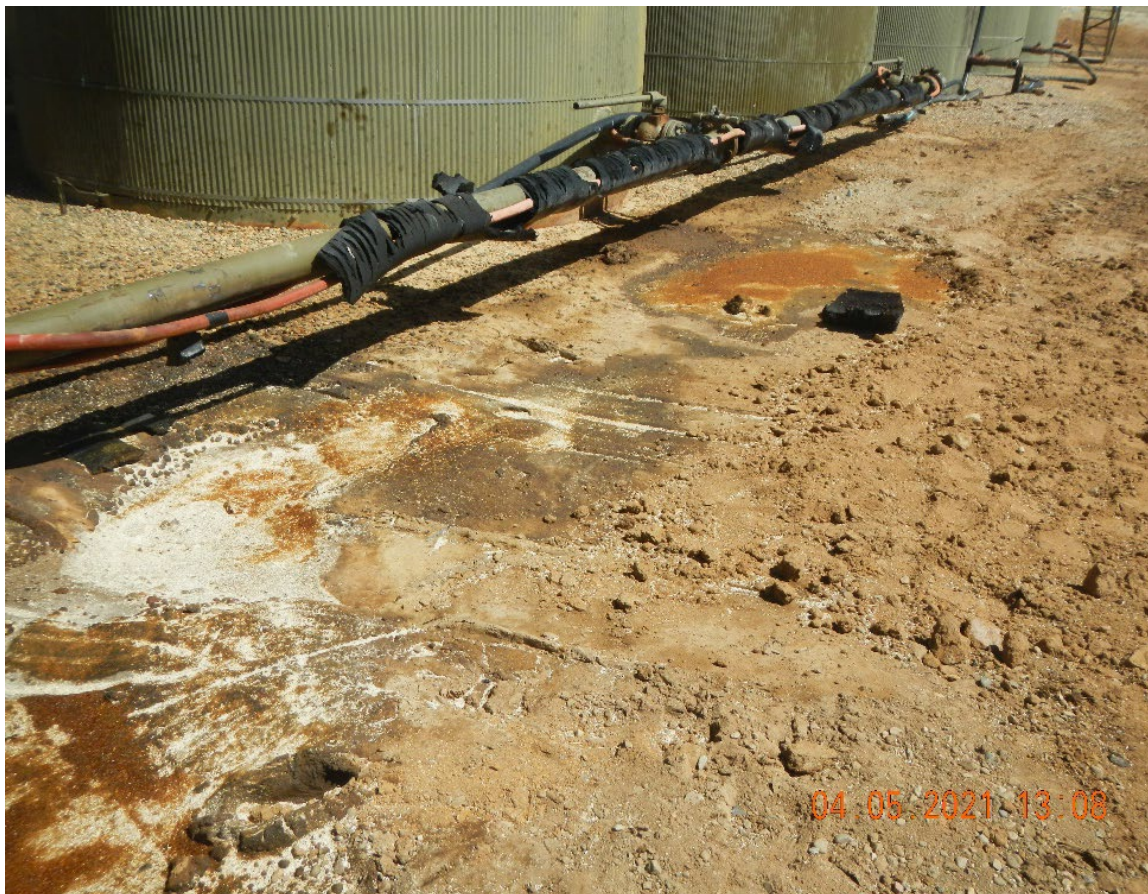
Photo #4 Stained soil area was; saturated, hydrocarbon stained, appeared that a wood-based amendment was added to surface.

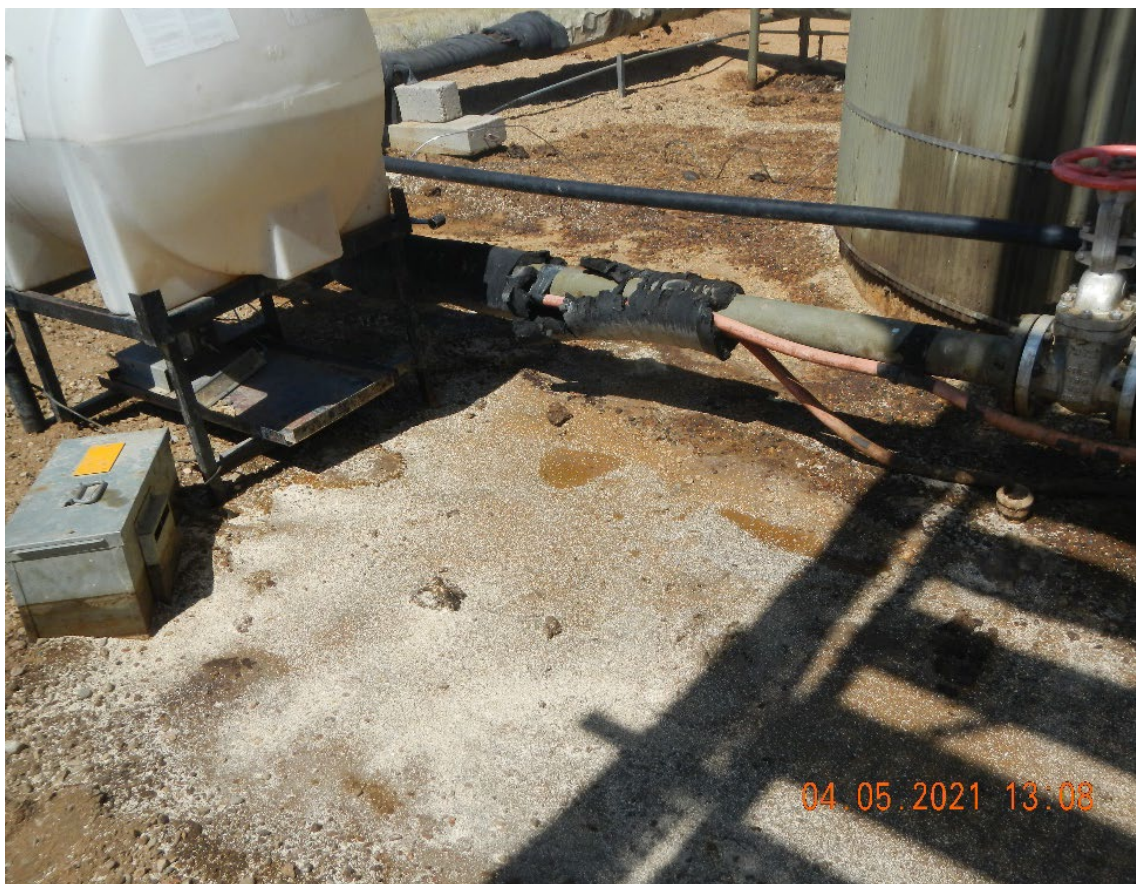
Photo #5 inside tank battery, area where spilled fluid pooled. Material that looks white is a wood pulp additive.

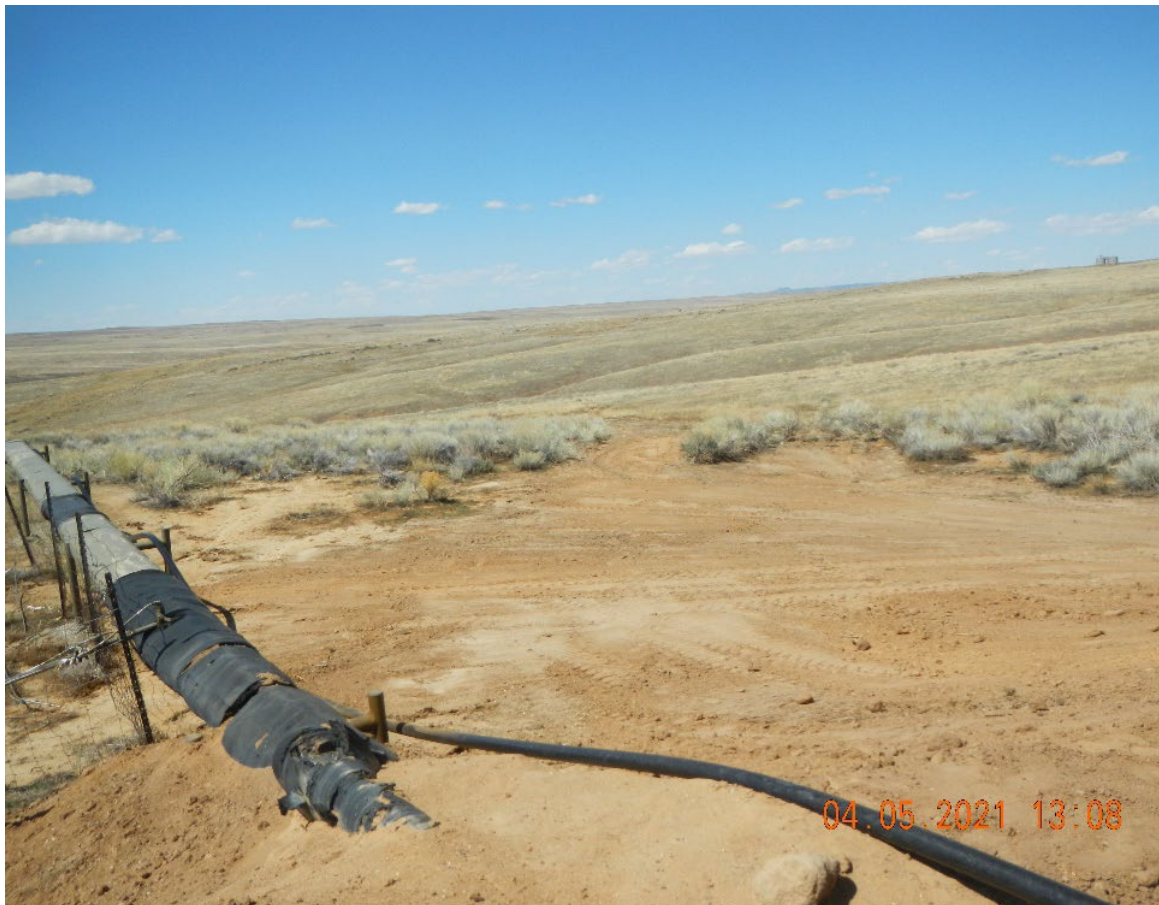
Photo #6 Photo taken near Southwest corner of tank battery berm,
looking northwest. The Scraped off soil area is area of impact from Spill.

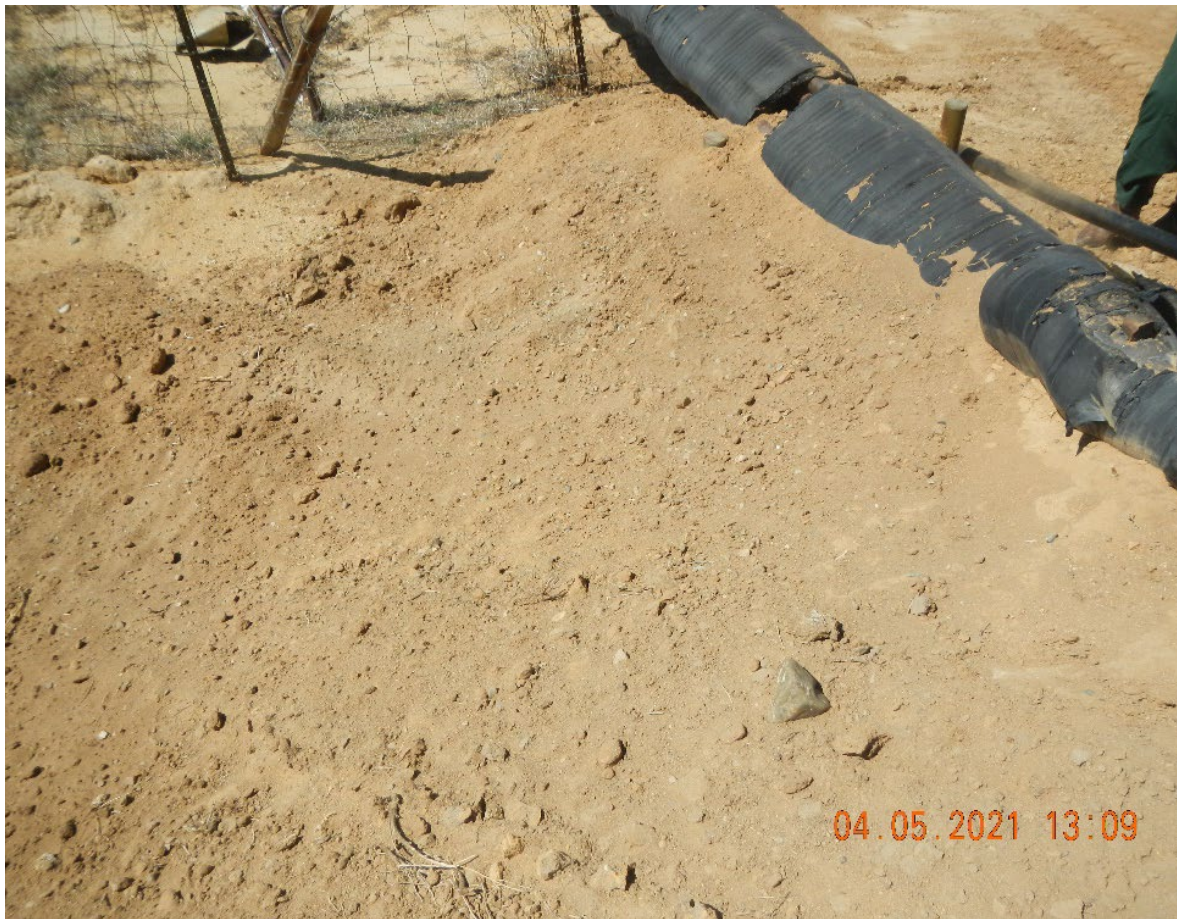
Photo #7 Close-up of surface piping seen in photo #6. appeared that soil was applied to piping and west side of berms. This is a area was observed 4/2/21 as where the spill exited the berm. Soils shall be delineated in this area and where pipe supports penetrated ground surface.

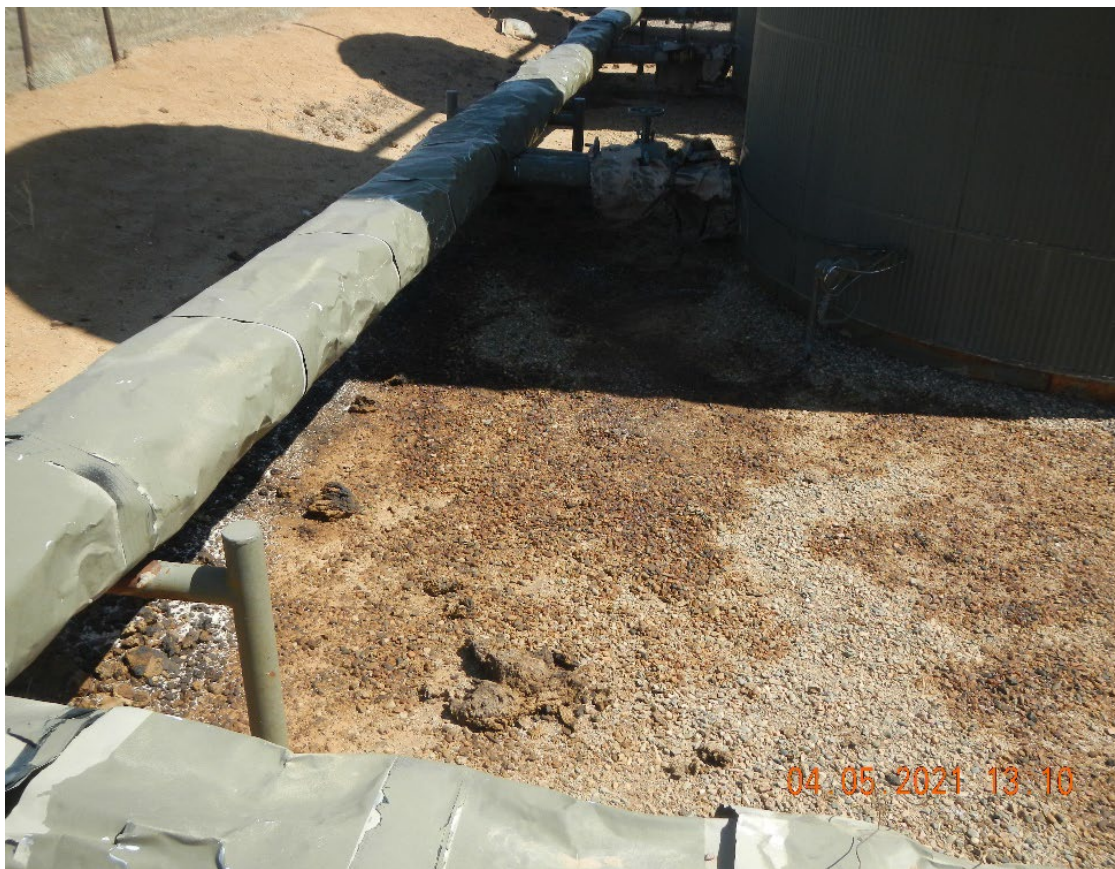
Photo #9 looking at the back of western most tank, fluid had accumulated here.

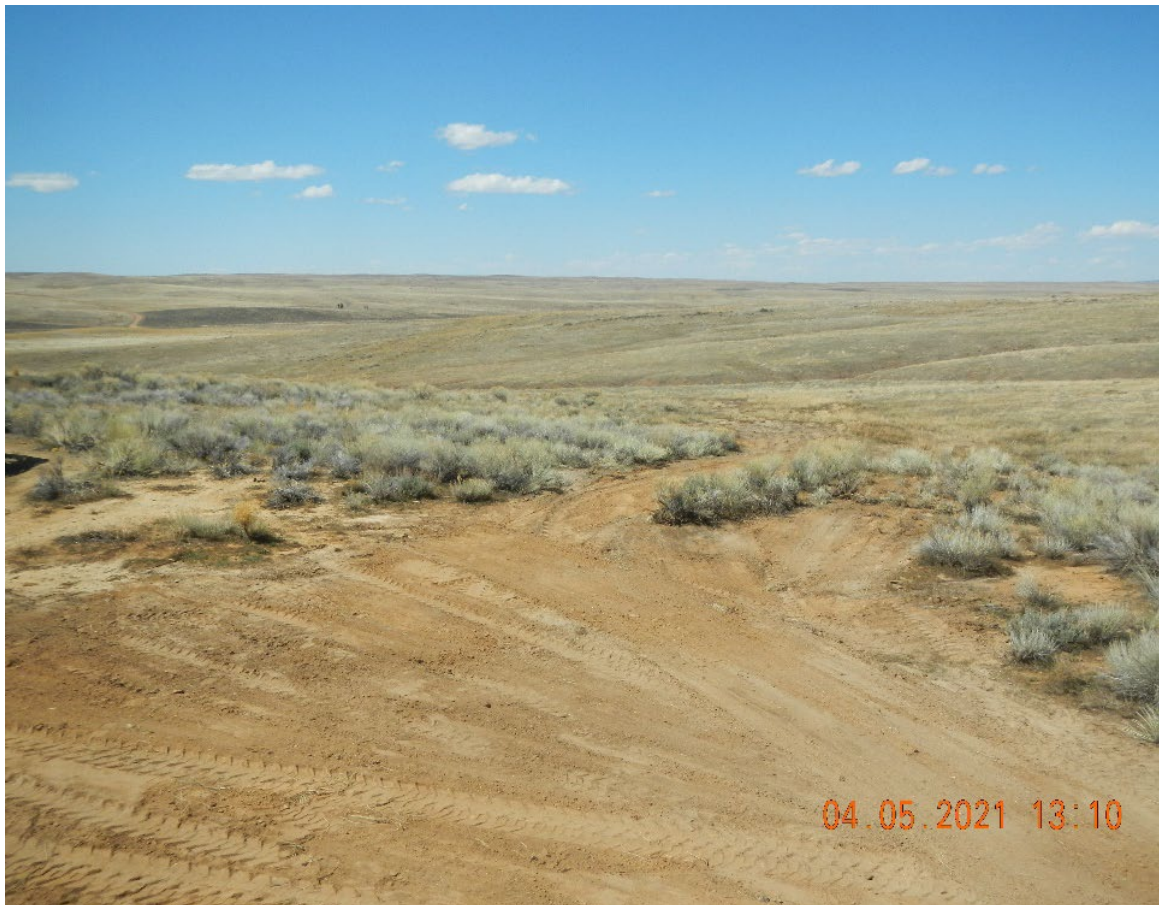
Photo #11 Photo taken near Southwest corner of tank battery berm, looking northwest. The Scraped off soil area is area of impact from Spill. Note: bare spot in center of photo, this was part of the flow path downhill, as well as to the right of bare spot.

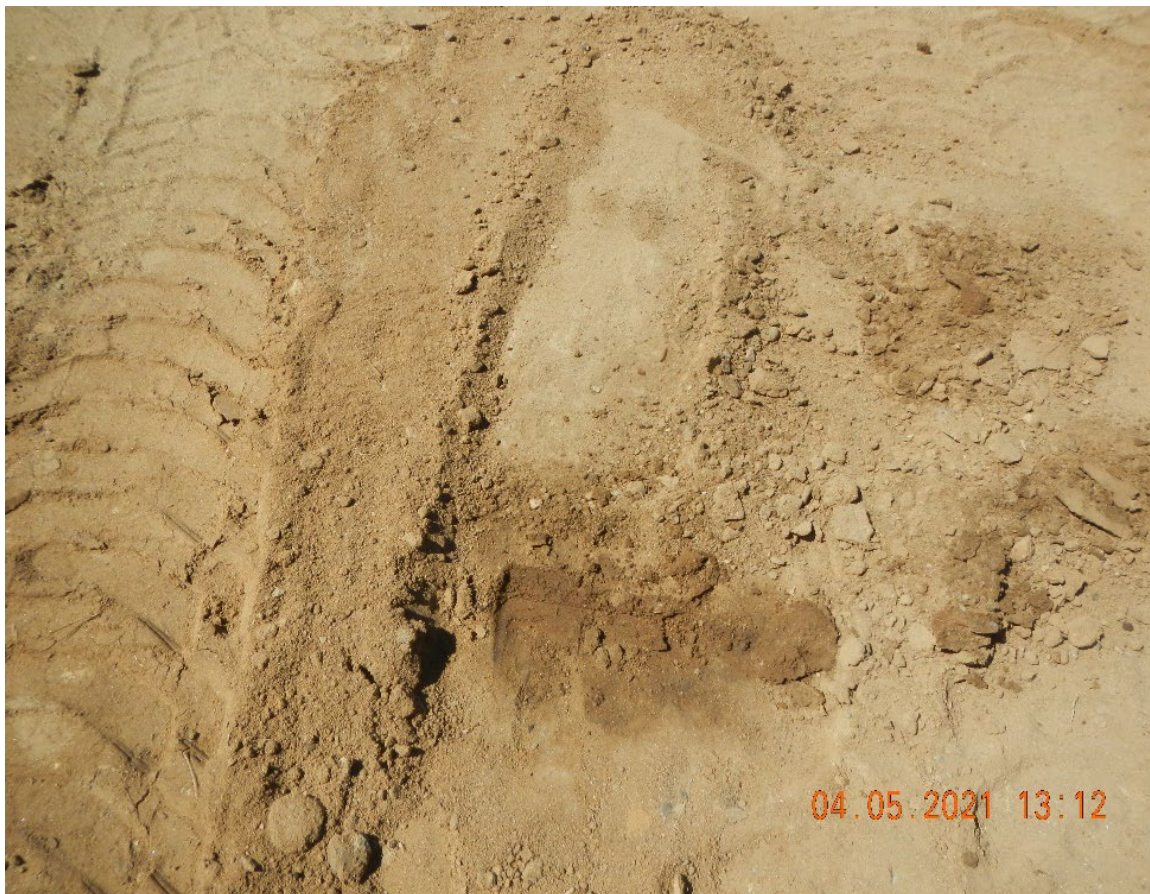
Photo #12 area where the top 2" of soil was removed for observation, it had a slight hydrocarbon odor. Location~40.831607,-107.900598

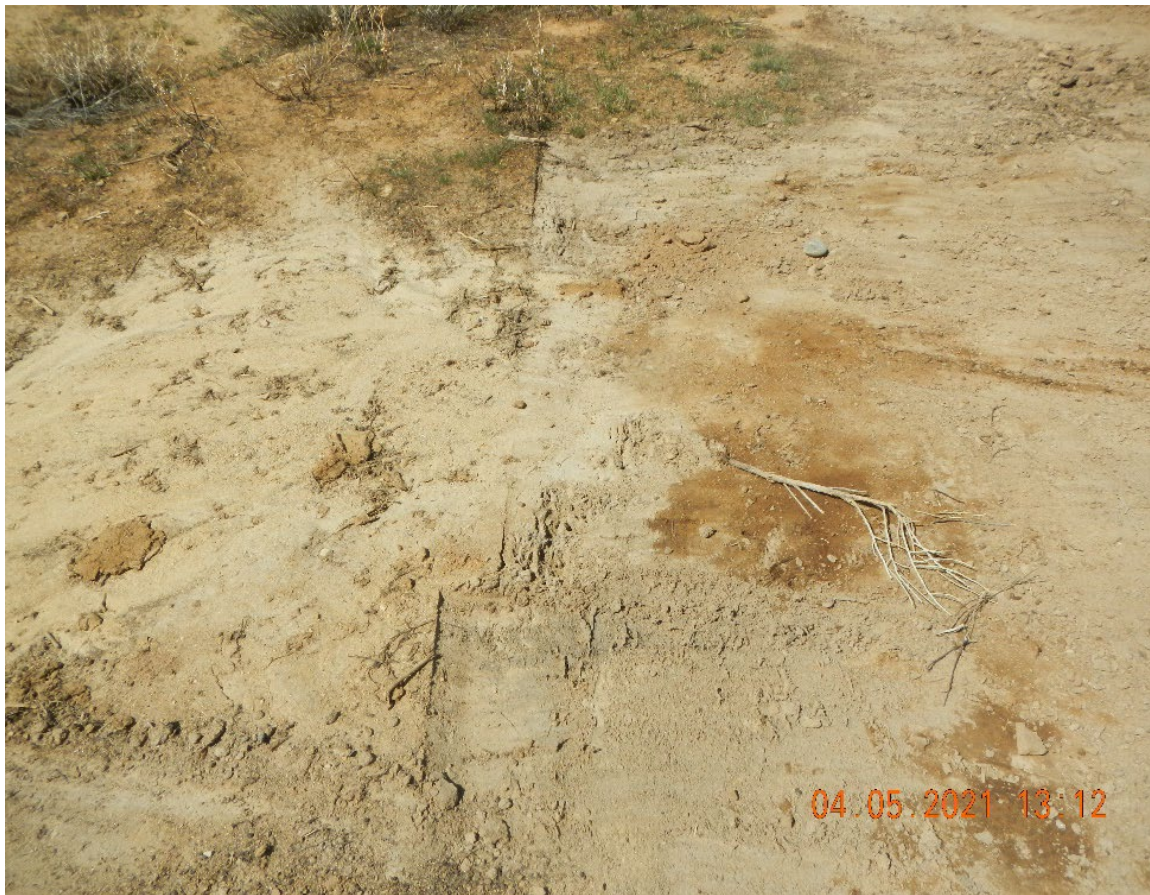
Photo #13 area where soils were scraped.

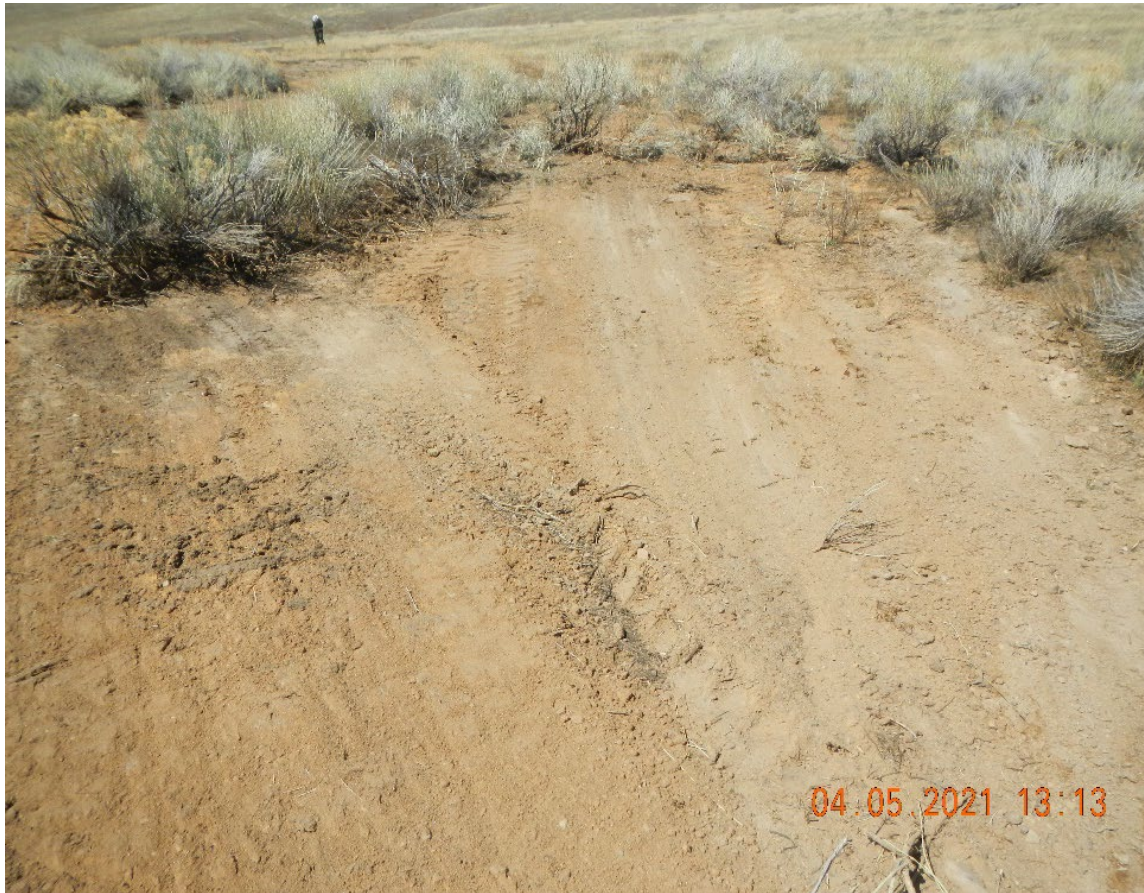
Photo #14, surface appears to have been scraped with a skidsteer.

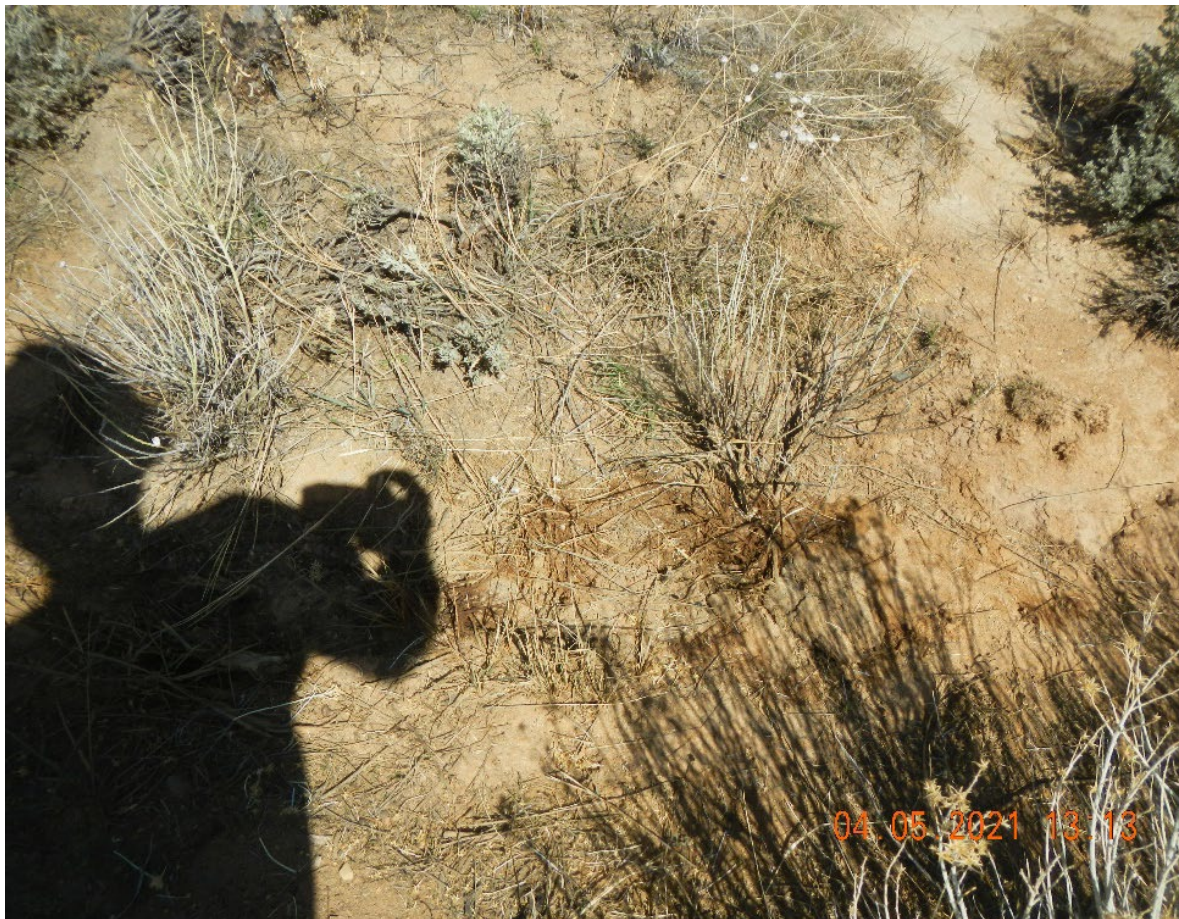
Photo #15 area of soil staining. Location~40.831820,-107.901128)

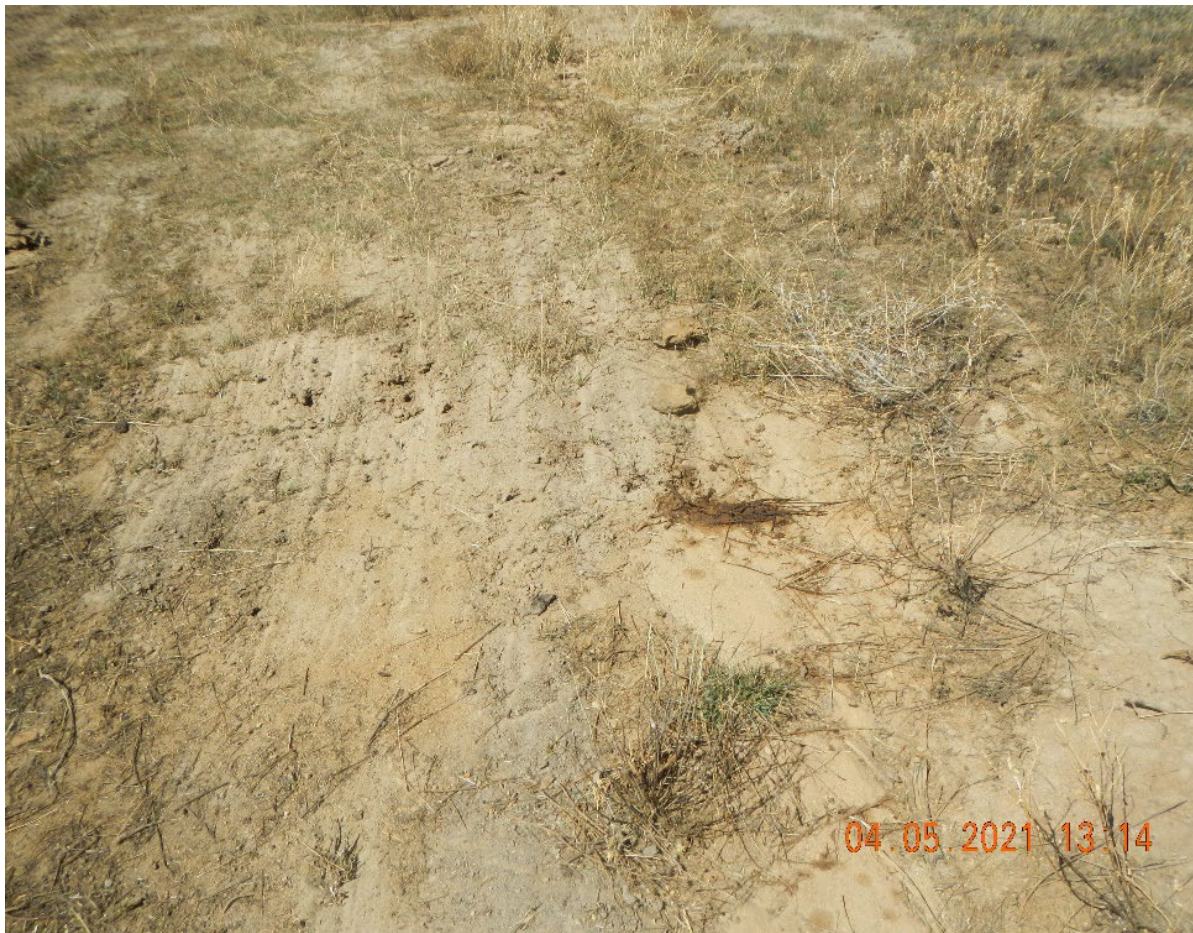
Photo #16 soil staining

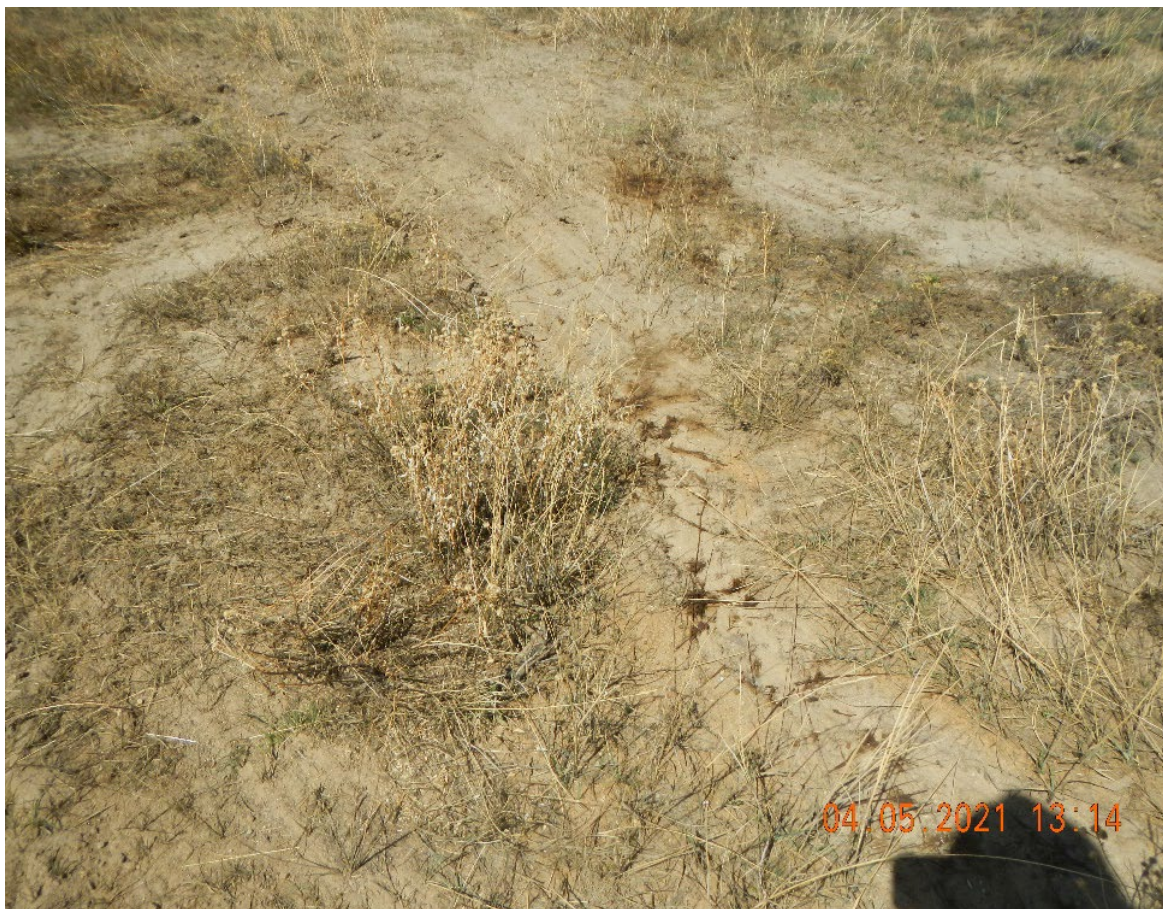
Photo #17 remaining soil staining.

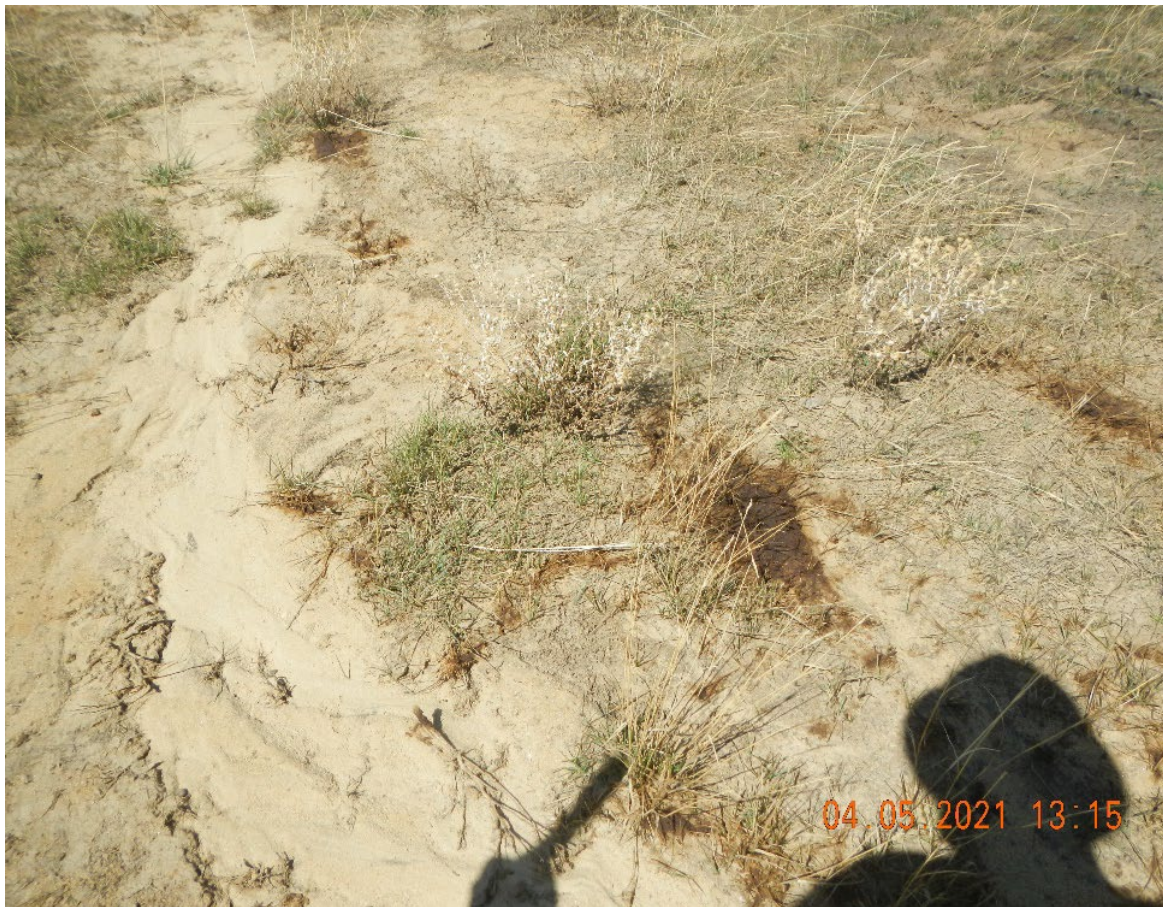
Photo #20 remaining soil staining location~40.831907,-107.901467

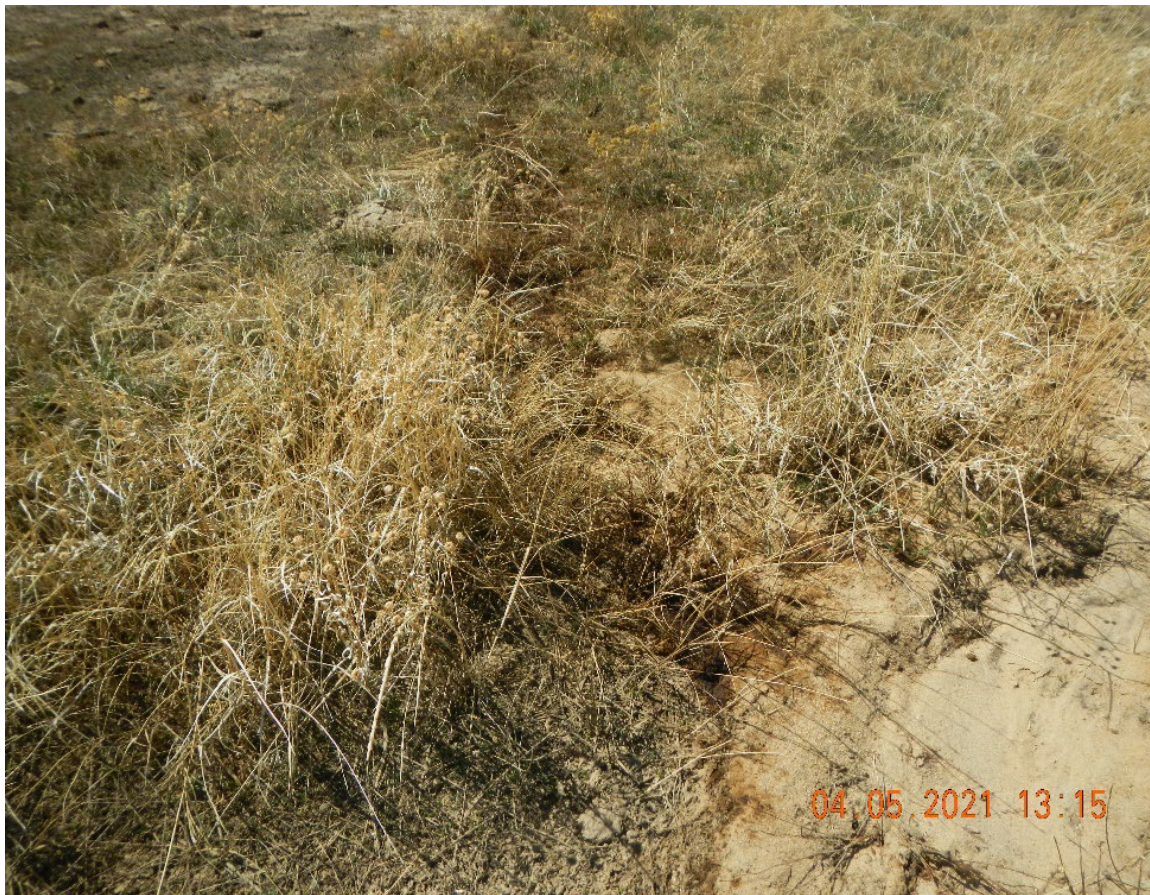
Photo #21 remaining soil staining

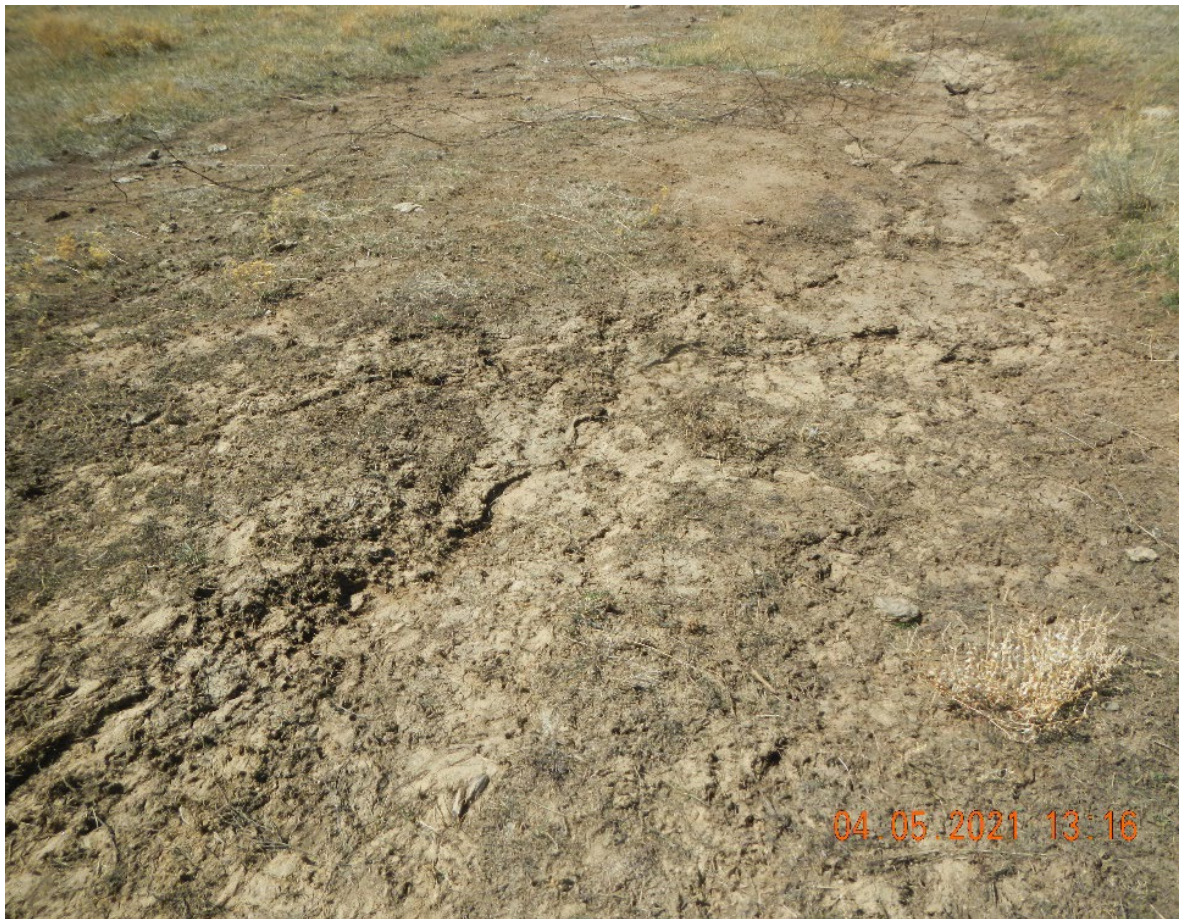
Photo #22 erosion and barbwire (trash)

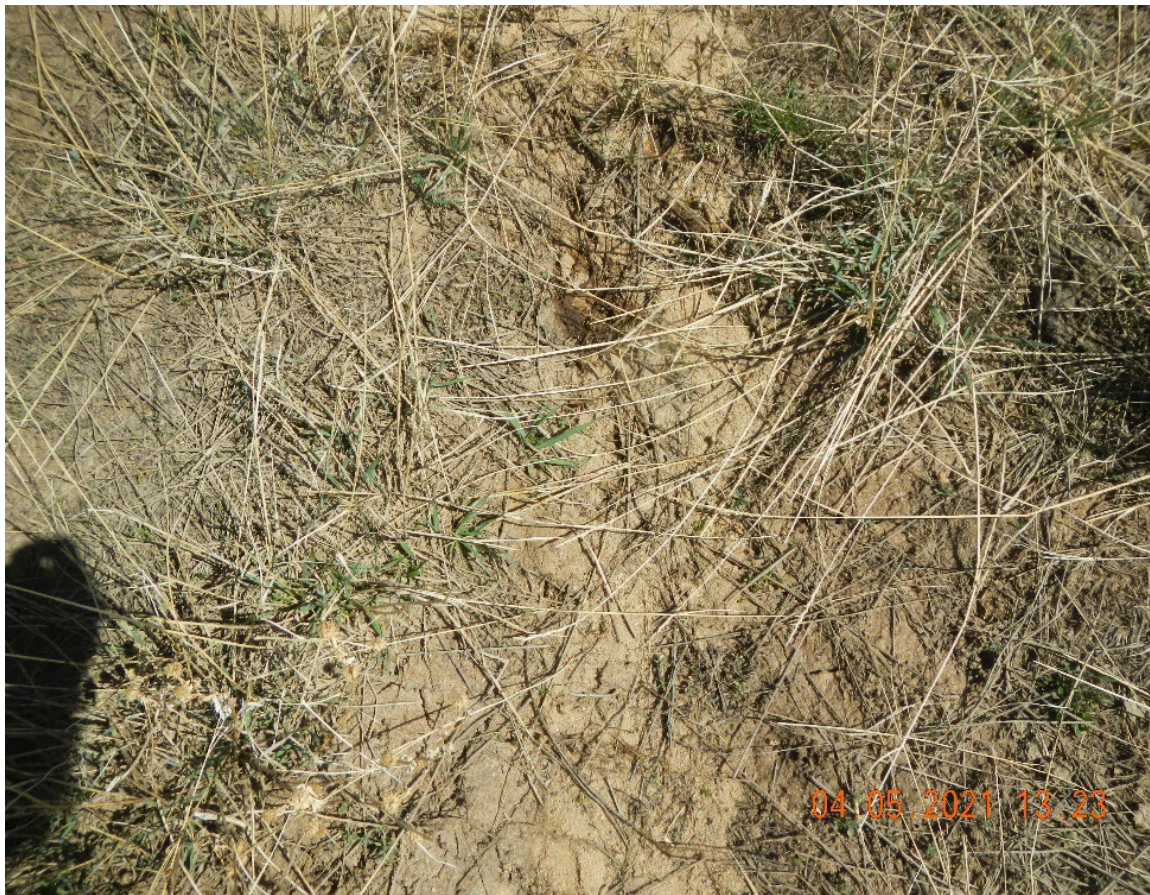
Photo #remaining soil staining, location~40.831932,-107.901617

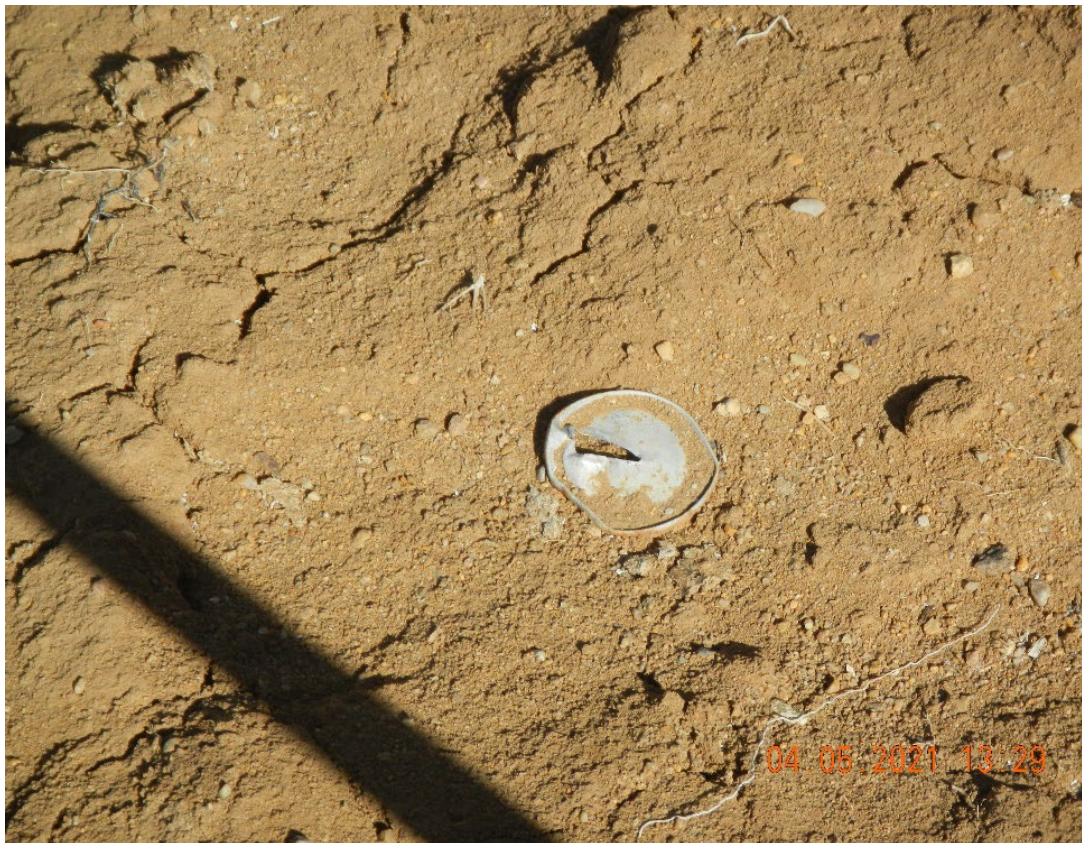
Photo #25 observed trash near tank battery.

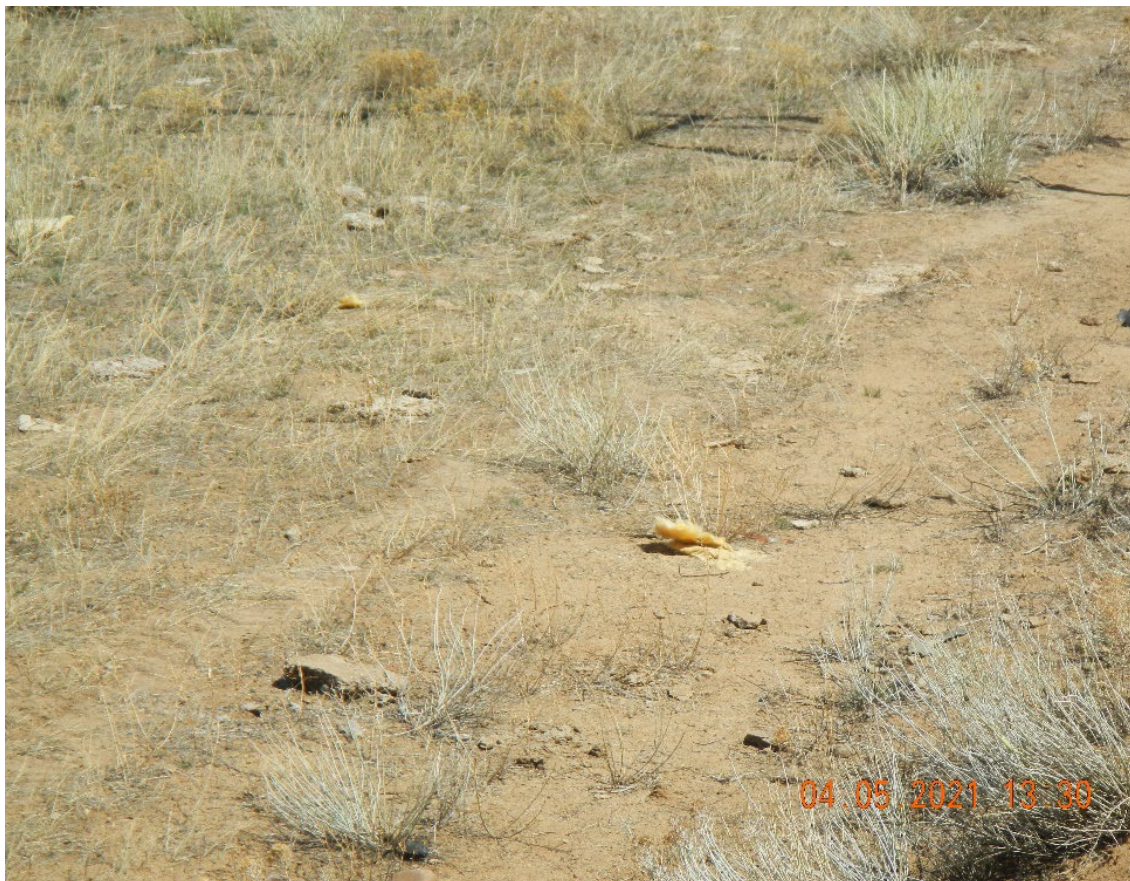
Photo #26 observed trash on the north side of tank battery. Photo taken from tank battery.

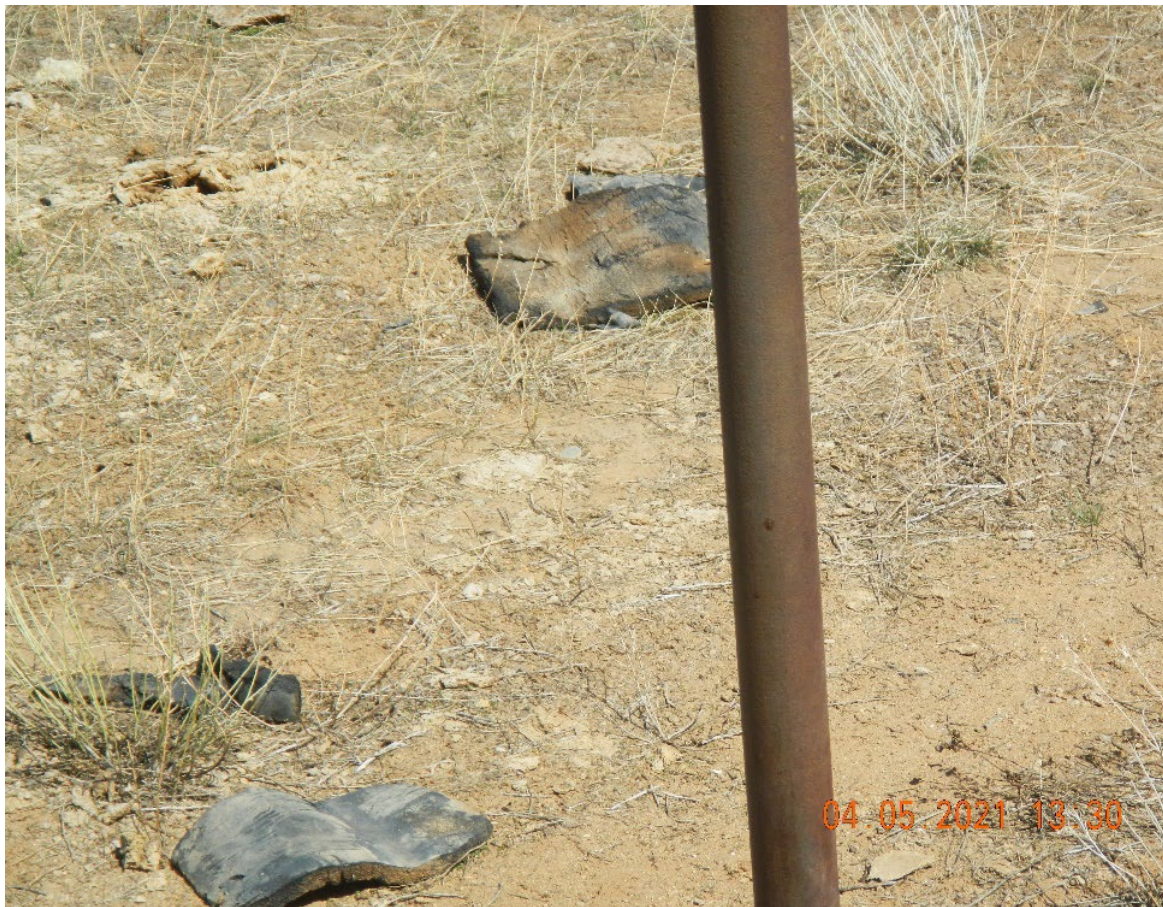
Photo #27 observed trash on the north side of tank battery. Photo taken from tank battery.
