Inspection Photos
Well 081-06242
Inspection Date: 4/6/2021
All Photos taken by Kris Neidel

COLORADO
Oil & Gas Conservation
Commission
Department of Natural Resources

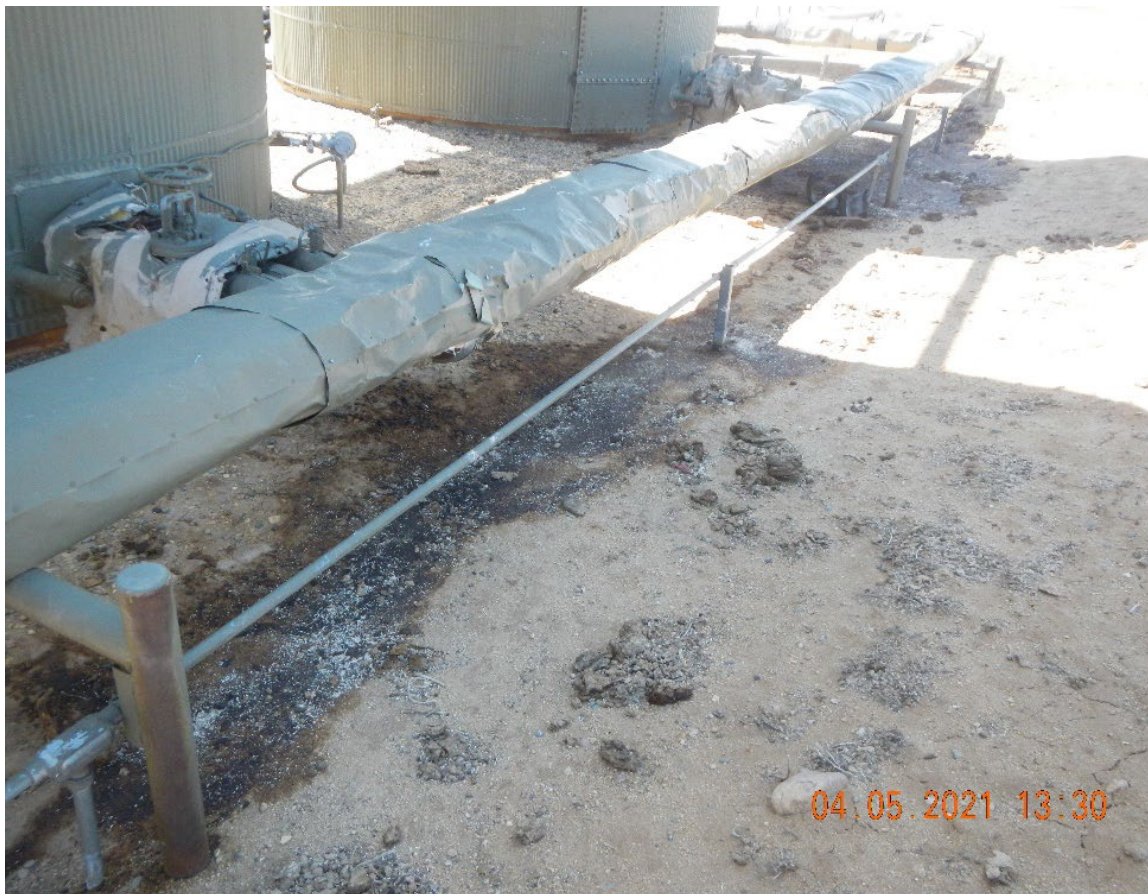
Photo #28 north side of tanks. Is this remaining impact from the 4/2/2021 spill?

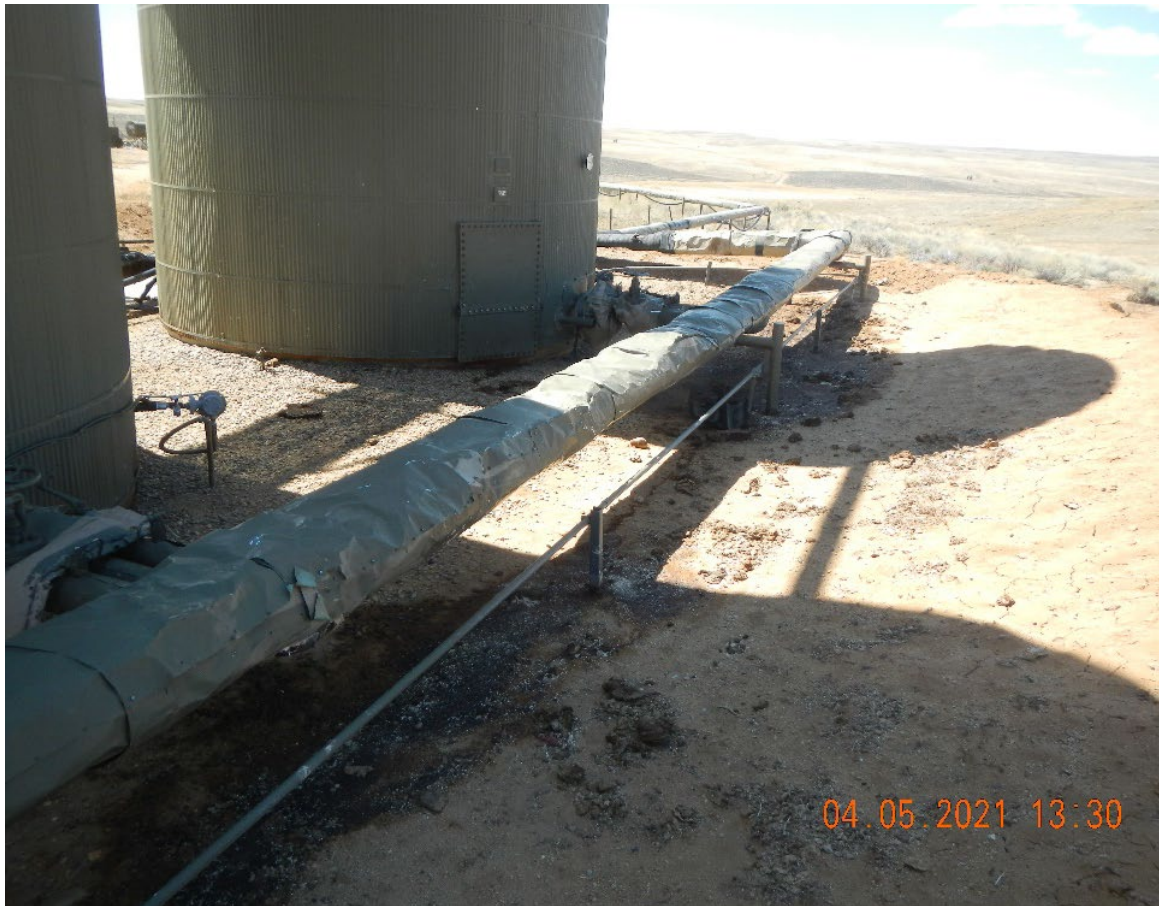
Photo #29 north side of tanks. Is this remaining impact from the 4/2/2021 spill?

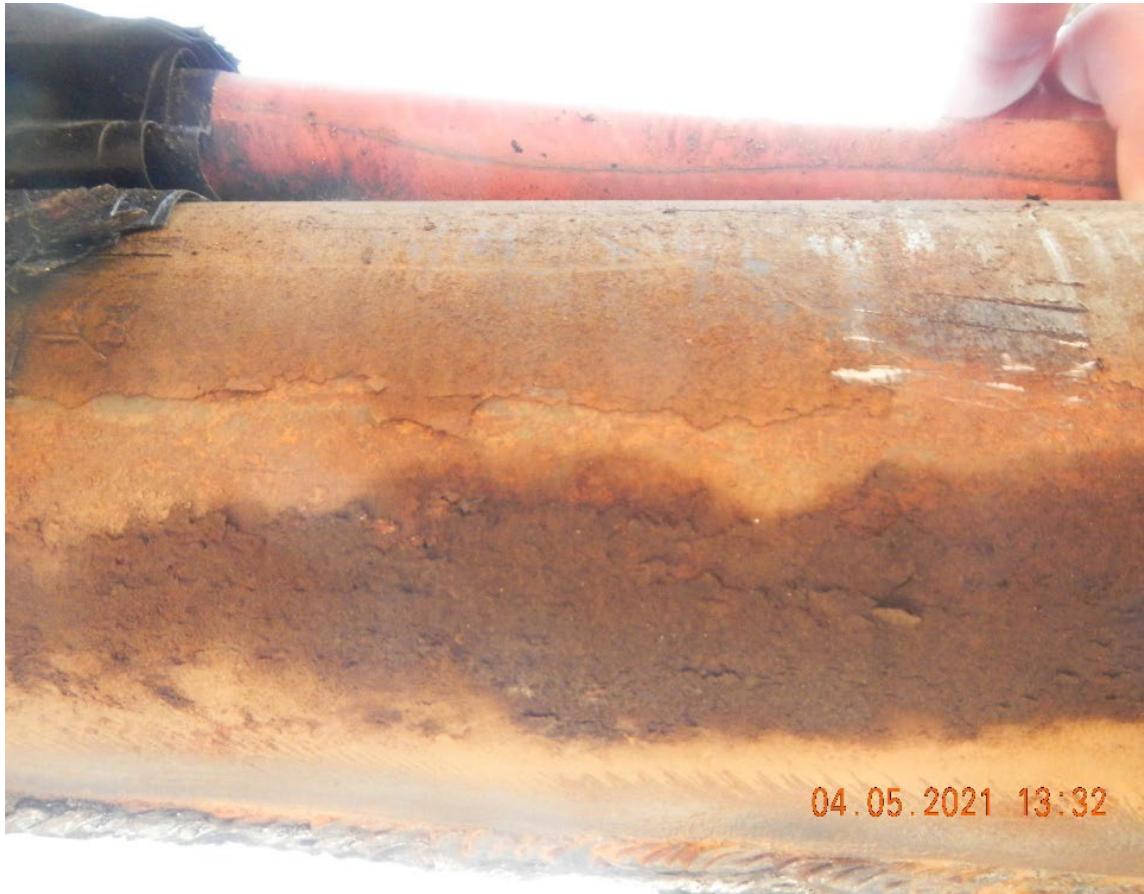
Photo #30 Looking at pipe top of the photo is up. Note: there is a weld on bottom of pipe (facing the ground). Weld is where the pipe failure was observed on 4/2/21. The pipe had foam insulation, some rust, the pipe is elevated from ground with rack support, liquid heat trace line was run with elevated pipe.

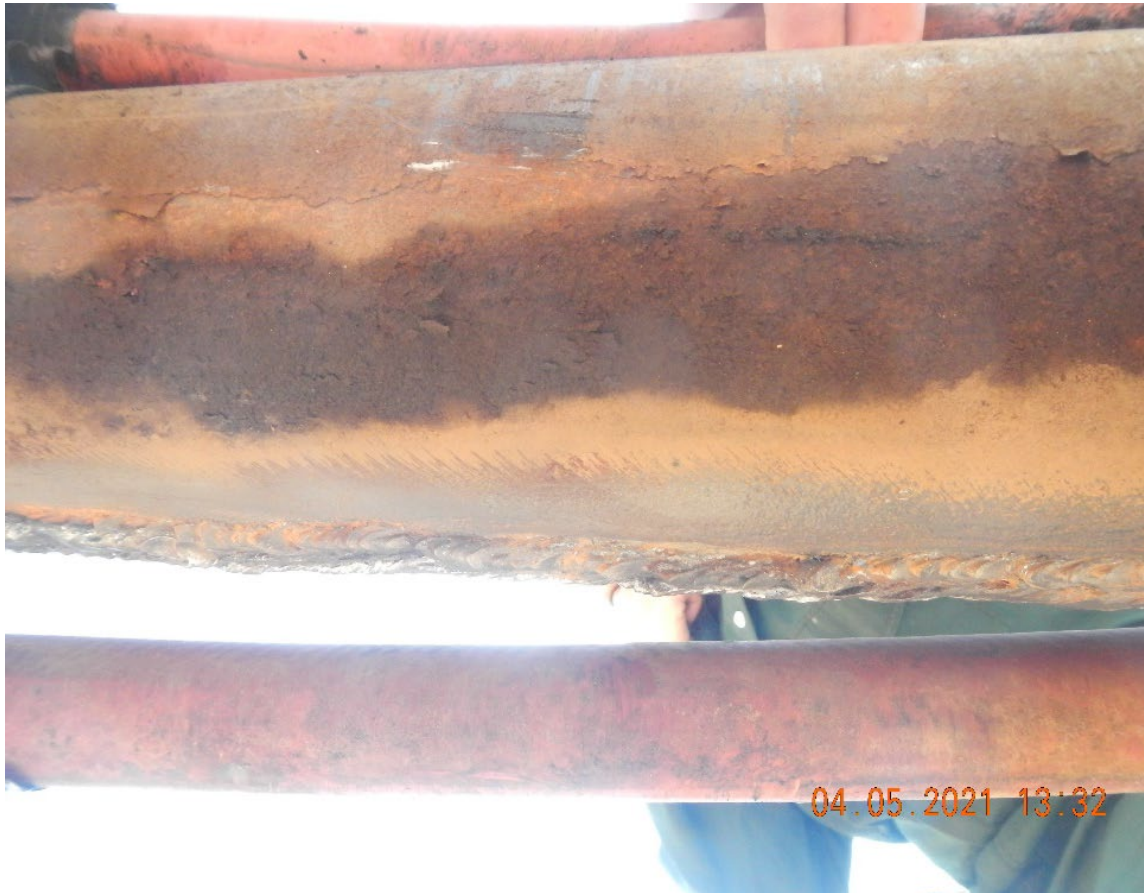
Photo #31 Looking at pipe top of the photo is up. Note: there is a weld on bottom of pipe (facing the ground). Weld is where the pipe failure was observed on 4/2/21. The pipe had foam insulation, some rust, the pipe is elevated from ground with rack support, liquid heat trace line was run with elevated pipe.

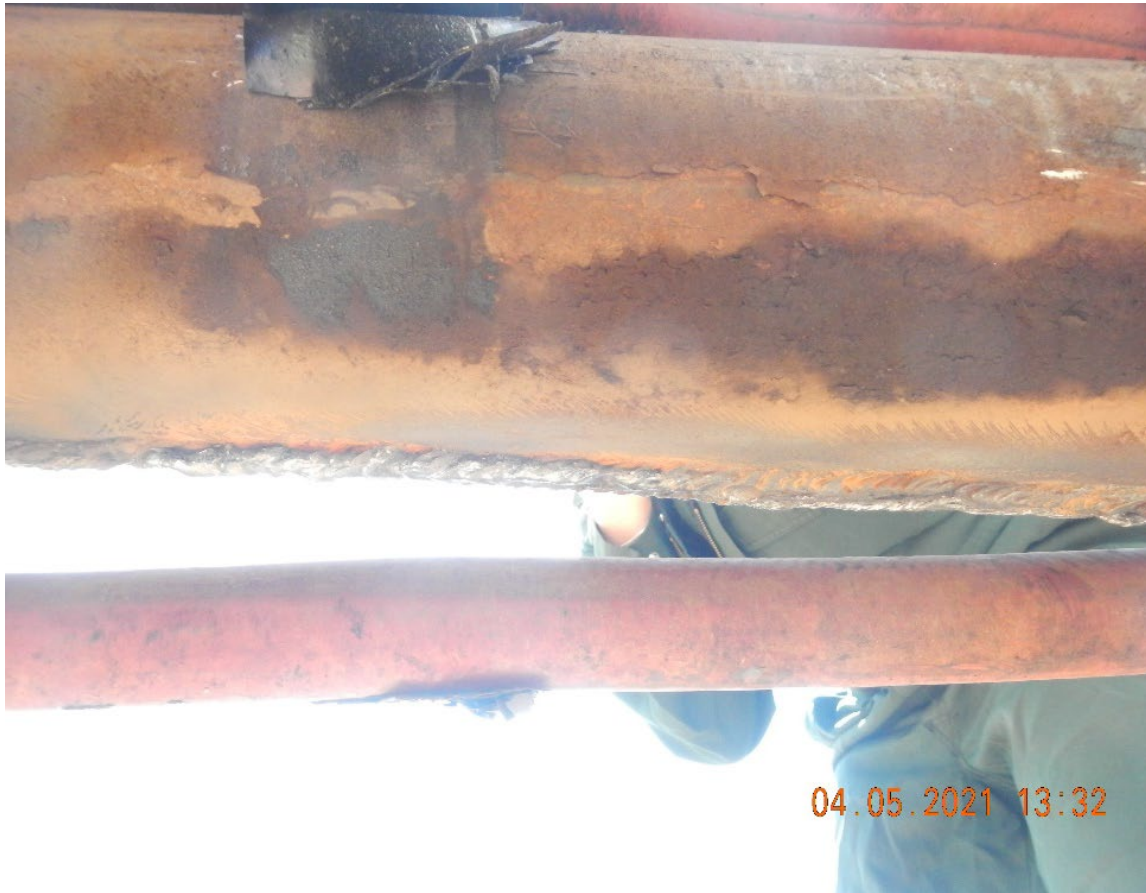
Photo #32 Same as previous photos.

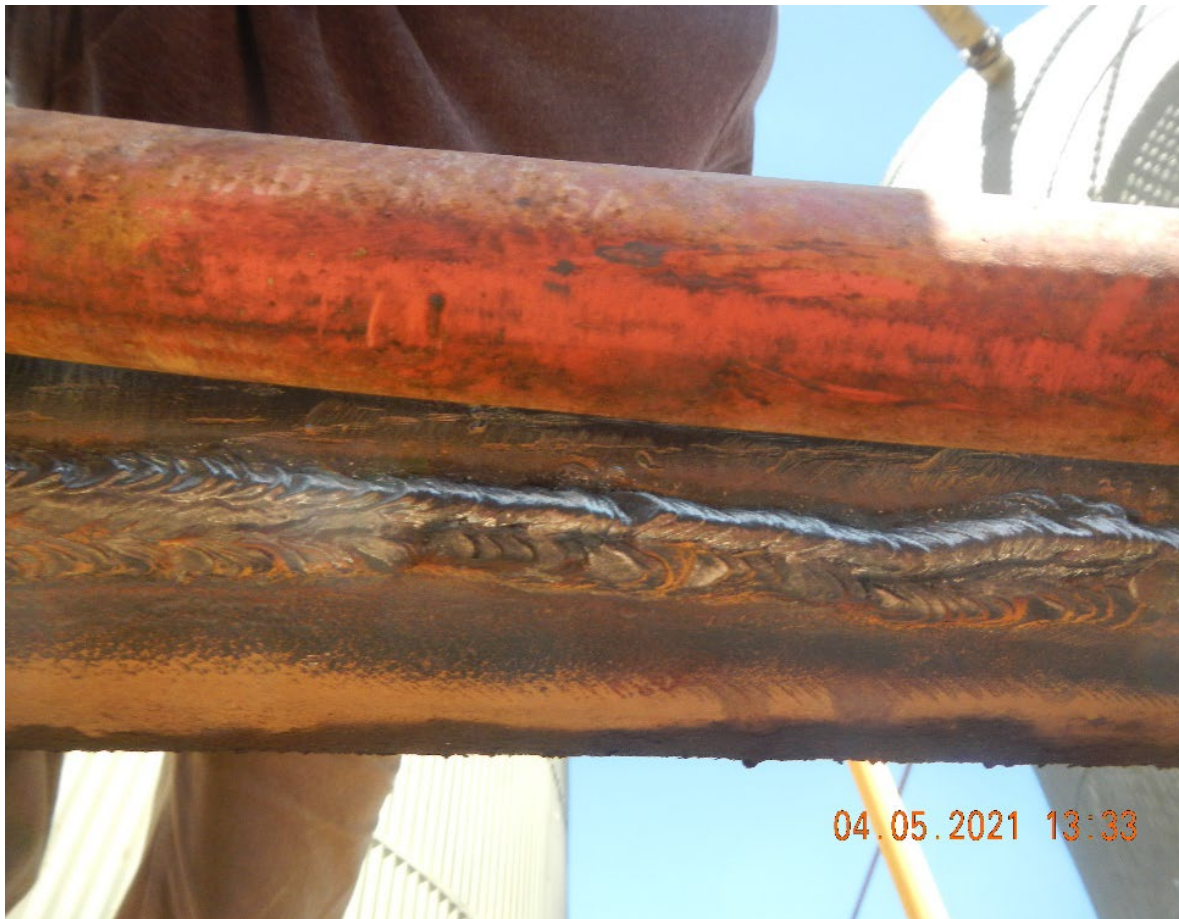
Photo #33 Photo taken perpendicular to the repair weld.

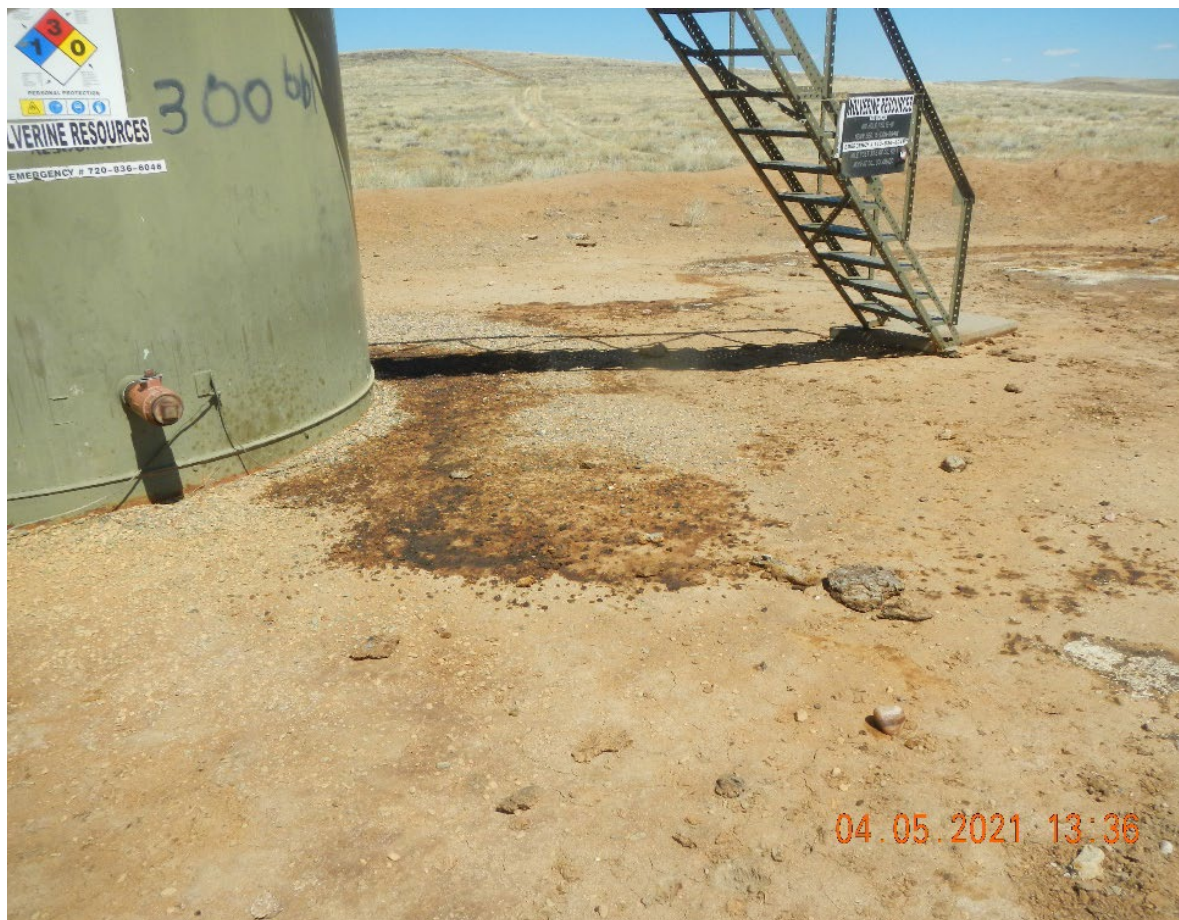
Photo #36 stained soil observed inside tank battery, on the East side of tank battery. Is this staining related to the 4/2/21 spill? Removed stained soil.

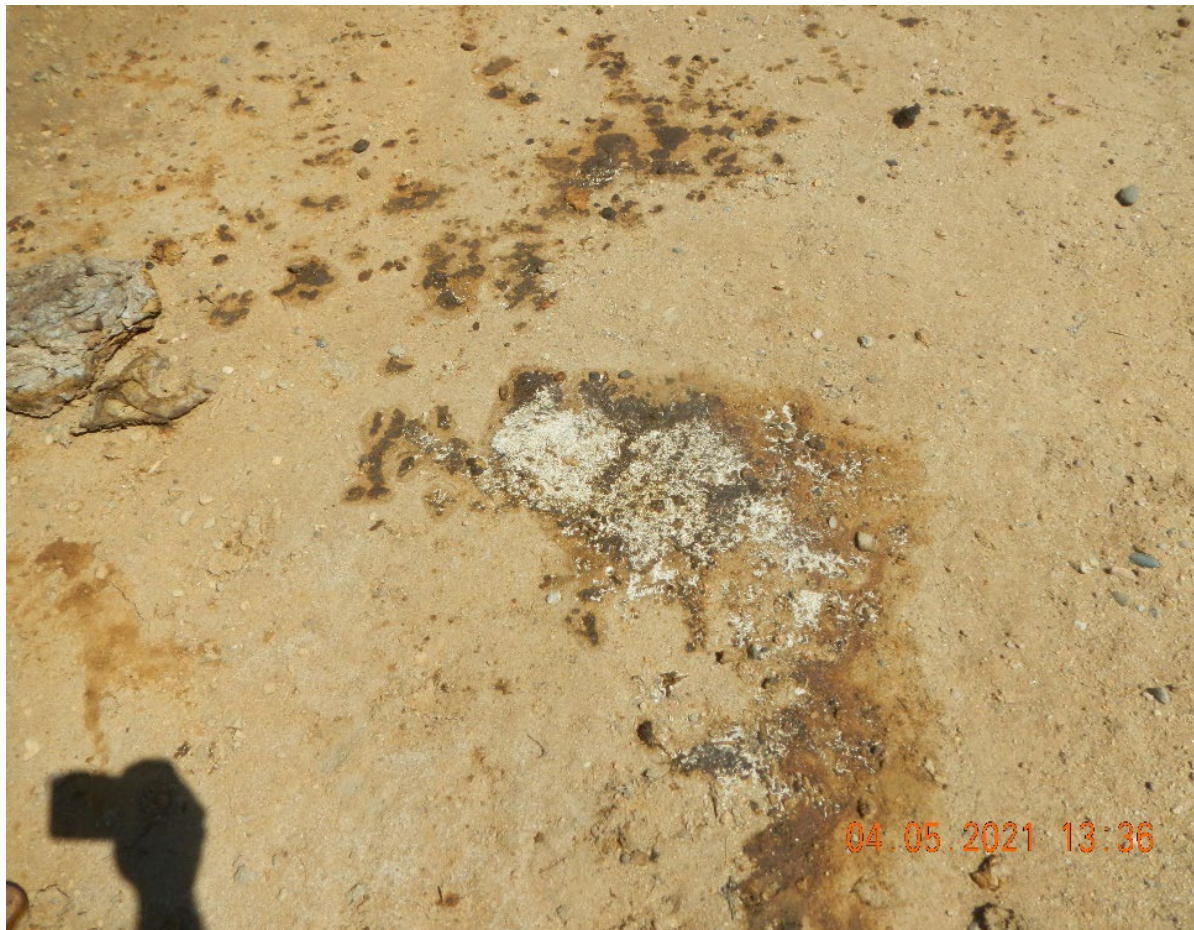
Photo #37 stained soil observed inside tank battery, on the East side of tank battery. Is this staining related to the 4/2/21 spill? Removed stained soil.

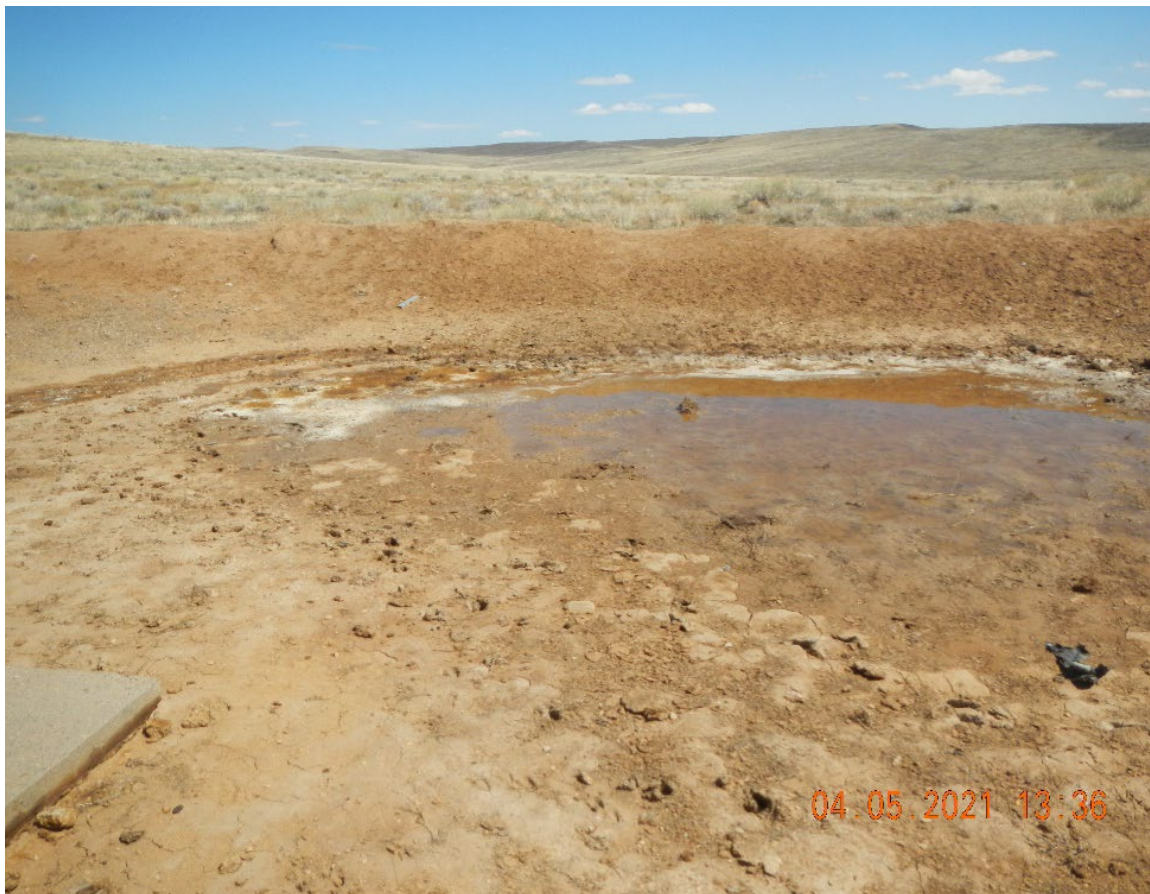
Photo #38 pooled water inside tank battery on far east side.

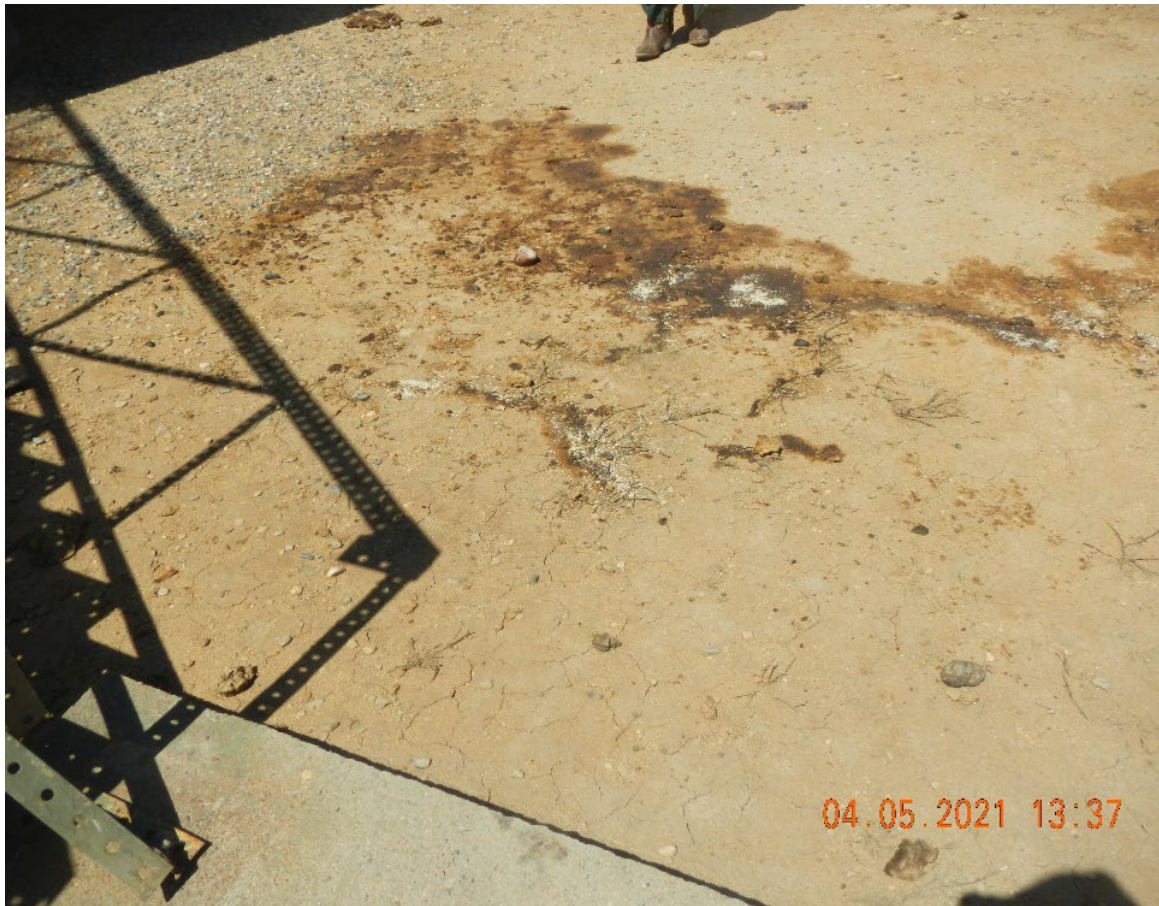
Photo #39 stained soil observed inside tank battery, on the East side of tank battery. Is this staining related to the 4/2/21 spill? Removed stained soil.

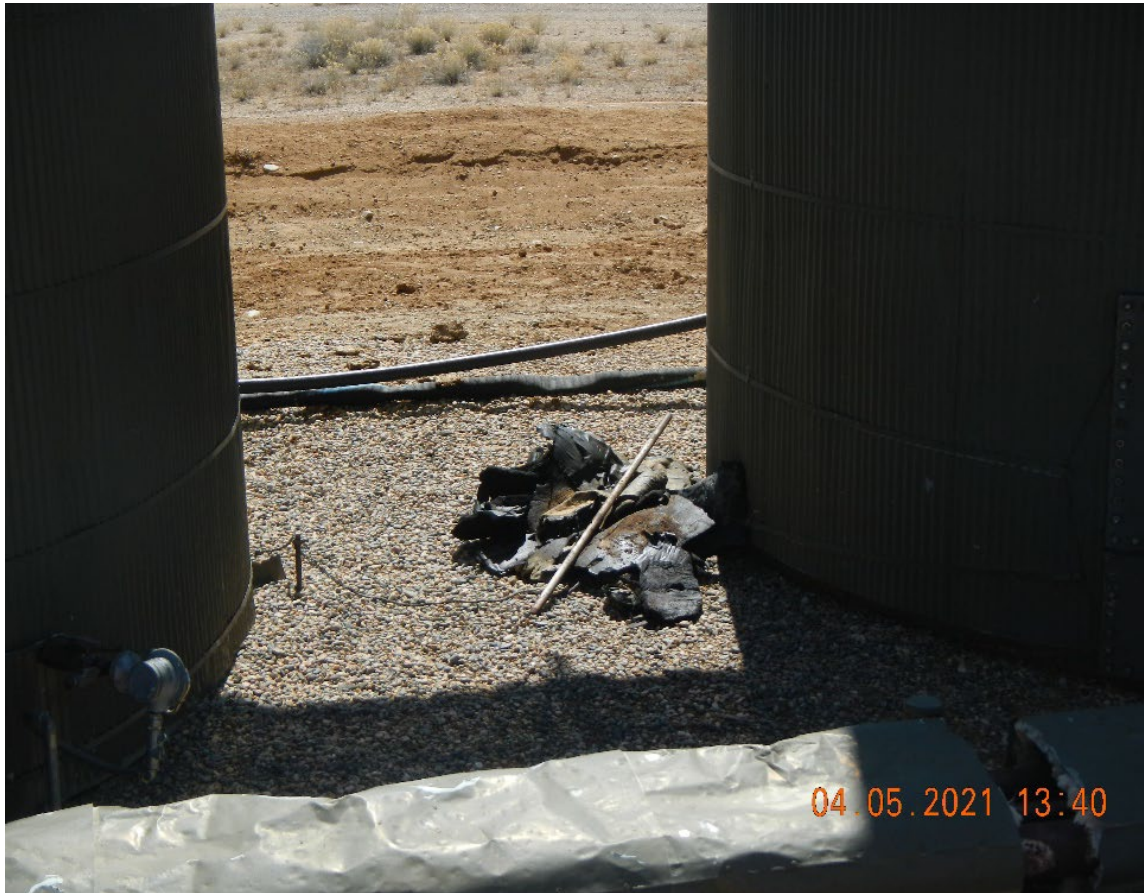
Photo #41 trash/debris inside tank battery.

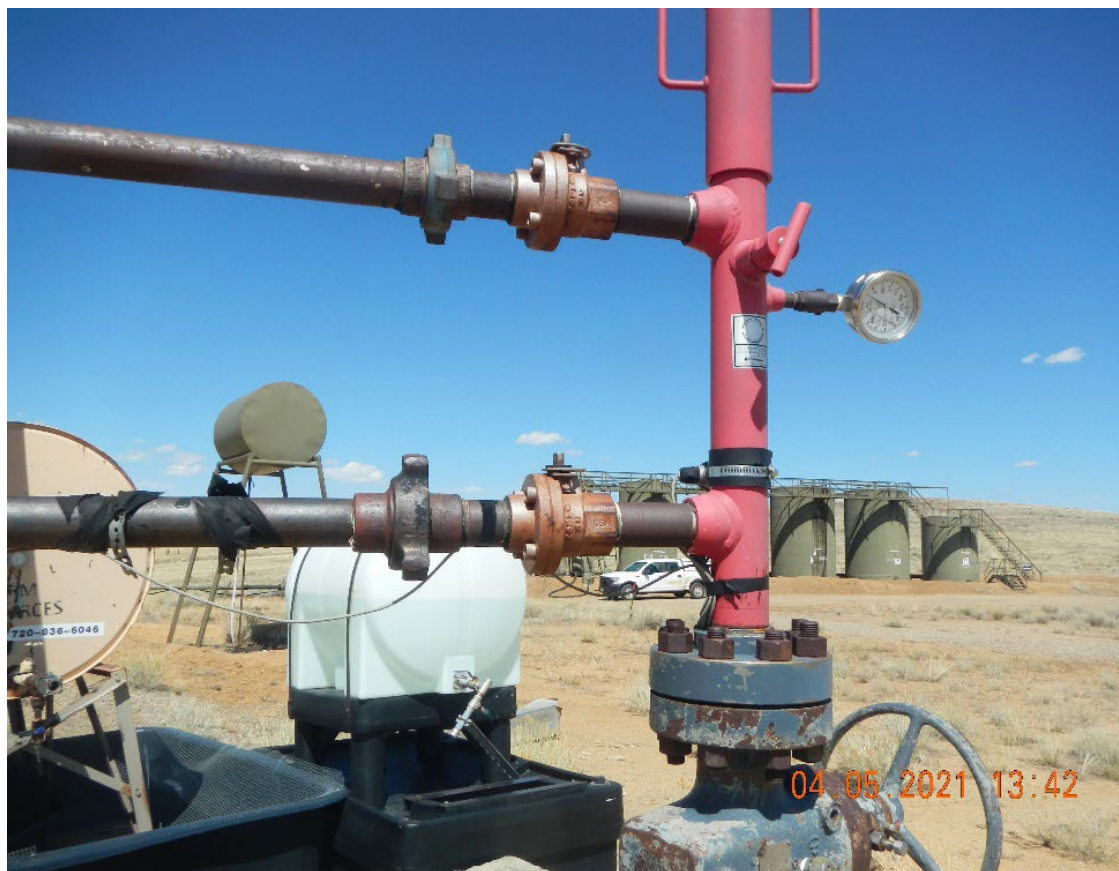
Photo #42, wellhead SI at time of inspection
