Inspection Photos

Location Name: TEP ROCKY MOUNTAIN LLC DIAMOND ELK-66S95W /36SWSE

Location ID: 335029

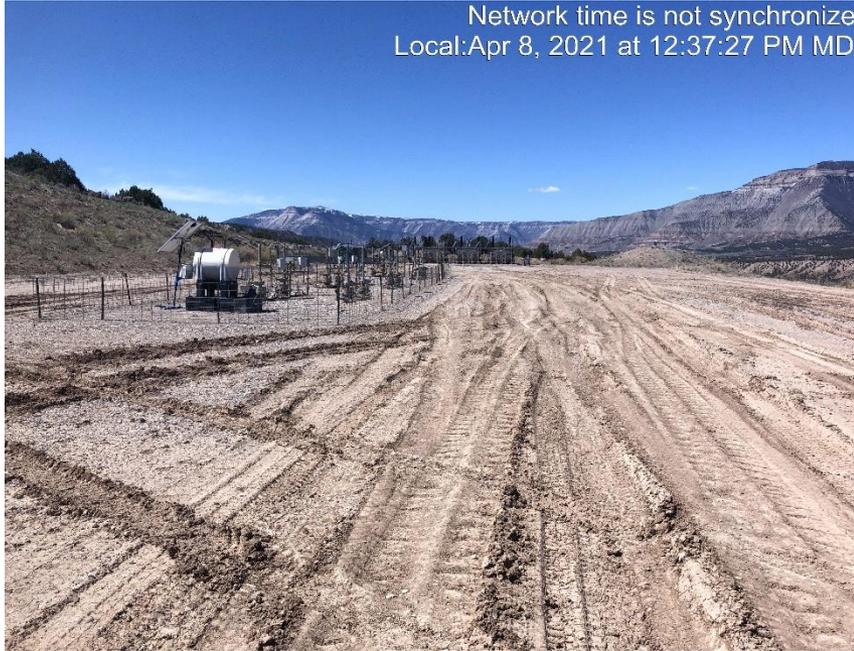
Photo #3412 from entrance to location.

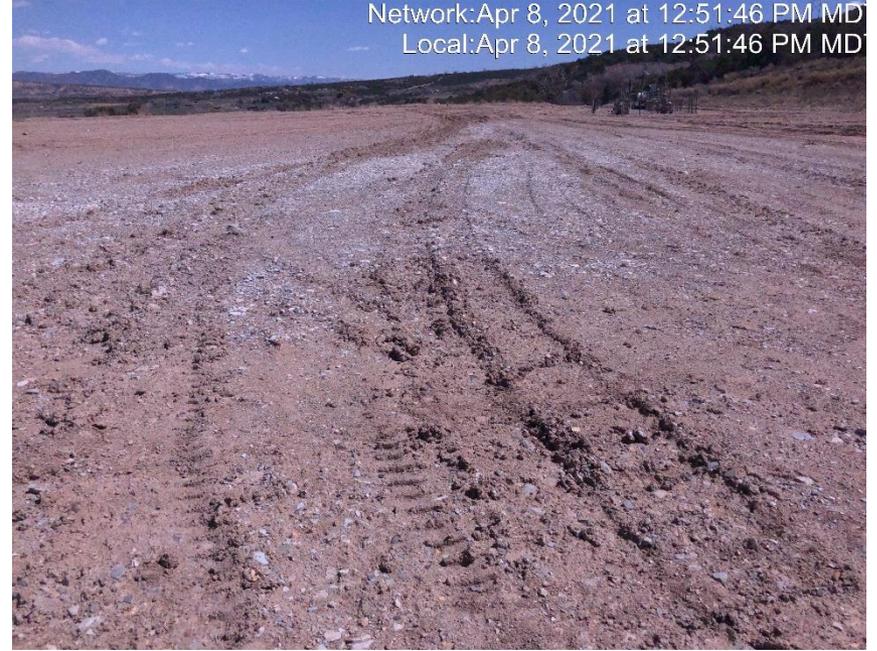
Photo #3413 Location lacks stabilization.

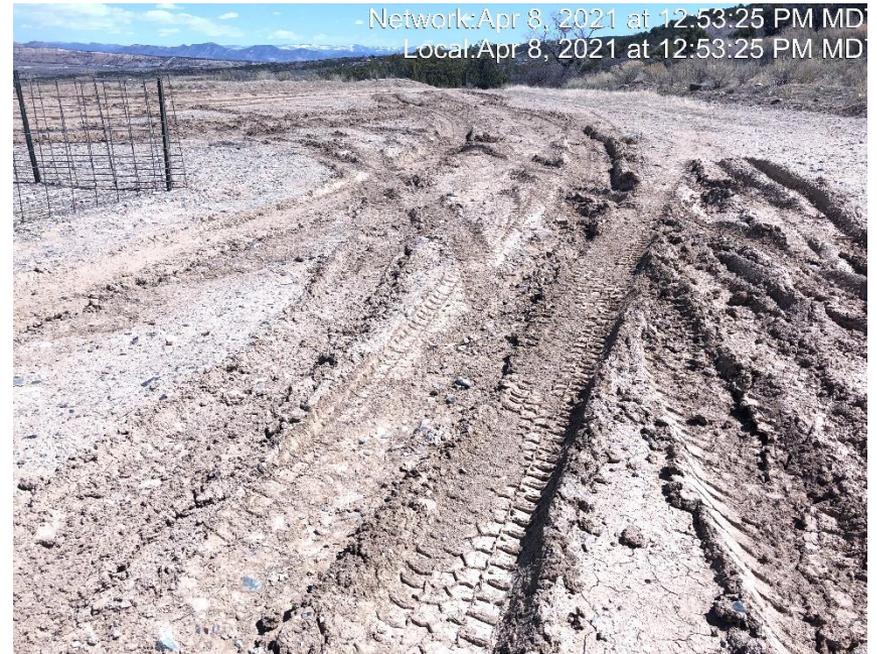
Photo #3416 Location lacks stabilization.

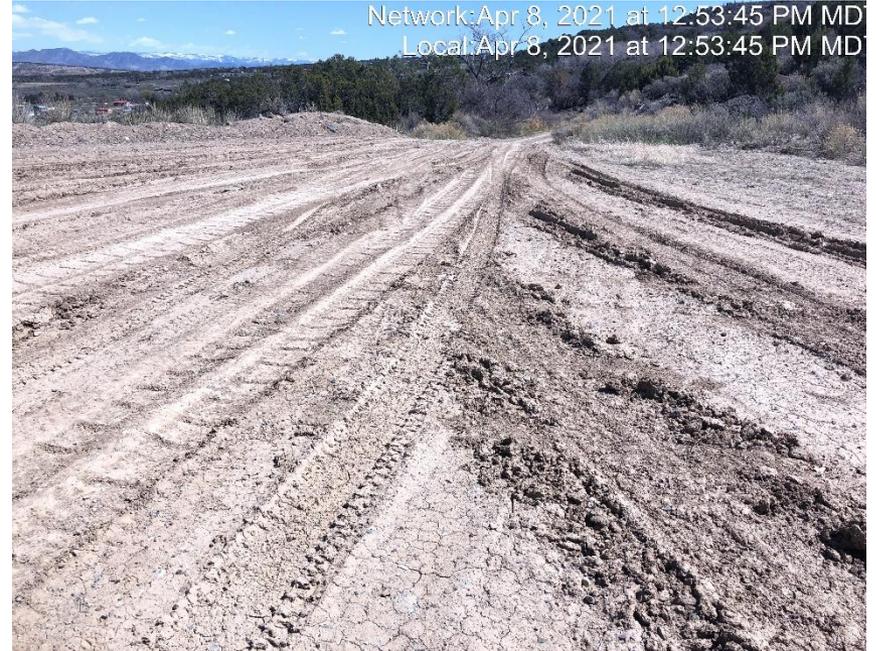
Photo #3417 No form of tracking control at entrance to location.

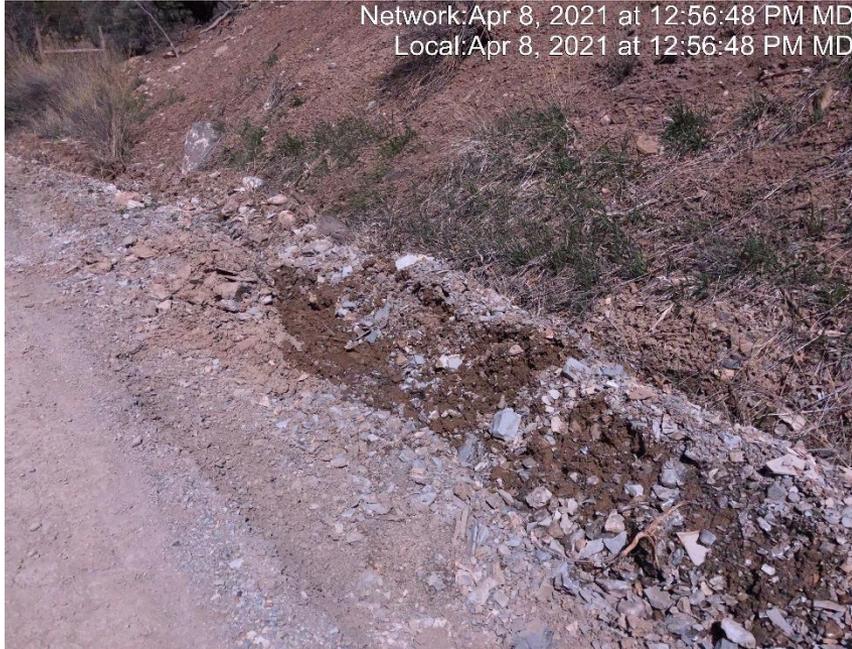
Photo #3420 Storm water is being obstructed.

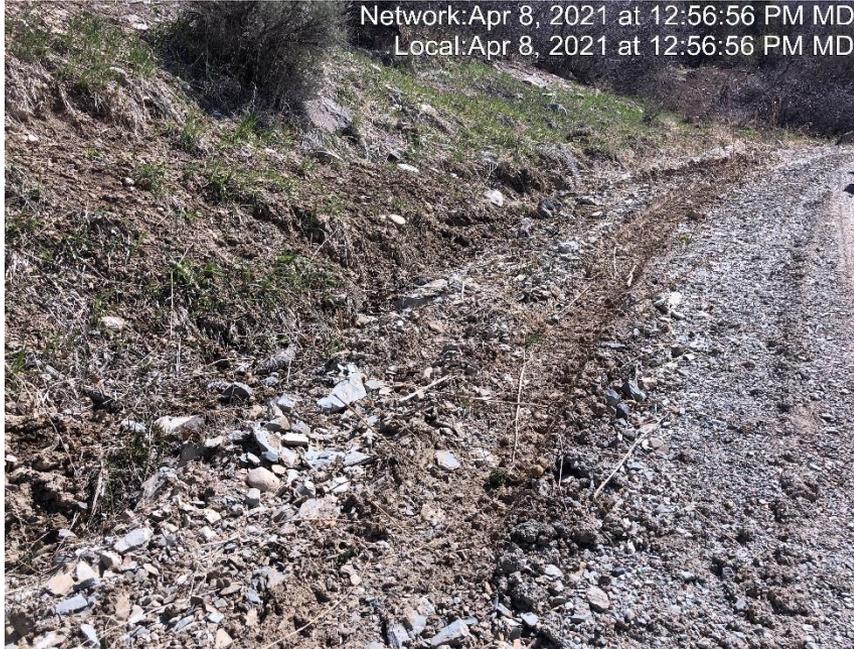
Photo #3421 Storm water is being obstructed.

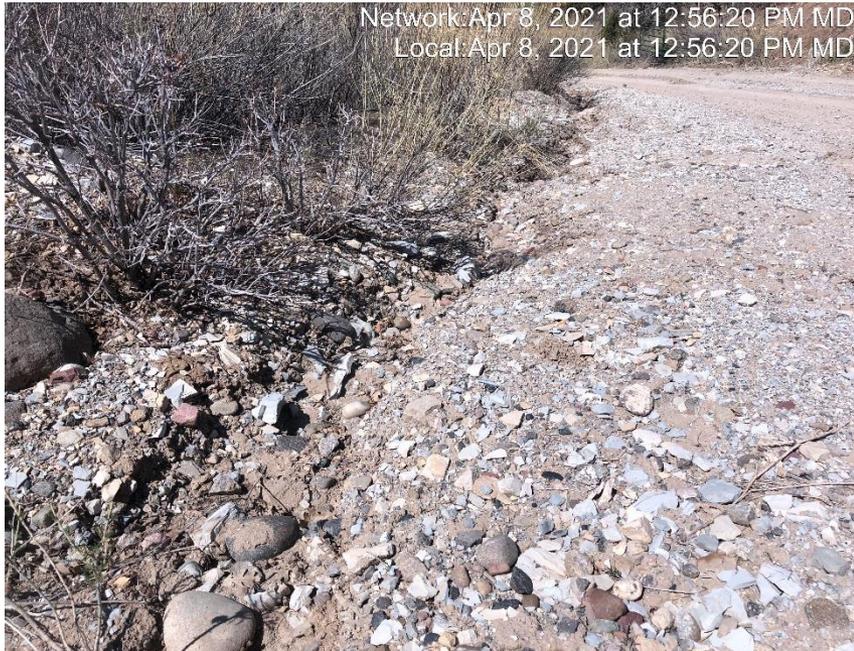
Photo #3418 Rill erosion occurring in ditch.

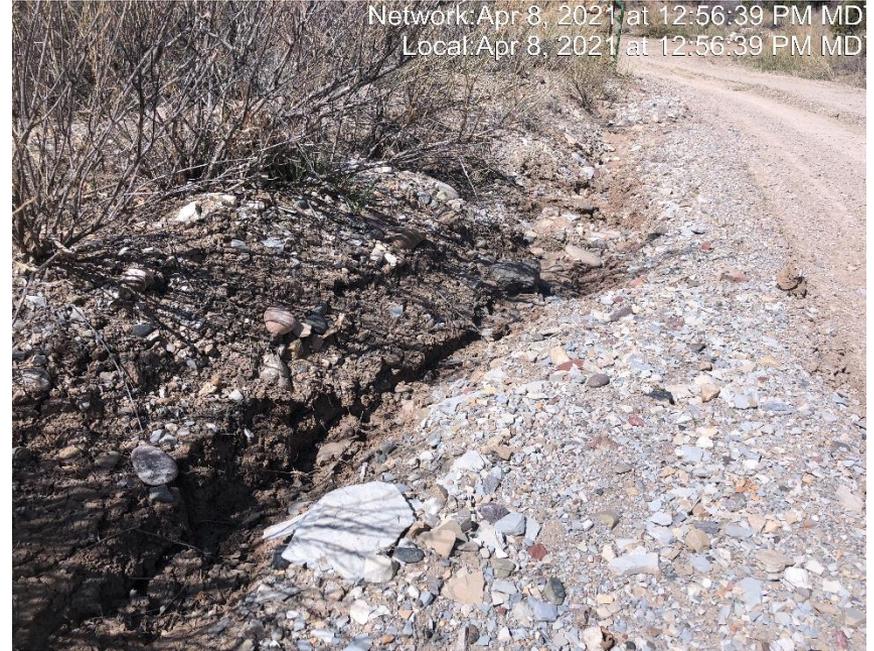
Photo #3419 No velocity checks located in ditch.
