Stormwater Inspection Report

Operator:	Laramie Energy, LLC
Project:	Collbran Project Area
Location:	Anderson 7-12
Date:	Friday, April 9, 2021
Weather:	Clear, Sunny 64°, Lo 44°

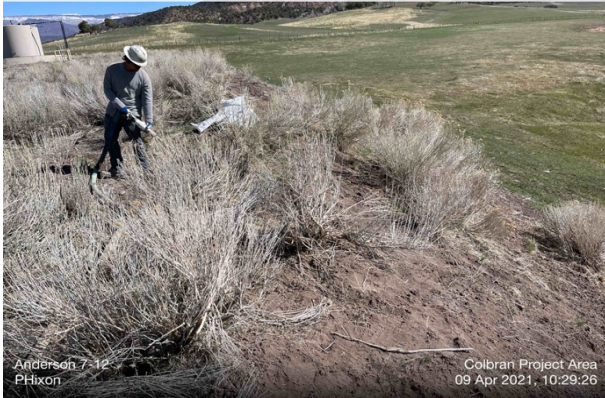
Photo 1

Contractor using a water/bentonite mixture to seal a sinkhole.

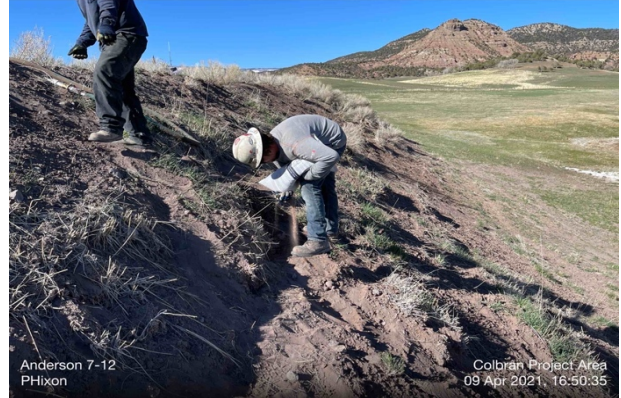
Photo 2

Bentonite being added to the fissure to seal the opening.

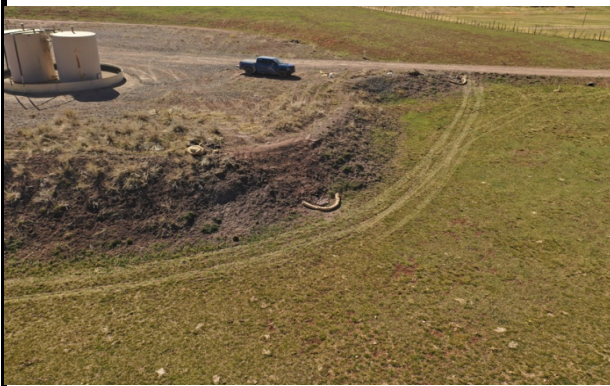
Photo 3

The North side of Anderson 7-12; where the drain tile was replaced and new BMP's were placed.

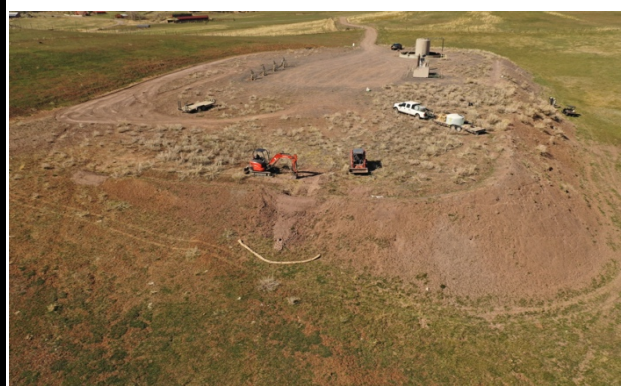
Photo 4

South Side of Anderson 7-12 showing the reconstruction of the outlet and inlet from the sump.
