# Inspection Photos

API: 071-06815

Operator: WAPITI OPERATING LLC

Inspection Date: 4/12/2021

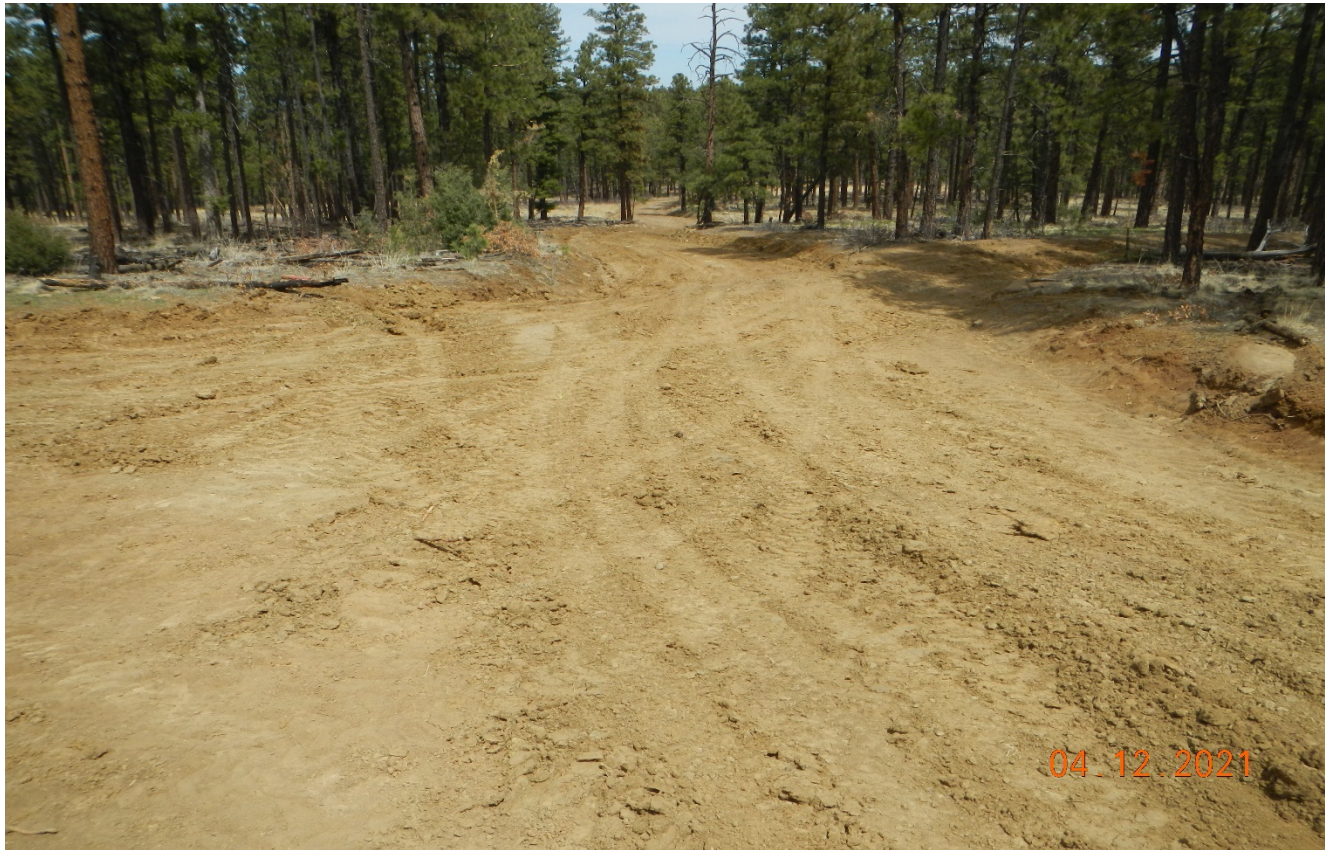
**Photo 1.** Facing north toward the access road. It appears grading was recently performed however, there is signs of vehicle rutting. The road is not stabilized.

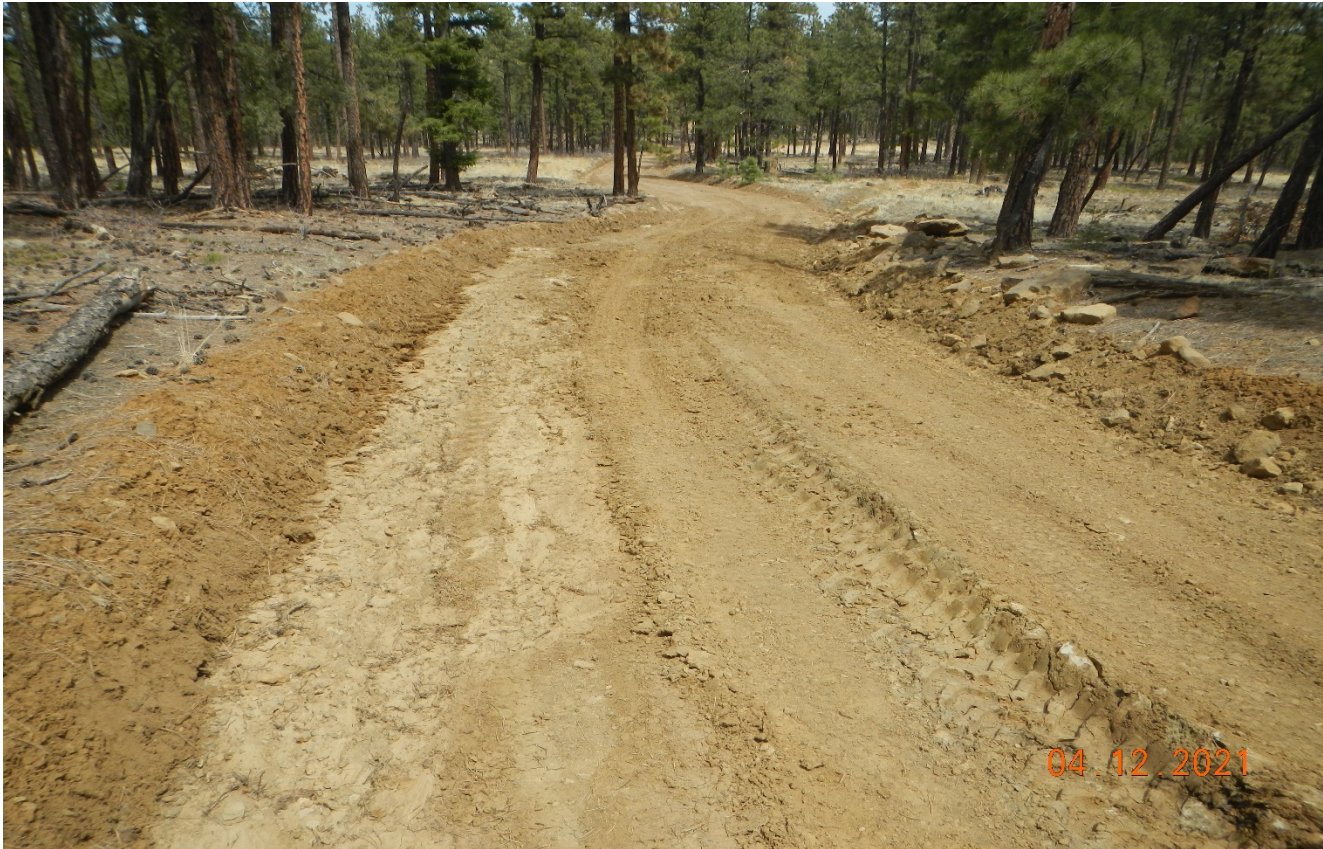
**Photo 2.** Facing north along the access road. The road is not stabilized

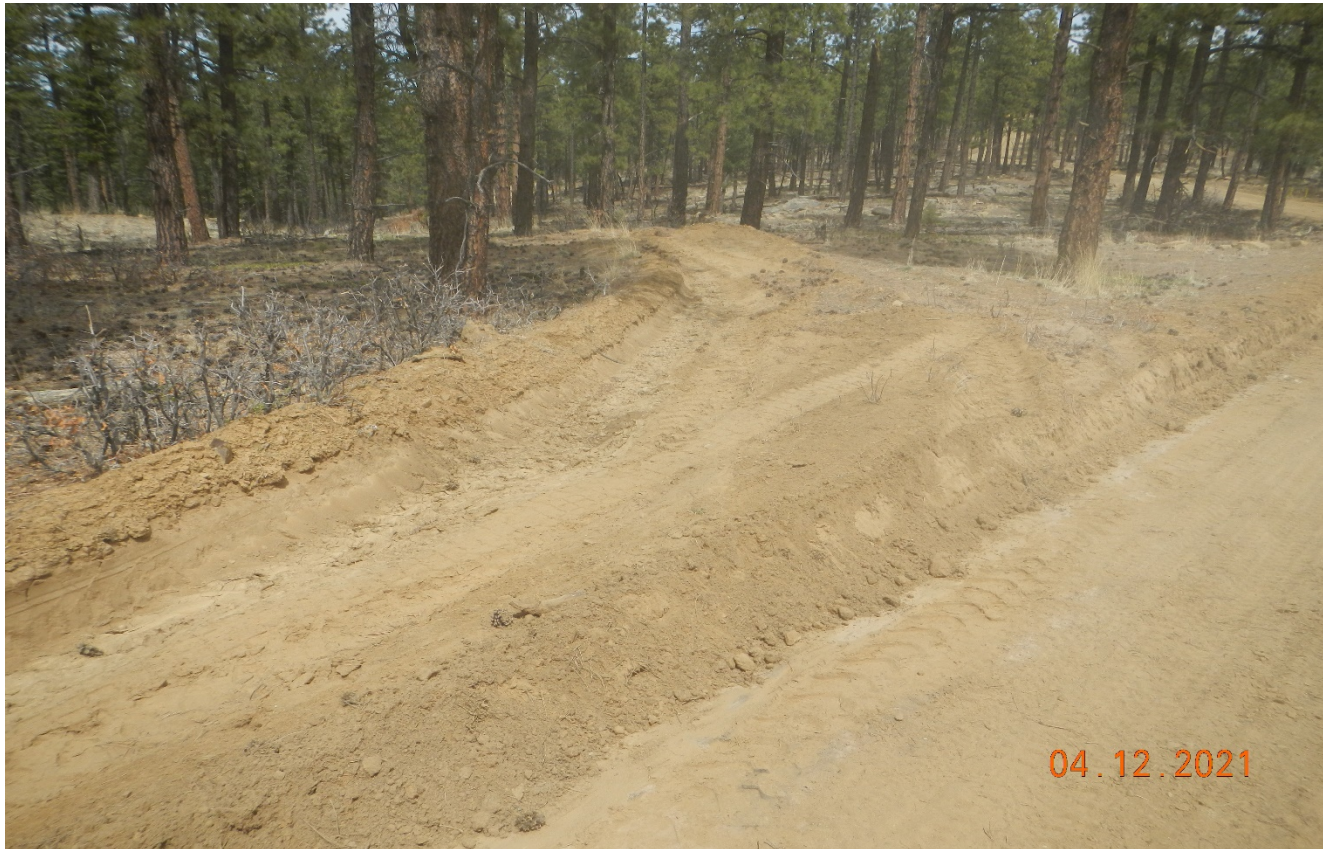
**Photo 3.** A ditch was bladed to divert stormwater off the road however, BMP's are required to prevent sediment discharge. BMP's such as a sediment trap, rip/rap, check dams need to be installed.

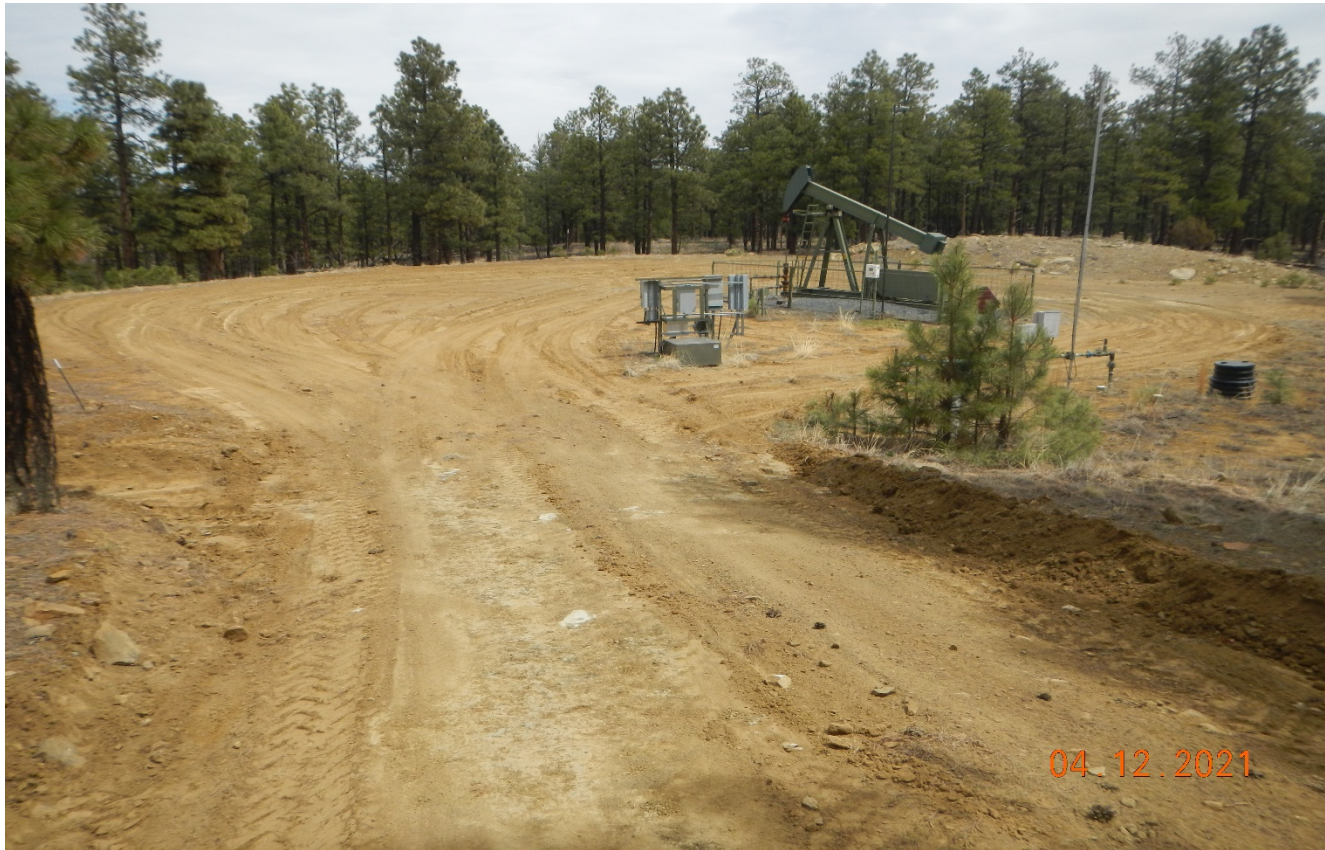
**Photo 4.** Facing toward the location.

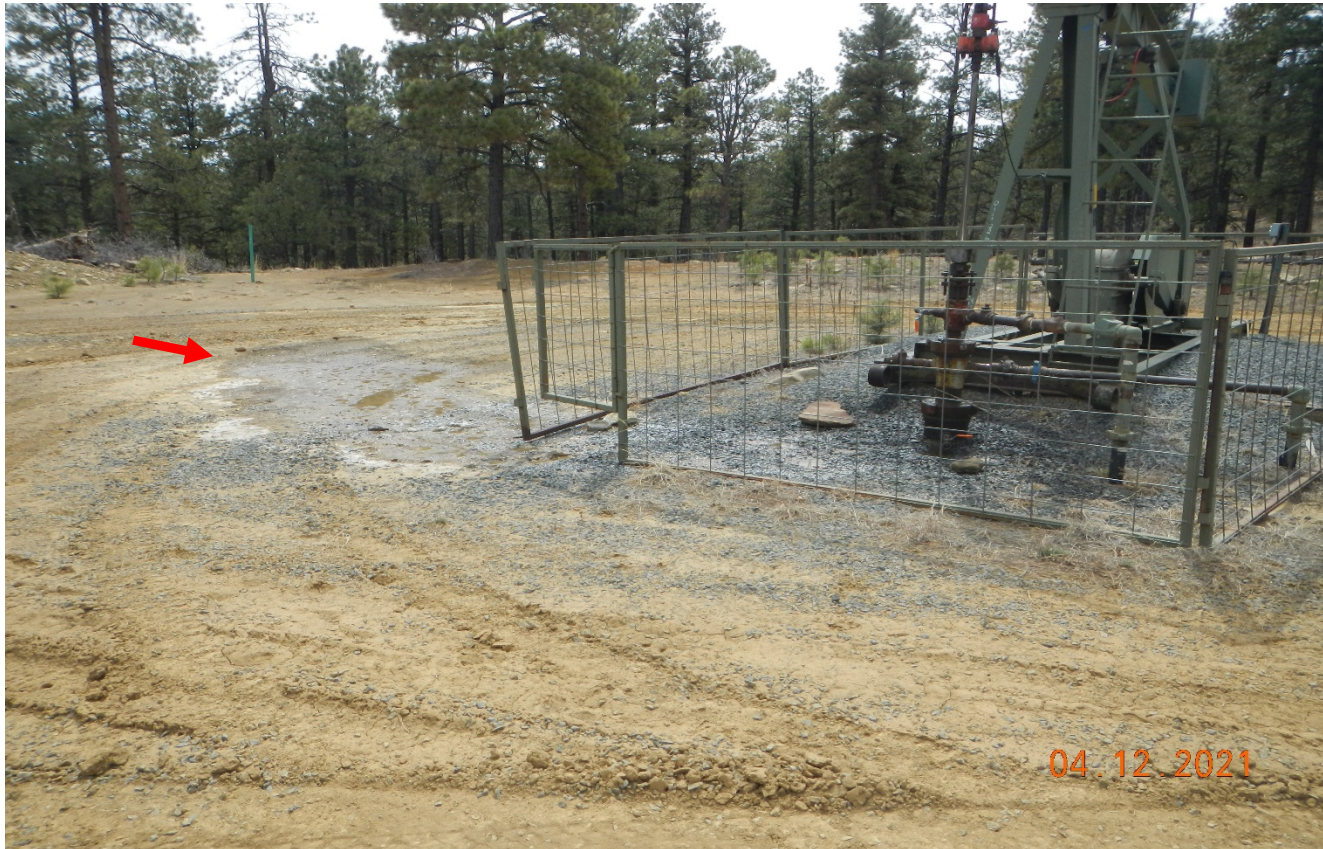
**Photo 5.** There is produced water leaking from the wellhead.
