Inspection Photos

API: 071-06816

Operator: WAPITI OPERATING LLC

Inspection Date: 4/12/2021

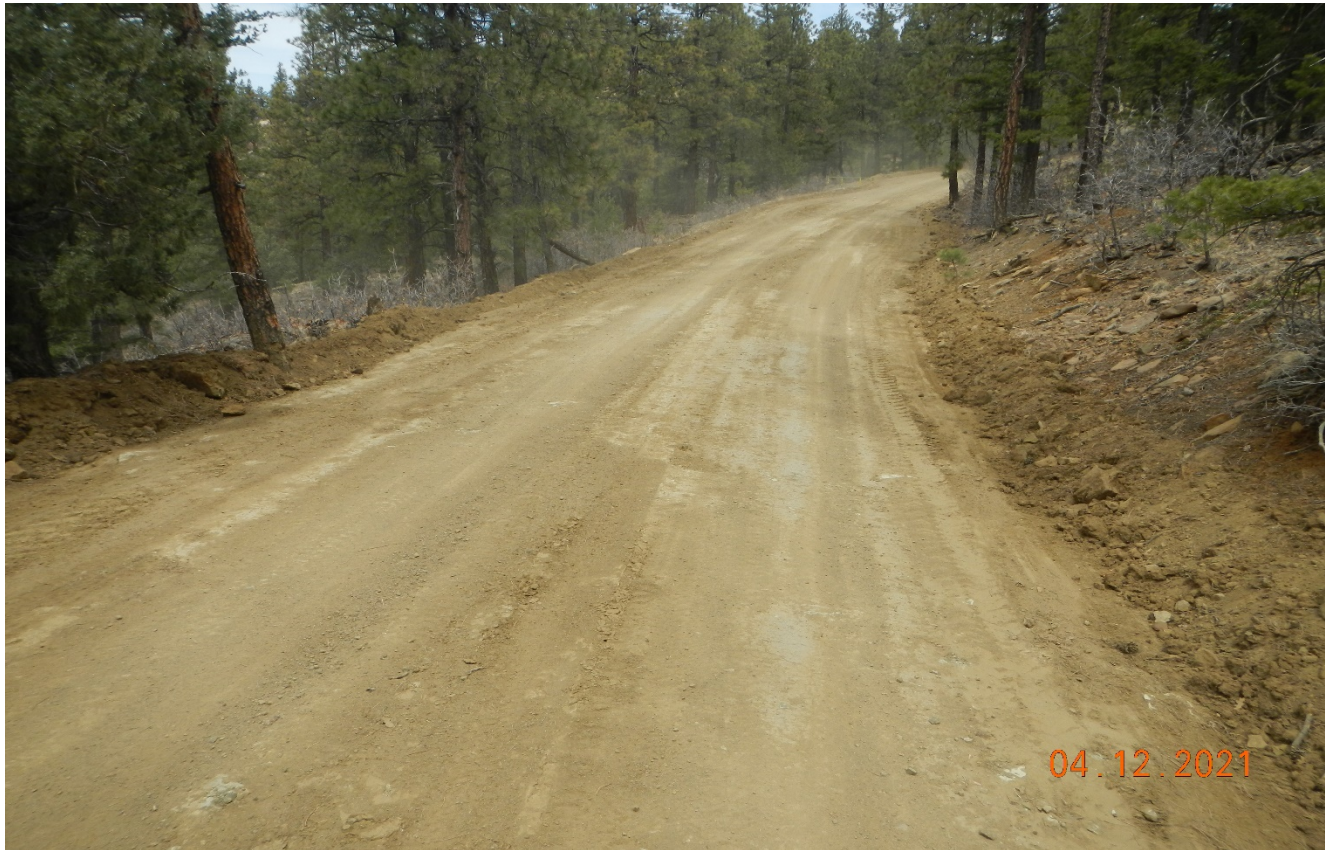
Photo 1. Facing northeast along the access road. The road was recently graded.

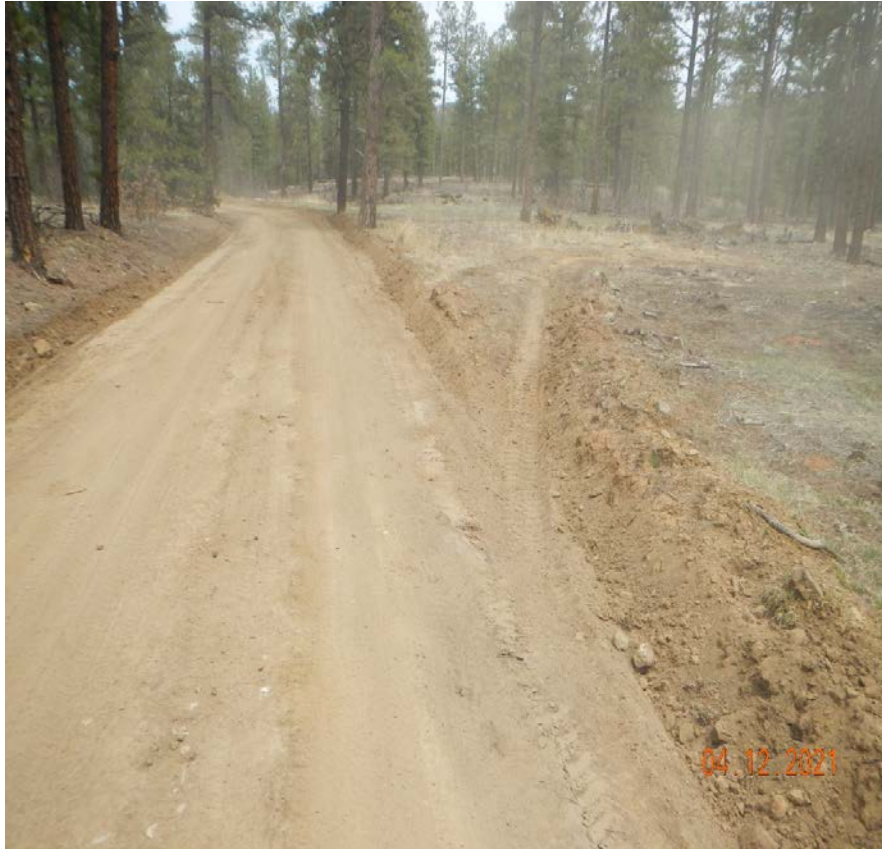
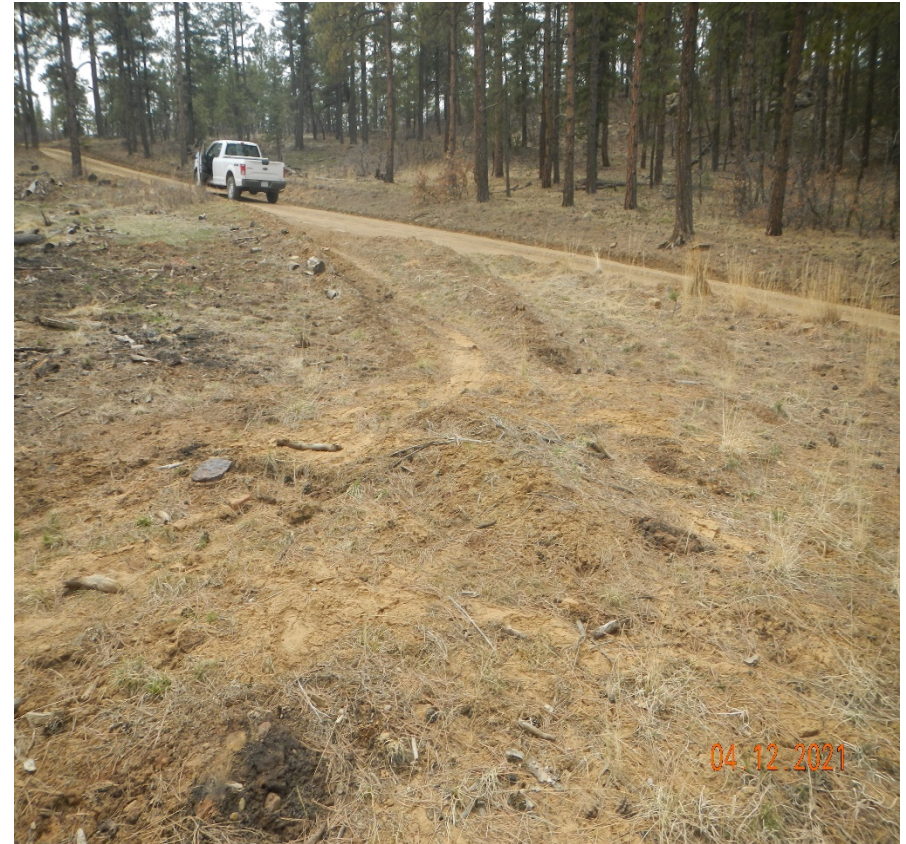
Photo 2. A ditch was bladed to divert stormwater off the road however, BMP's are required to prevent sediment discharge. BMP's such as a sediment trap, rip/rap, check damns need to be installed. Photo on the right shows sediment accumulation from the access road. Erosion controls are required to stabilize the road.

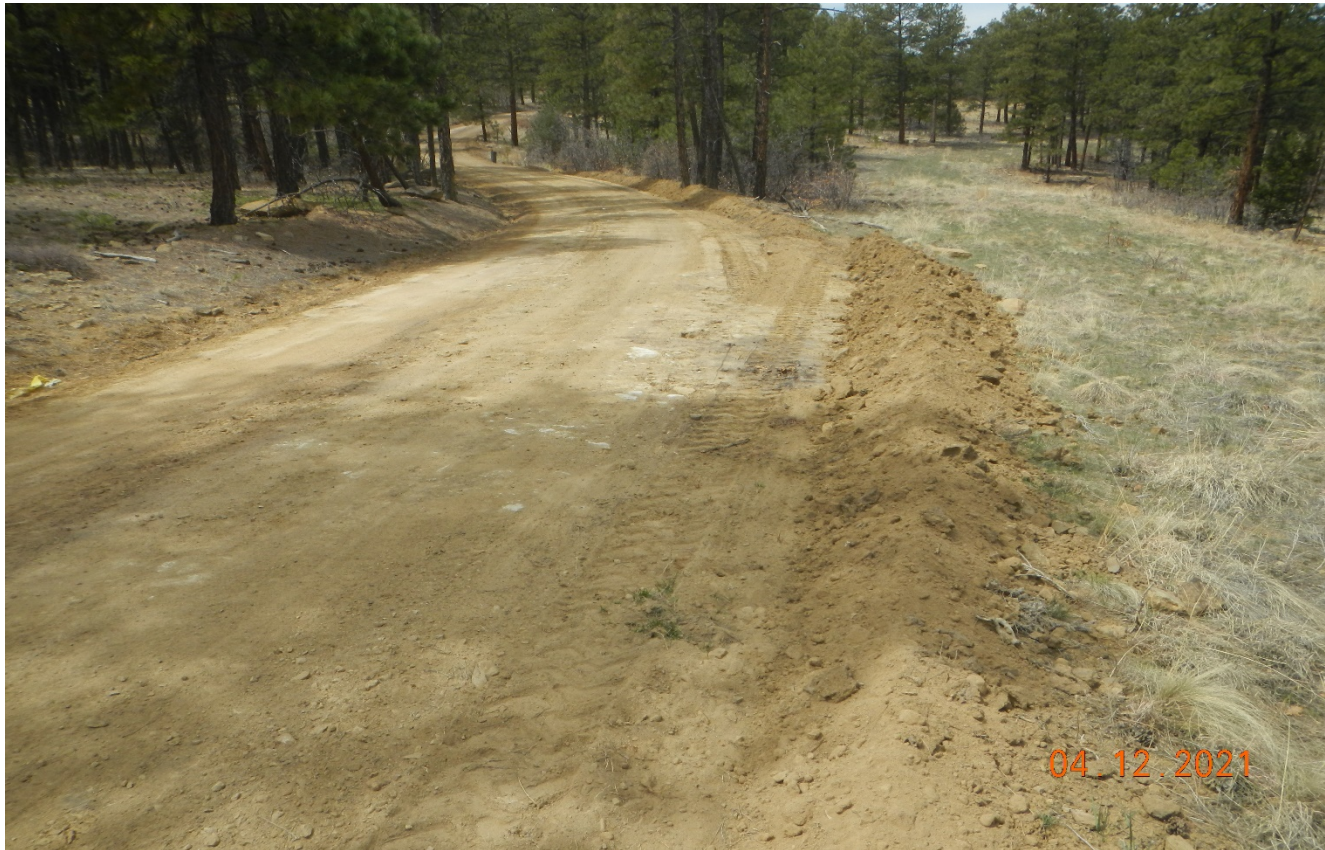
Photo 3. The road which was recently bladed has pushed loose material off the road. There is insufficient stabilization along the road.

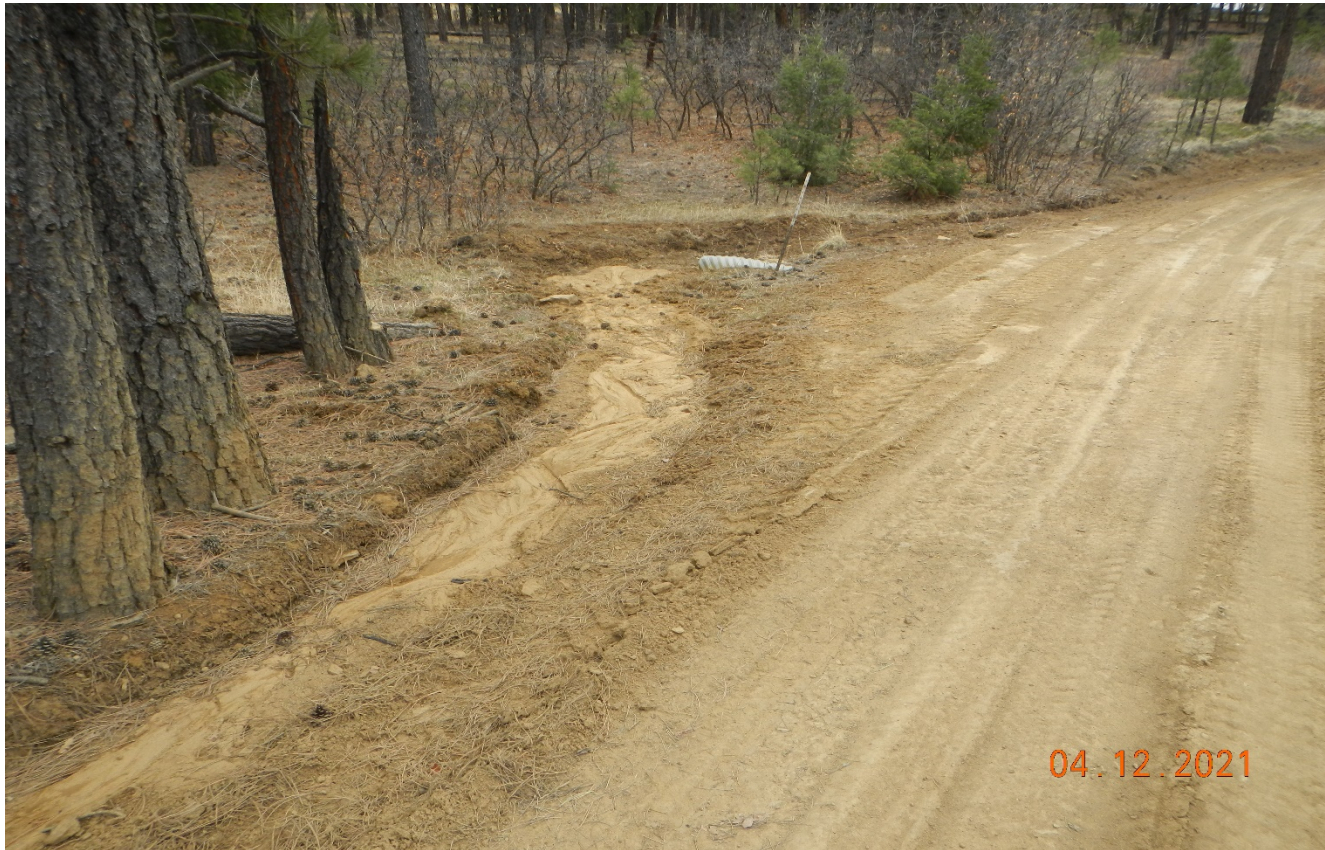
Photo 4. There is sediment accumulation near the culvert which needs to be maintained.

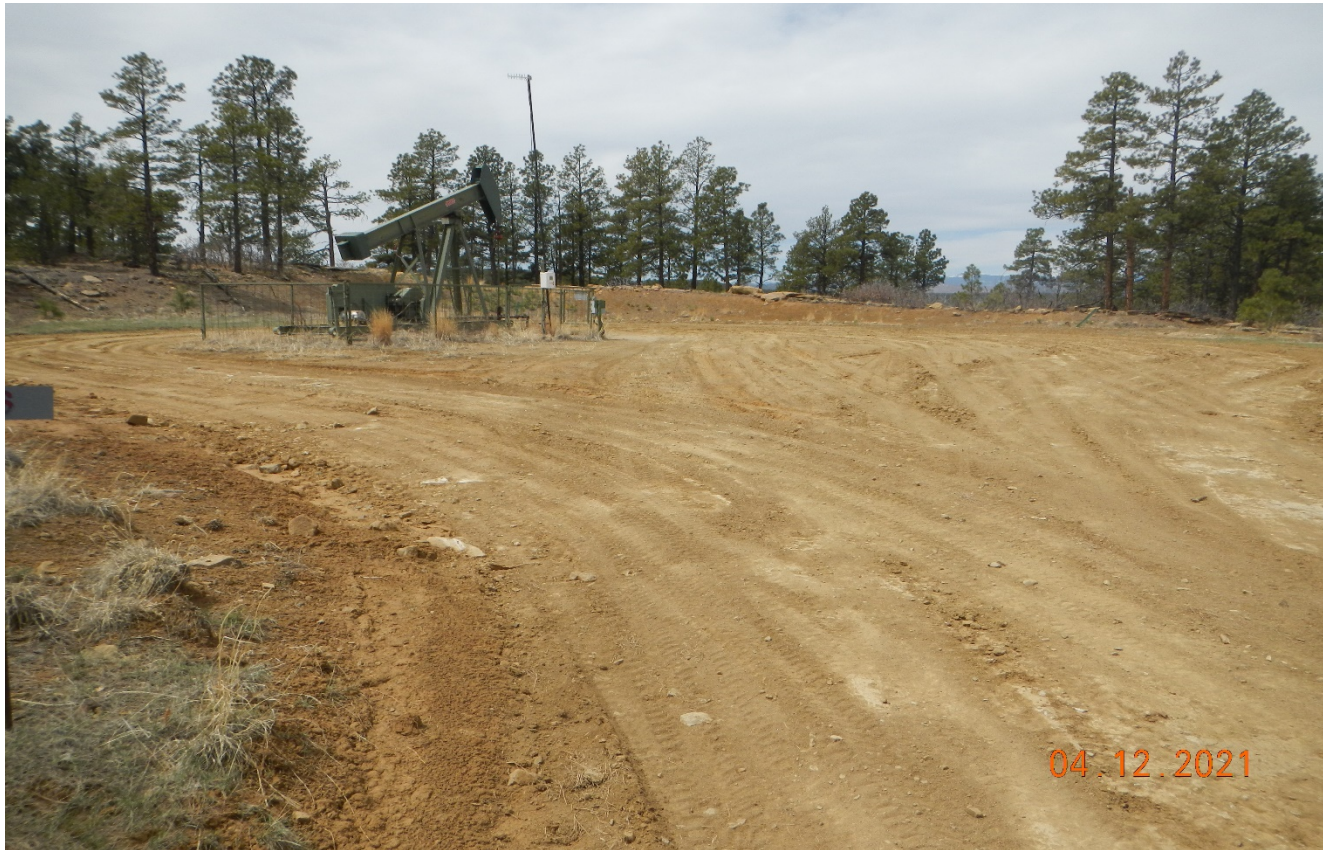
Photo 5. Facing toward the location.

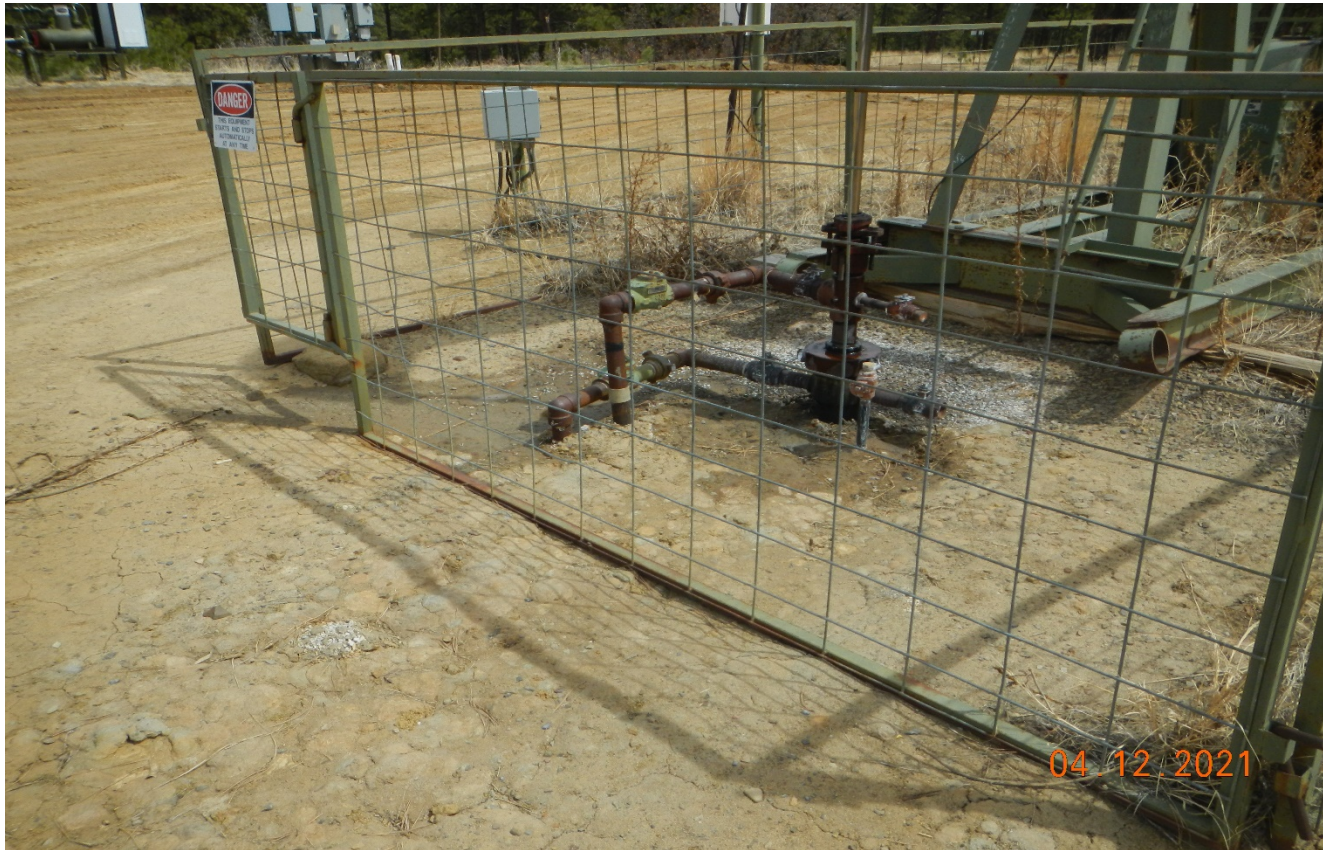
Photo 6. There is slight produced water leaking from the wellhead.
