Inspection Photos
Operator: Linde
Facility: 083-06514
Date: 4/6/2021

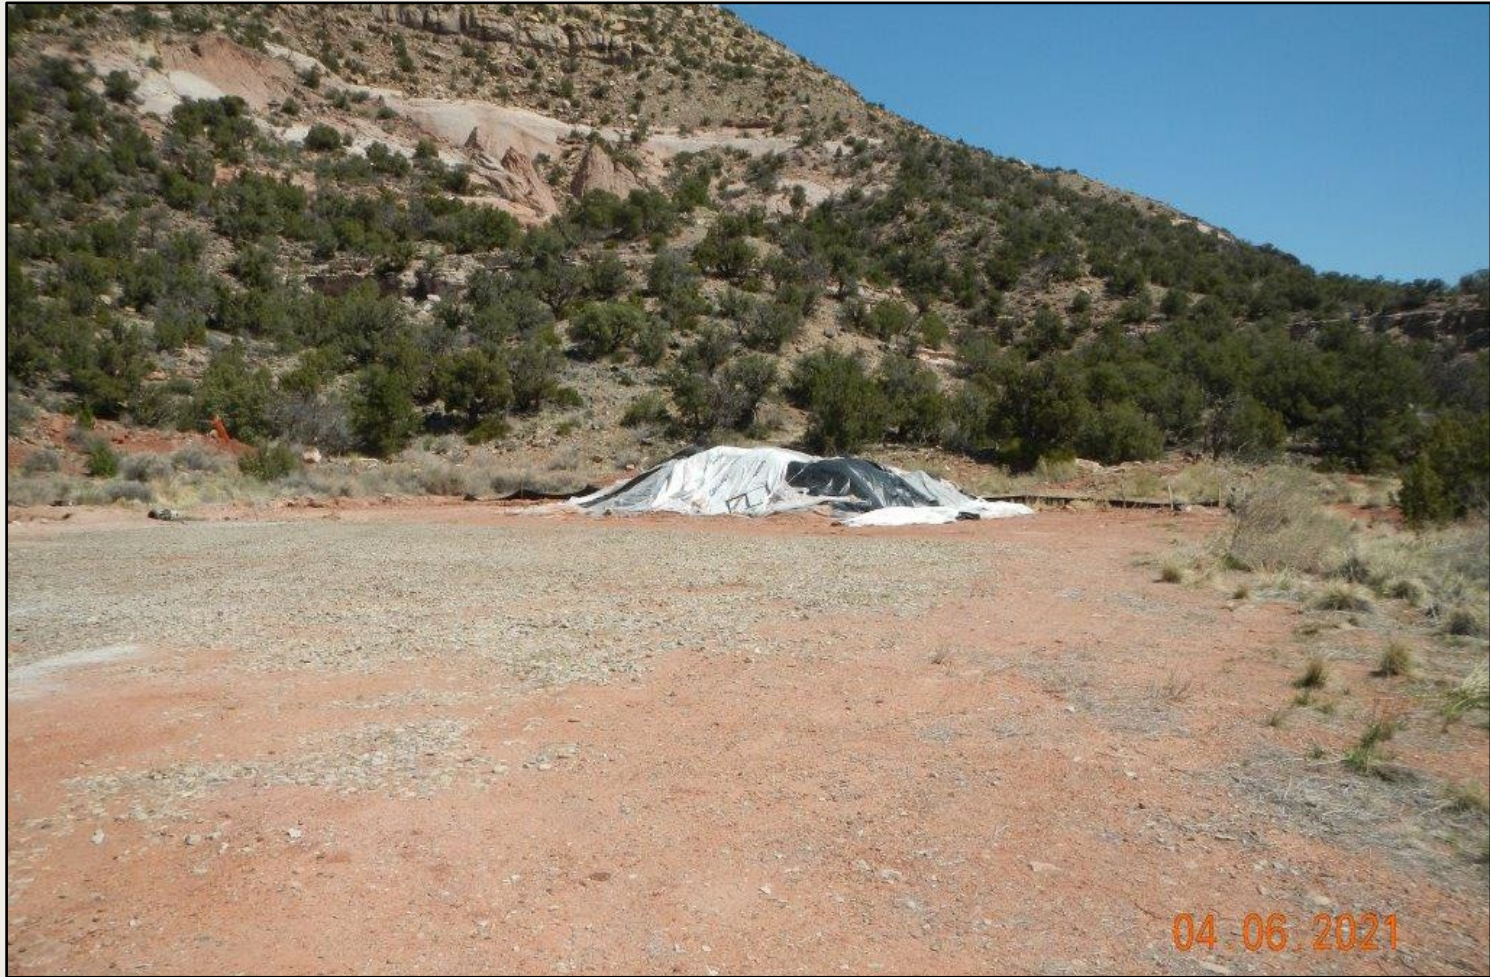
Photo 1. View of the eastern project area from the well pad entrance. Two soil piles observed on well pad are covered in decomposing plastic.

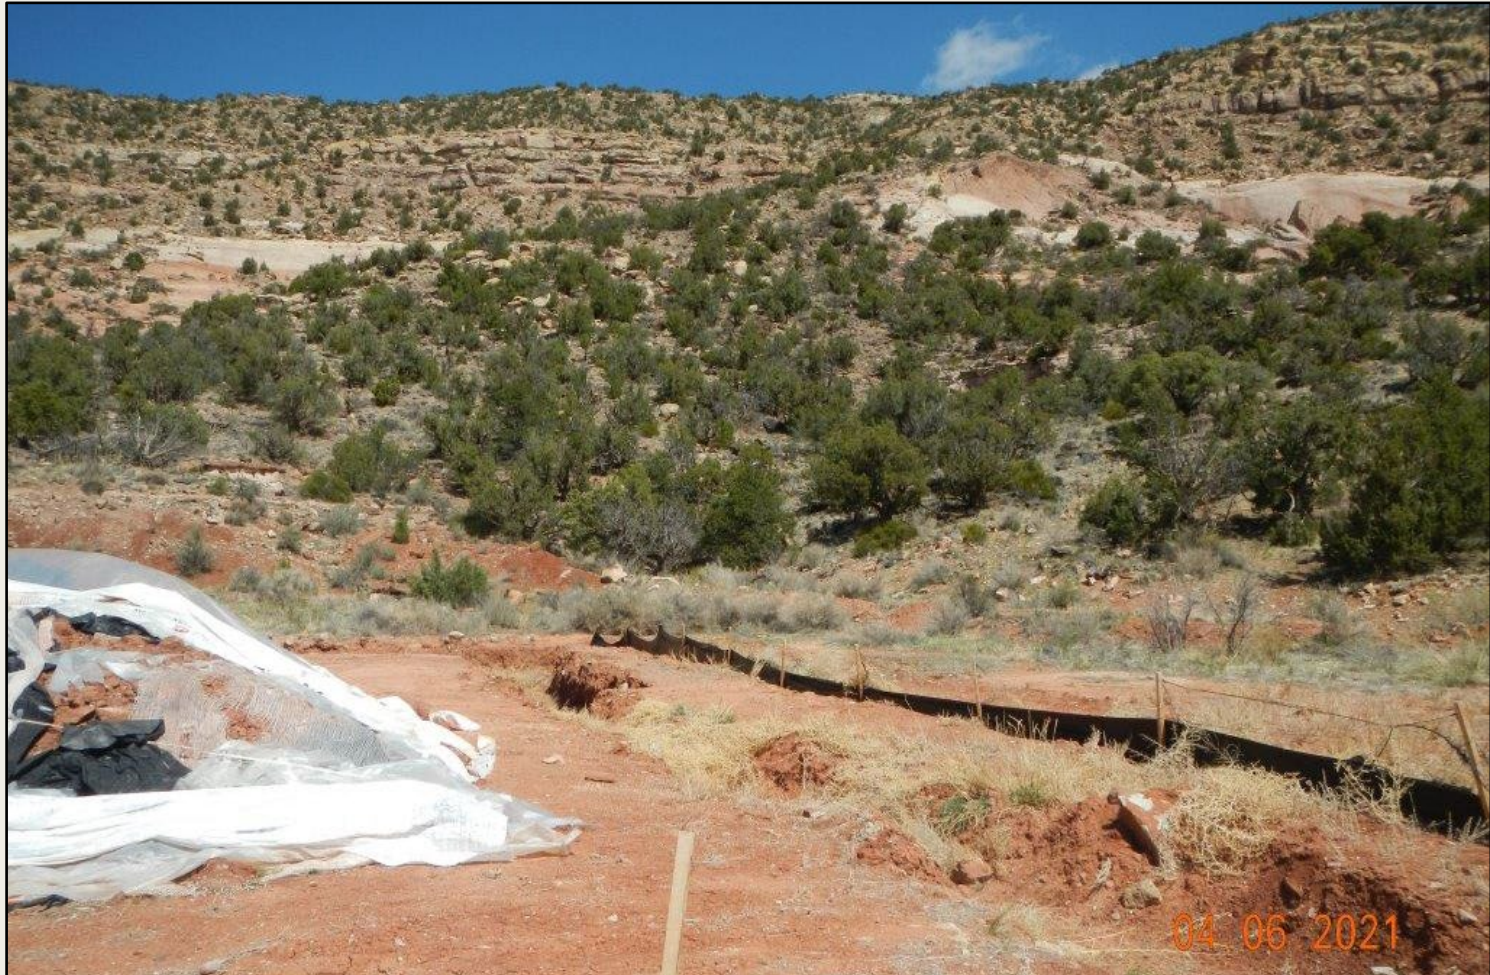
Photo 2. View of trench, approximately 2.5 feet deep and 3 feet wide, and silt fence in the eastern project area.

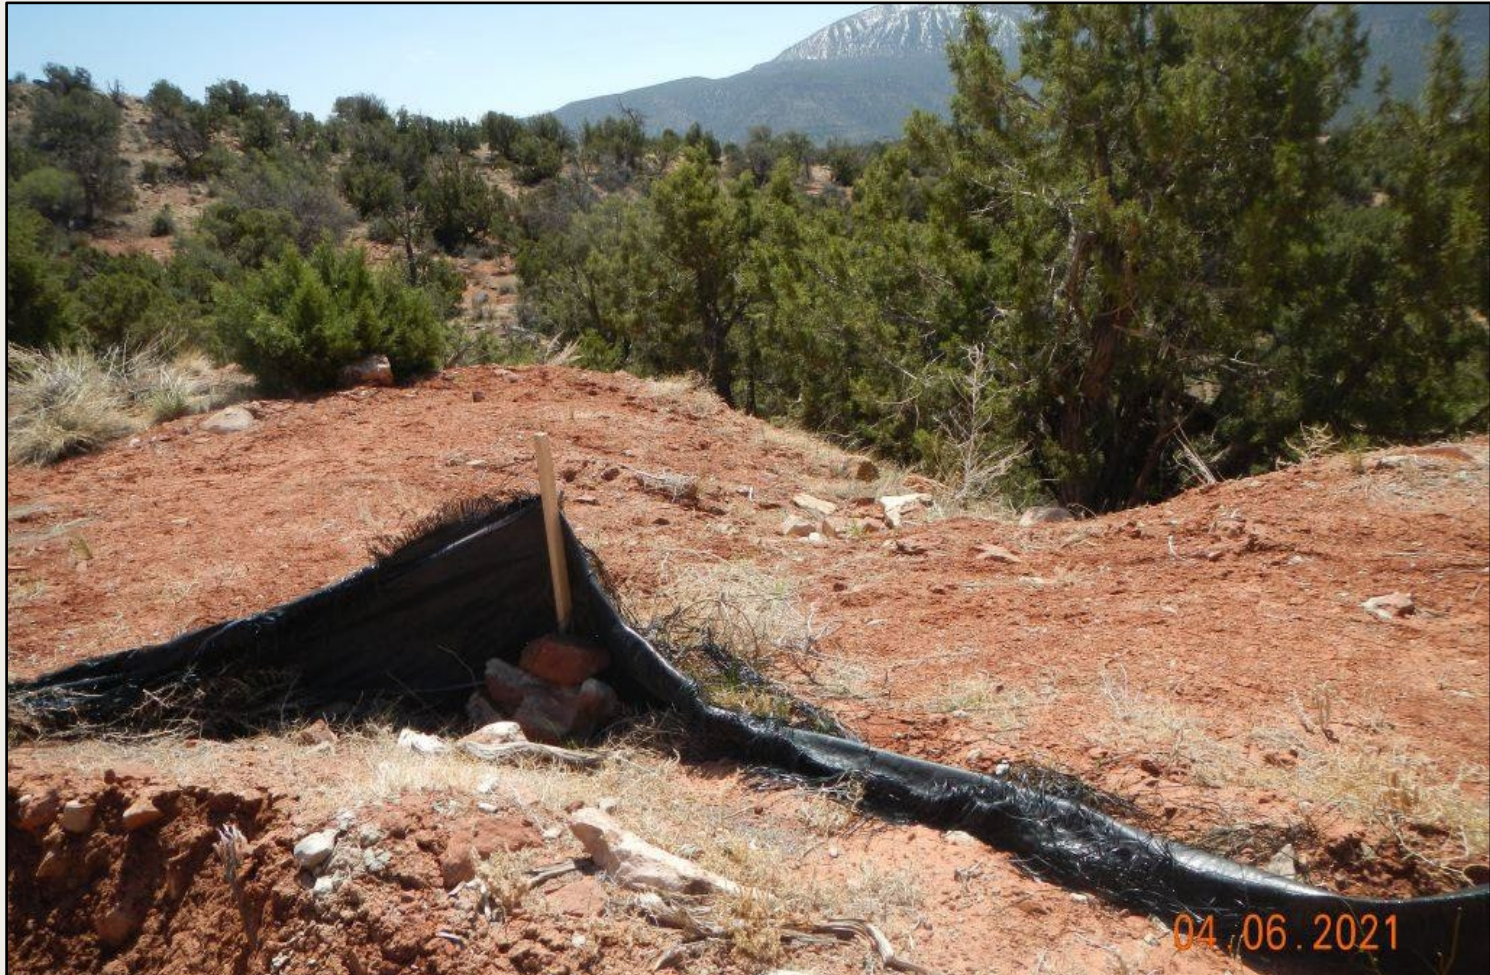
Photo 3. View of silt fence in the southeastern project area, in disrepair.

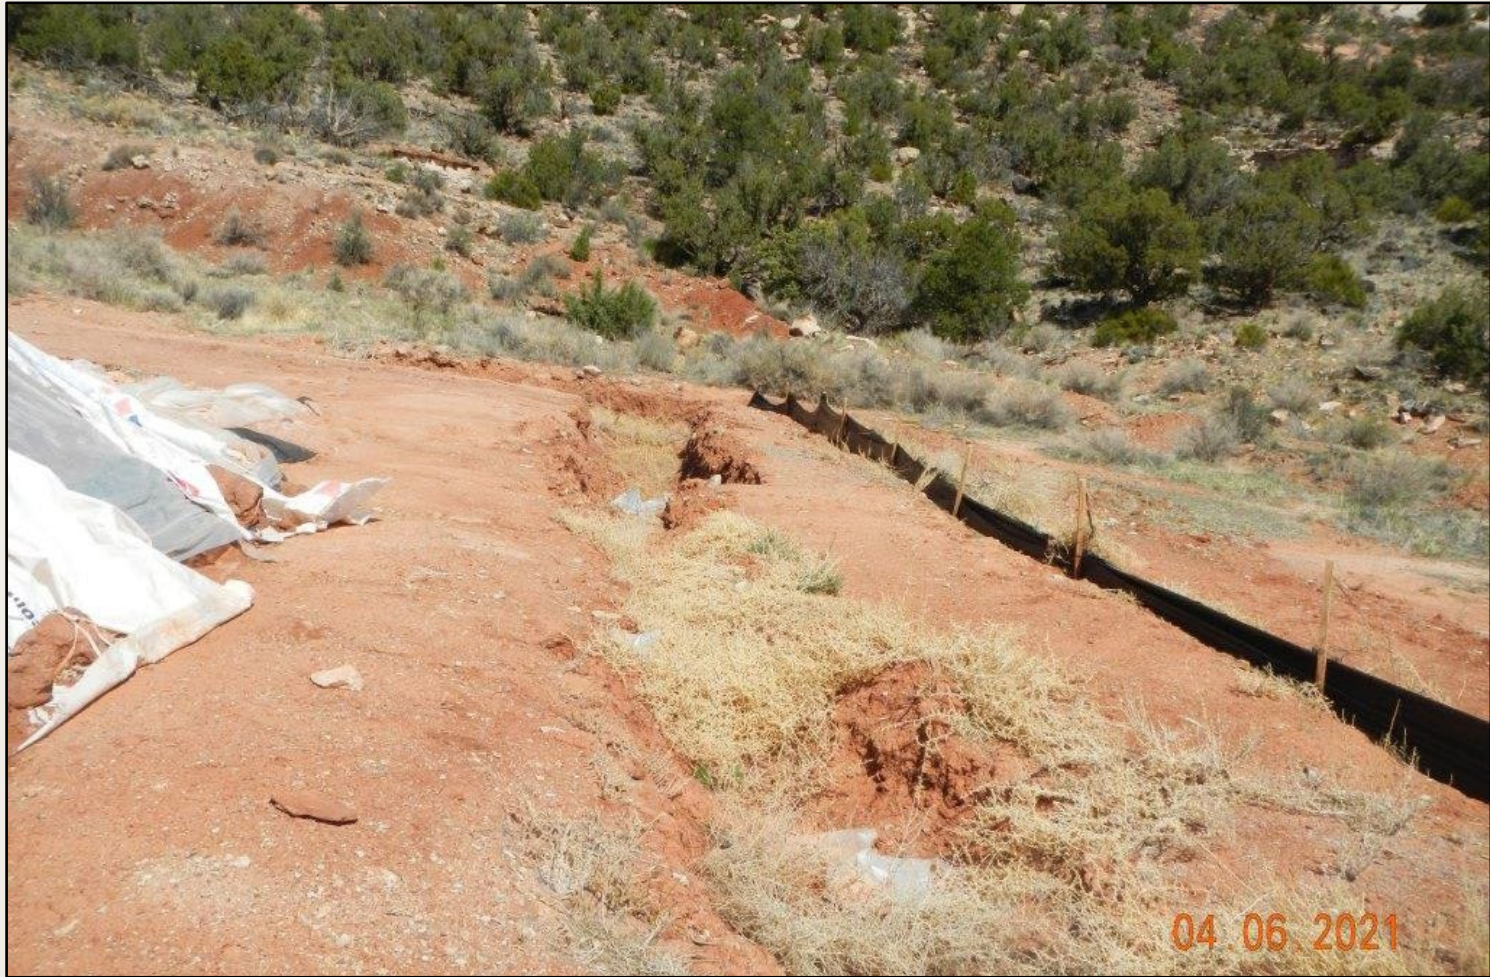
Photo 4. Another view of trench and silt fence in the eastern project area. Russian thistle and plastic debris observed in trench.

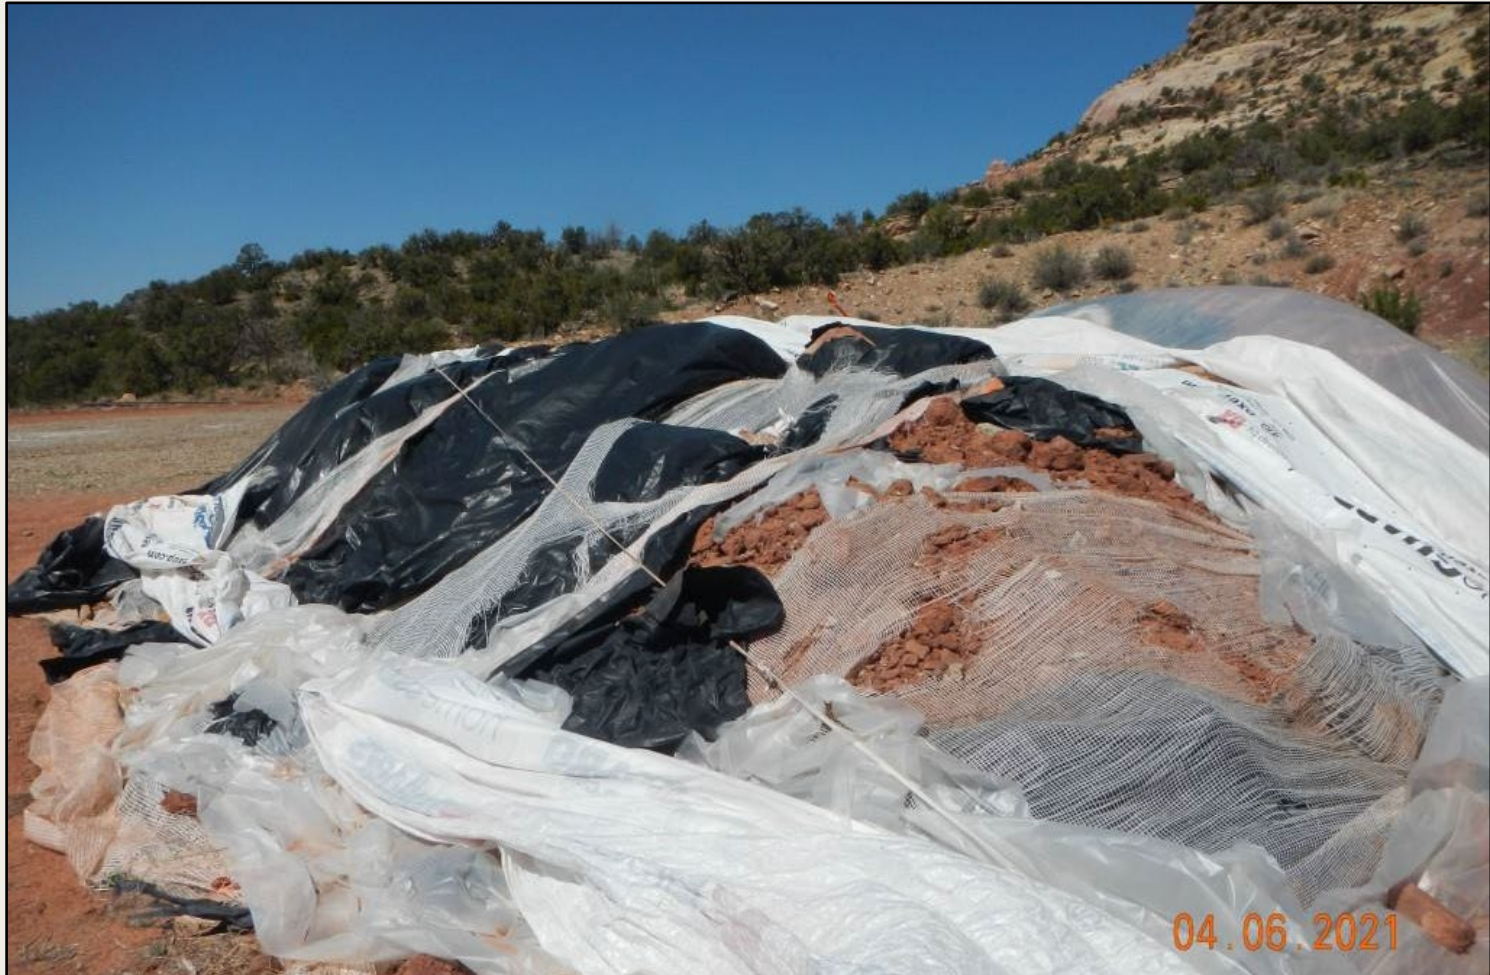
Photo 5. View of decomposing plastic covering soil pile in the eastern project area.

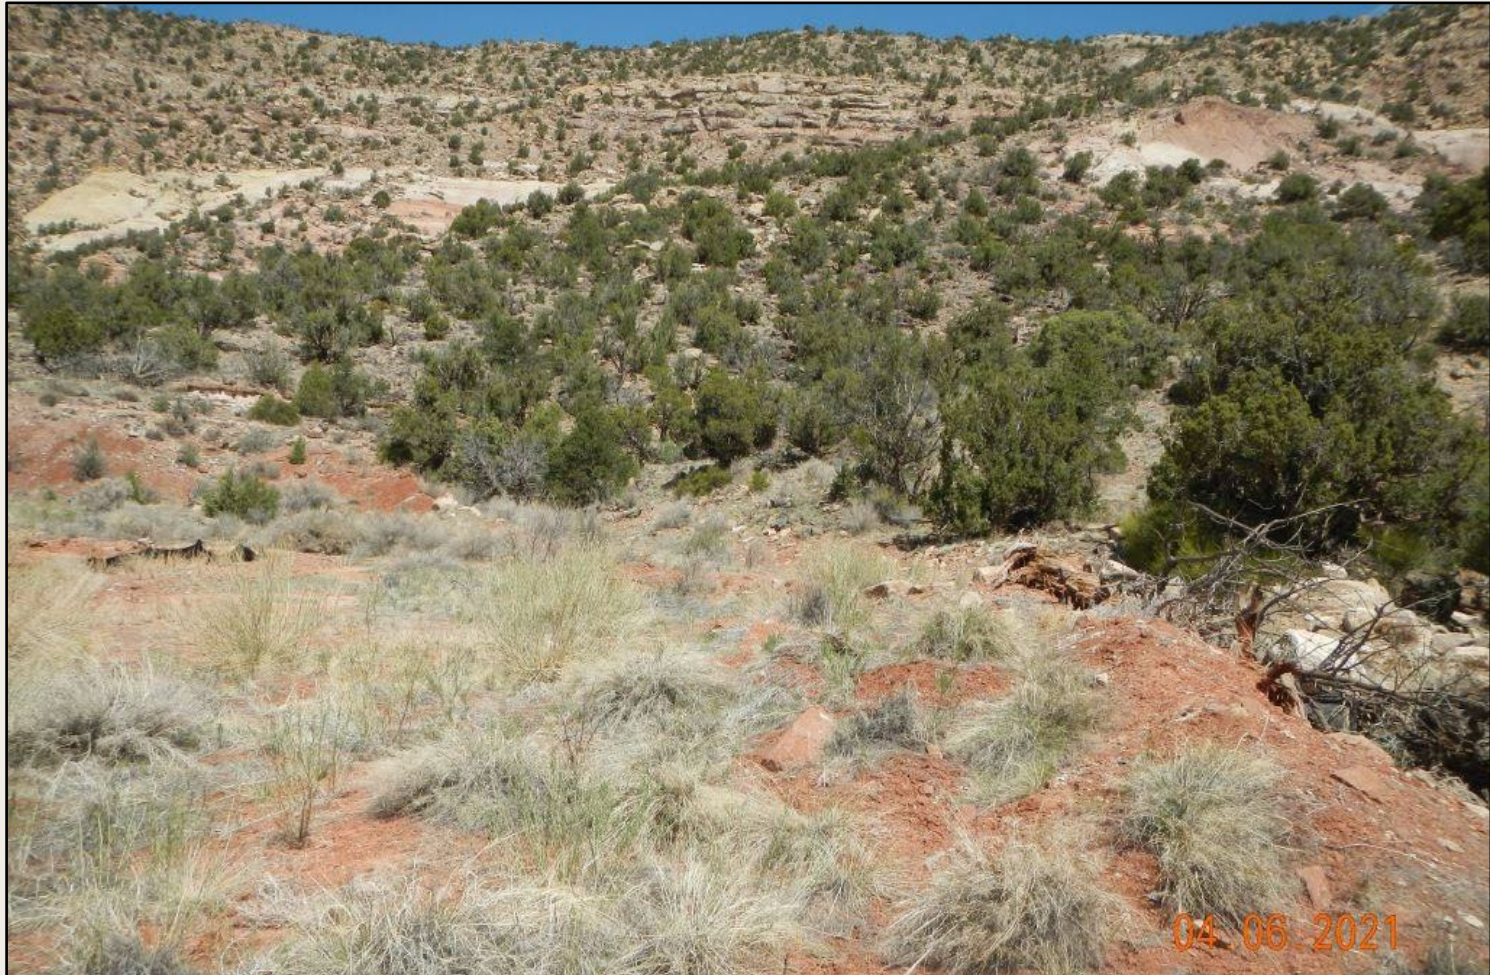
Photo 6. View of revegetation with Indian ricegrass and rubber rabbitbrush within the eastern project area, facing northward.

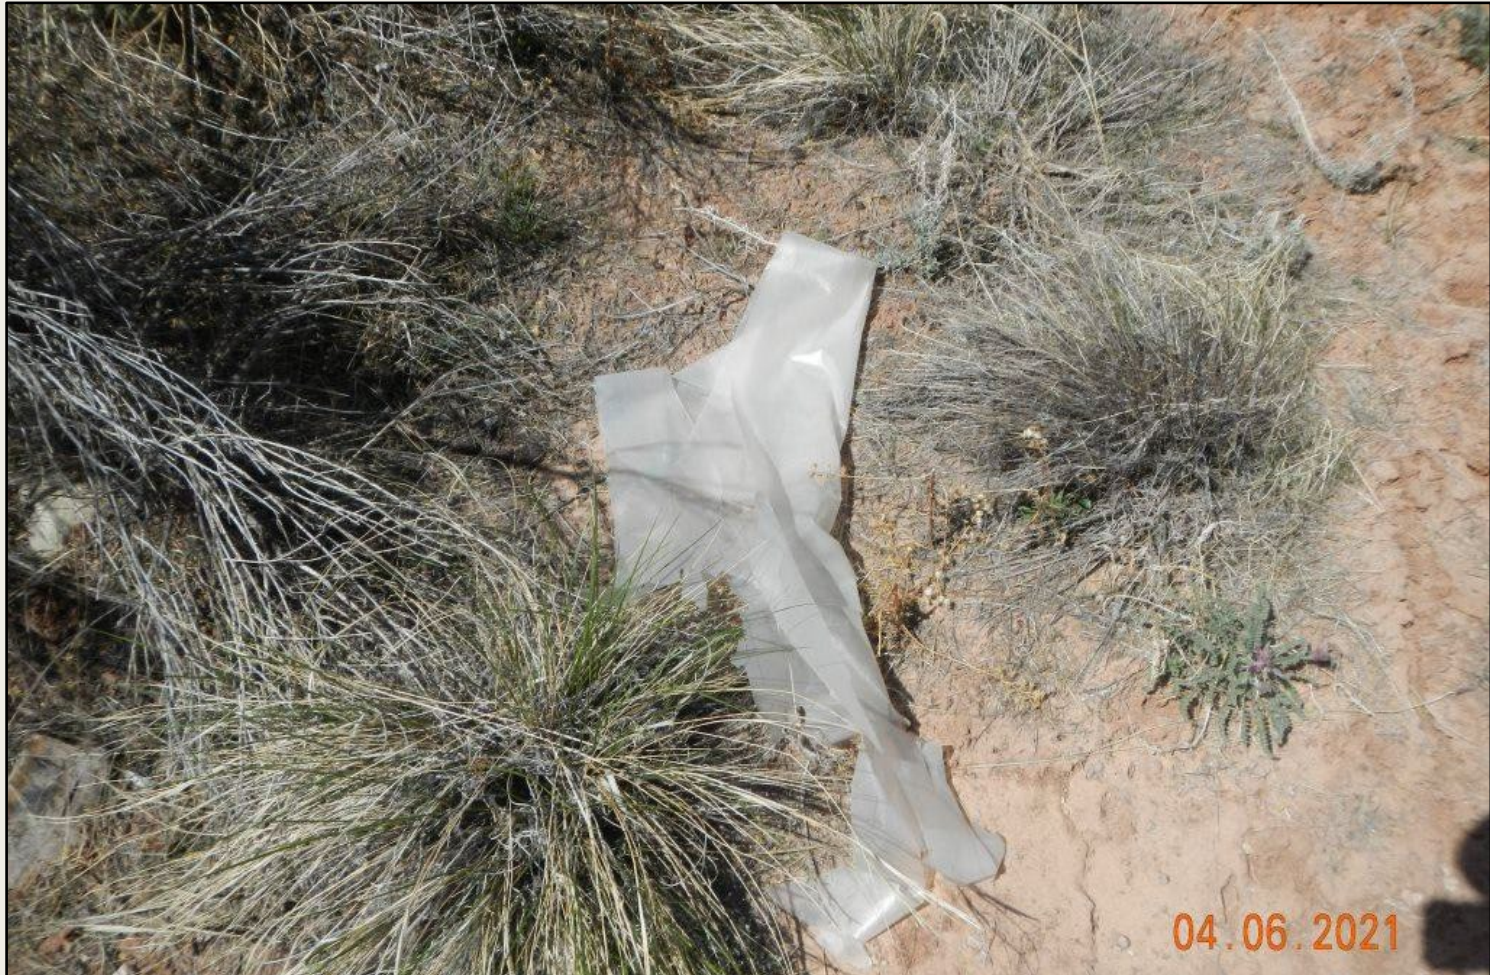
Photo 7. View of plastic debris blown off of the well pad.

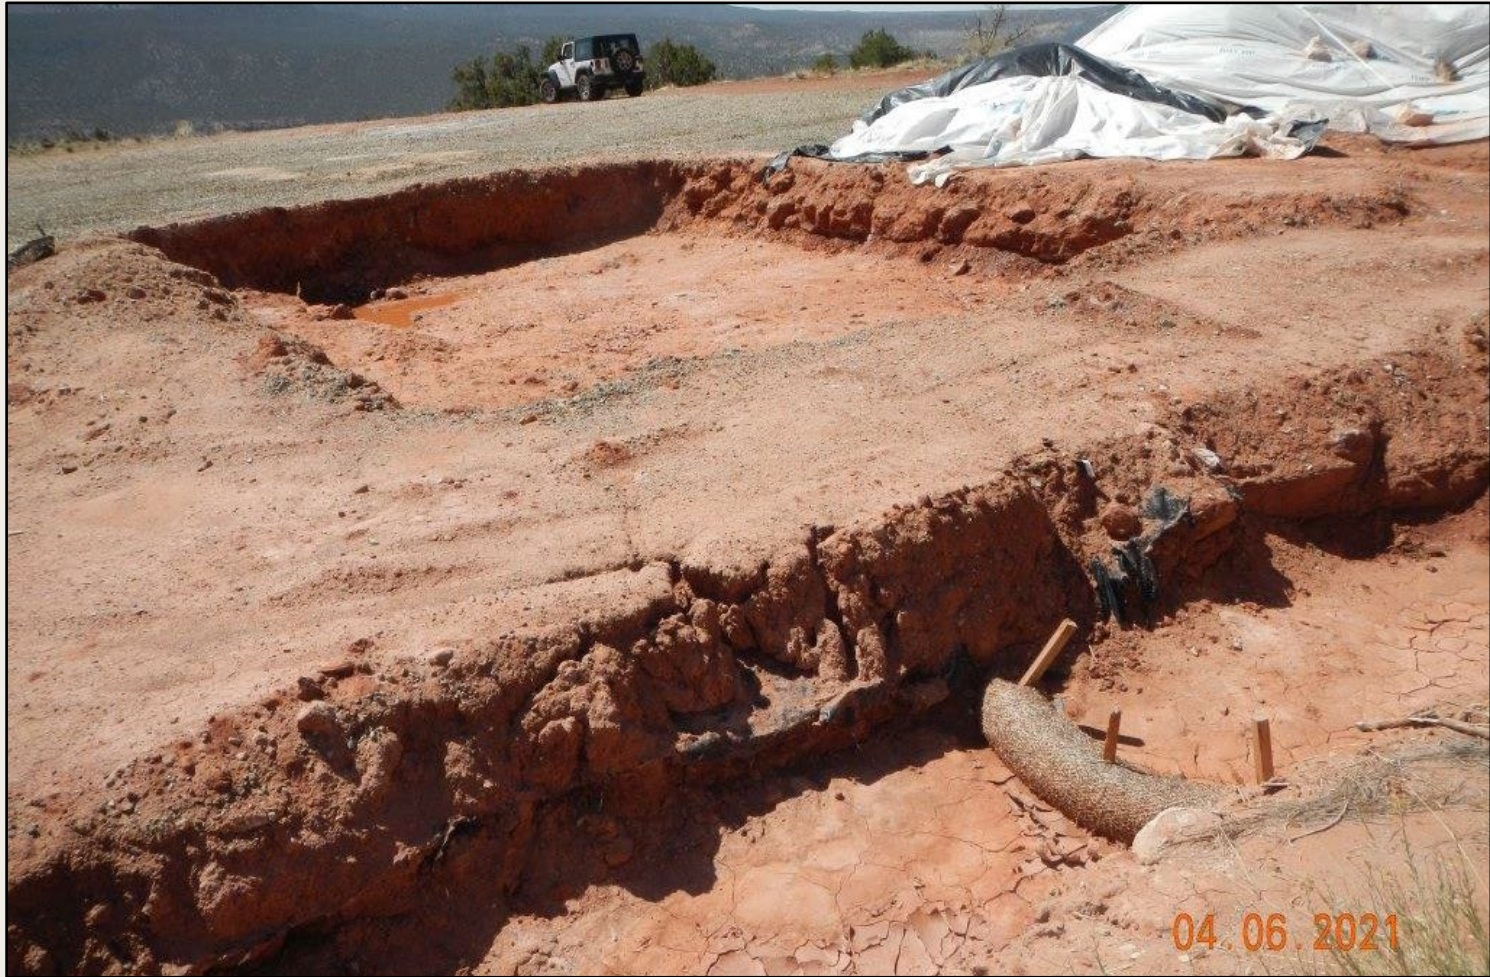
Photo 8. View of excavated area in the northern project area and trench in foreground

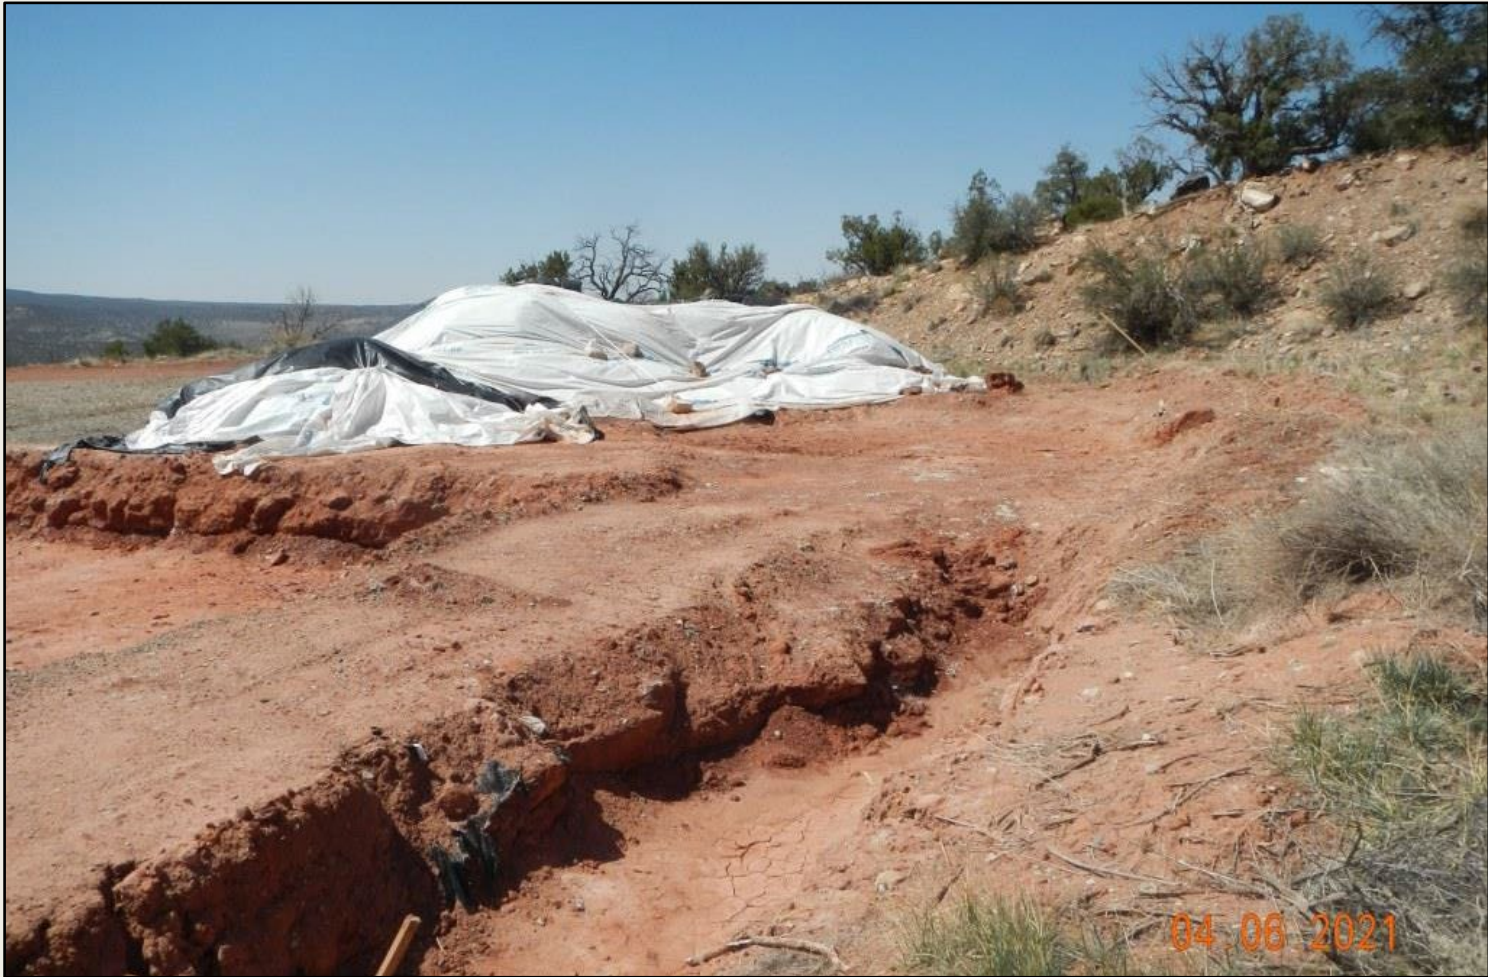
Photo 9. View of covered soil pile in the western project area.

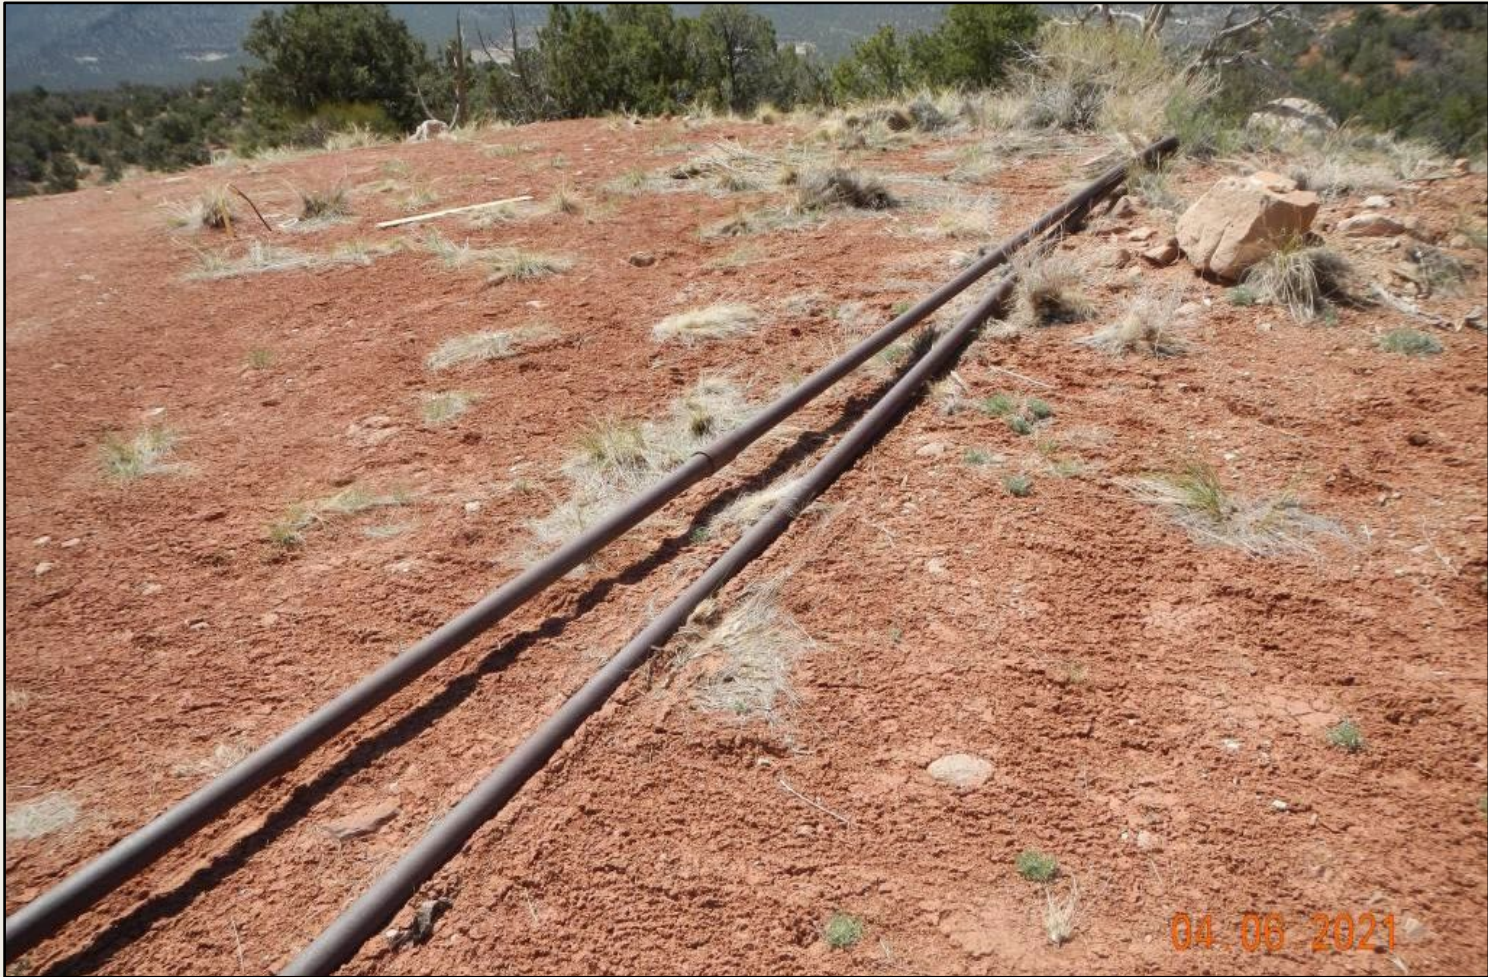
Photo 10. View of surface flowlines need to be properly abandoned.

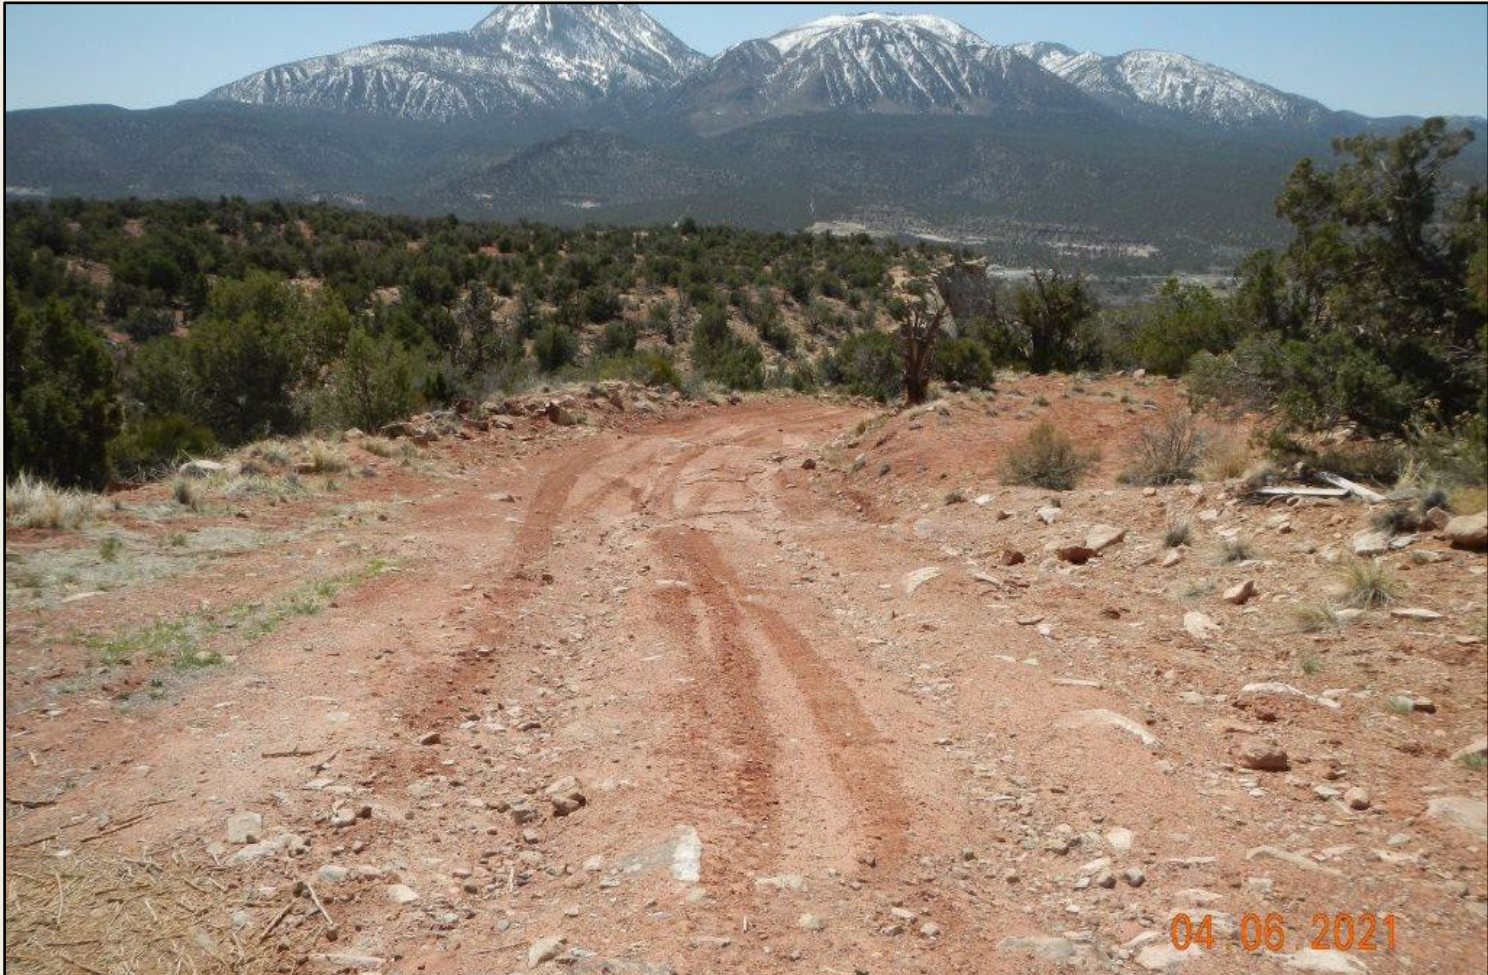
Photo 11. View of access road that needs to be reclaimed.

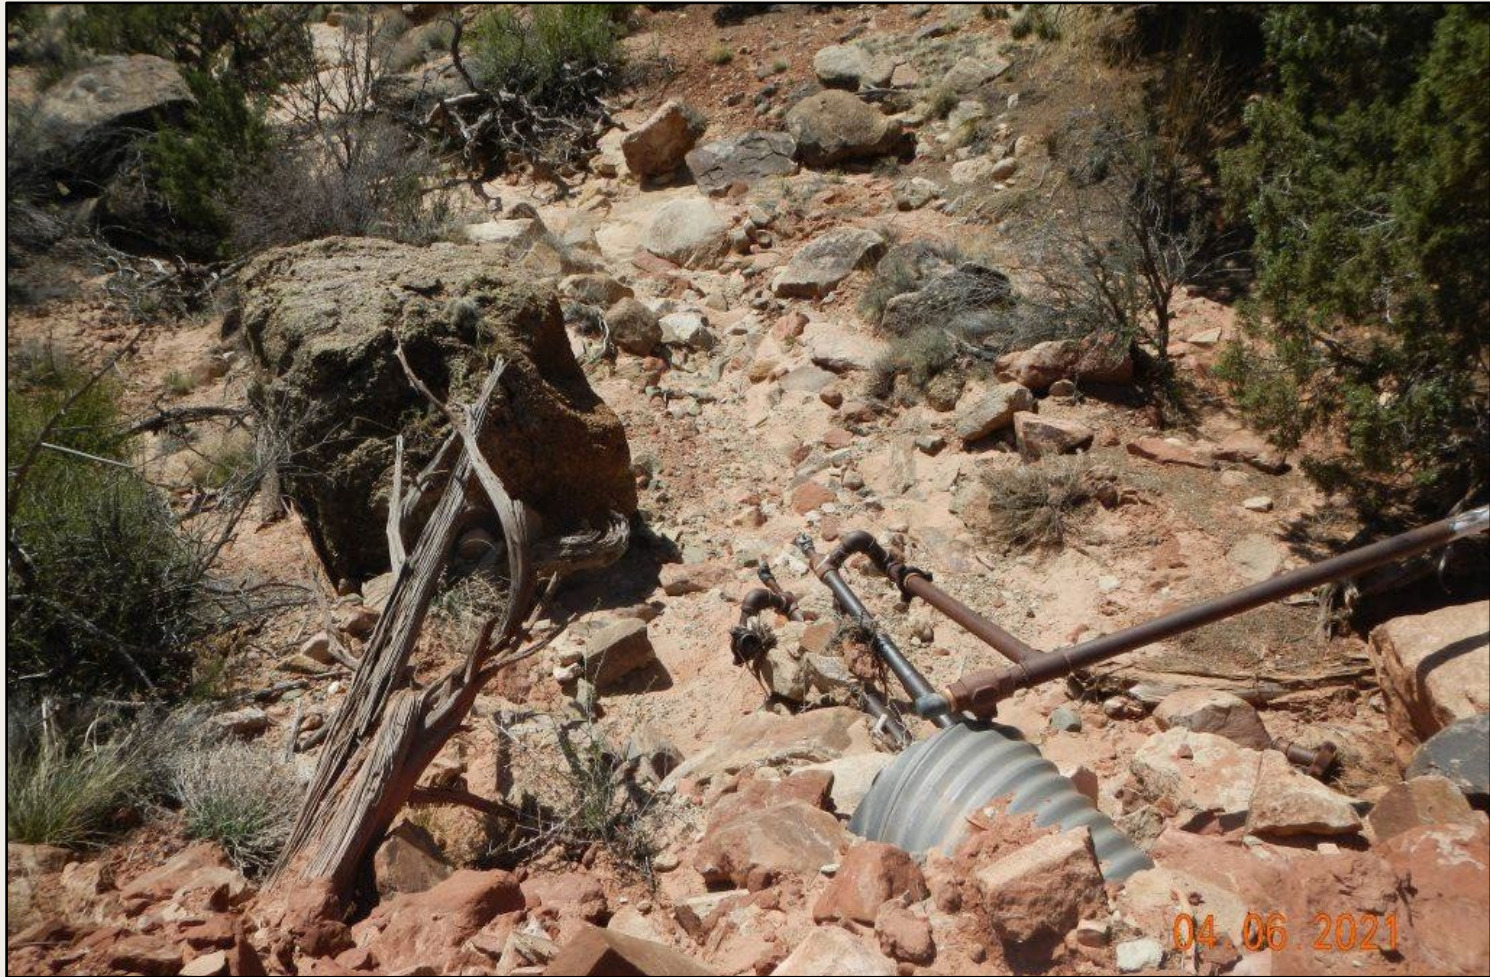
Photo 12. View of flowline at drainage intersection. Valve is open into drainage.

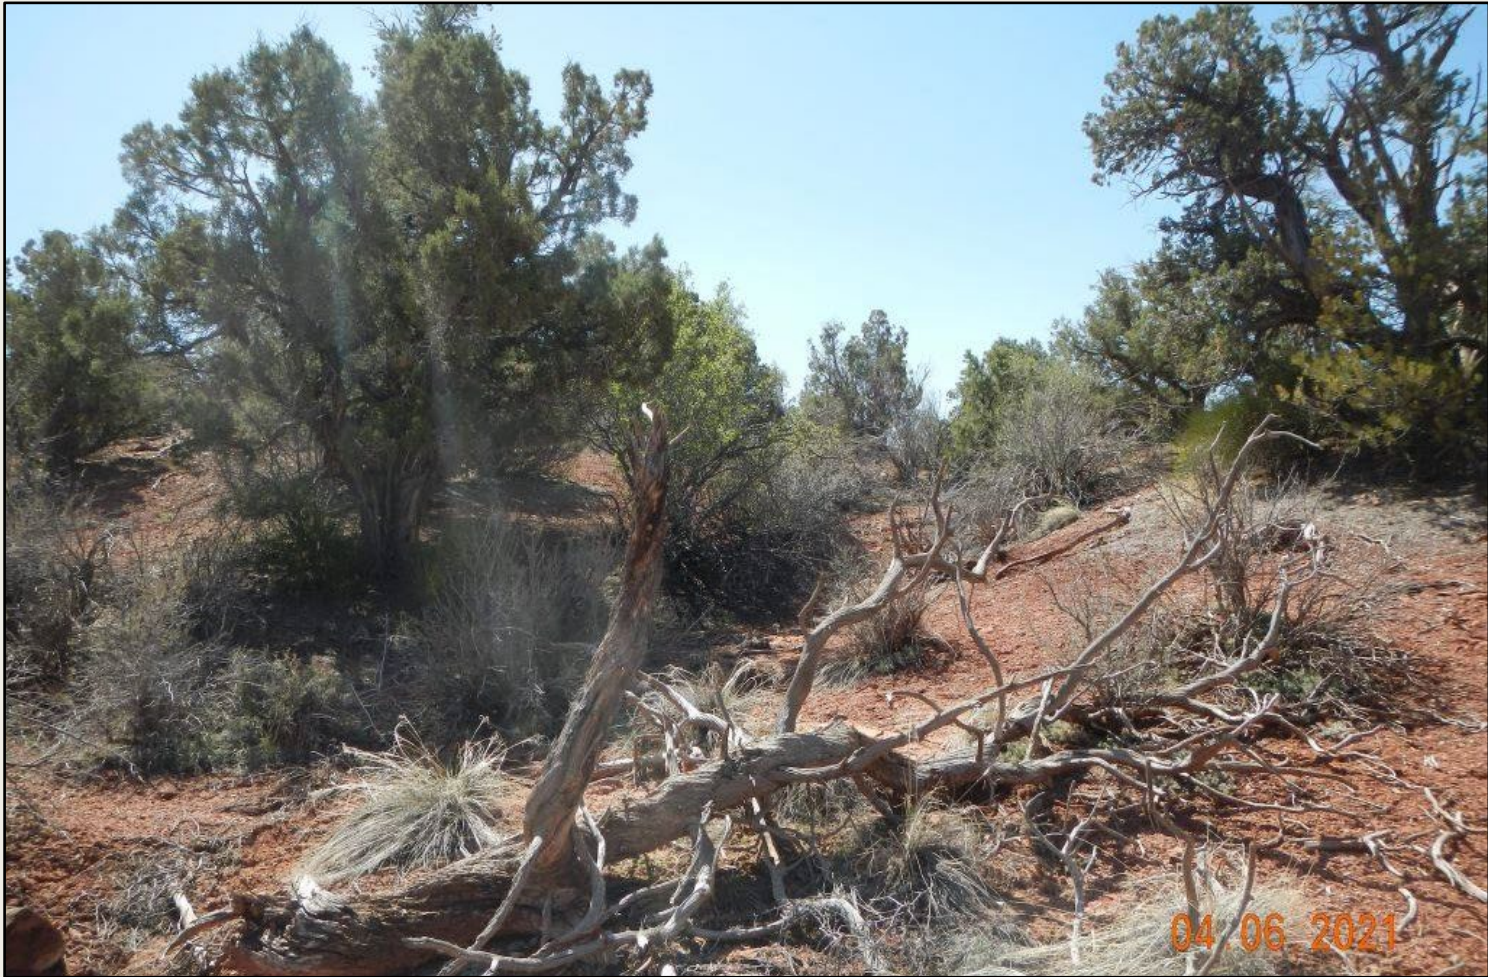
Photo 13. View of the reference area comprised of pinyon and juniper woodland with understory of serviceberry, cliffrose, and Indian ricegrass.
