Inspection Photos
Operator: Hilcorp Energy
Facility: 067-07403
Date: 4/12/2021

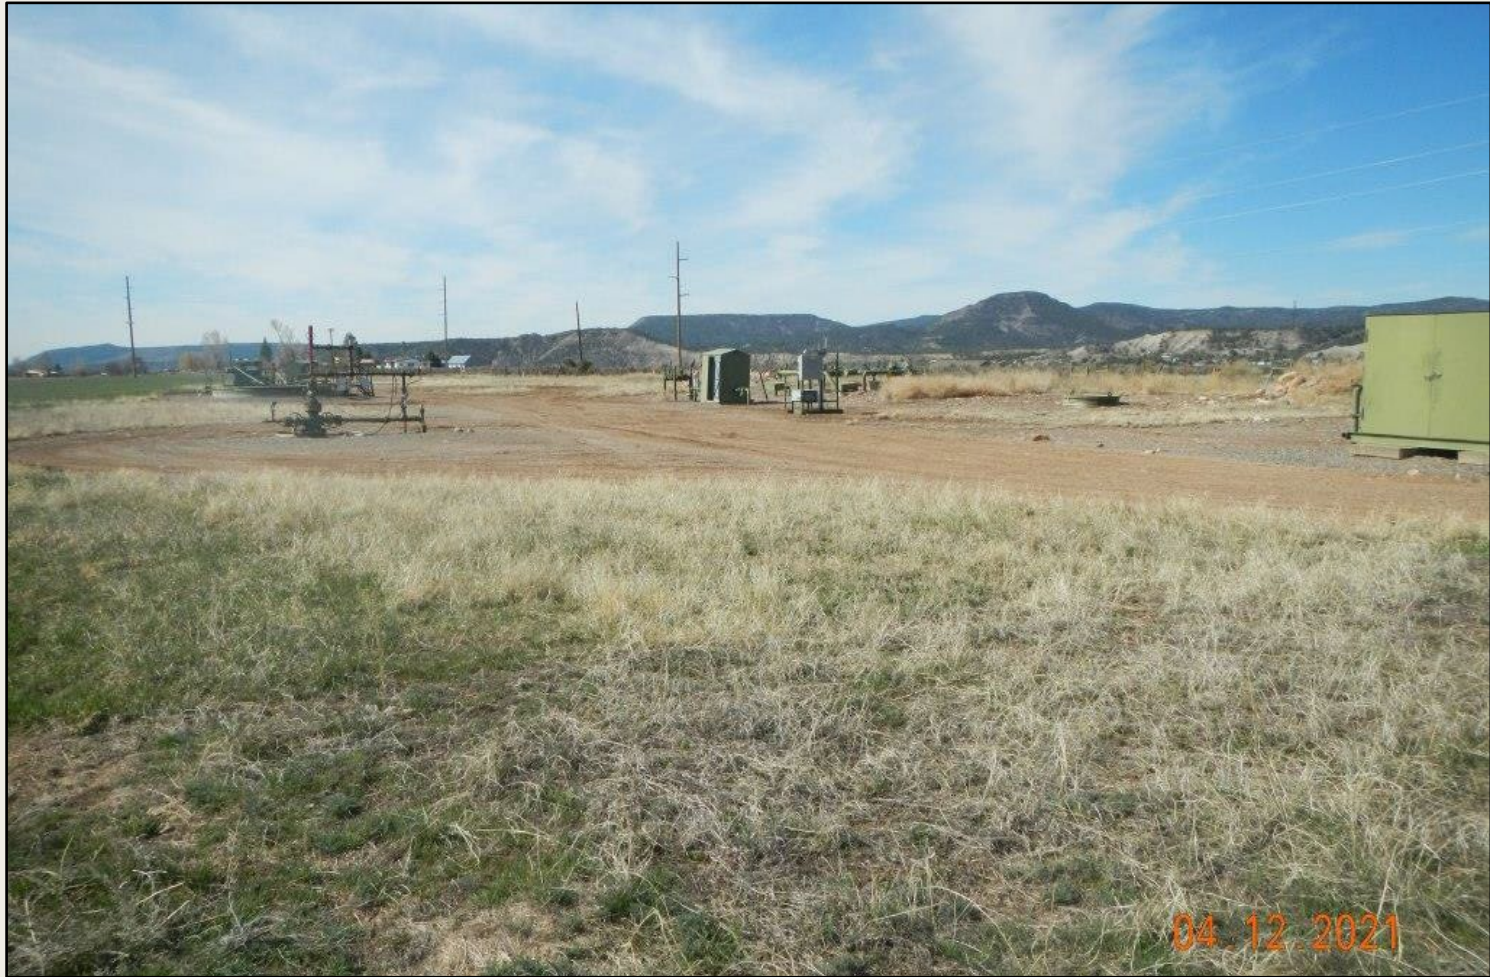
Photo 1. View of the project area from the northeastern corner facing center.

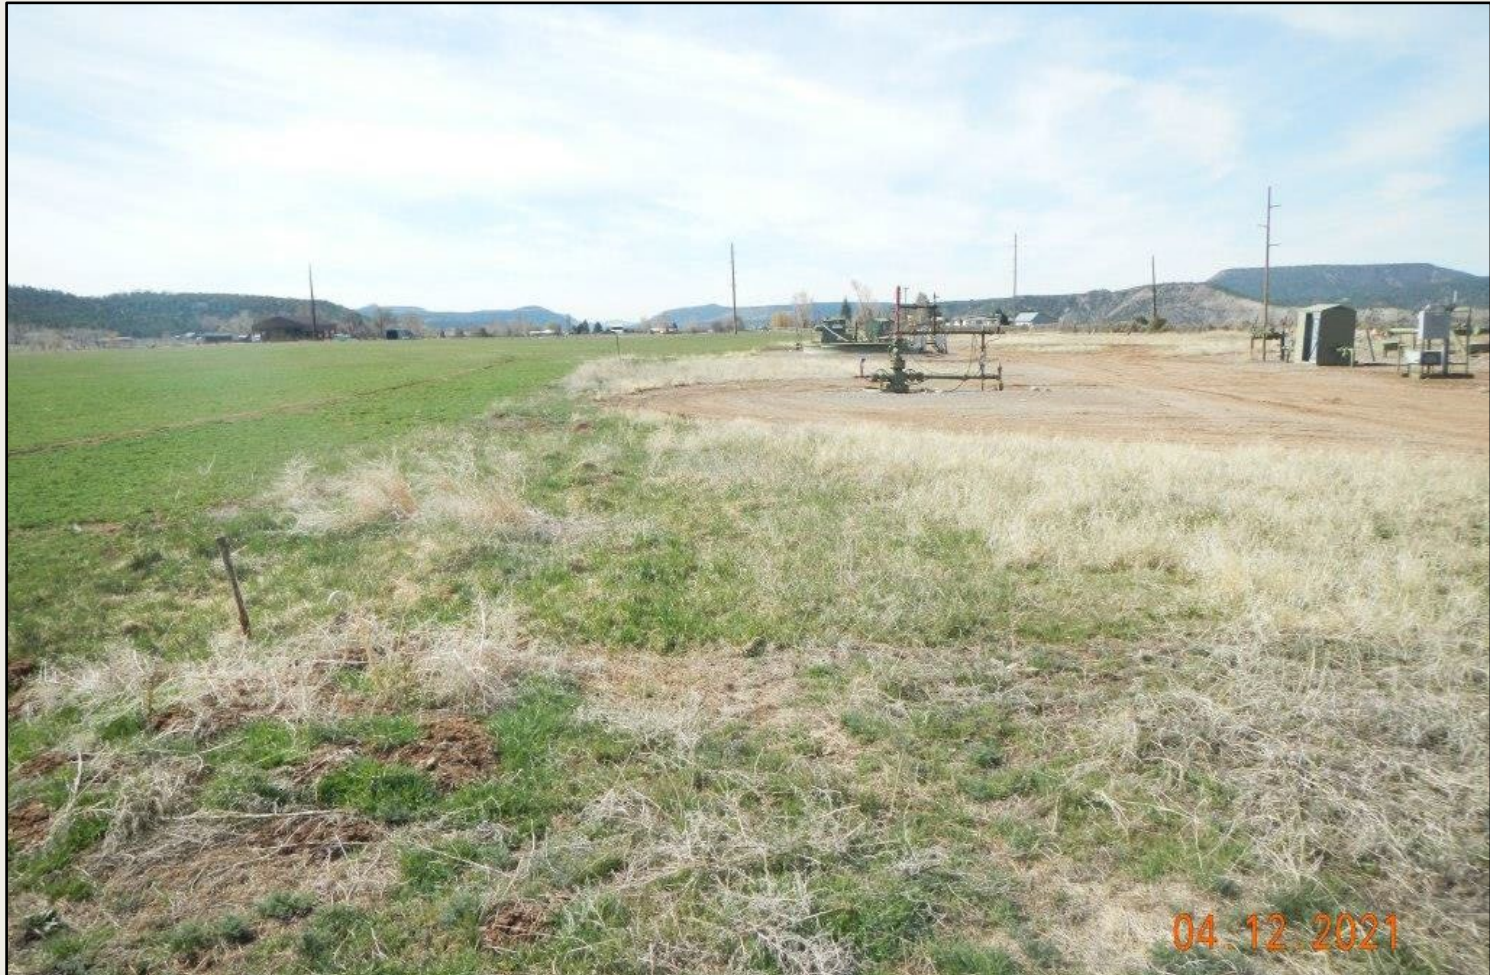
Photo 2. View of the eastern project area from the northeastern corner facing southward. Revegetation is progressing, partially returned to alfalfa crop field in the eastern project area, and revegetated with upland grasses such as sand dropseed, western wheatgrass, crested wheatgrass, and smooth brome in the non-irrigated portions.

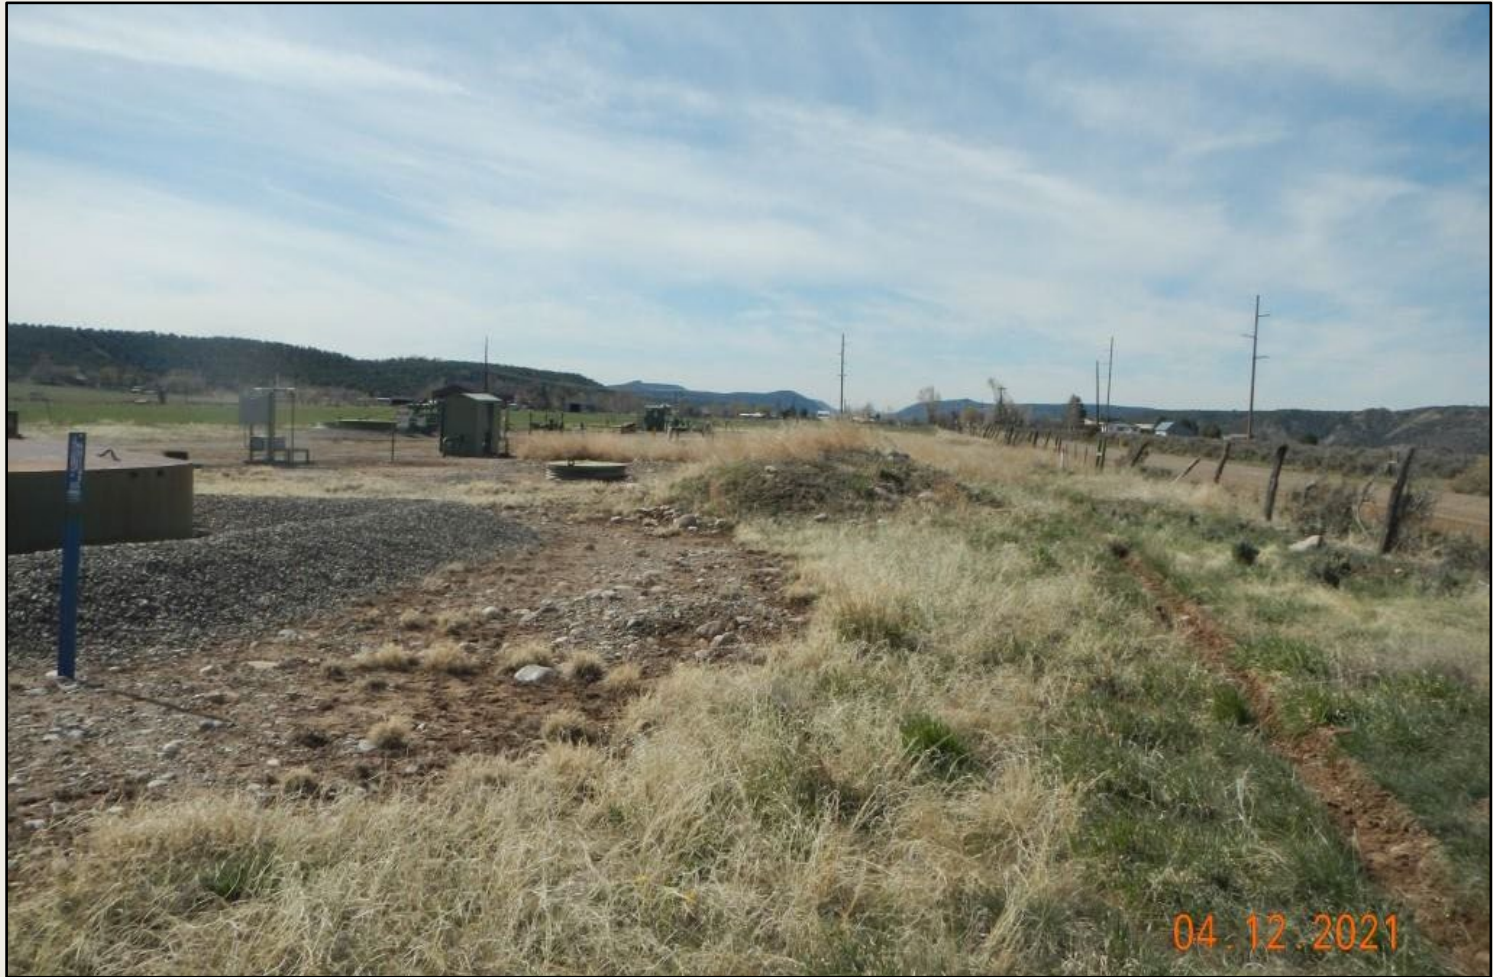
Photo 3. View of the western project area facing southward.

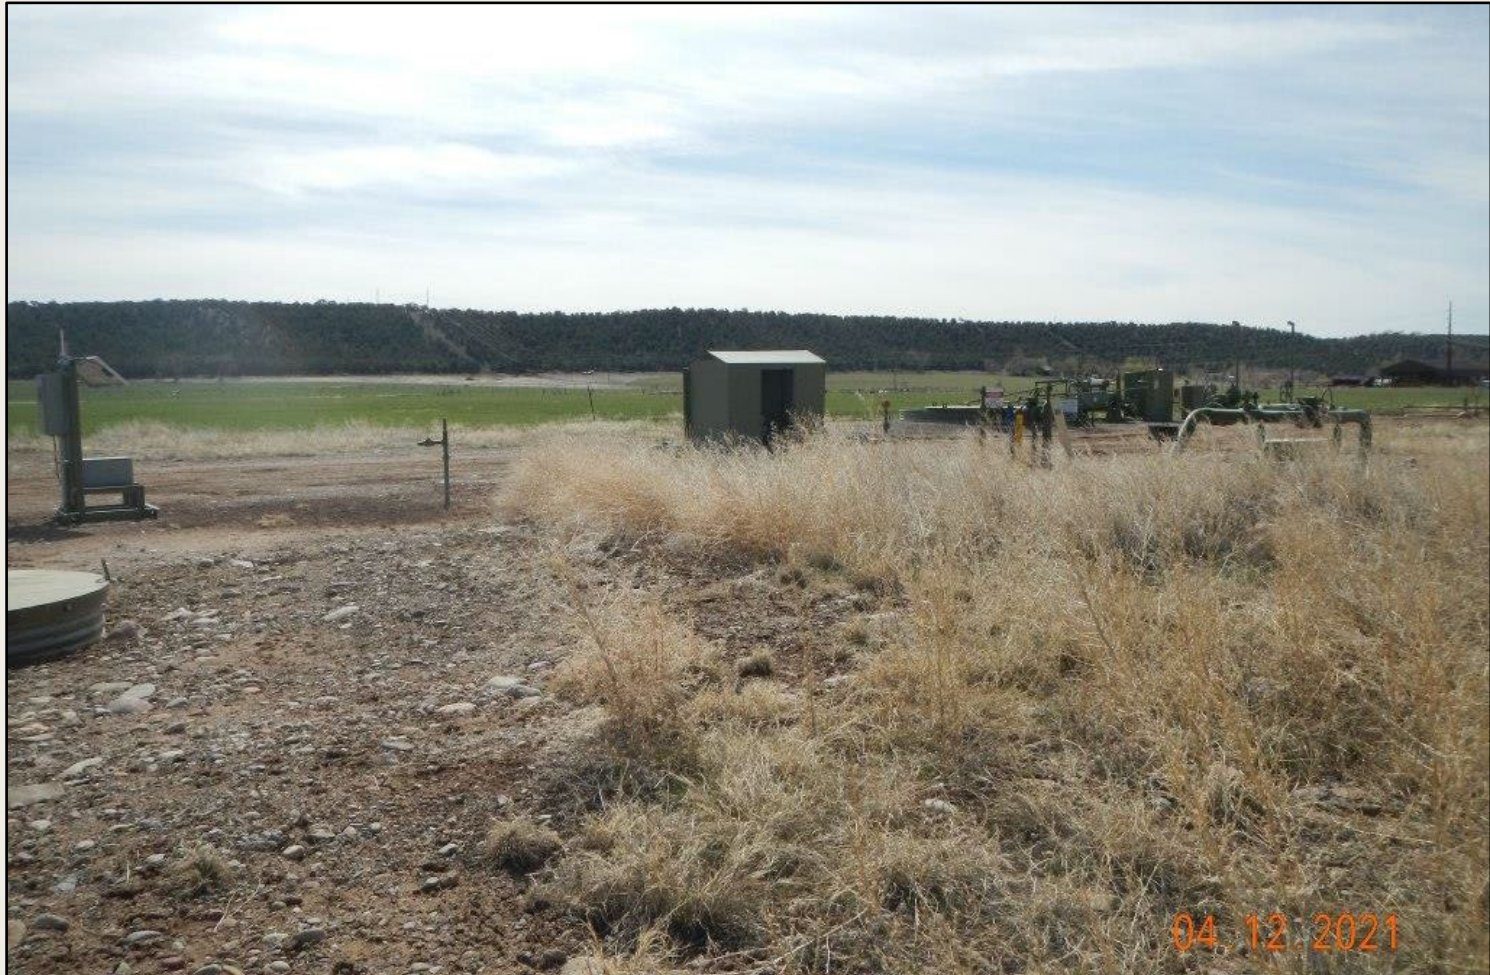
Photo 4. View of kochia debris within the southern project area, needs to be removed and properly disposed of.

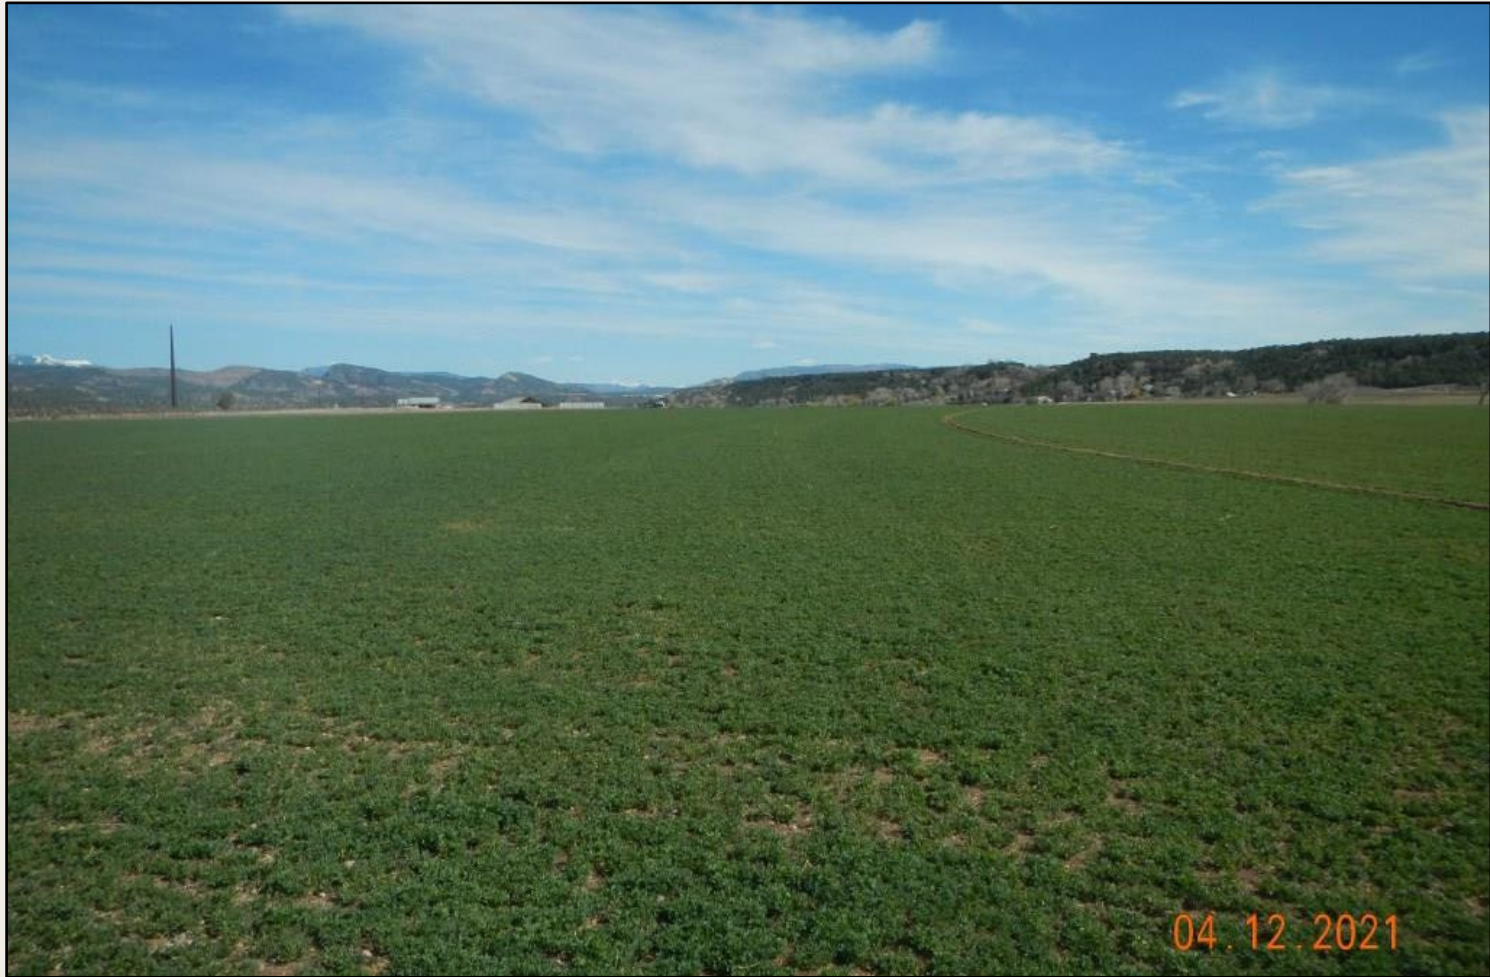
Photo 5. View of the reference area comprised of irrigated alfalfa field. Portions of the project area are returned to alfalfa production. Other portions are not irrigated and comprised of upland grasses.
