**Inspection Photos**  
**Location Name: UPRR 43 PAN AM B #7**  
**Location ID: 318400**

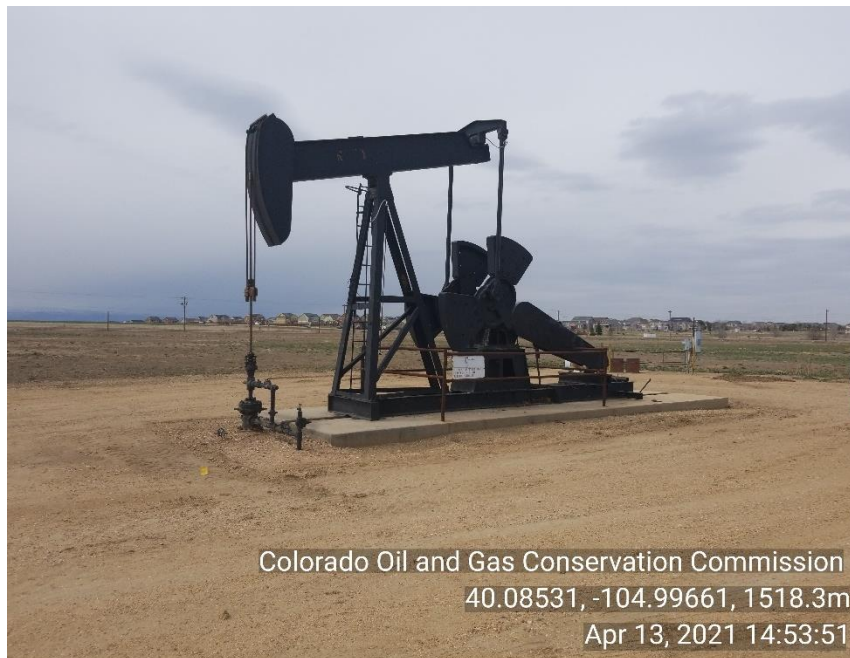
**Photo 1 WH. Well head sign peeling and faded need to replace.**

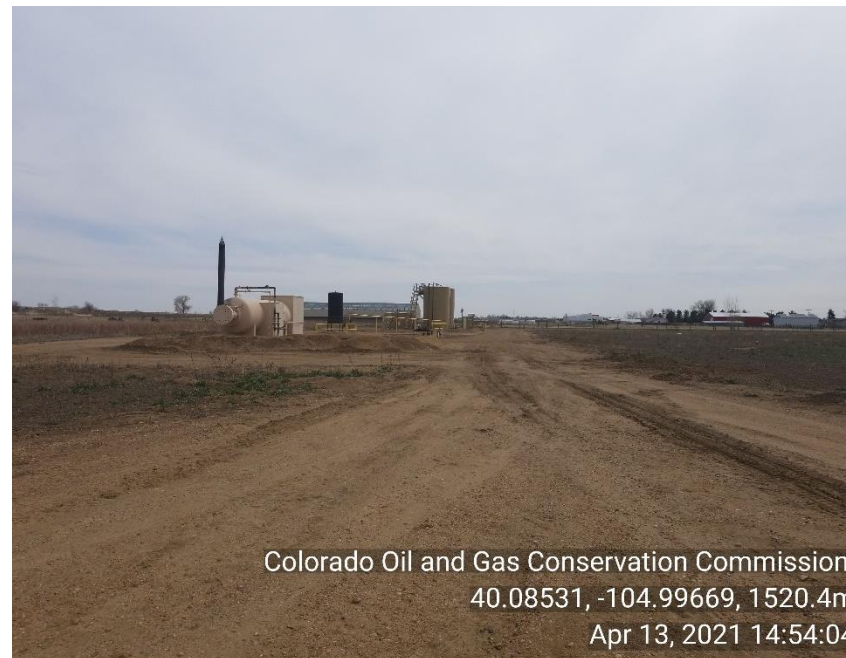
**Photo 2 production equipment. Ruts on road and location no BMP's.**

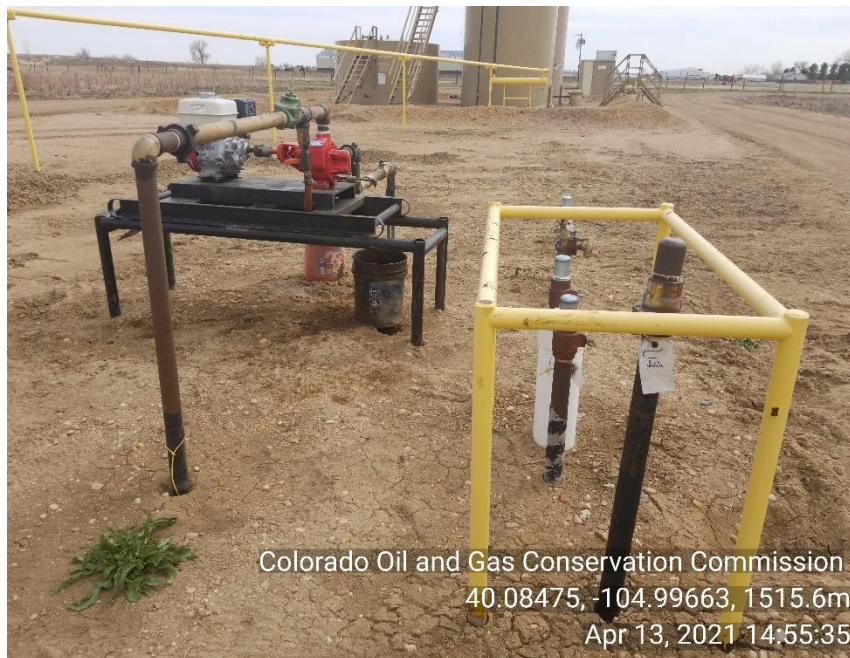
**Photo 3 Stained soil under recirc pump. Improper BMP under pump. Risers tags are missing, faded, or torn.**

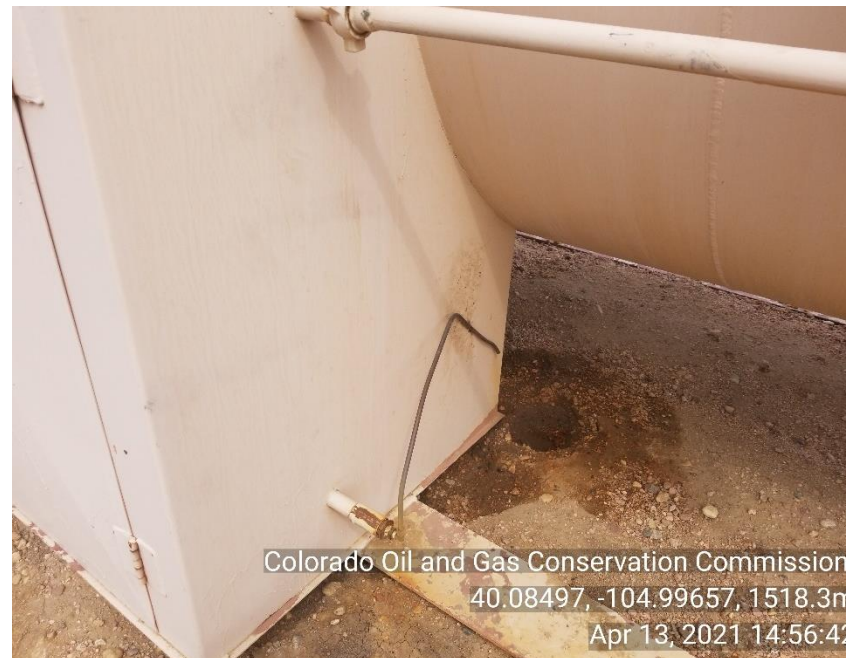
**Photo 4 Improper discharge of fluid, separator being dumped on ground. Stained soil.**

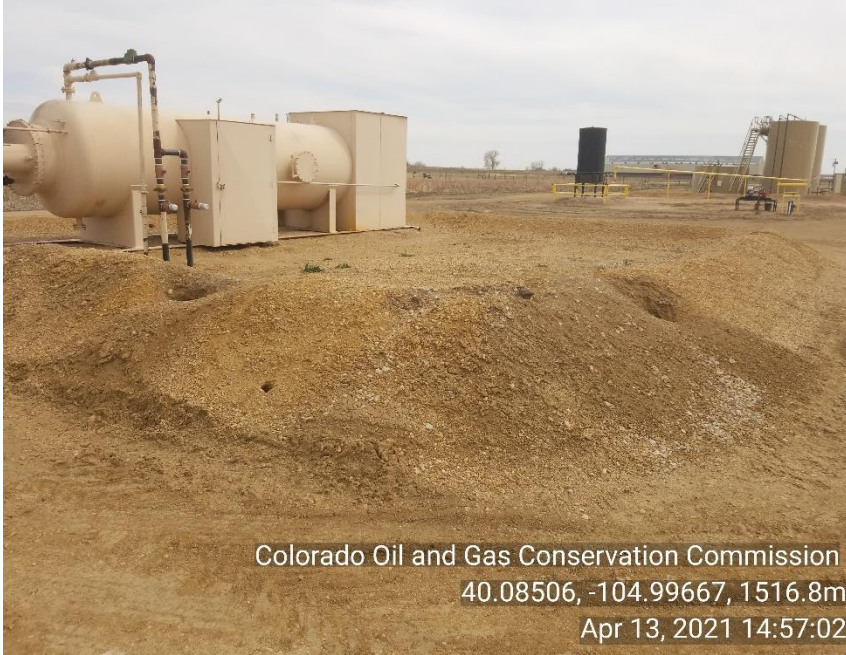
**Photo 5 Secondary BMP in disrepair Prairie dog holes.**

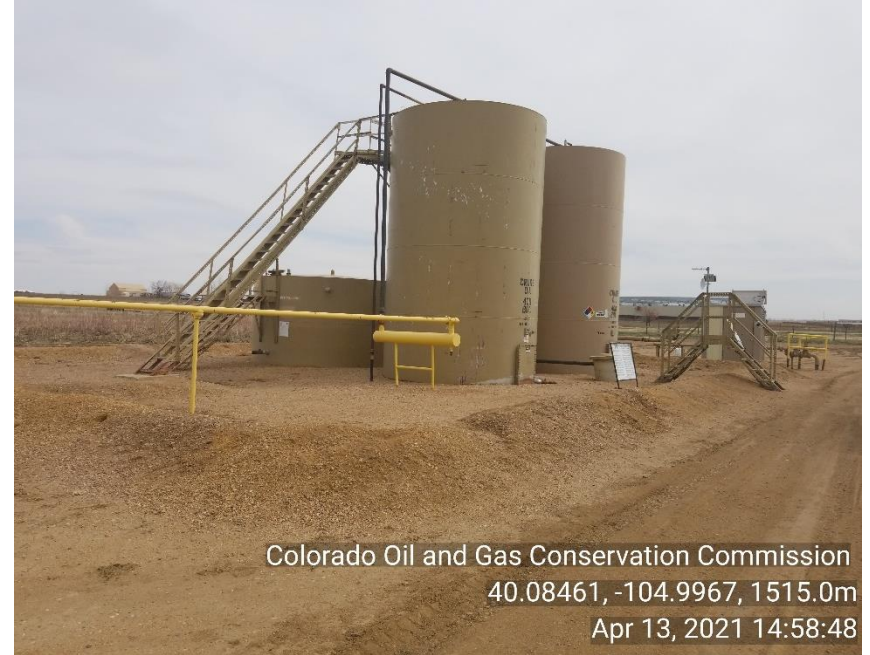
**Photo 6 TNK BTRY. Secondary containment in disrepair Not adequate height and Prairie dog holes throughout berm.**

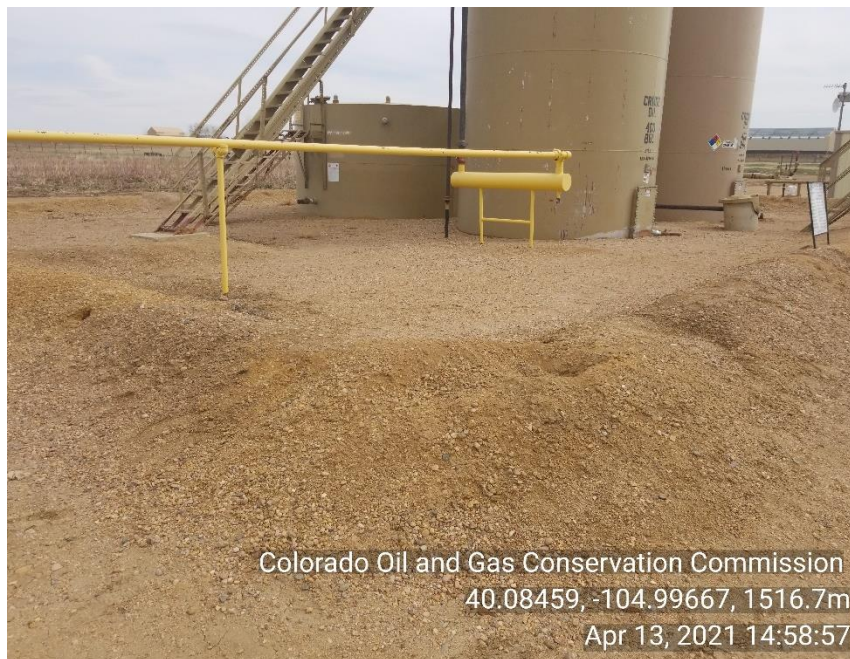
**Photo 7 Secondary containment in disrepair.**

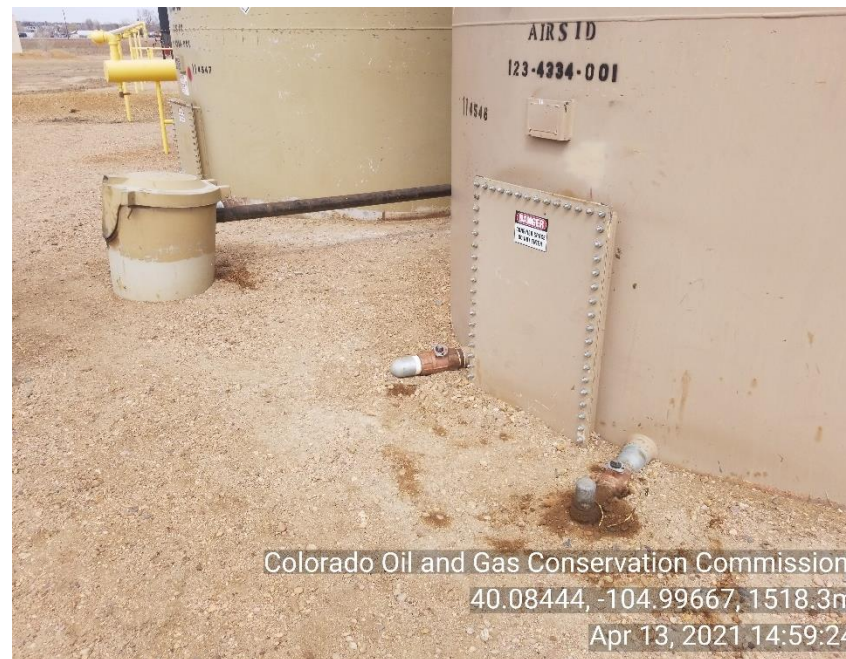
**Photo 8 Stained soil under load out line on crude oil tanks.  
Mechanical issue 2" piping and valves.**

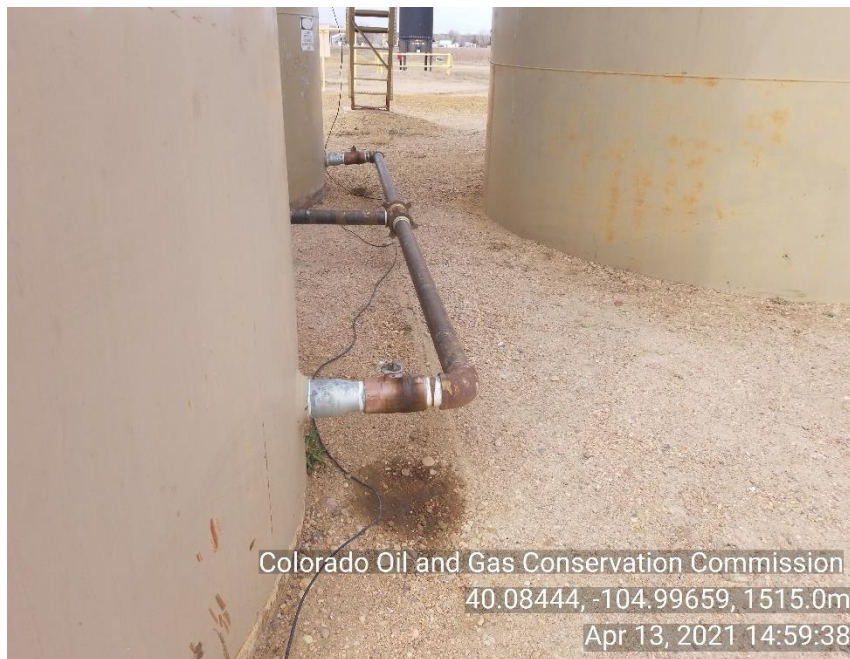
**Photo 9 Stained soil under load lines on crude oil tanks.  
Mechanical issues 2" piping.**

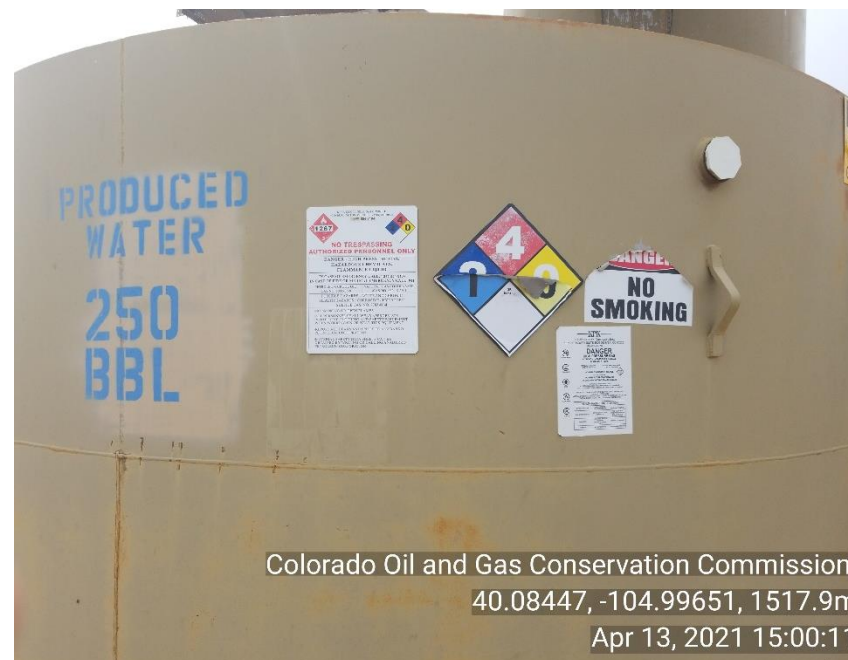
**Photo 10 NFPA placard peeling and faded on produced water tank.**

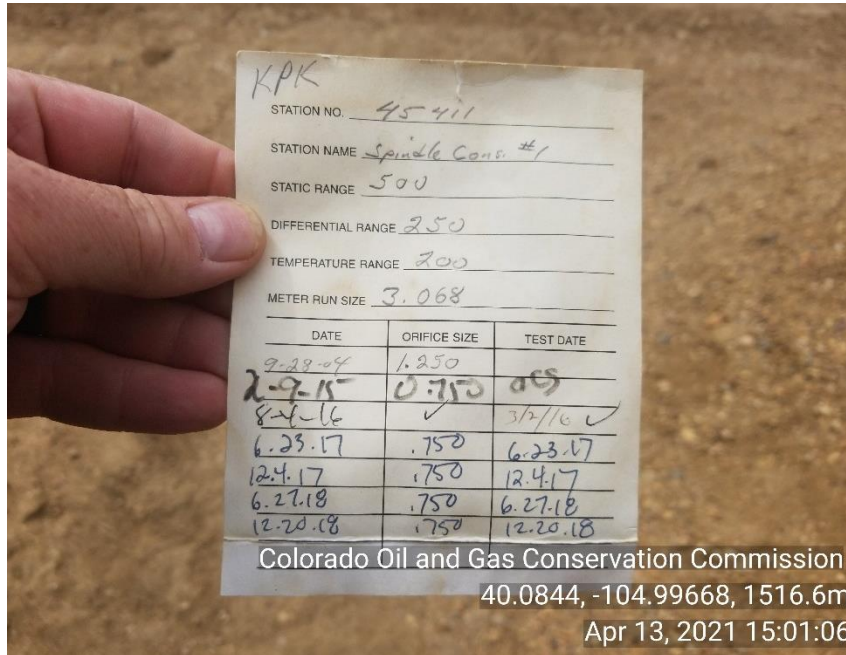
**Photo 11 Meter calibration test card date 12-20-18.**

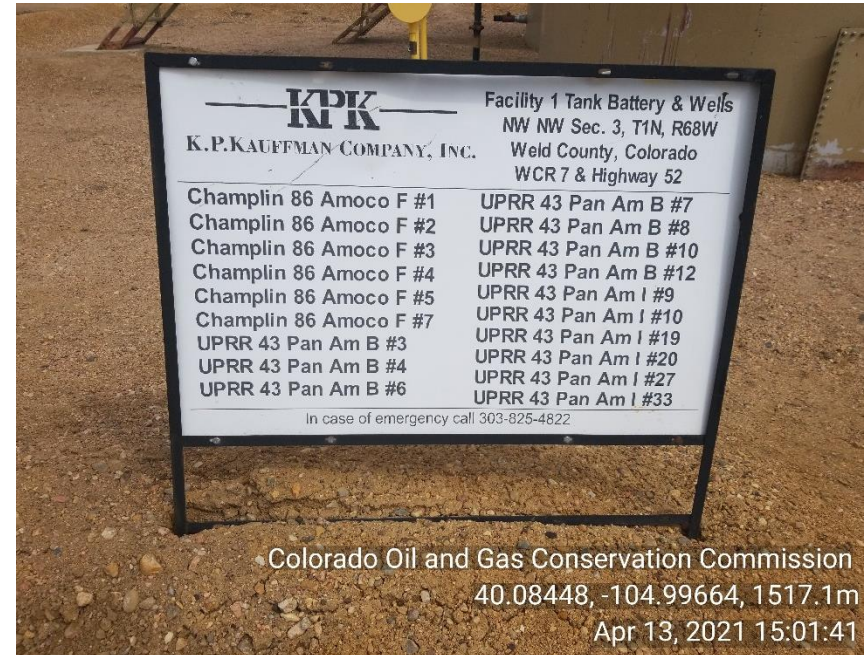
**Photo 12 TNK BTRY well sign.**

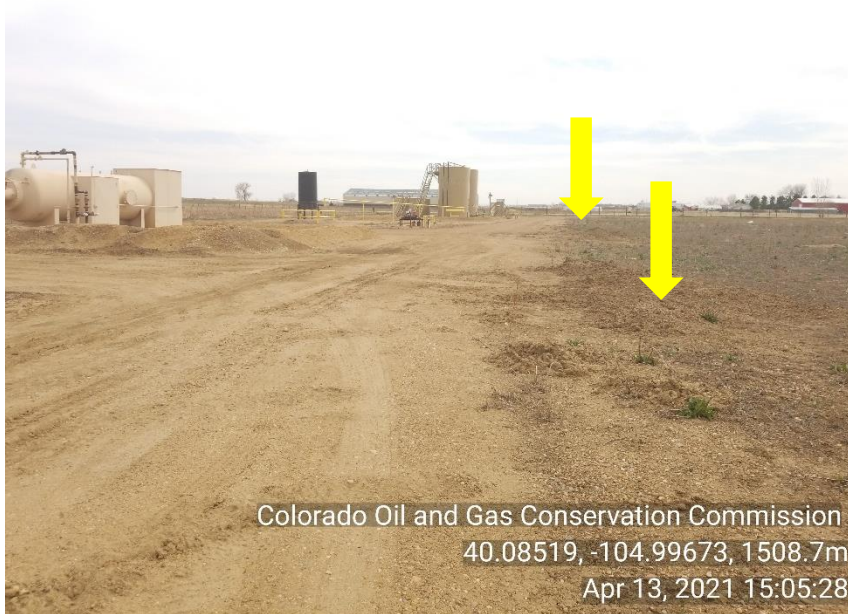
**Photo 13 Material being pushed off location not NO BMP's in place.**

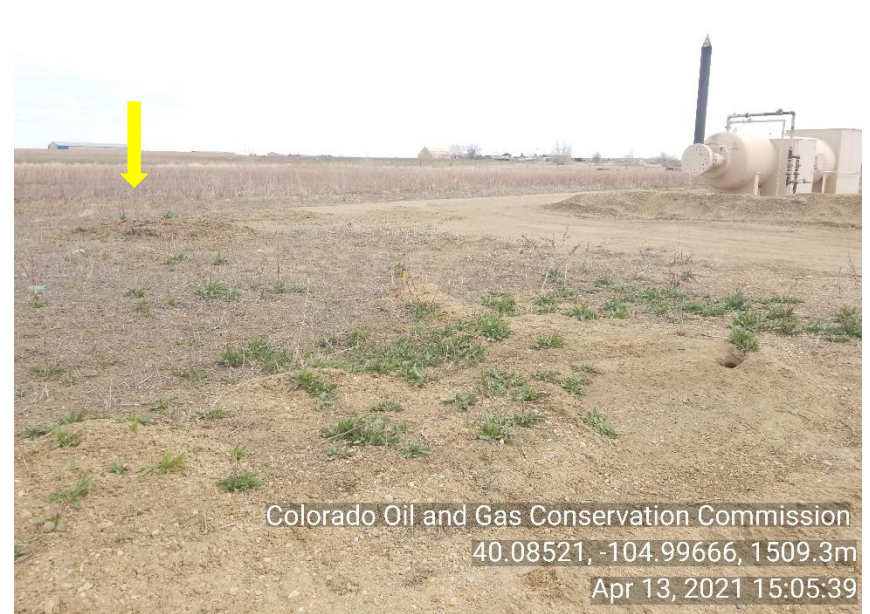
**Photo 14 Material being pushed off location not NO BMP's in place.**

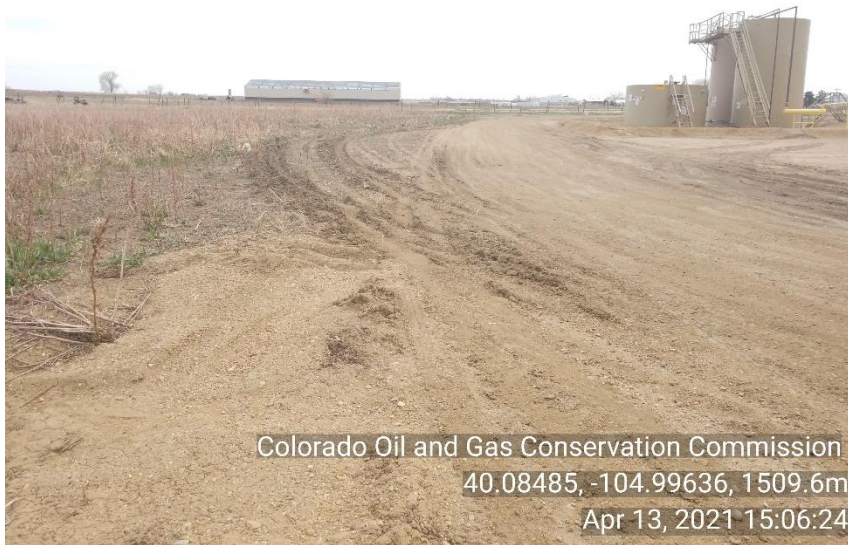
**Photo 15 Material and truck traffic off location no BMP's in place.**
