GOLDEN EAGLE 28-07 API# 05-071-07778 – TIMBER CREEK OPERATING
OGCC OPERATOR NUMBER 10672 - DATE: APRIL 09, 2021
CORRECTIVE ACTIONS COMPLETED REGARDING COGCC FIR DOCUMENT # 690200646

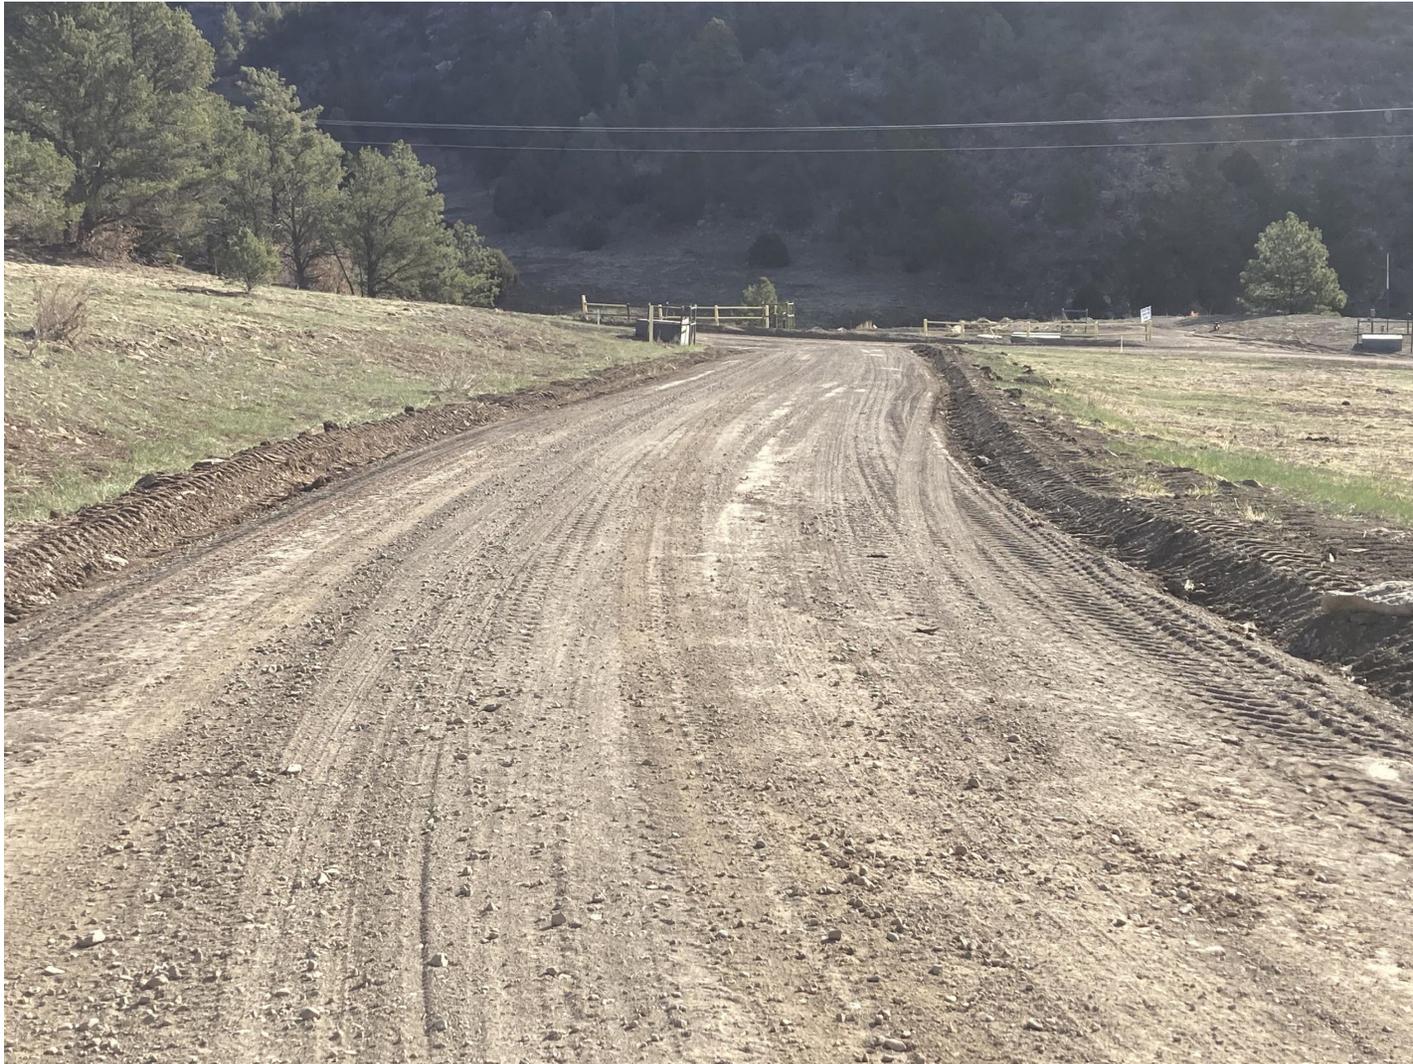
PHOTO 3: FACING BACK DOWN THE LEASE ROAD TO THE INTERSECTION IN LOPEZ CANYON.
