Inspection Photos
Operator: IKAV
Facility: 067-07455
Date: 4/12/2021

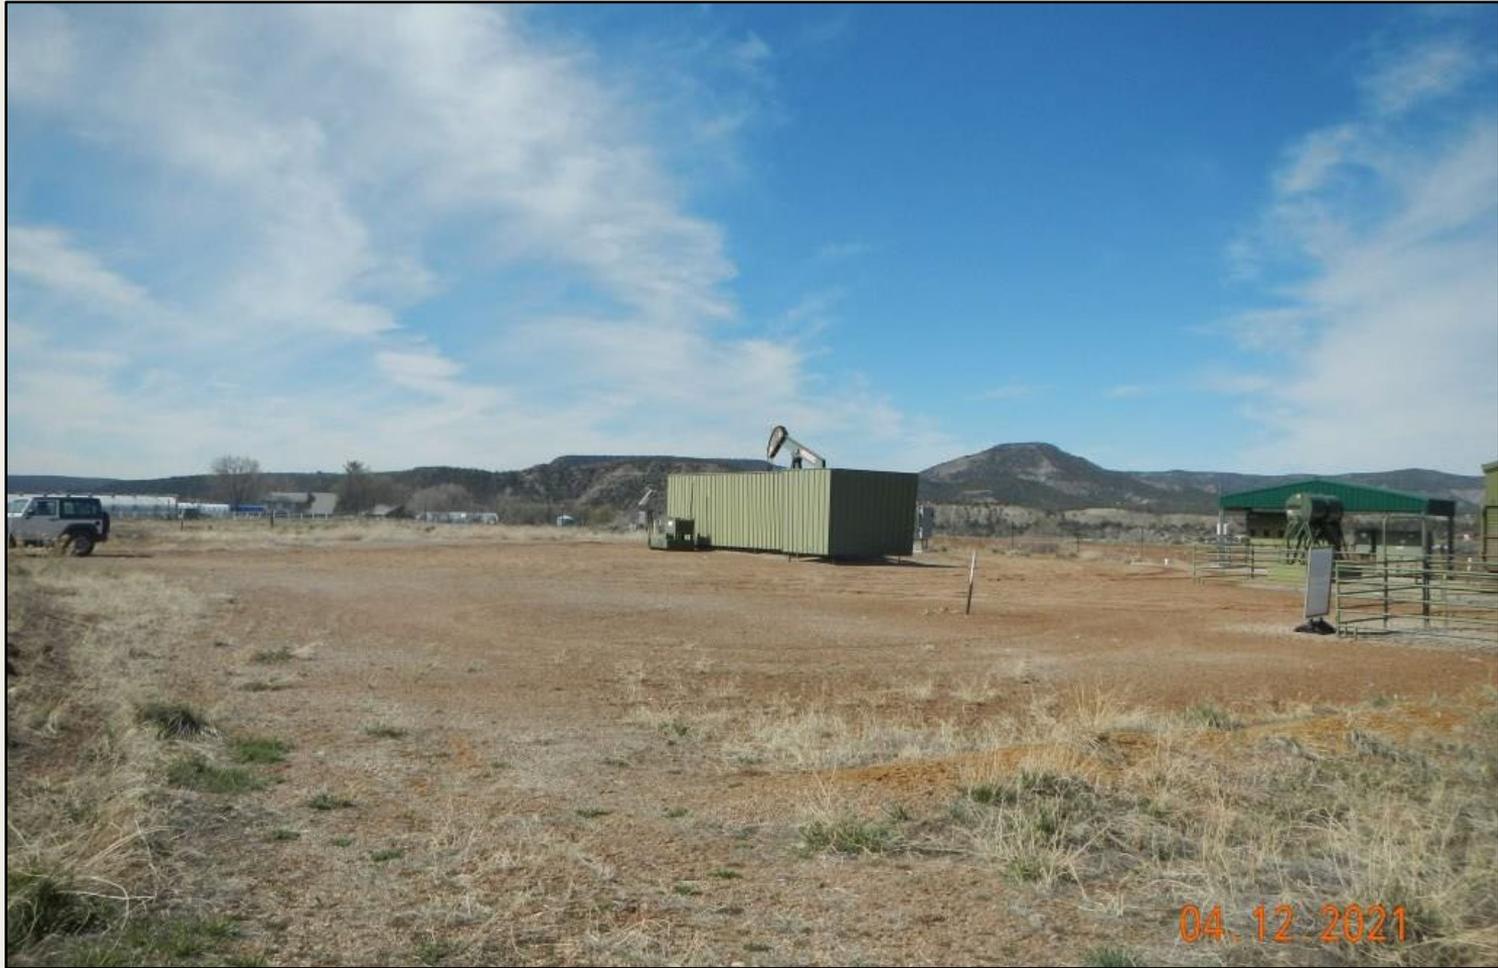
Photo 1. View of the project area from the northeastern corner facing center.

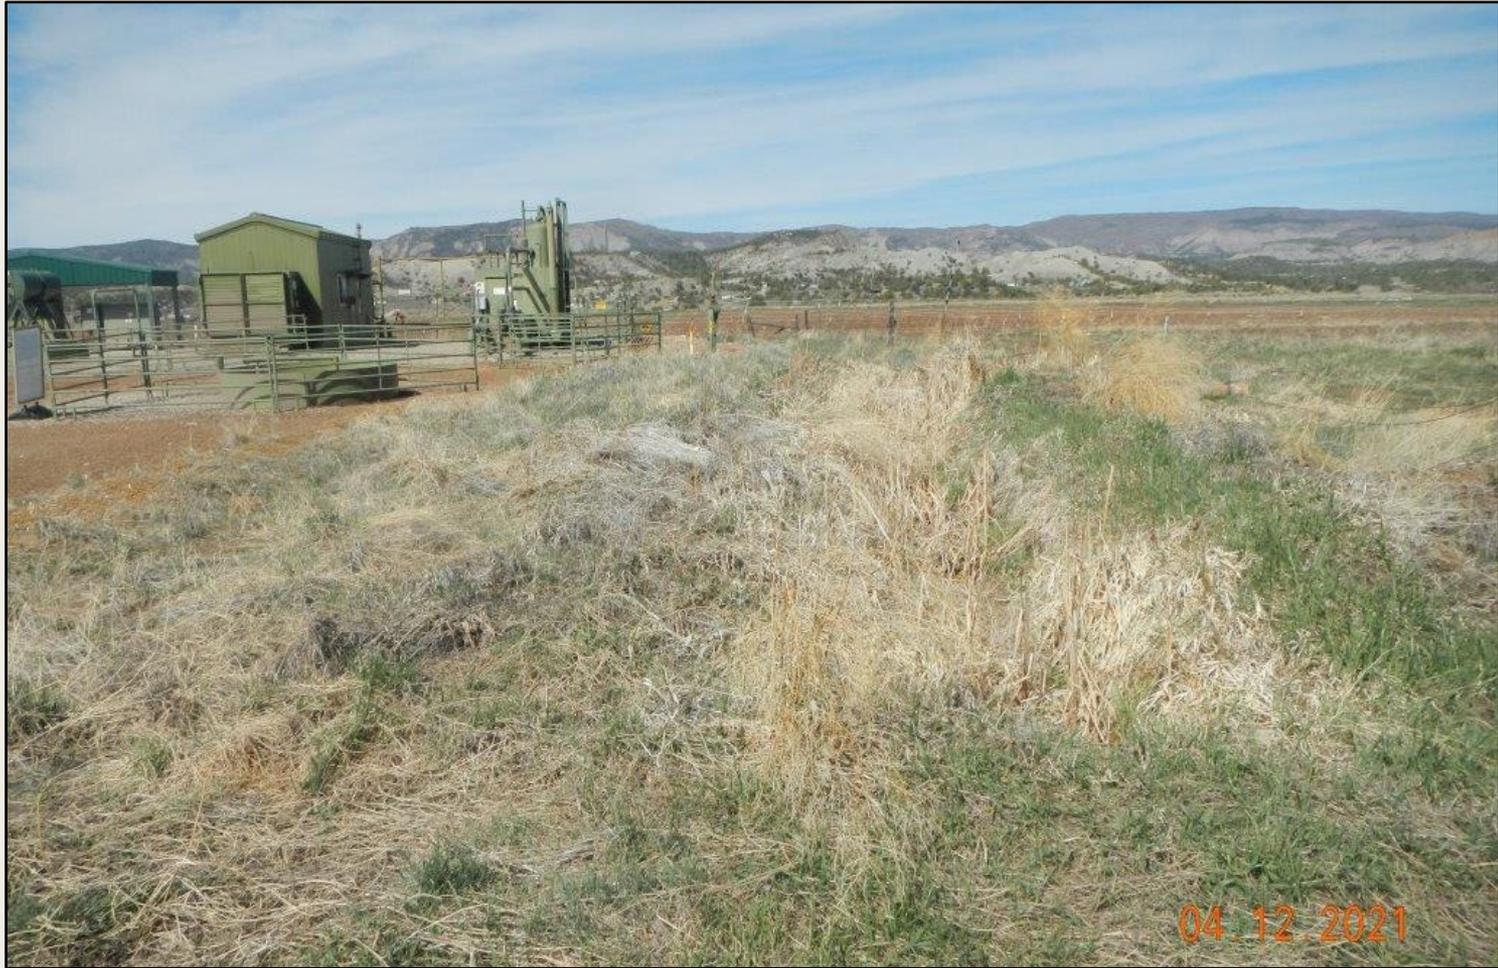
Photo 2. View of the northern project area from the northeastern corner facing westward. Revegetation is progressing with smooth brome and sand dropseed.

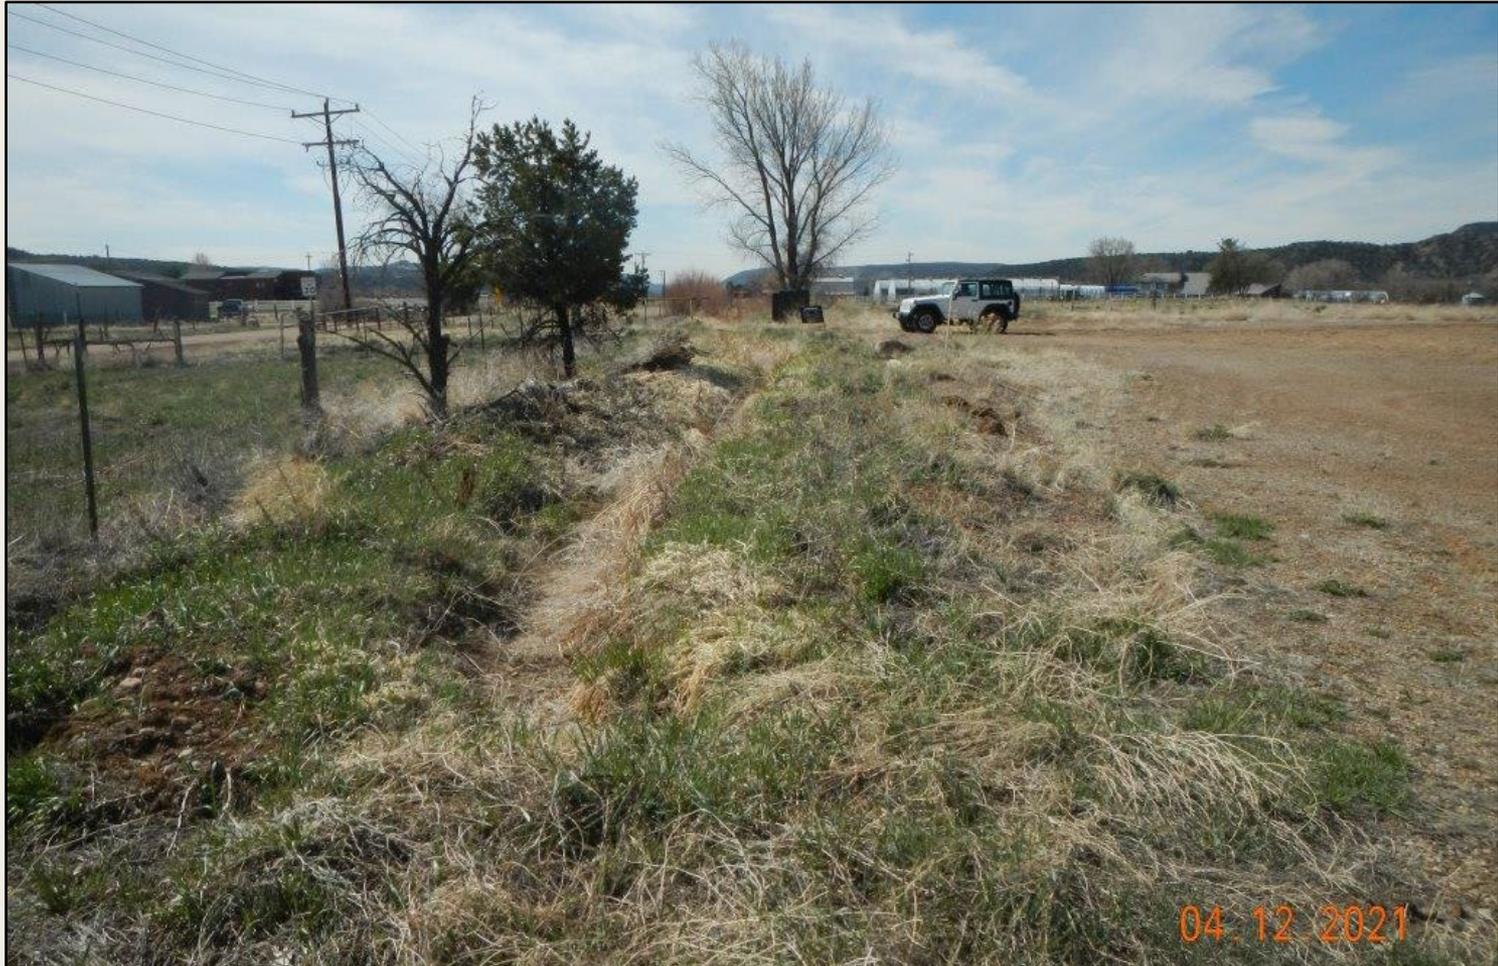
Photo 3. View of the eastern project area from the northeastern corner facing southward.

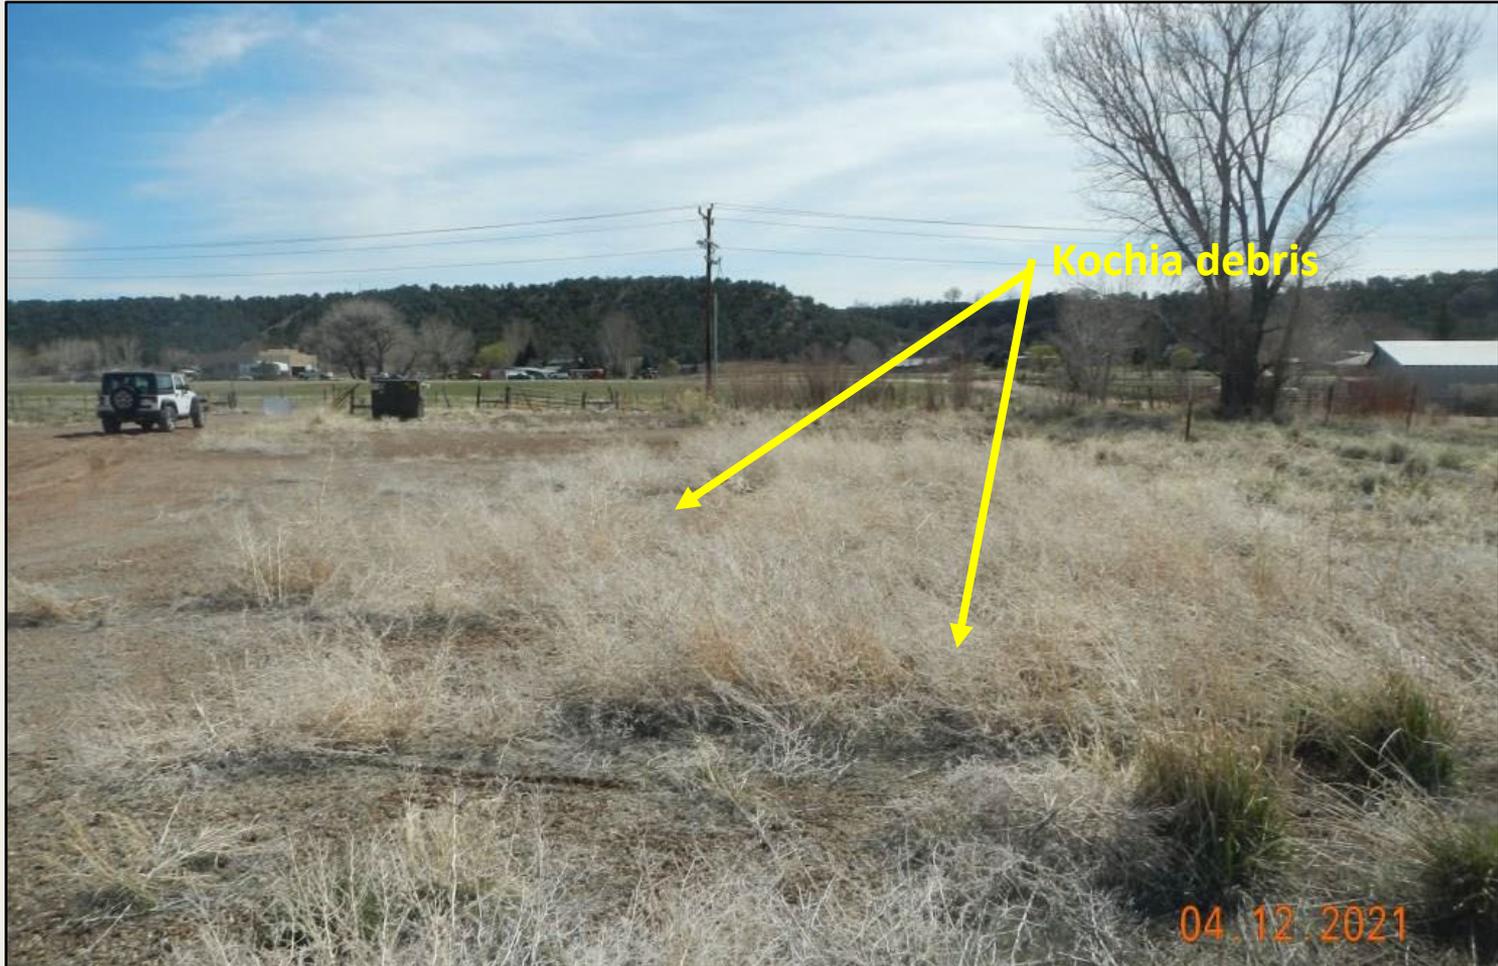
Photo 4. View of the dense kochia debris within the southeastern project area, needs to be removed and properly disposed of.

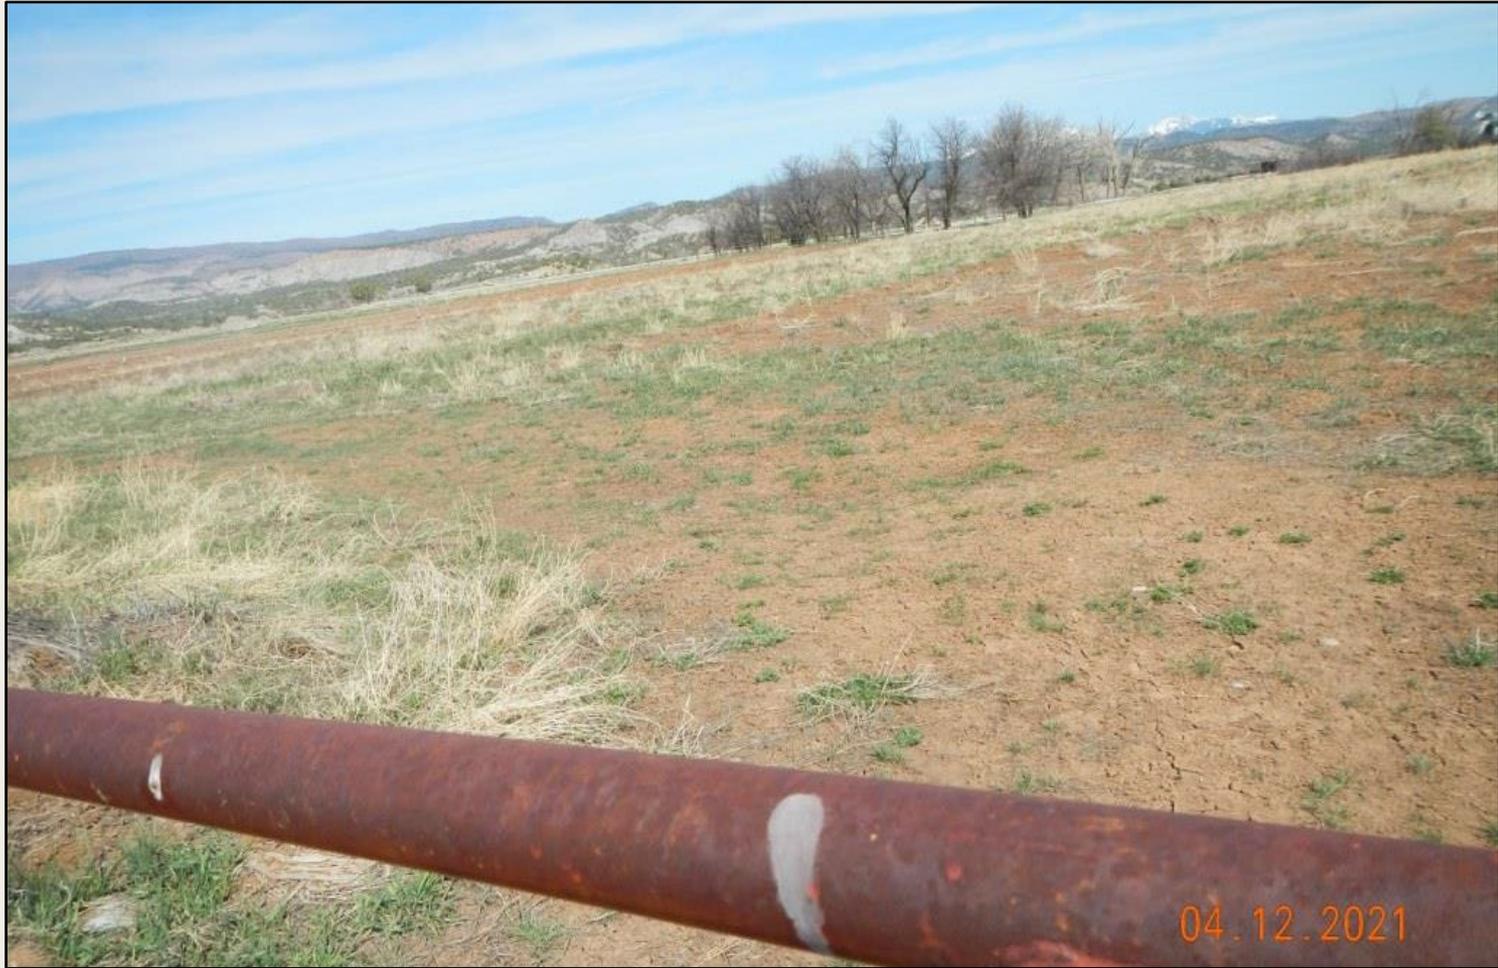
Photo 5. View of the reference area comprised of crop field, largely fallow at this time, with grasses such as western wheatgrass, and smooth brome.
